Bridge Inspection Report

01915

US 412-08- LM 5.52

Main Lateral Drain Ditch

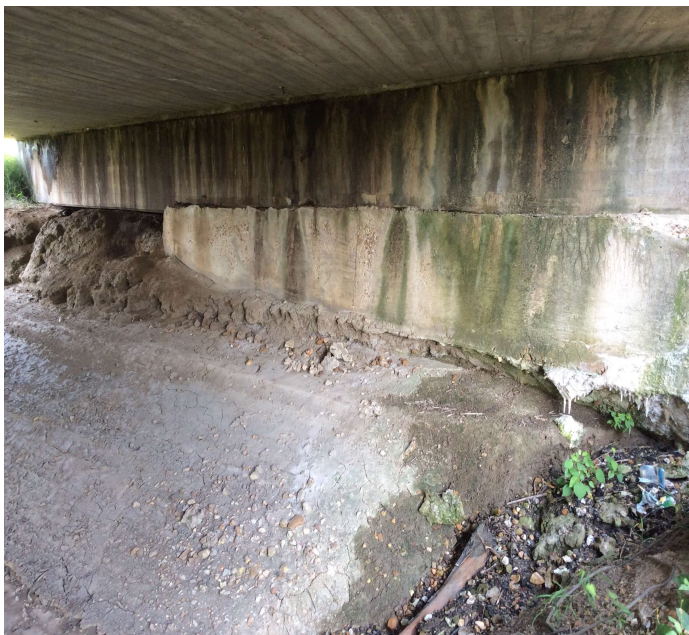
PHOTO 1 Description

Embankment erosion is undermining Abutments Bent 1&4 up to 2.5ft. from roadway runoff exposing Piles 4&5 Bent 4, see 2017 photo.
