Bridge Inspection Report

01974

US 412-08- LM 5.28

OVERCUP SLOUGH

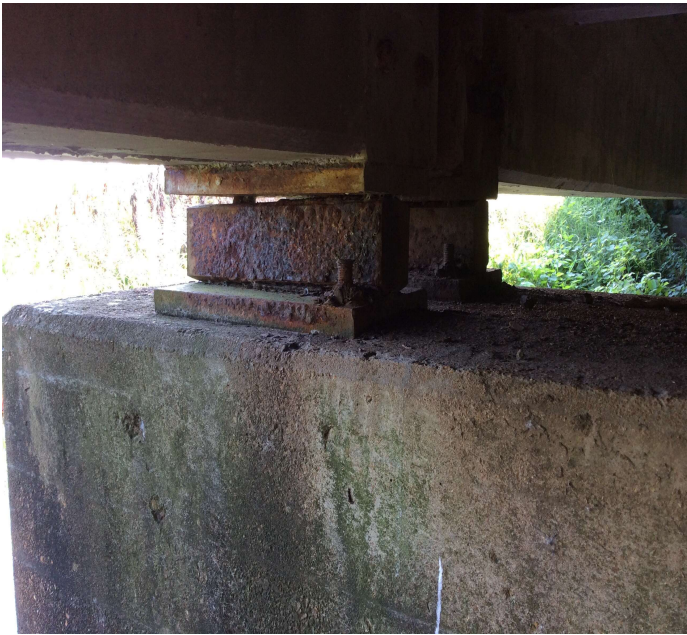
PHOTO 1 Description

Spans 1&2 Girder 1 over Bent 2 is moving under traffic.

Span 1 Girder 1 over Bent 2 has a 1/2 gap, see 2017 photo.

Stage: Monitor

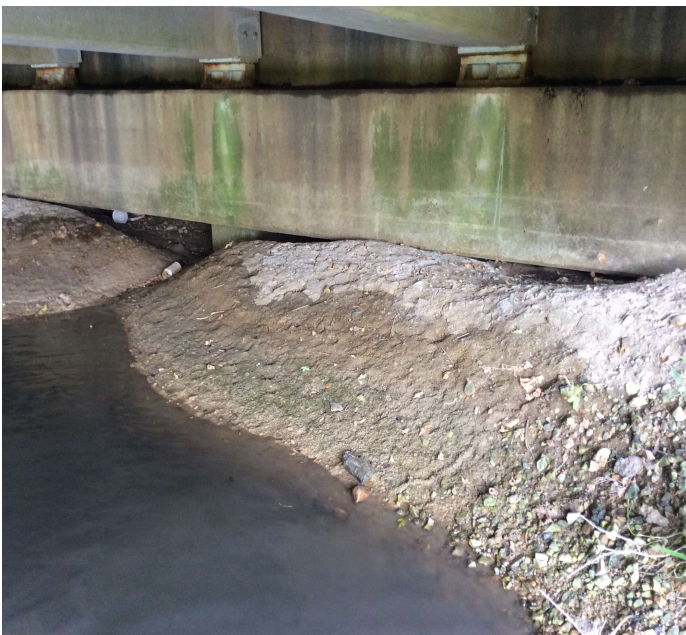
PHOTO 1 Description

Some erosion near Abutments Bents 1&3, with the Abutments at Pile 3 beginning to undermine up to 2ft., see 2017 photo.

Stage: Monitor
