WRONG-WAY CRASH STUDY

INTERSTATES AND FREEWAYS | CALENDAR YEAR 2021

Wrong-Way Crash Report

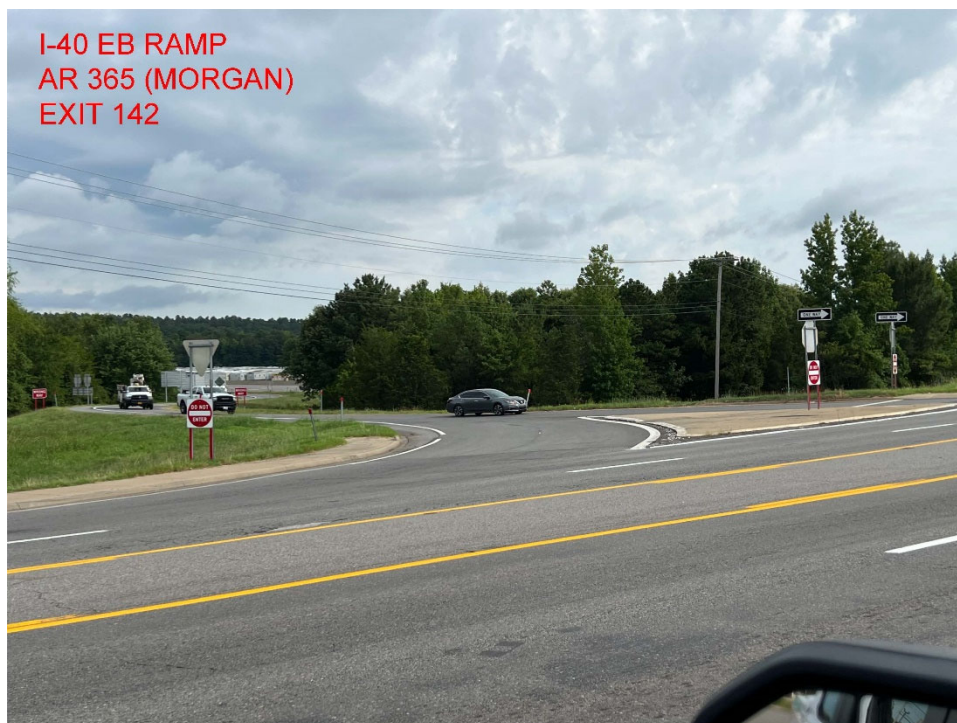
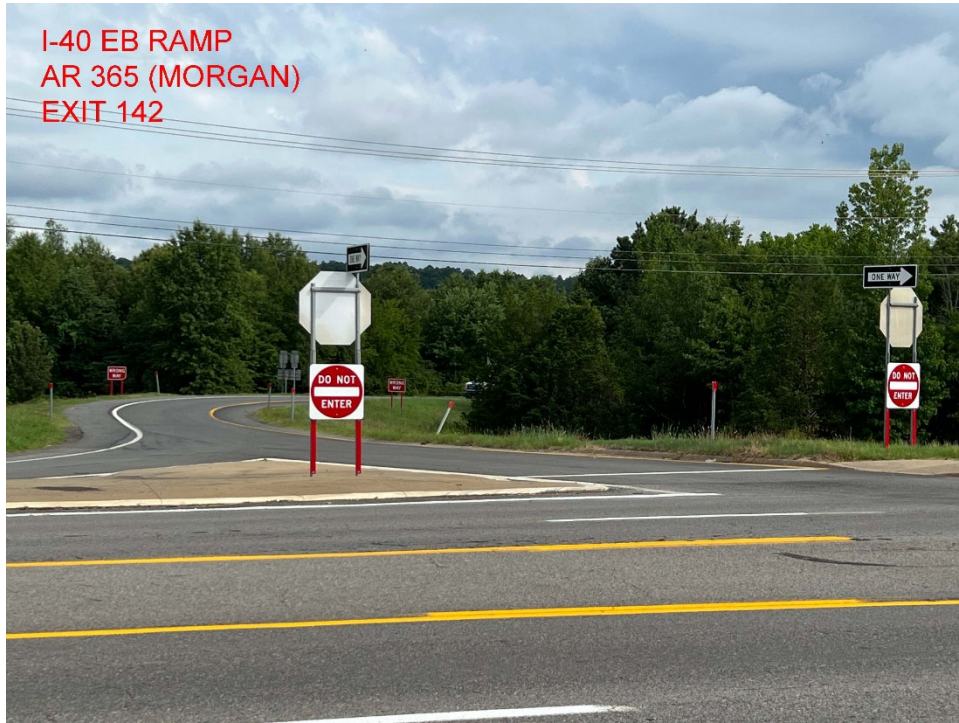
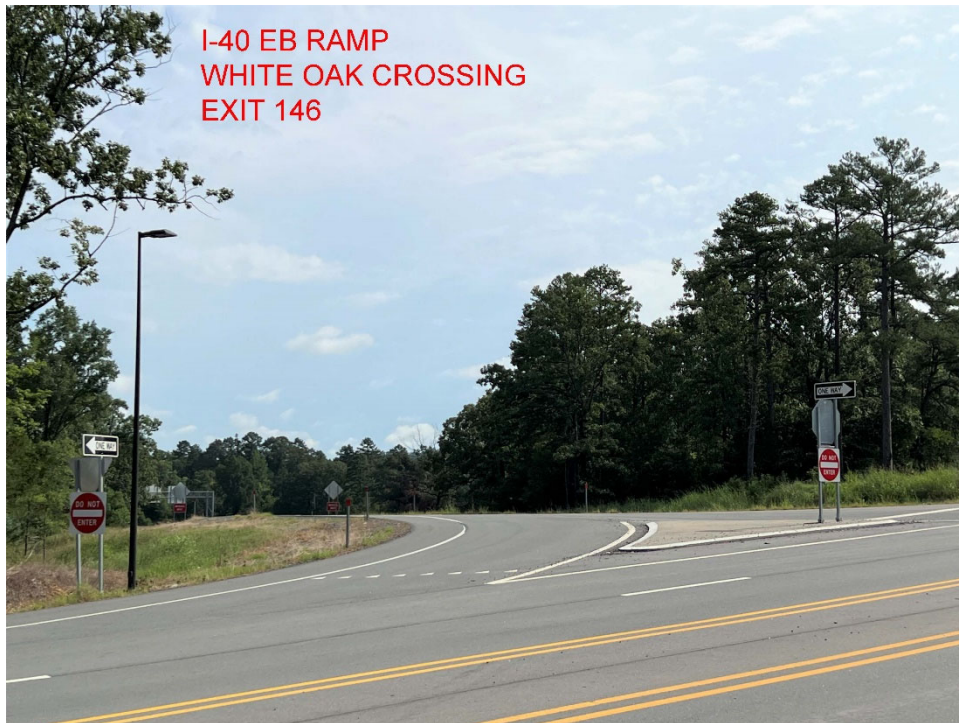
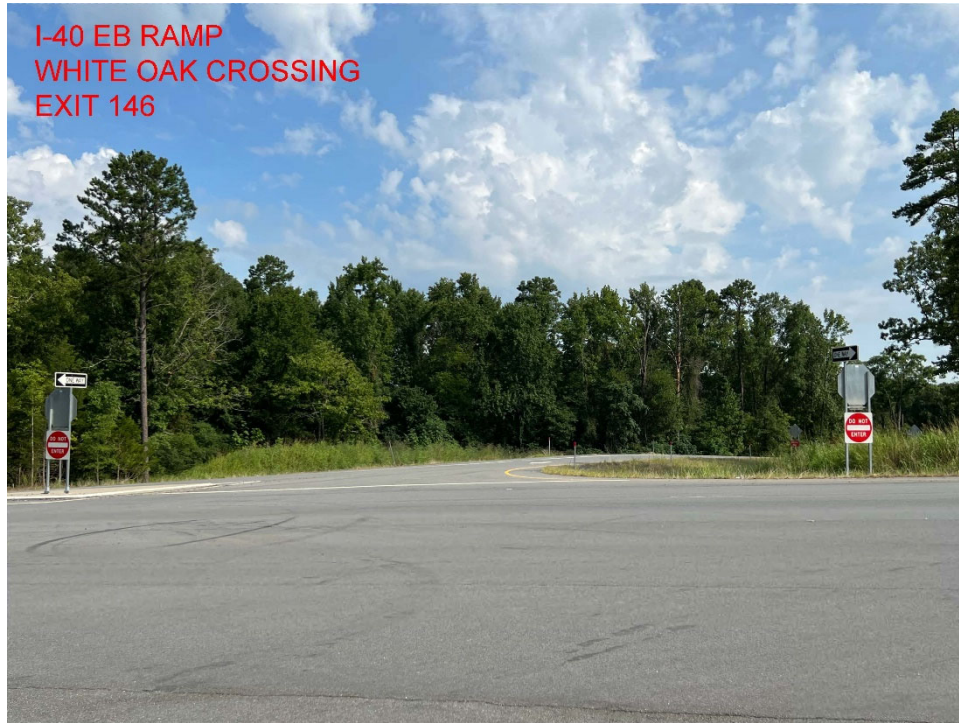
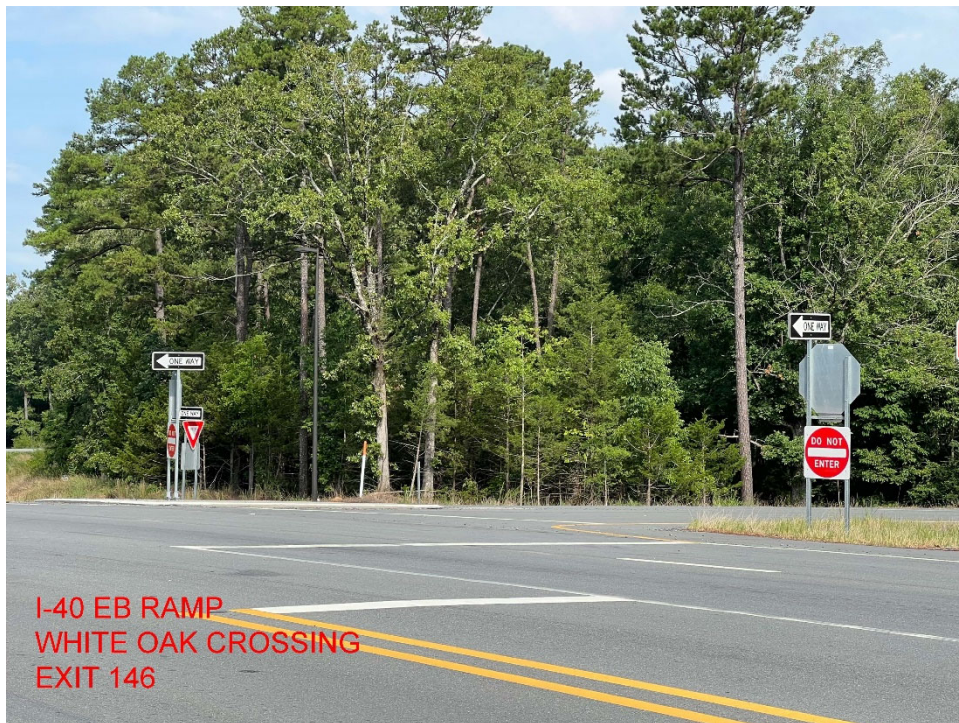
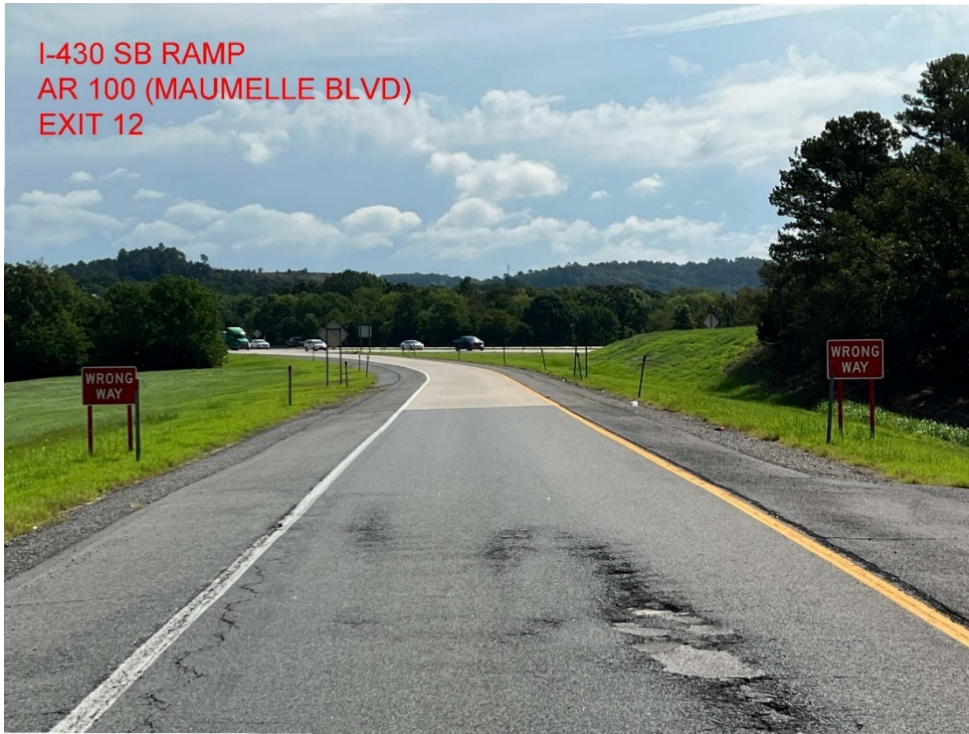
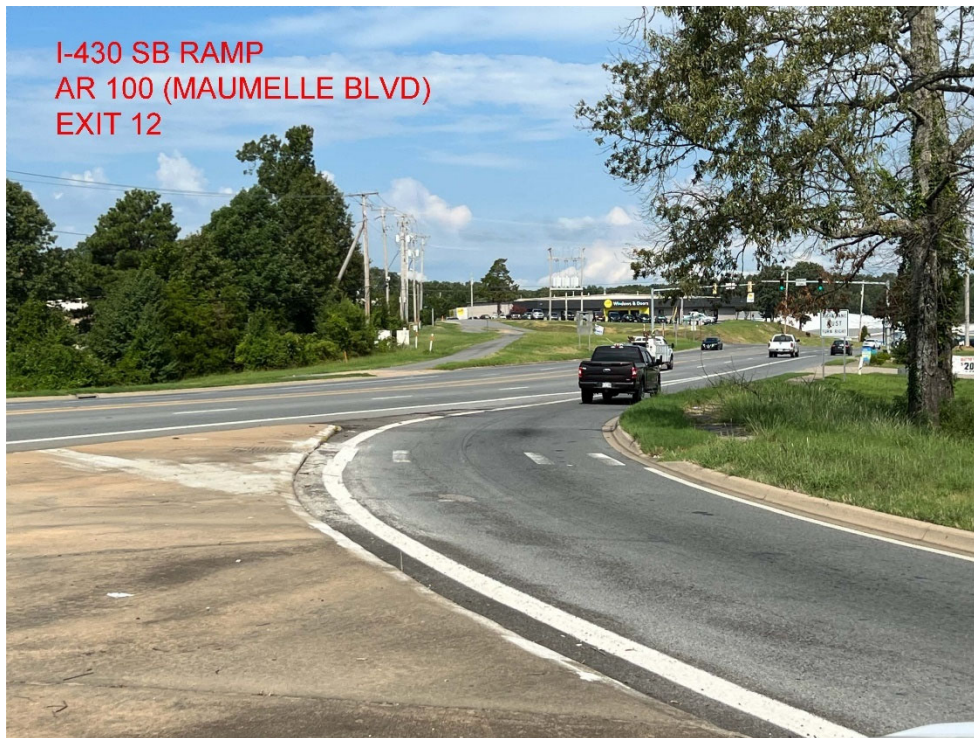
The interchange at Exit 142 was reviewed. Signs were in place and in conformance with MUTCD and ARDOT requirements. However, pavement markings (yield bar, arrow) have faded and need to be replaced to conform with current ARDOT requirements.

The interchange at Exit 12 via Exit 147 was reviewed. Signs were in place and in conformance with MUTCD. However, red vertical reflective strips need to be installed on the "Do Not Enter" and "Wrong Way" signposts to conform with current ARDOT requirements. Also, pavement markings (arrow) have faded and need to be replaced to conform with current ARDOT requirements. The sign modifications have been implemented.

The interchange at Exit 148 was reviewed. Pavement markings and signs were in conformance with MUTCD. However, the "Yield" sign was damaged and the "Do Not Enter" sign needed to be upsized to conform with current ARDOT requirements. Also, the sign assemblies needed to be straightened. These modifications have been implemented.

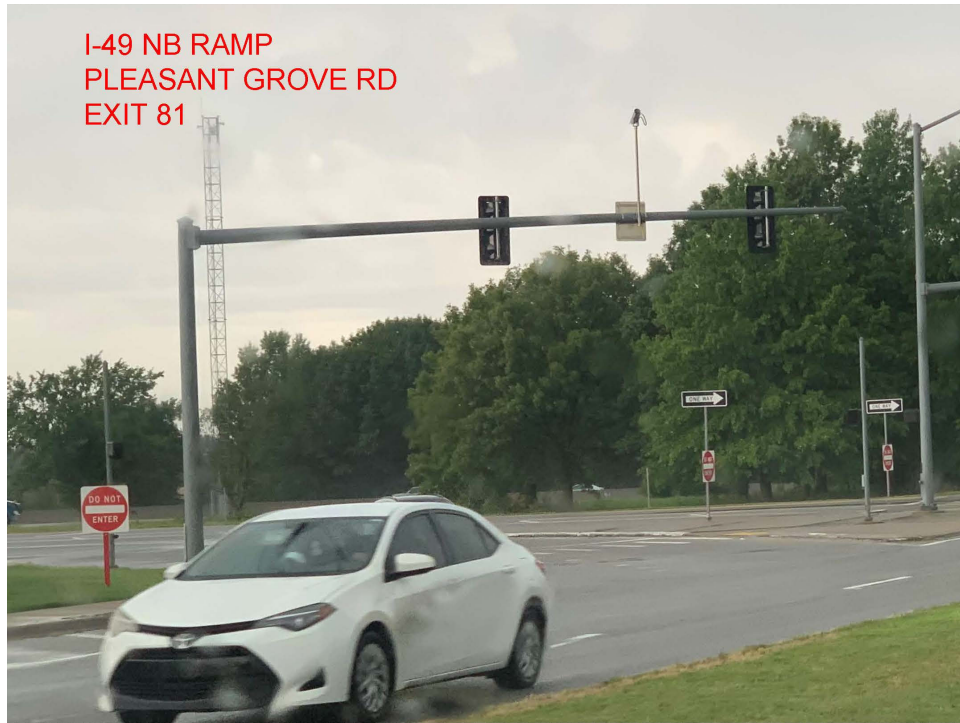
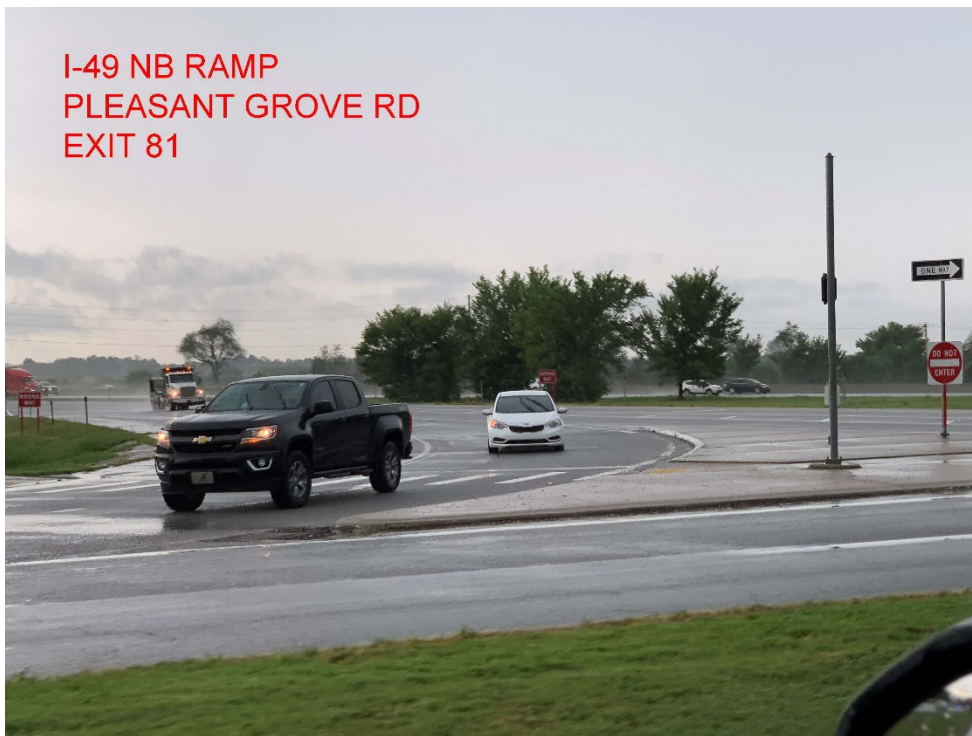
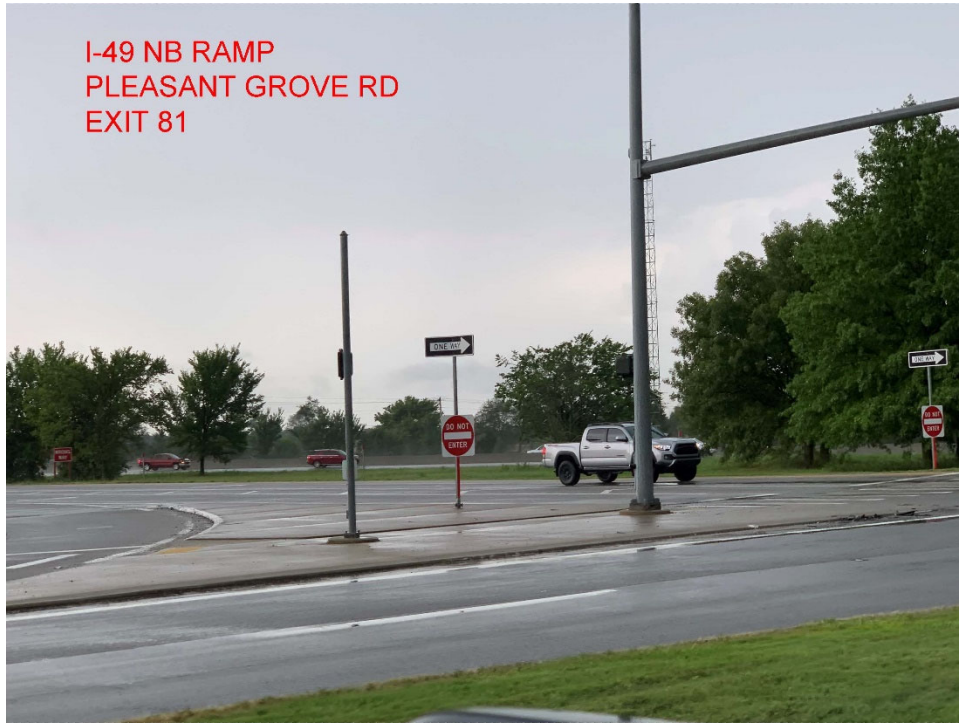
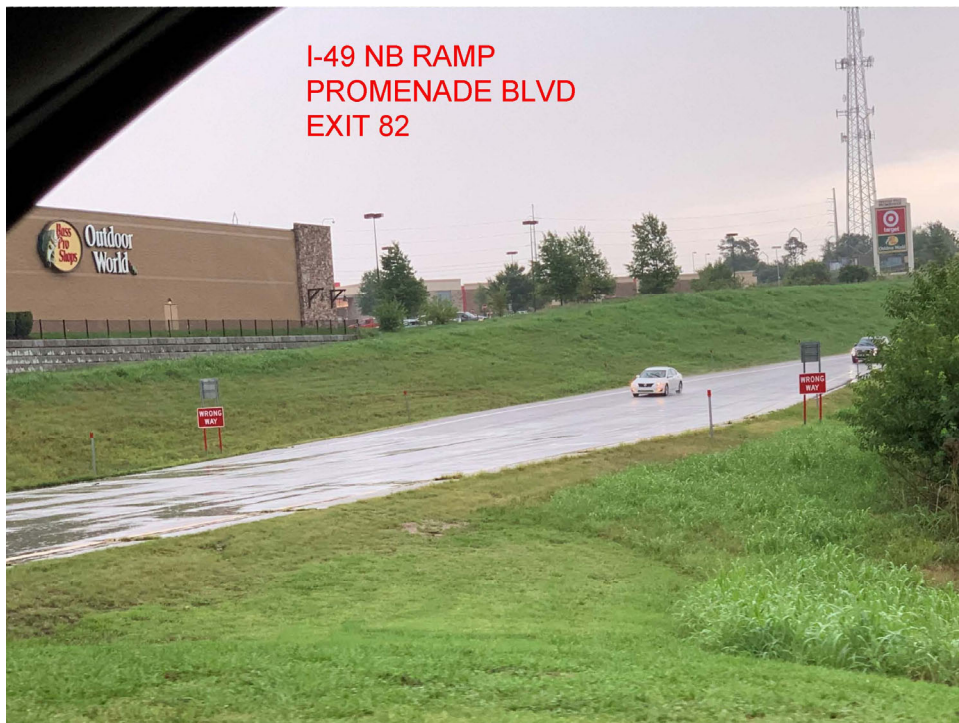
The interchange at Exit 81 was reviewed. Pavement markings and signs were in place and in conformance with MUTCD and ARDOT requirements.

The interchange at Exit 82 was reviewed. Signs were in place and in conformance with MUTCD. However, additional "Do Not Enter" signs need to be installed to conform with current ARDOT requirements. These modifications have been implemented.

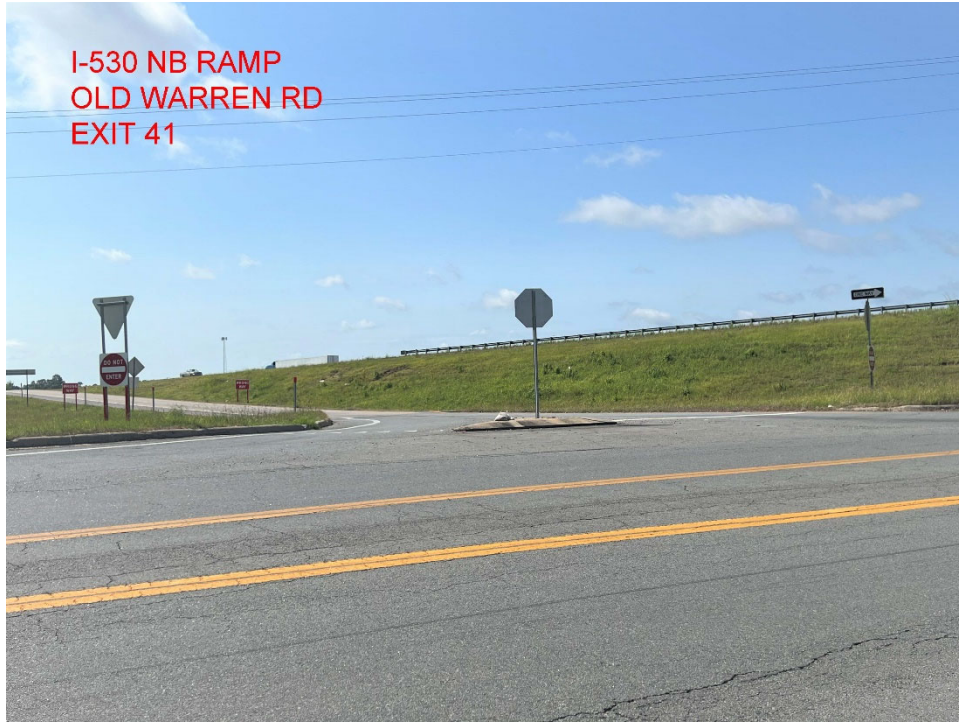
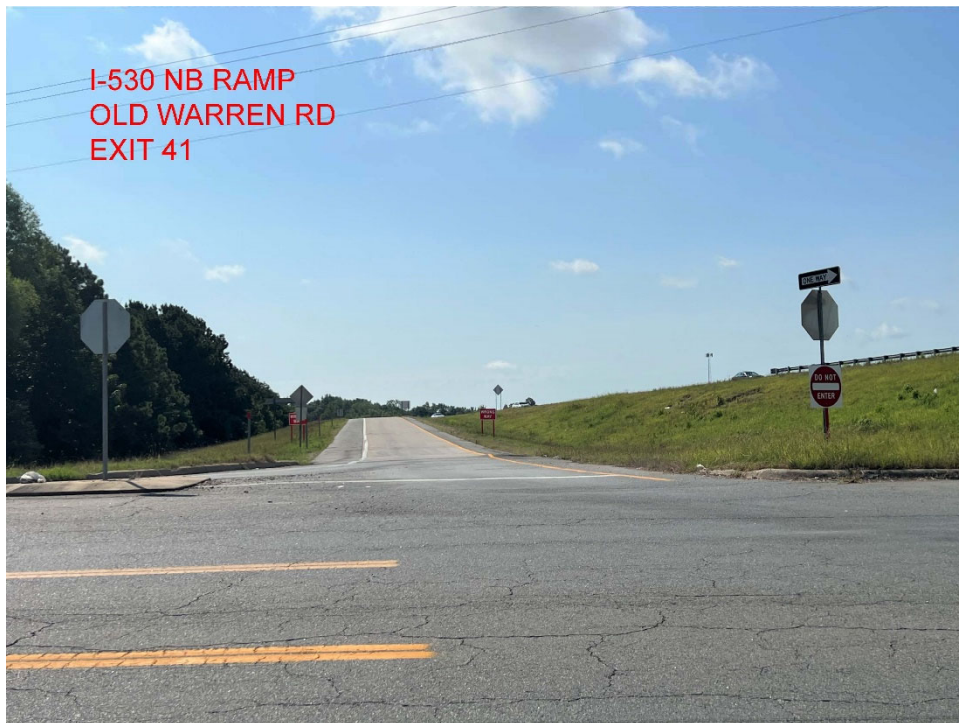
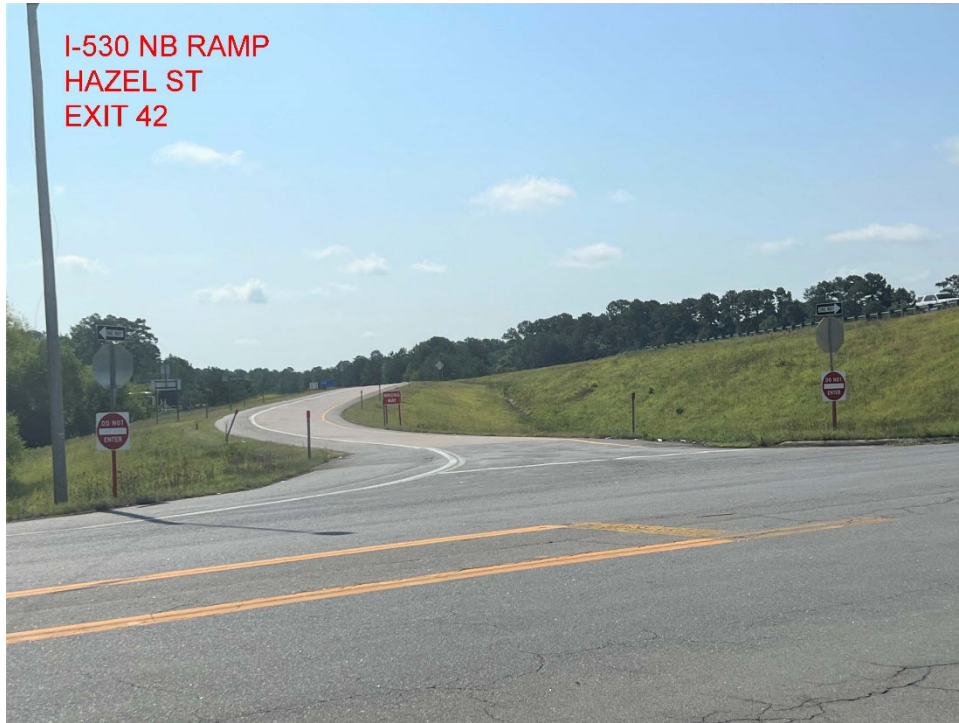
The interchange at Exit 41 was reviewed. Signs were in place and in conformance with MUTCD. However, the “Stop”, “Do Not Enter”, and “One Way” sign assemblies were missing, or damaged and red vertical reflective strips need to be installed on the signposts to be conform with current ARDOT requirements. Also, the pavement marking arrow needs to be moved up 90’ to conform with current ARDOT requirements. These modifications have been implemented.

The interchange at Exit 42 was reviewed. Signs were in conformance with MUTCD. However, the “Wrong Way” sign was missing and red vertical reflective strips need to be installed on the signpost to be consistent with current ARDOT requirements. Also, the pavement marking arrow needs to be moved up 200’ to conform with current ARDOT requirements. These modifications have been implemented.

The interchange at Exit 43 was reviewed. Pavement markings and signs were in place and in conformance with MUTCD and ARDOT requirements.

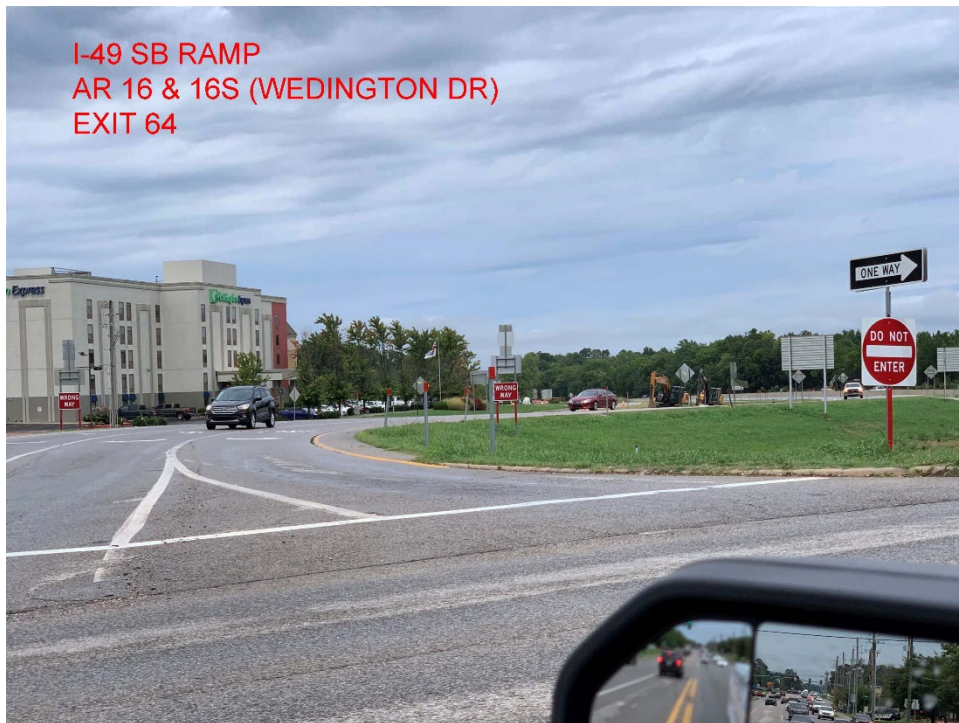
The interchange at Exit 64 was reviewed. Pavement markings and signs were in place and in conformance with MUTCD and ARDOT requirements.

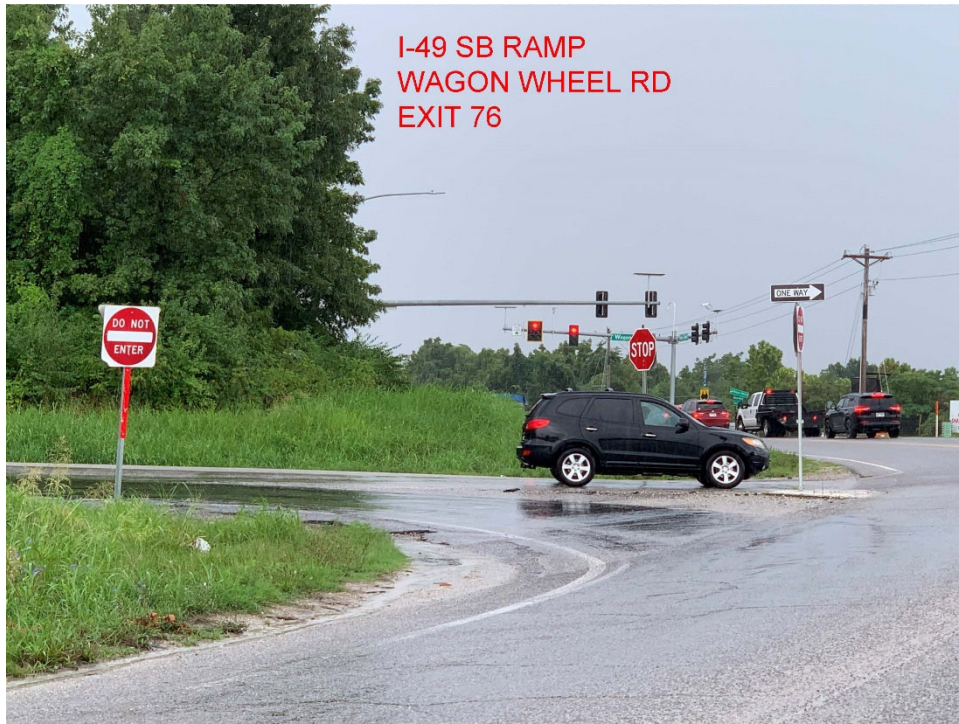
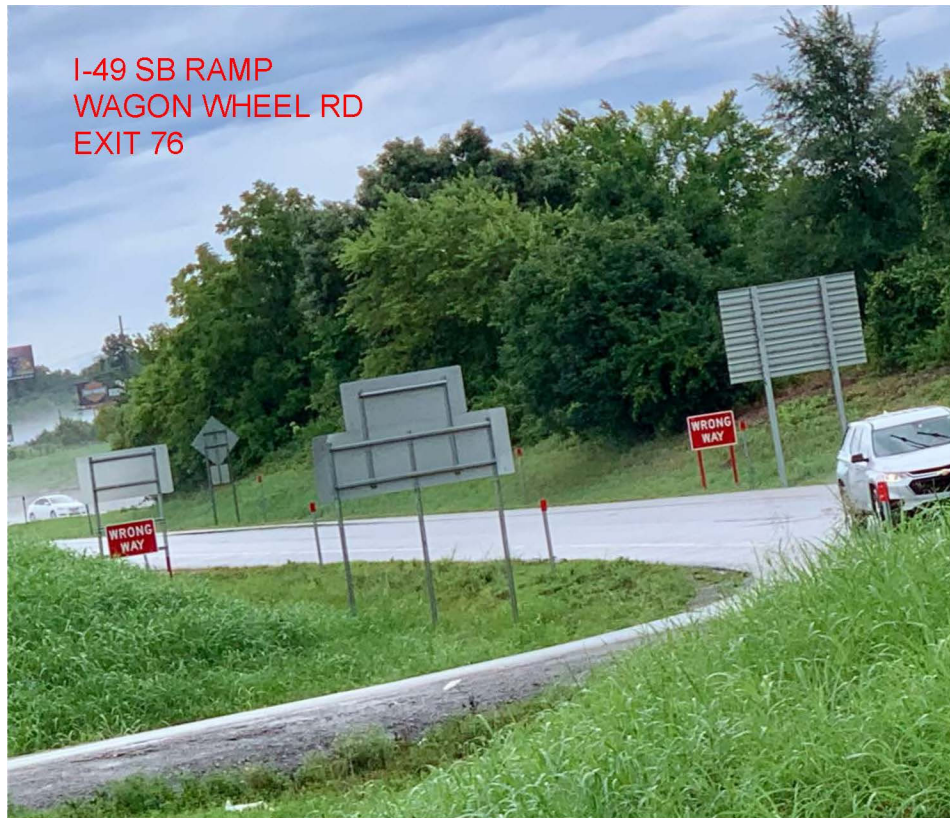
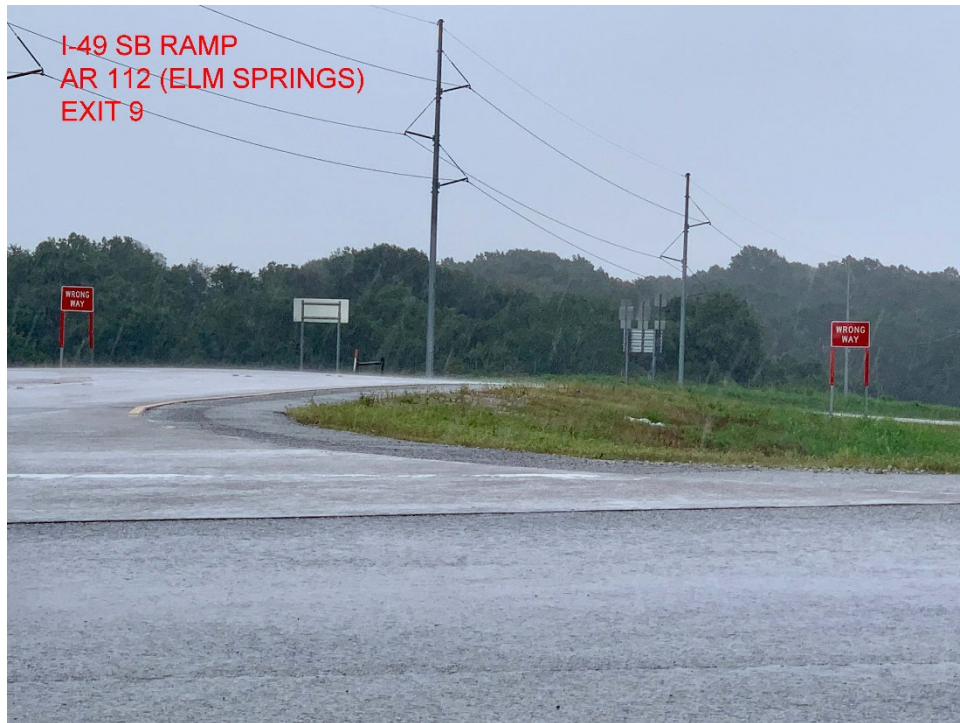
The interchange at Exit 76 was reviewed. Pavement markings were in place and in conformance with MUTCD and ARDOT requirements. However, the “One Way” signs were missing and need to be installed to conform with current ARDOT requirements. These modifications have been implemented.

The interchange at Exit 9 via Exit 77 was reviewed. Pavement markings and signs were in place and in conformance with MUTCD and ARDOT requirements.

The interchange at Exit 78 was reviewed. Pavement markings and signs were in place and in conformance with MUTCD and ARDOT requirements.

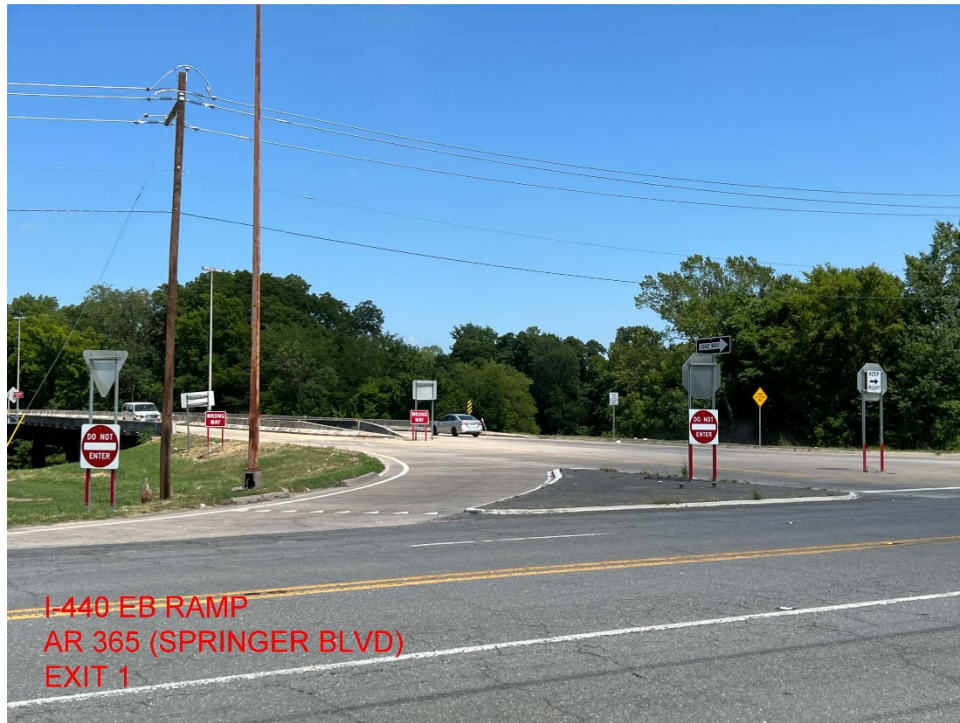
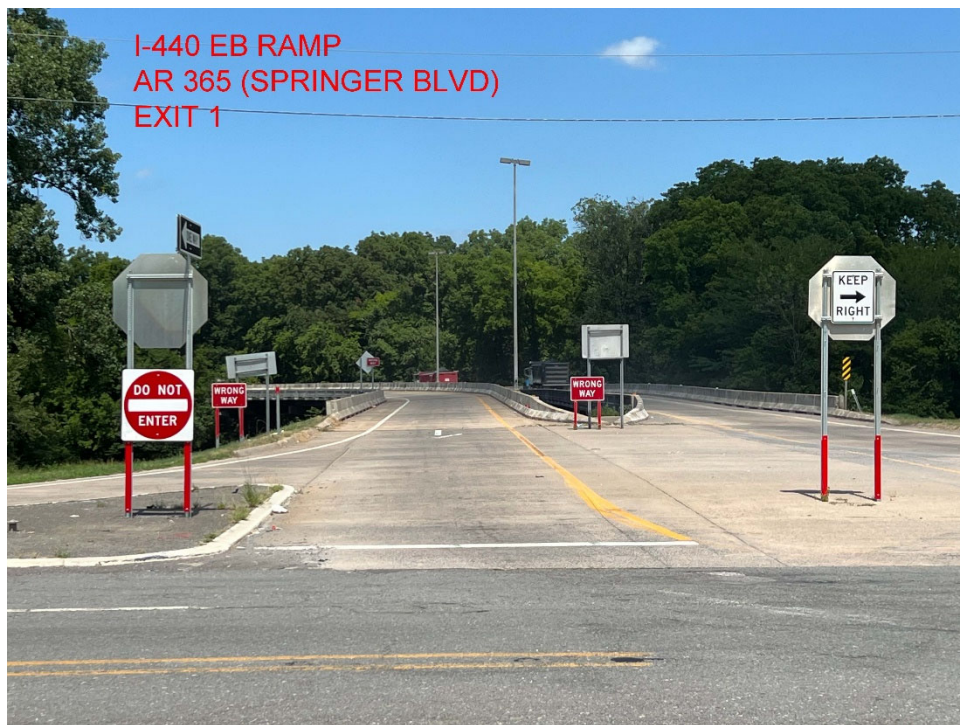
The interchange at Exit 1 via Exit 138A was reviewed. Signs were in place and in conformance with MUTCD and ARDOT requirements. However, pavement markings (arrow) have faded and need to be replaced to conform with current ARDOT requirements. These modifications have been implemented.

The interchange at Exit 3 via Exit 138B was reviewed. Signs were in conformance with MUTCD and ARDOT requirements. However, pavement markings (stop bar, yield bar, arrow) need to be installed to conform with current ARDOT requirements. These modifications have been implemented.

The interchange at Exit 139A was reviewed. Signs were in place and in conformance with MUTCD and ARDOT requirements. However, pavement markings (stop bar) need to be installed to conform with current ARDOT requirements. These modifications have been implemented.

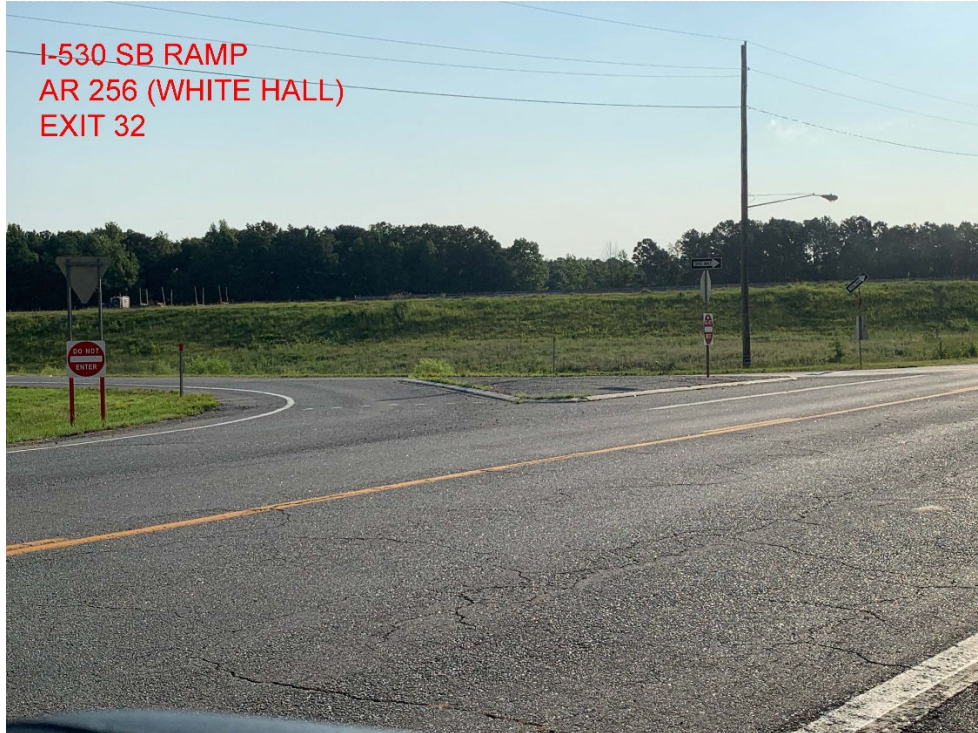
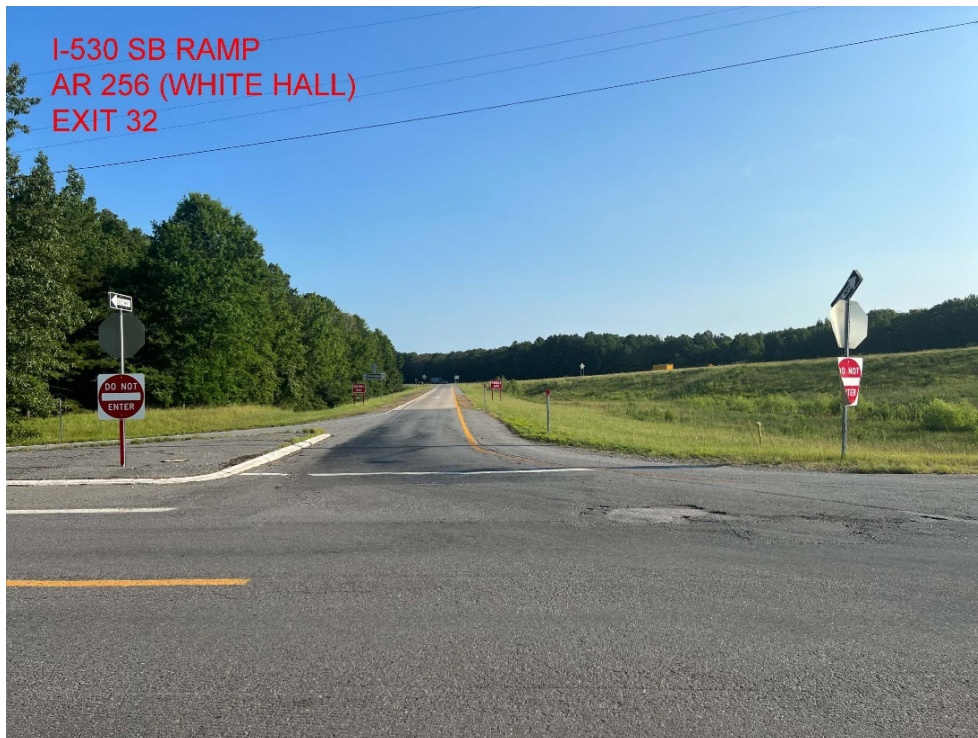
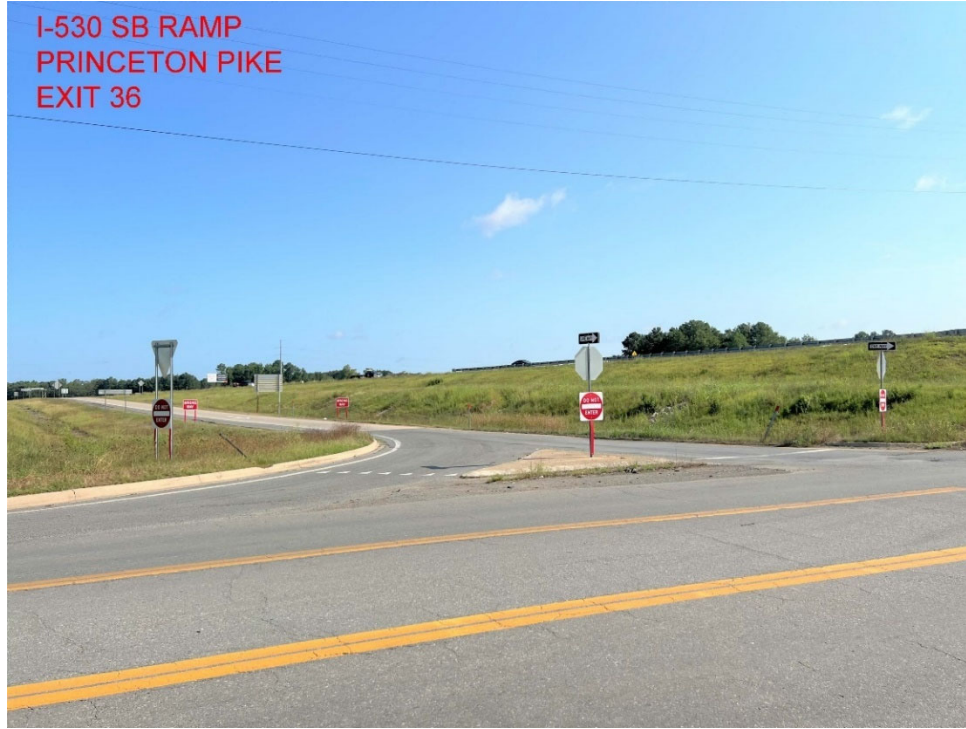
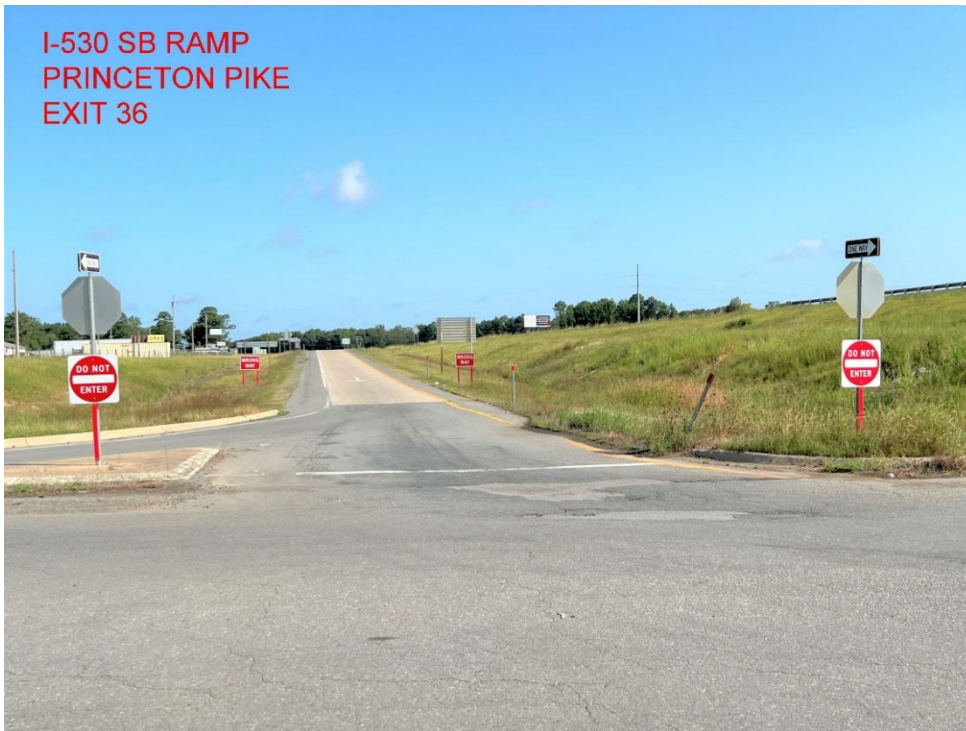
The interchange at Exit 32 was reviewed. Pavement markings and signs were in place and in conformance with MUTCD. However, the “Do Not Enter” sign needs to be replaced to conform with current ARDOT requirements. This modification has been implemented.

The interchange at Exit 34 was reviewed. Signs were in conformance with MUTCD and ARDOT requirements. However, pavement markings (stop bar and arrow) have faded and need to be replaced to conform with current ARDOT requirements. These modifications have been implemented.

The interchange at U.S. 65B and Bryant St via Exit 35 was reviewed. Pavement markings and signs were in place and in conformance with MUTCD. However, an additional “Do Not Enter” sign needs to be installed, and the existing “Do Not Enter”, “One Way” and “Yield” signs need to be upsized to conform with current ARDOT requirements. These modifications have been implemented.

The interchange at Exit 36 was reviewed. Pavement markings and signs were in place and in conformance with MUTCD and ARDOT requirements.

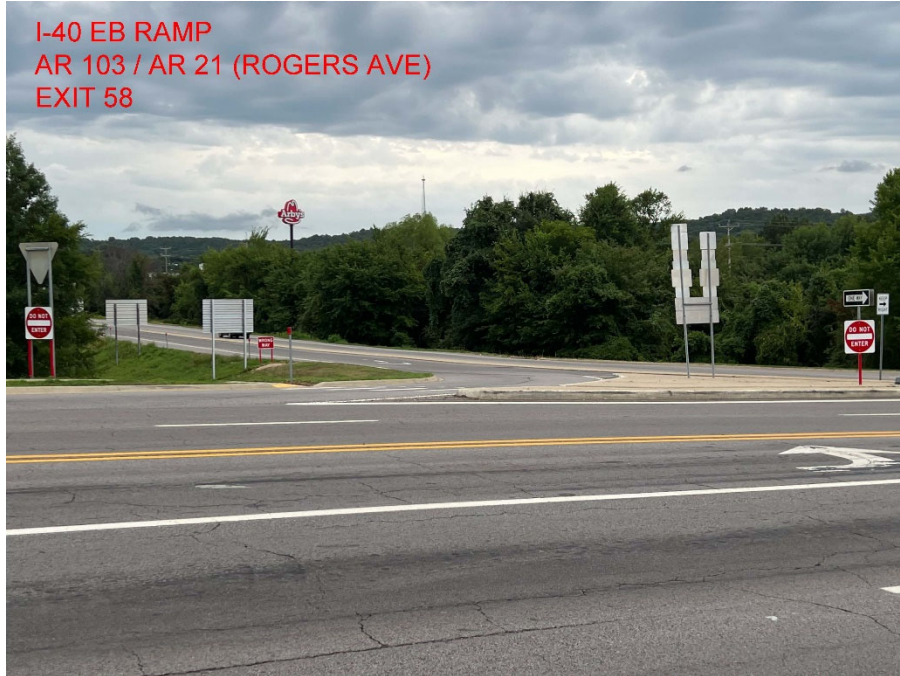
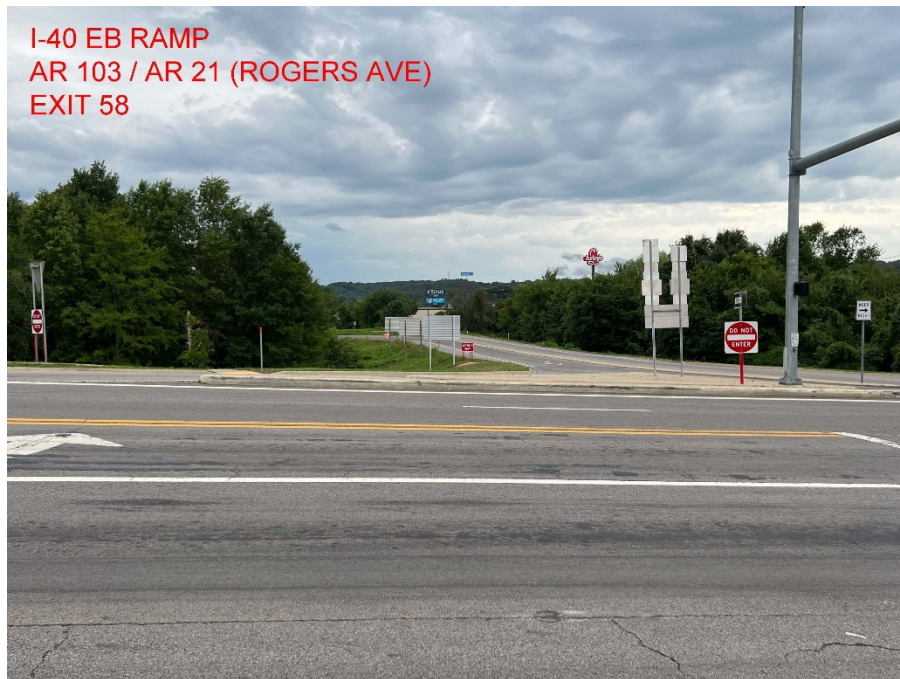
The interchange at Exit 58 was reviewed. Signs were in conformance with MUTCD. However, the “Keep Right” sign needs to be upsized to conform with current ARDOT requirements. Also, pavement markings (arrow and cat tracks) have faded and need to be replaced to conform with current ARDOT requirements. The sign modifications have been implemented.
