# WRONG-WAY CRASH STUDY

INTERSTATES AND FREEWAYS | CALENDAR YEAR 2022

## Wrong-Way Crash Report

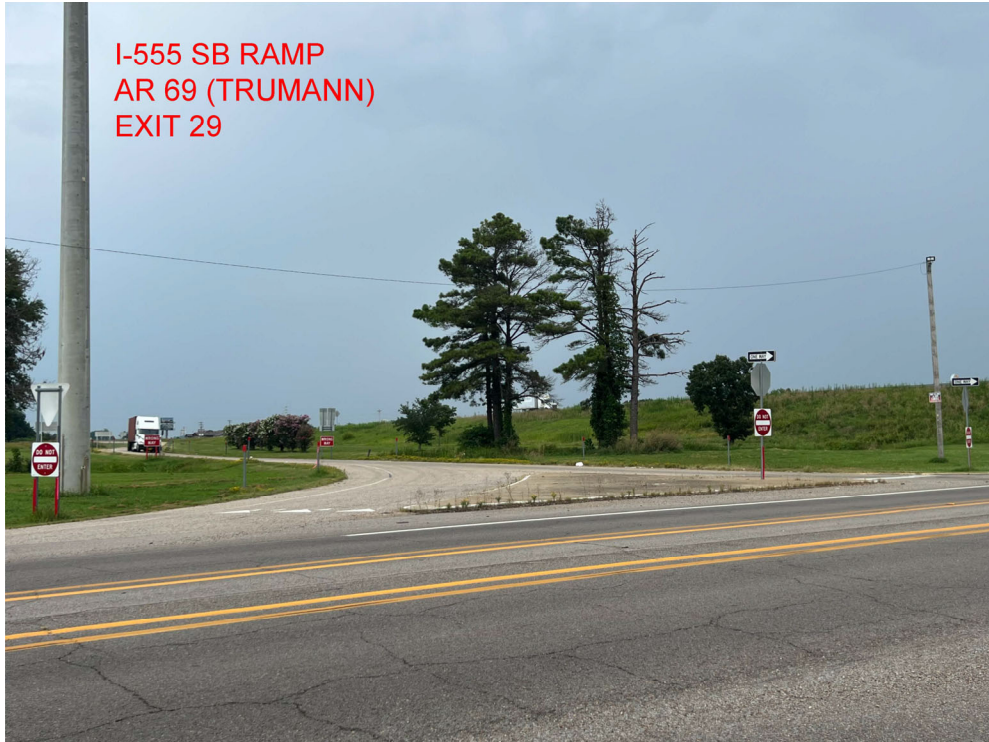
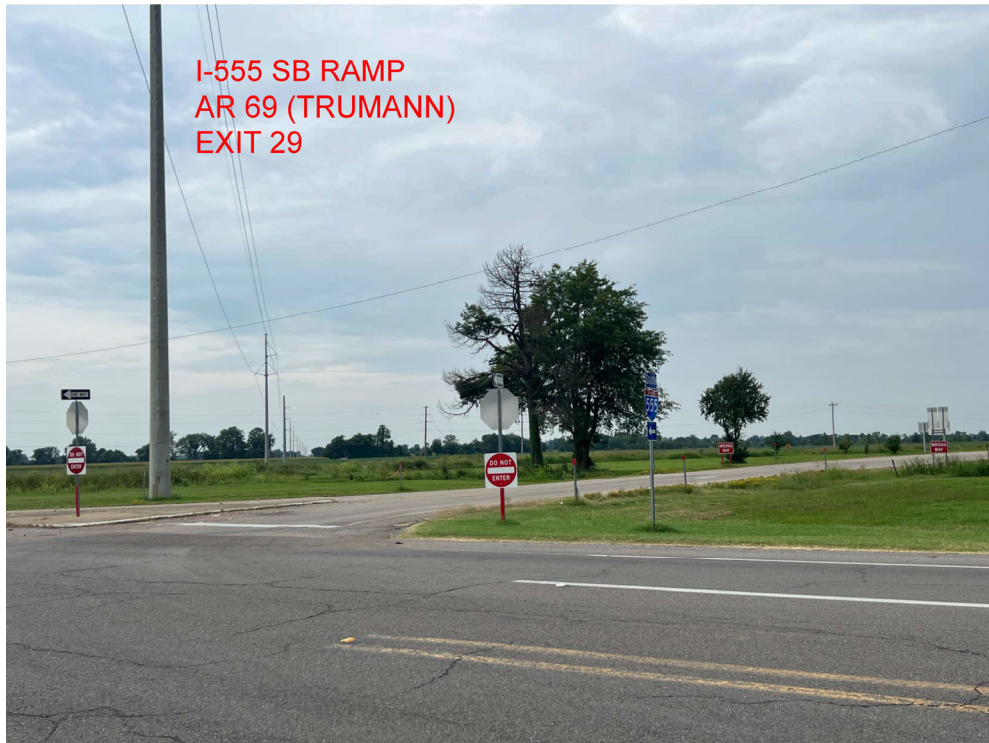
The interchange at Exit 29 was reviewed. Pavement markings and signs were in place and in conformance with MUTCD. However, red vertical strips need to be installed on one of the “Wrong Way” signposts to conform with current ARDOT requirements. This modification has been implemented.

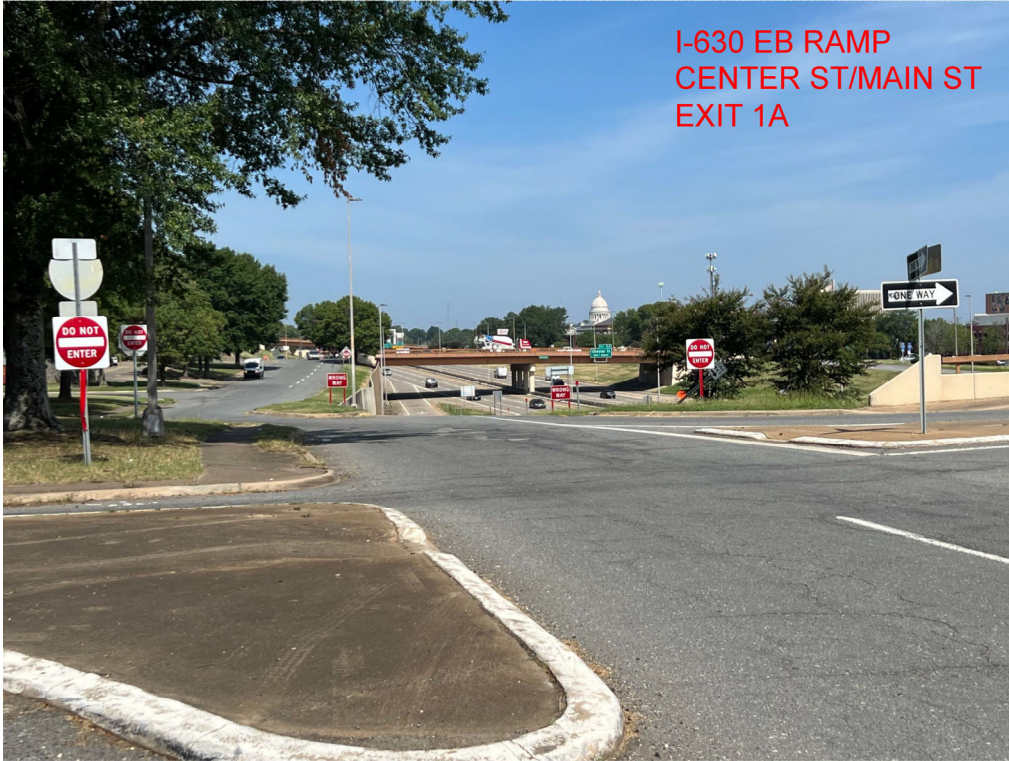
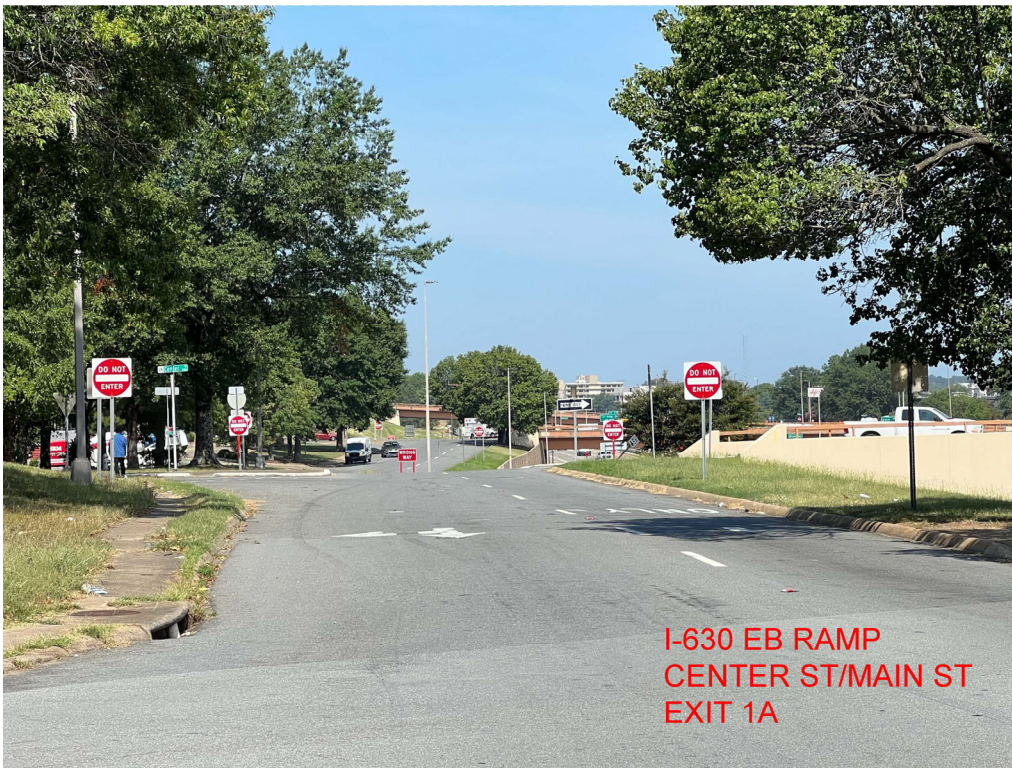
The interchange at Exit 1A was reviewed. Pavement markings and signs were in place and in conformance with MUTCD and ARDOT requirements.

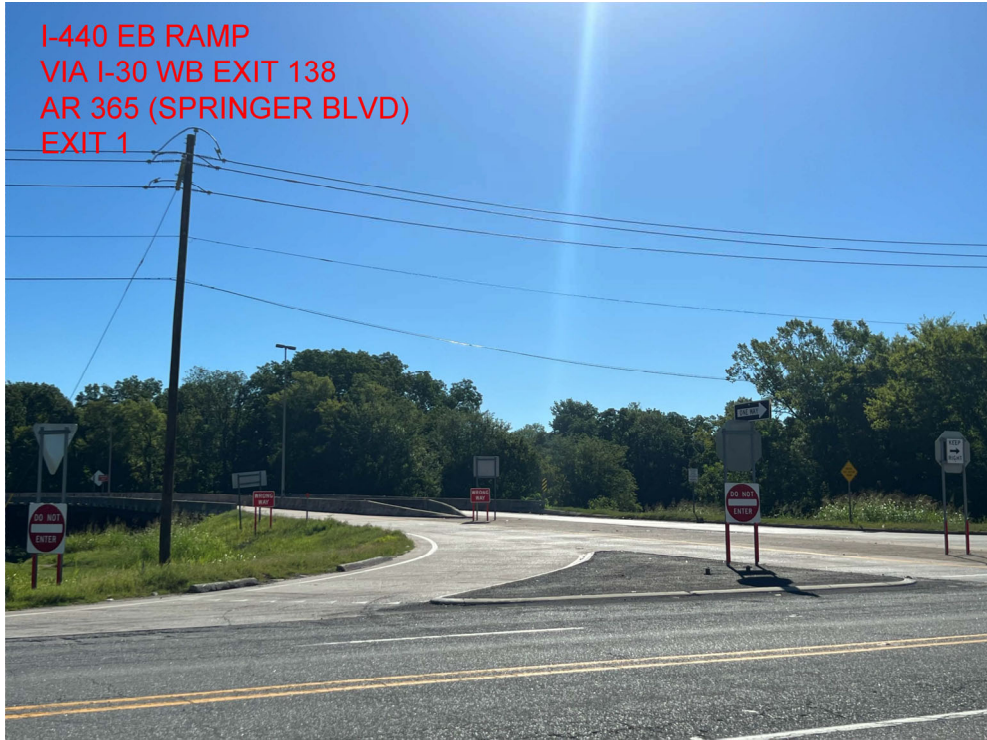
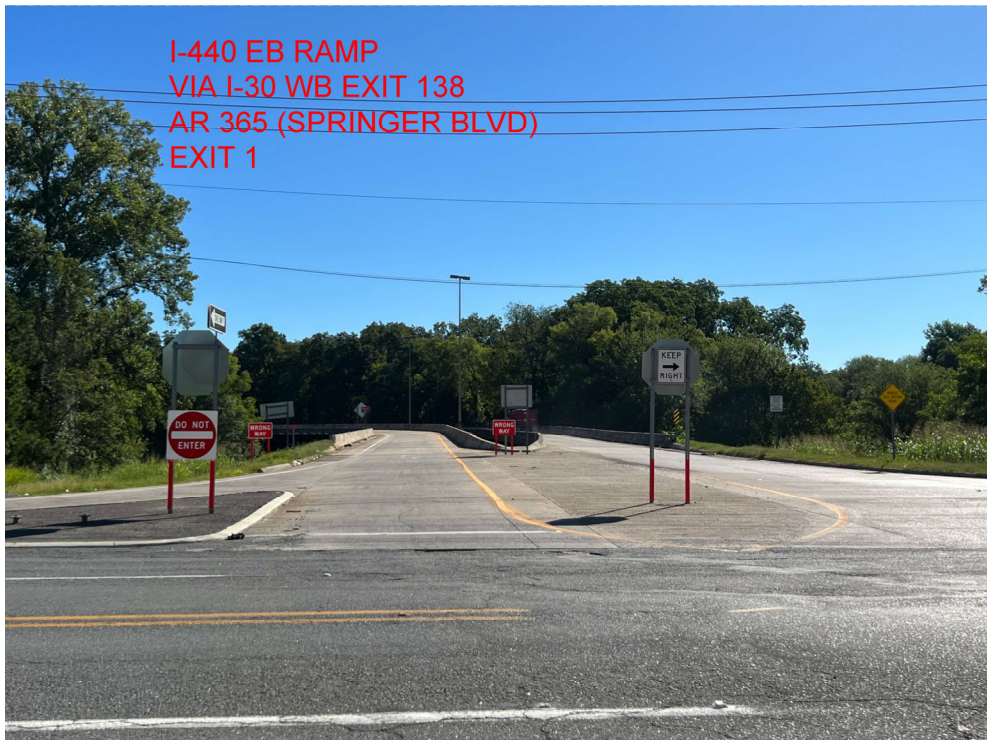
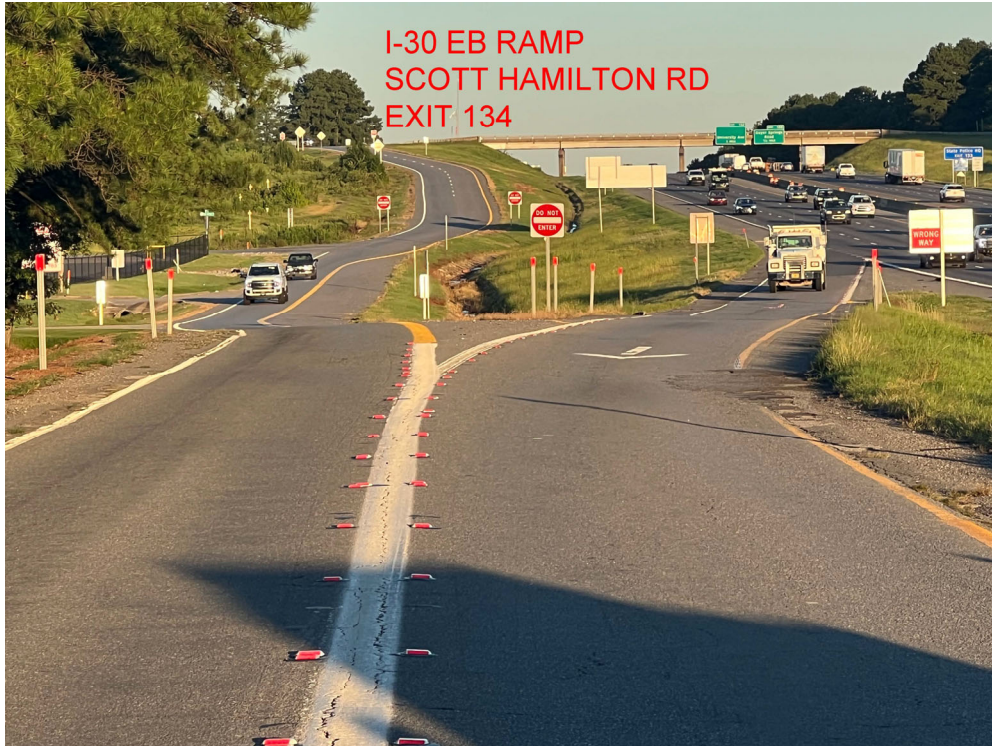
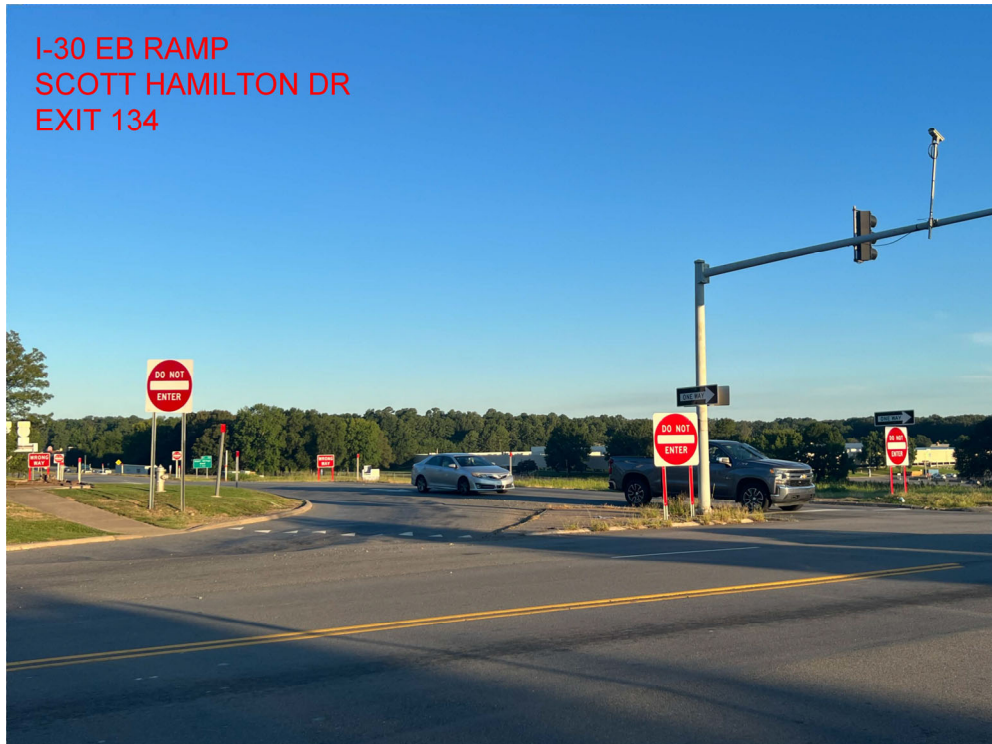
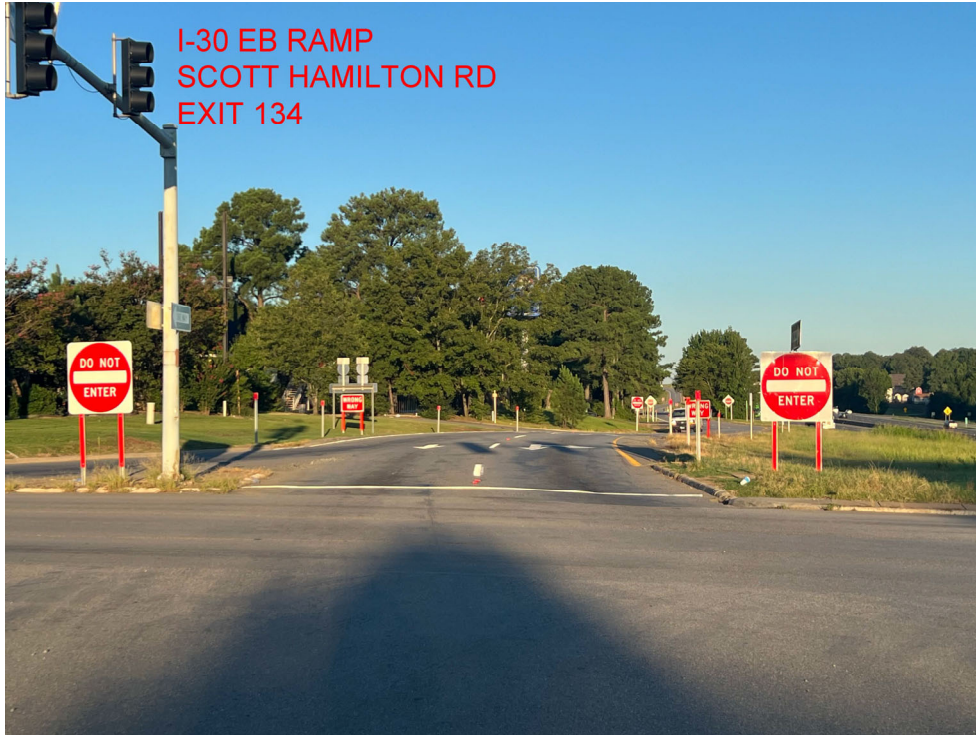
The interchange at Exit 1 via Exit 138 was reviewed. Signs were in place and in conformance with MUTCD and ARDOT requirements. However, pavement markings (arrow & cat tracks) have faded and need to be replaced to conform with current ARDOT requirements. These modifications have been implemented.

The interchange at Exit 134 was reviewed. Pavement markings and signs were in place and in conformance with MUTCD. However, an additional "Wrong Way" sign needs to be installed with red vertical reflective strips on the signpost to conform with current ARDOT requirements. These modifications have been implemented.

The interchange at Exit 135 was reviewed. Pavement markings and signs were in place and in conformance with MUTCD and ARDOT requirements.

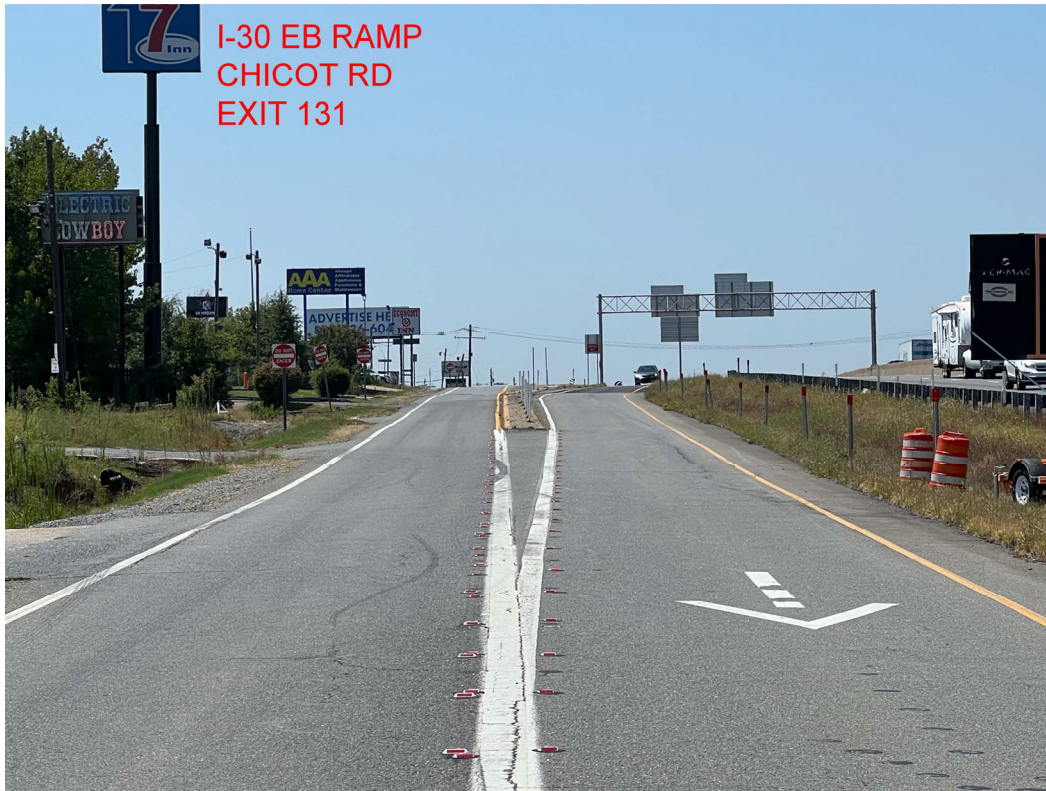
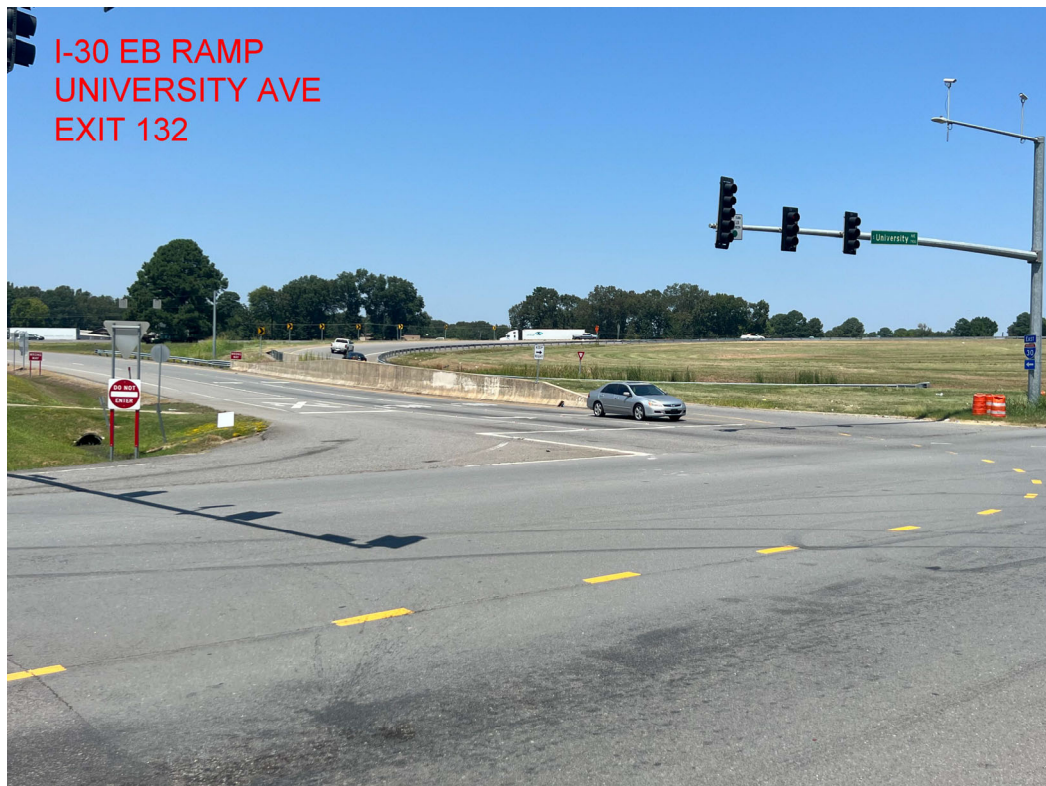
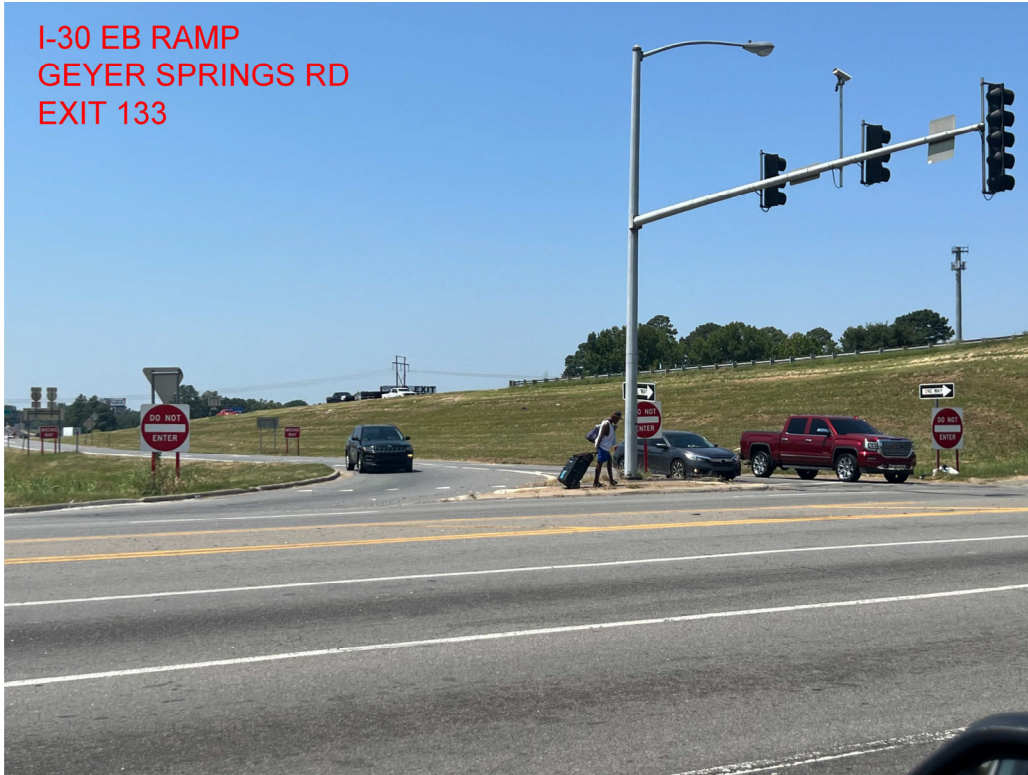
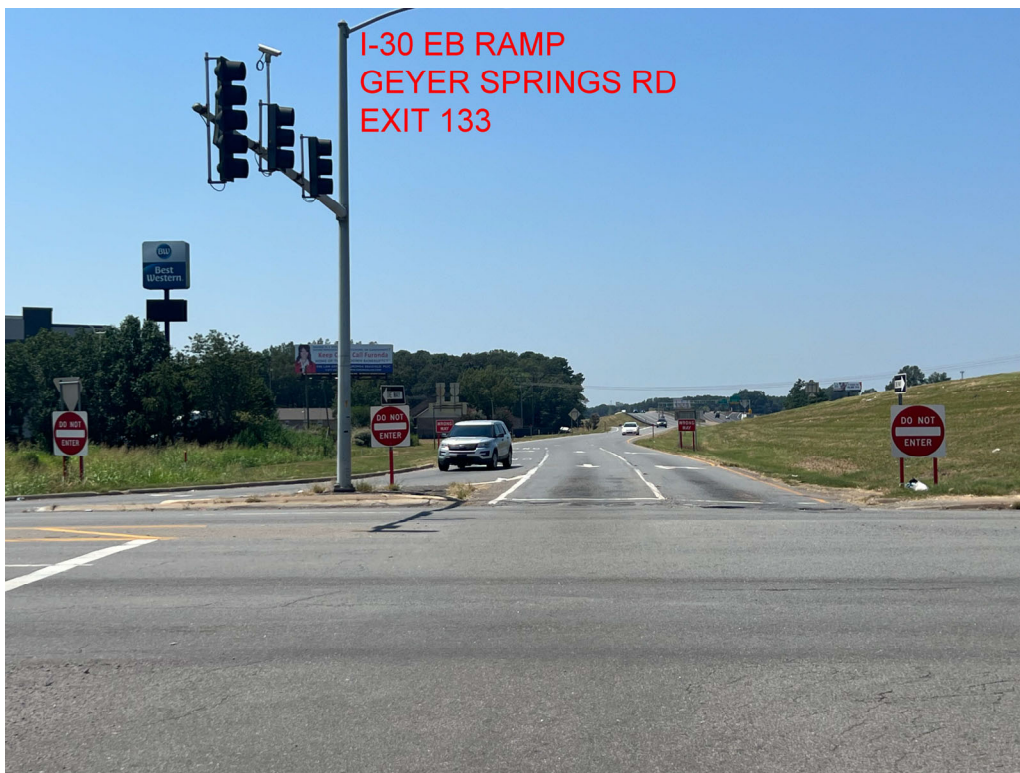
The interchange at Exit 132 was reviewed. Pavement markings and signs were in place and in conformance with MUTCD. However, red reflective strips need to be installed on the “Do Not Enter”, and “One Way” signs to conform with current ARDOT requirements. These modifications have been implemented.

The interchange at Exit 133 was reviewed. Pavement markings and signs were in place and in conformance with MUTCD and ARDOT requirements.

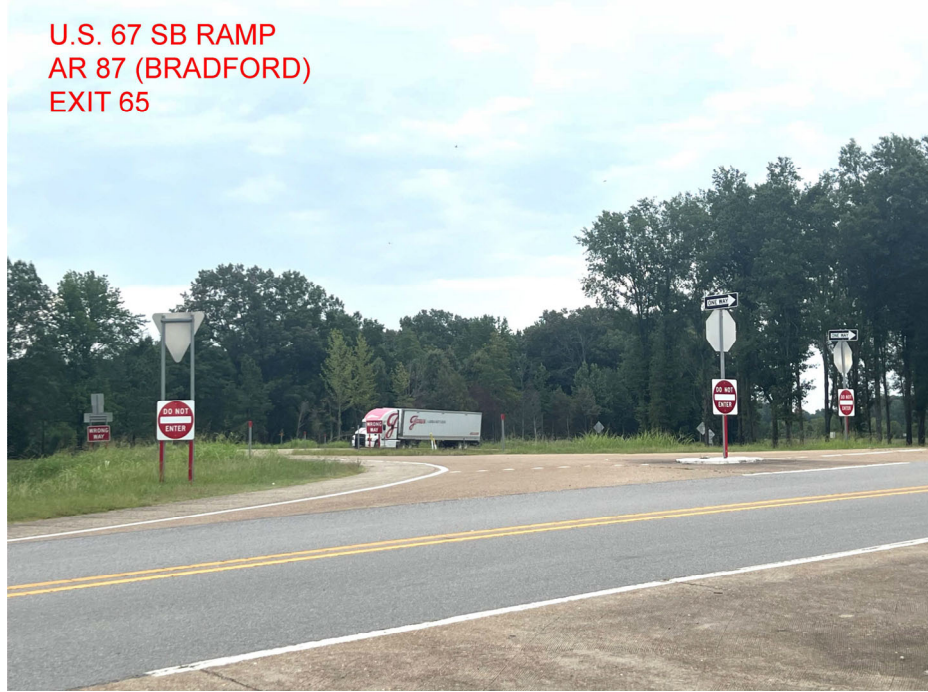
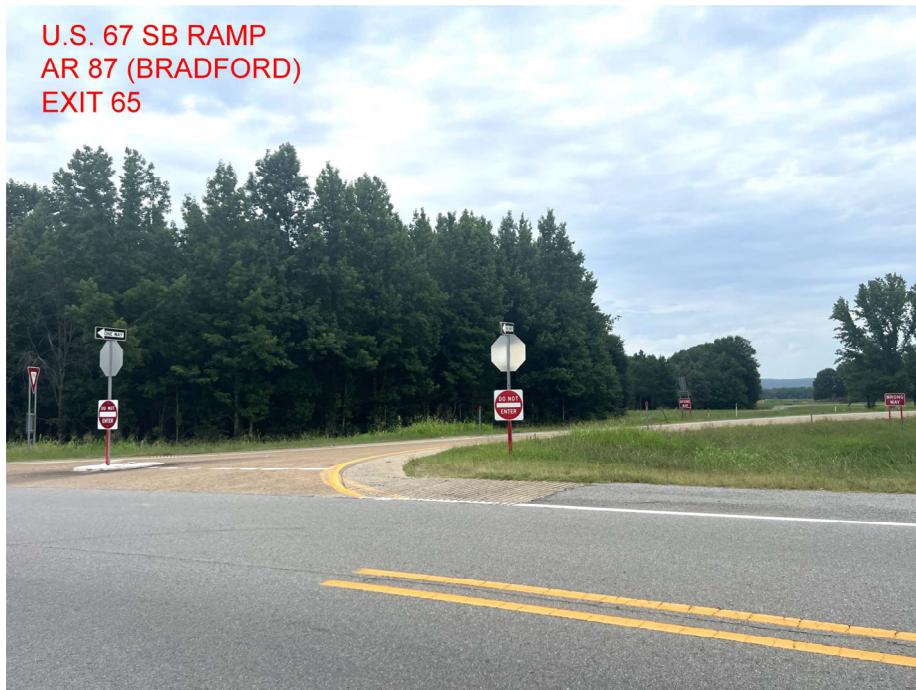
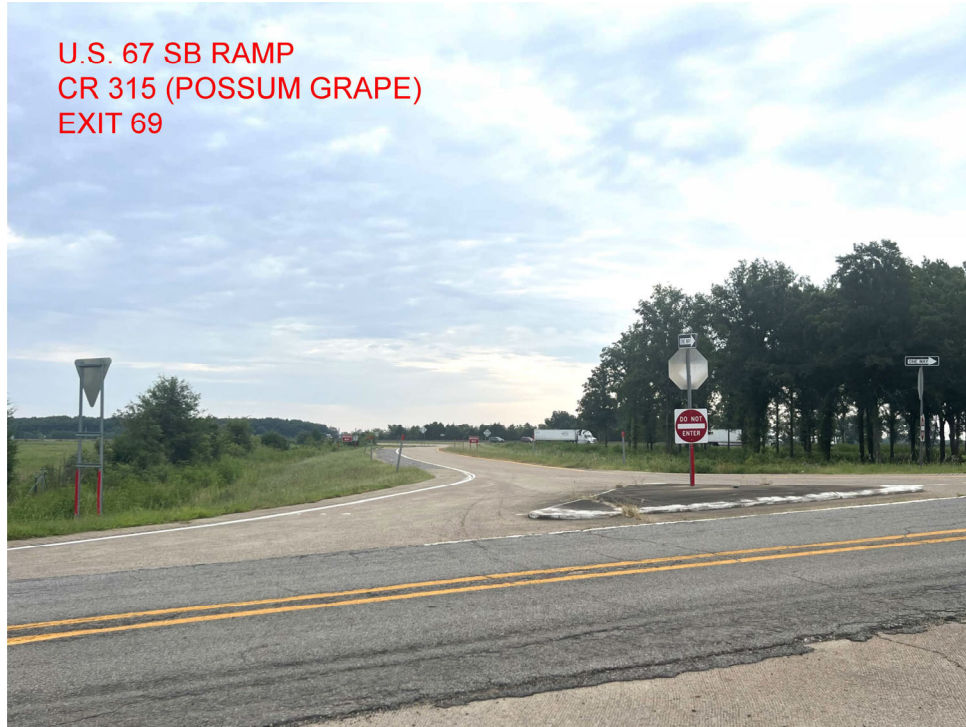
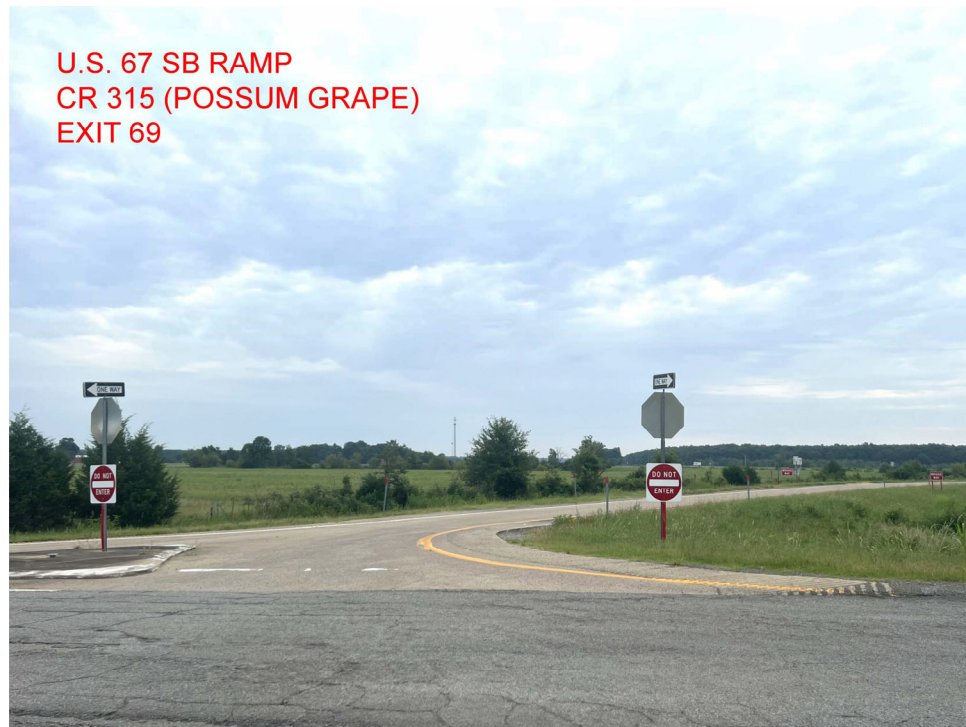
The interchange at Exit 65 was reviewed. Signs were in place and conformance with MUTCD and ARDOT requirements. However, pavement markings (stop bar) have faded and will need to be replaced. Also, the pavement marking arrow needs to be moved up 445' to conform with current ARDOT requirements.

The interchange at Exit 69 was reviewed. Signs were in place and in conformance with MUTCD. However, an additional "Do Not Enter" sign needs to be installed to conform with current ARDOT requirements. Also, pavement markings (stop bar and yield bar) have faded and need to be replaced and the pavement marking arrow needs to be moved up 470' to conform with current ARDOT requirements. The sign modifications have been implemented.

The interchange at Exit 74 was reviewed. Signs were in place and in conformance with MUTCD. However, additional "Wrong Way" signs need to be installed and red vertical reflective strips need to be installed on the signpost to conform with current ARDOT requirements. Also, pavement markings (stop bar and yield bar) have faded and need to be replaced and the pavement marking arrow needs to be moved up 480' to conform with current ARDOT requirements. The sign modifications have been implemented.

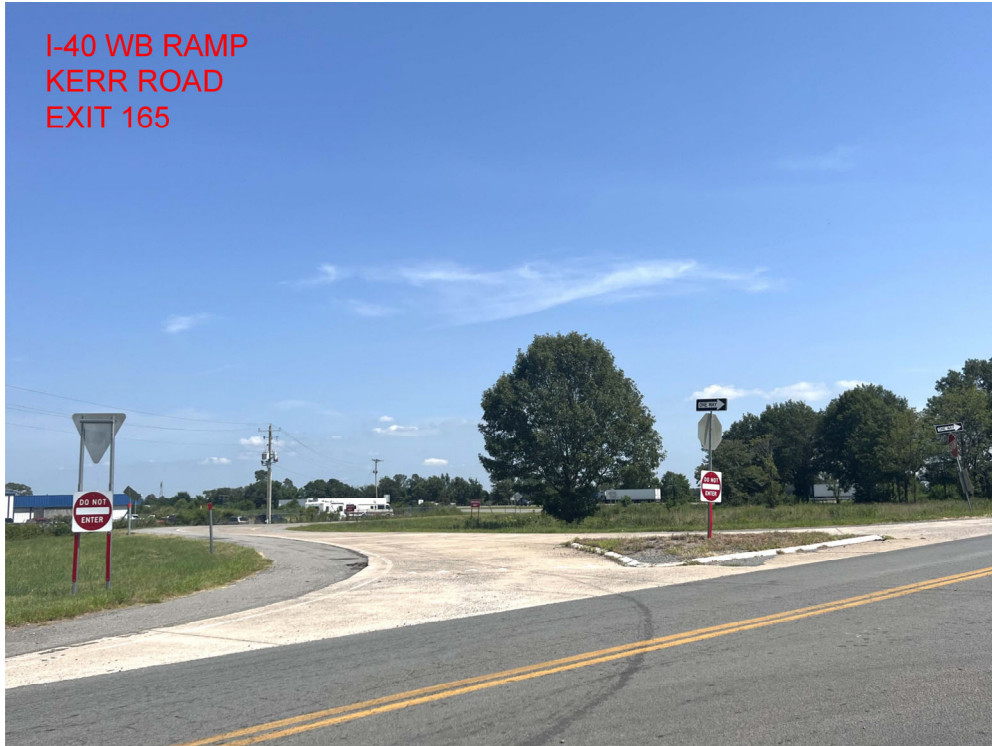
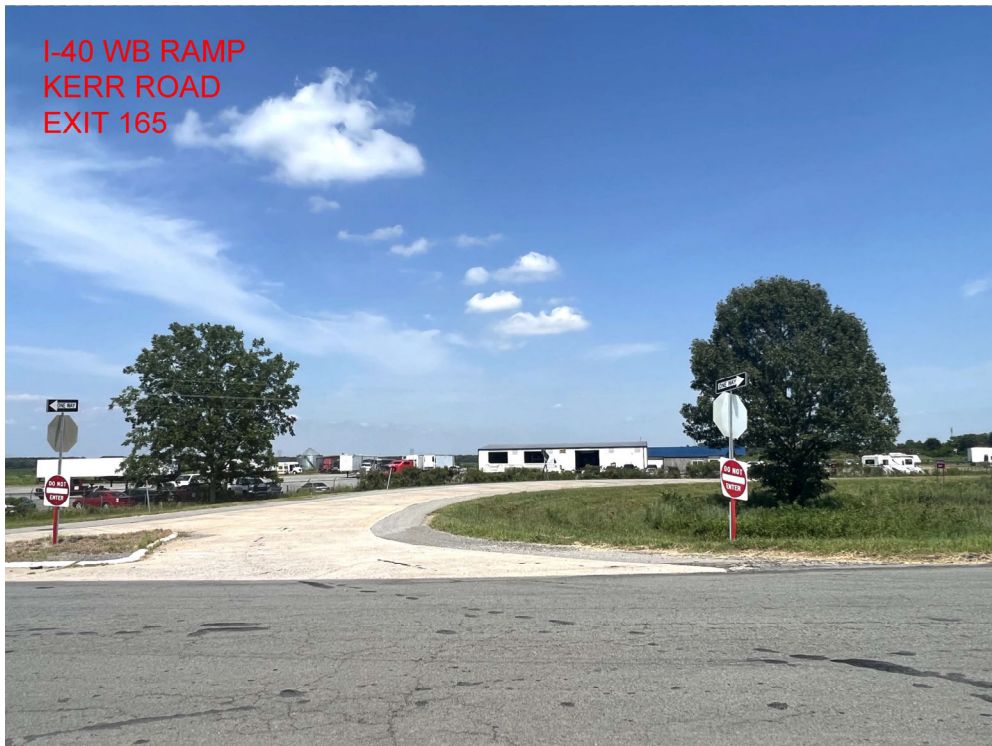
The interchange at Exit 165 was reviewed. Signs were in place and conformance with MUTCD and ARDOT requirements. However, pavement markings (stop bar and yield bar) have faded and need to be replaced and the pavement marking arrow needs to be moved up 345' to conform with current ARDOT requirements. These modifications have been implemented.

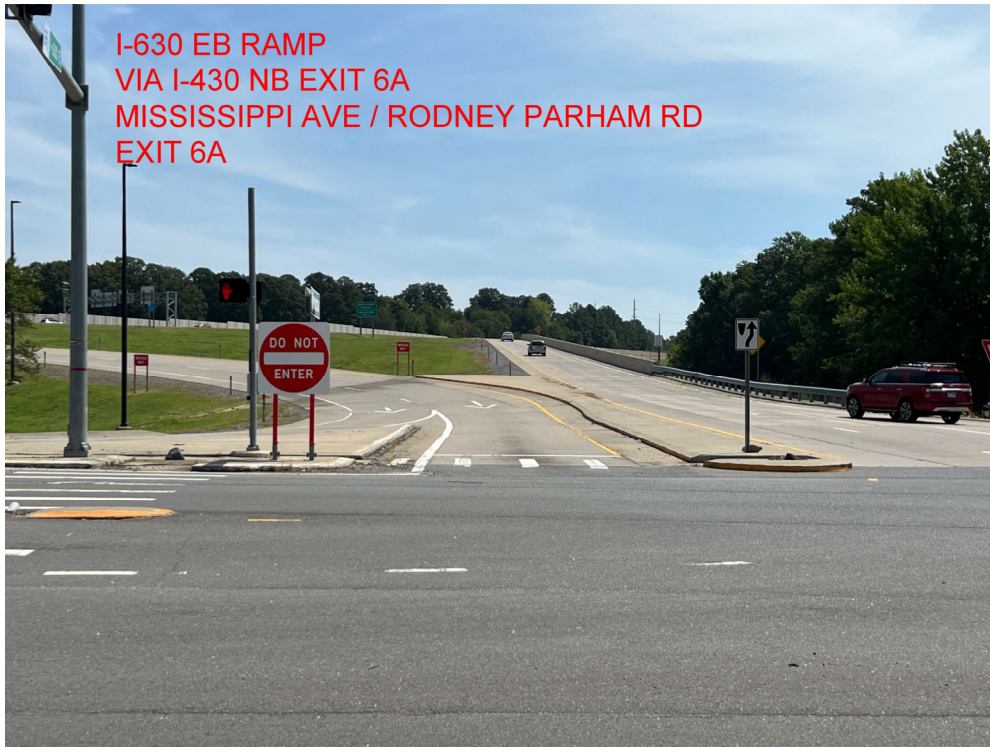
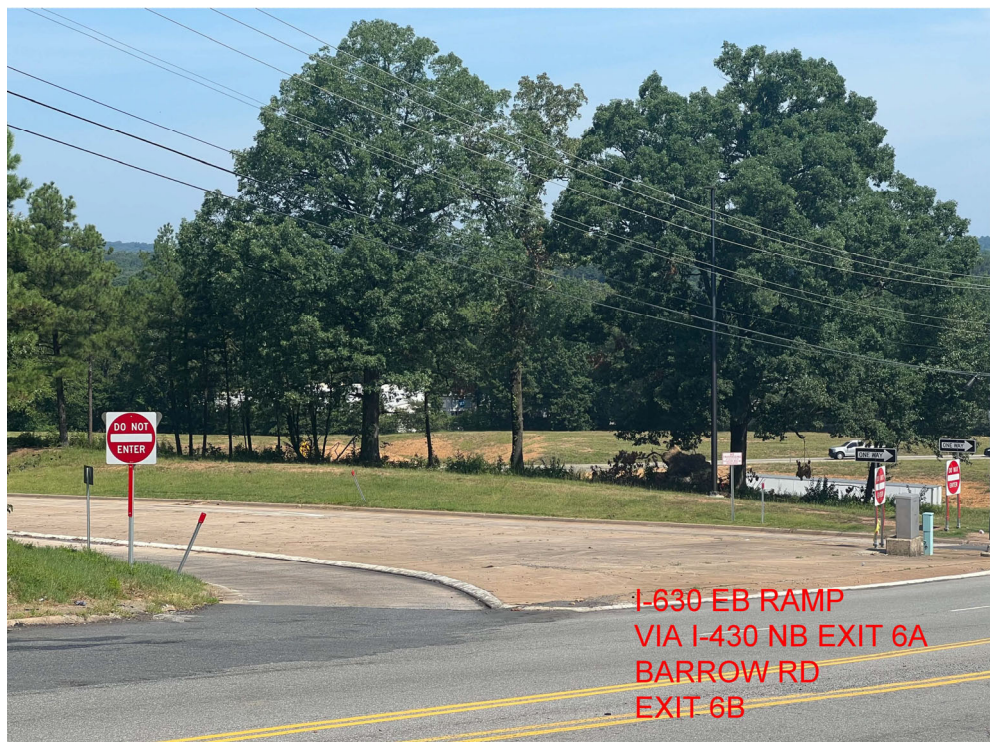
The interchange at Exit 6A was reviewed. Signs were in conformance with MUTCD. However, the “Keep Right” sign needs to be upsized. Also, pavement marking (cat tracks) have faded and need to be replaced to conform with current ARDOT requirements.

The interchange at the Baptist Health Exit was reviewed. Pavement markings and Signs were in place and in conformance with MUTCD and ARDOT requirements.
