## Bridge 02899 Inspection Report

Arnold Road ID:54x49x11xA, Arnold Log mile:0.569

# National Bridge Inventory Data Sheet

| IDENTIFICATION | |
|---|---|
| (7) Facility Carried | US 49- Phillips Co |

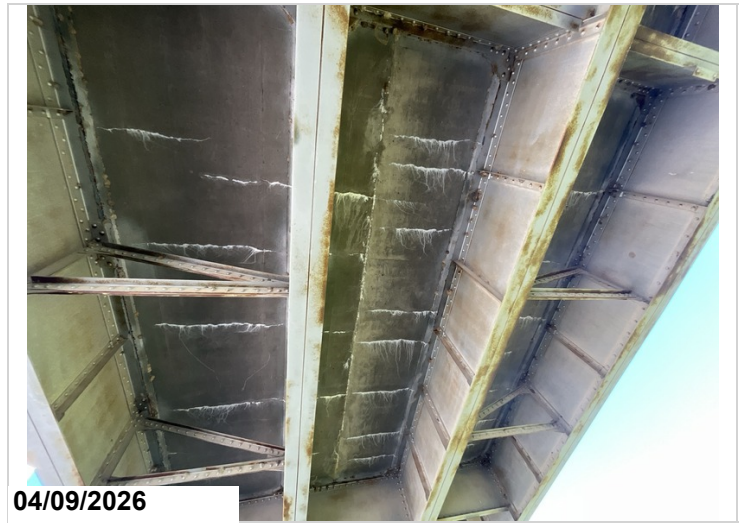
Span 10: Large amount of cracking with efflorescence.

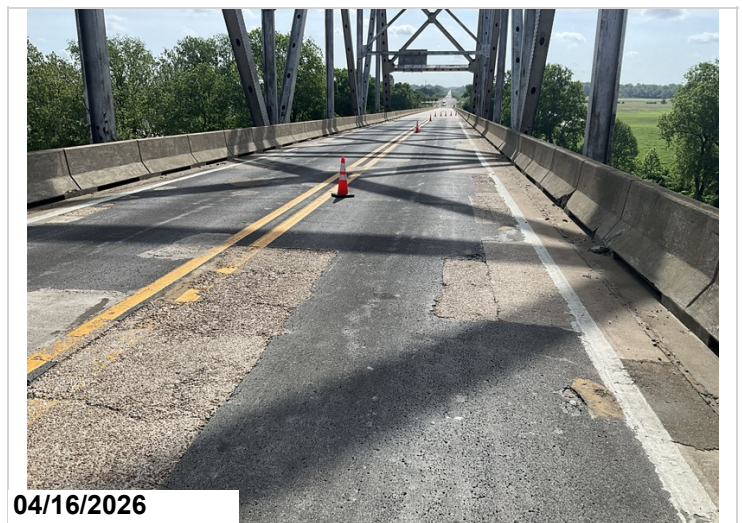
PP71 - PP74: 230SF of CS2 delam/patched areas and 5SF of CS3 exposed reinforcing steel.

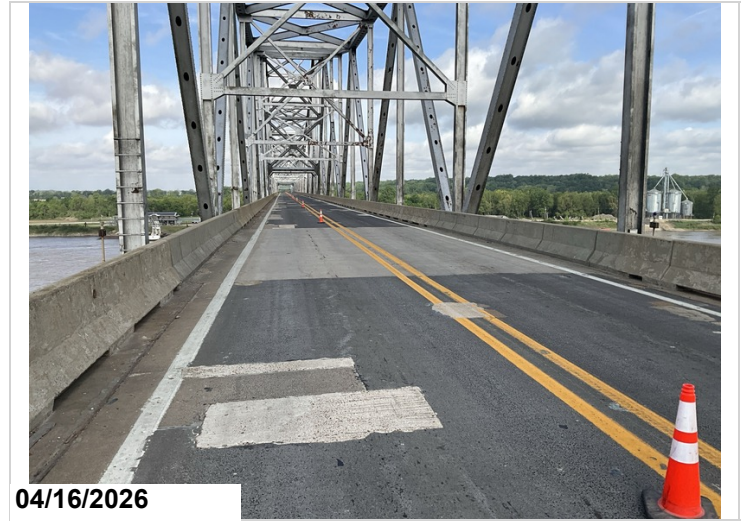
PP40 - PP43: 120SF of CS2 delam/patched areas and 41SF of CS3 spalling and unsound patched areas.

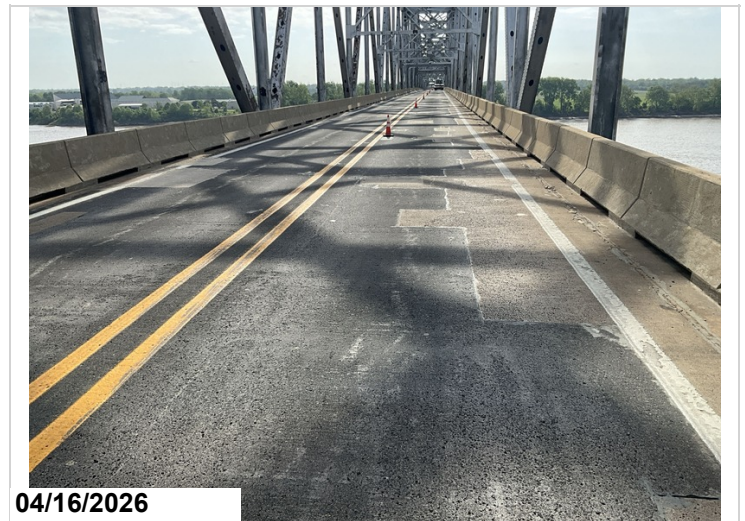
PP36 - PP40: 195SF of CS2 delam/patched areas and 56SF of CS3 spalling and unsound patched areas.

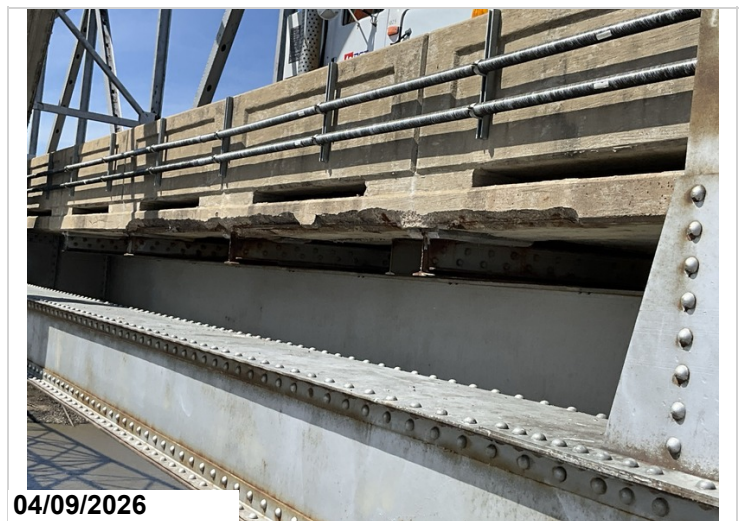
Span 12, Right Overhang, Between PP20 - PP21: Spalling with exposed reinforcing steel. CS3 Exposed reinforcing steel.

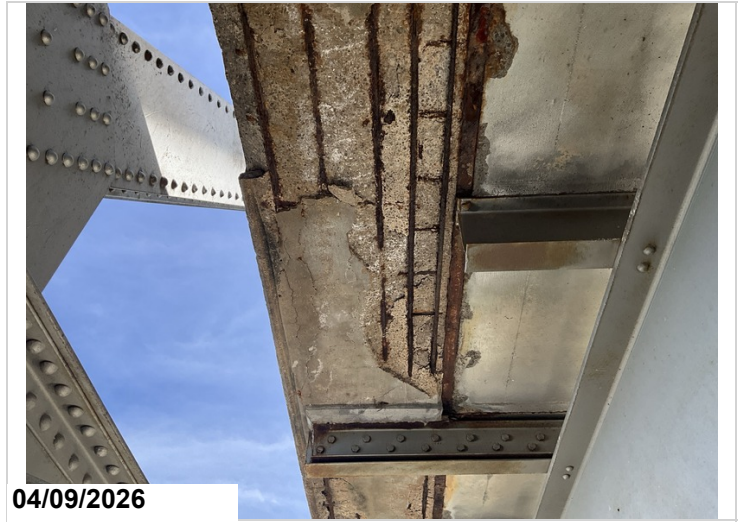
Span 11, Right Overhang, Near PP8: Large spalling, typical throughout the structure.

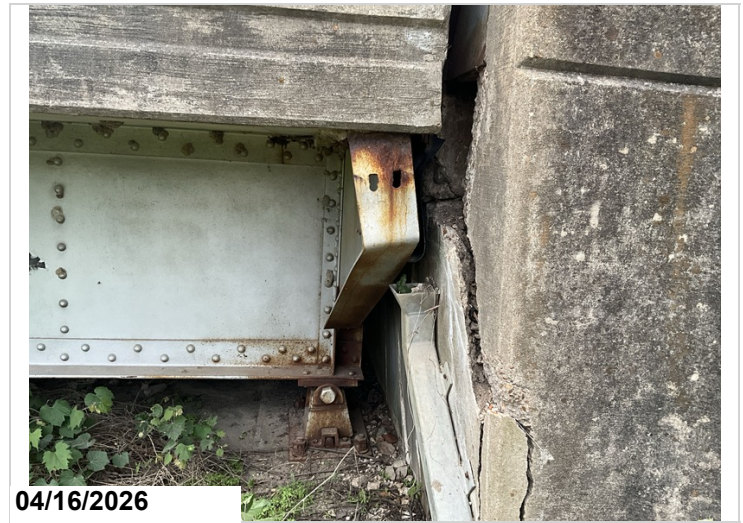
Span 1, Abutment 1, Girder 1, Left: Active corrosion with pack rust up to 1/2".

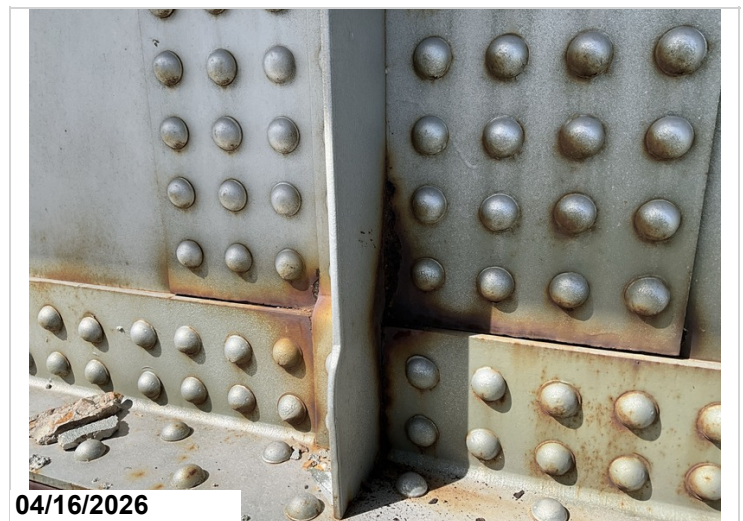
Span 16, Girder 2, third splice: Corrosion with up to 1/8" section loss to lower web splice plate. 1 LF CS3.

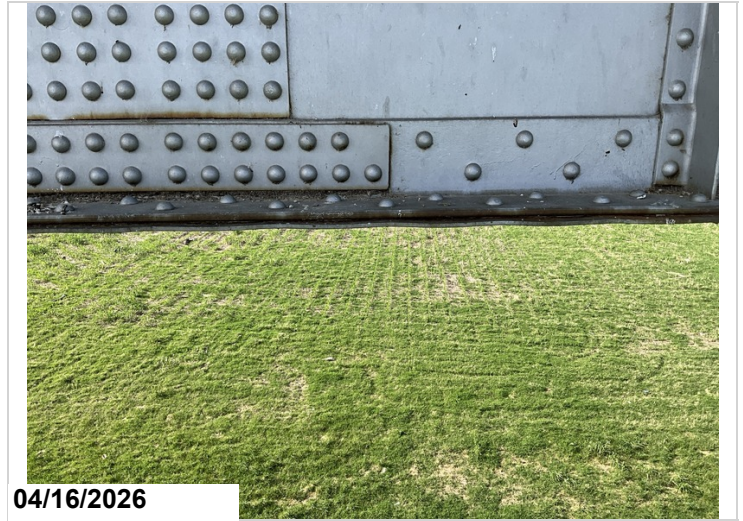
Span 19, Girder 1: typical pack rust and minor distortion to bottom flange cover plate. Typical Girder 2. Typical Span 18.

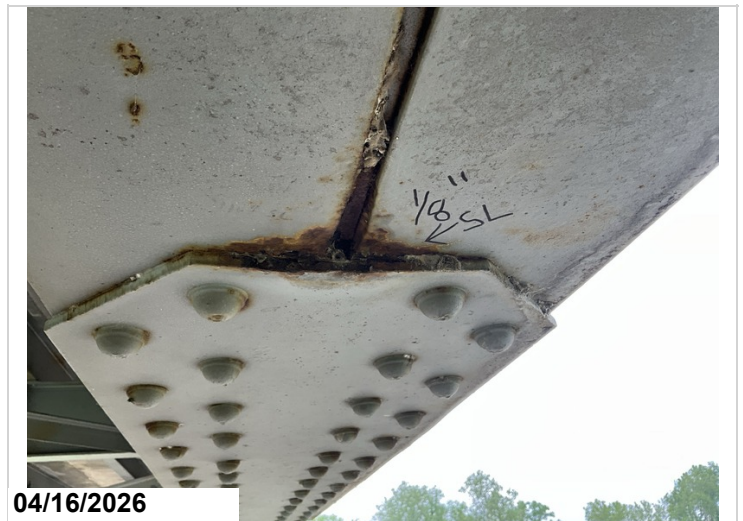
Span 20, Girder 1, Left, Floorbeam 3 cantilever: pack rust distorting lower cantilever web up to 7/8". 1 LF CS3

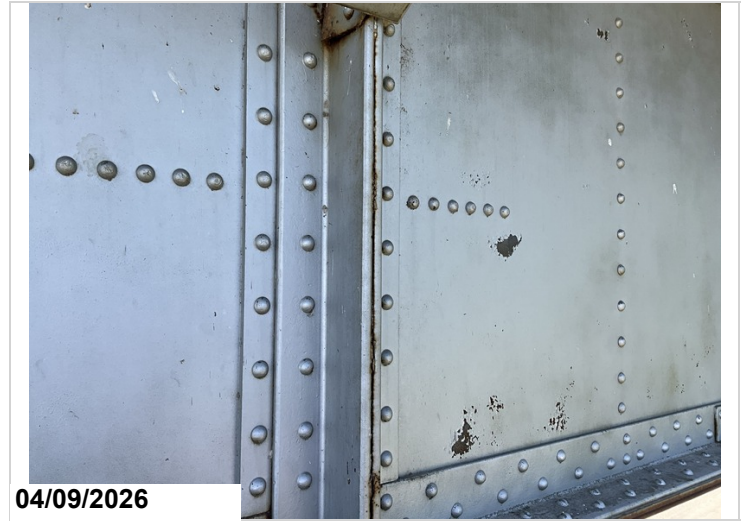
Pier 8, Girder 2, Right: Cracked tack welds at bearing stiffener due to pack rust at the stiffeners, fully arrested. 1LF CS3 corrosion.

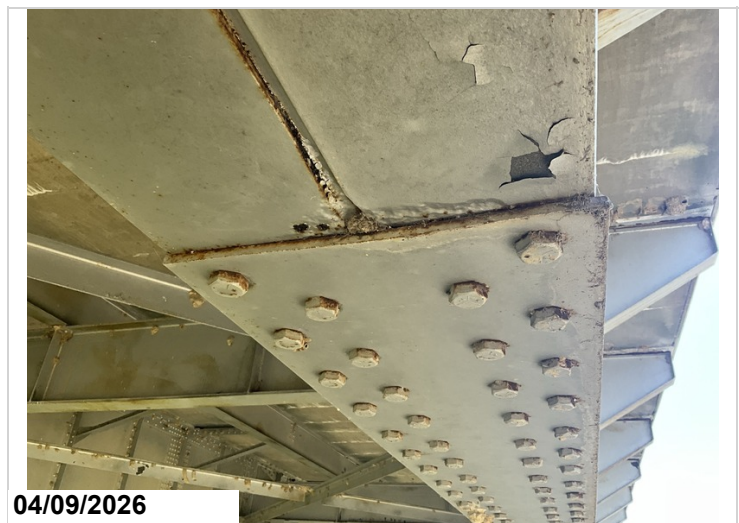
Pier 6, girder 1, pack rust between stiffener angles breaking welds. Typical

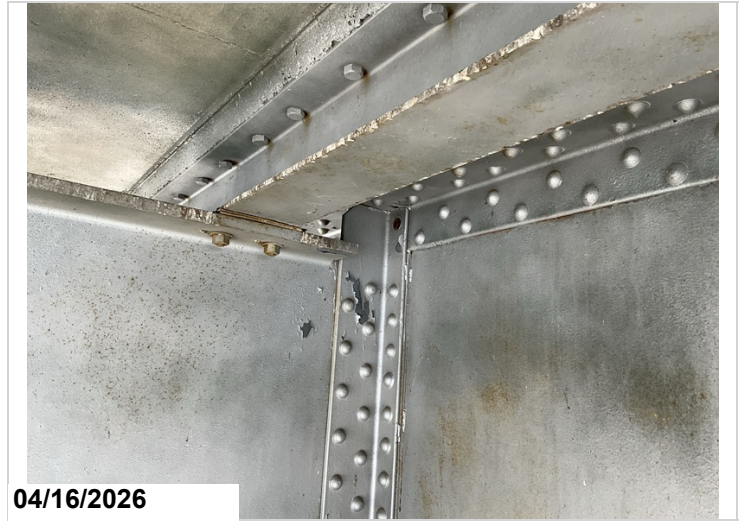
Span 13, Stringer 1, between PP41 and 42: Rolling defect.

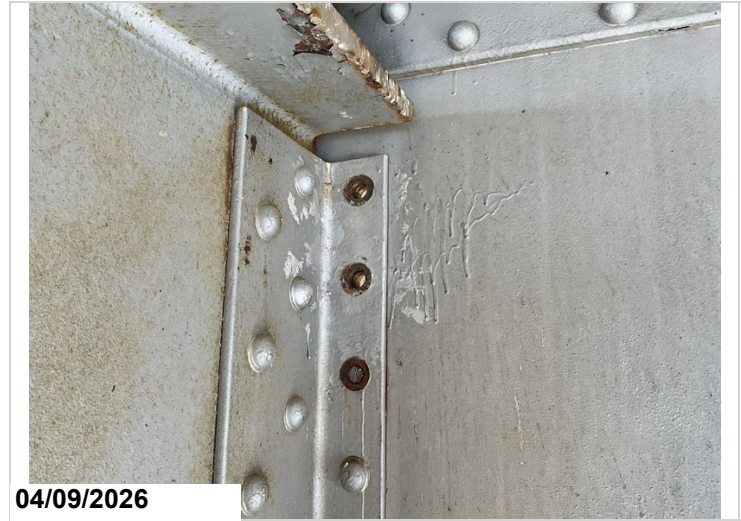
Span 15, Stringer 1, Floorbeam 69: Active corrosion with section loss up to 1/8" to the stringer web. 1LF CS3 corrosion.

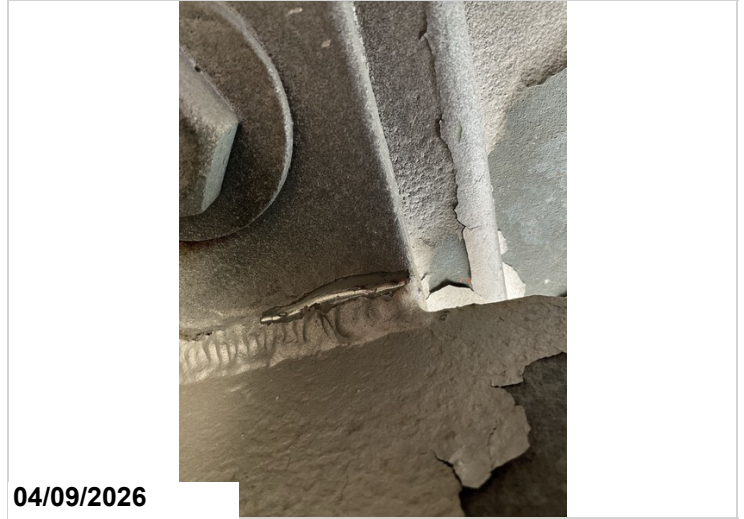
Span 15, Stringer 2, Floorbeam 68, Back, Kicker plate: 1 3/4" crack in weld in stringer kicker plate. 1LF CS3 crack.

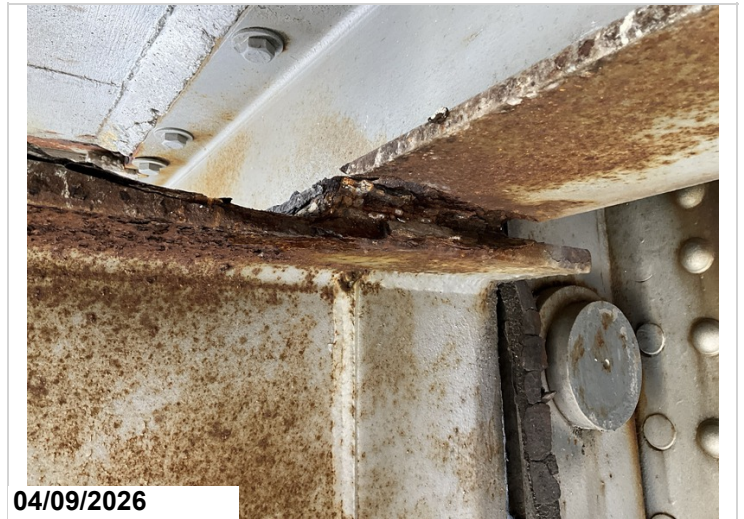
Span 15, Stringer 2, Right, Bottom Flange, Ahead of Floorbeam 67: Active corrosion with section loss up to 3/8" to the Bottom Flange. 1LF CS3 corrosion.

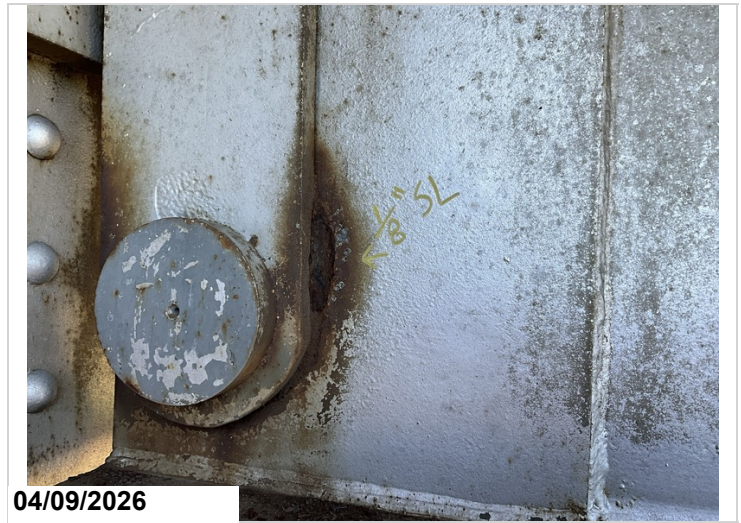
Span 15, Stringer 3, Floorbeam 71: Active corrosion with section loss up to 1/8" to the built-up stringer web plate. 1LF CS3 corrosion.

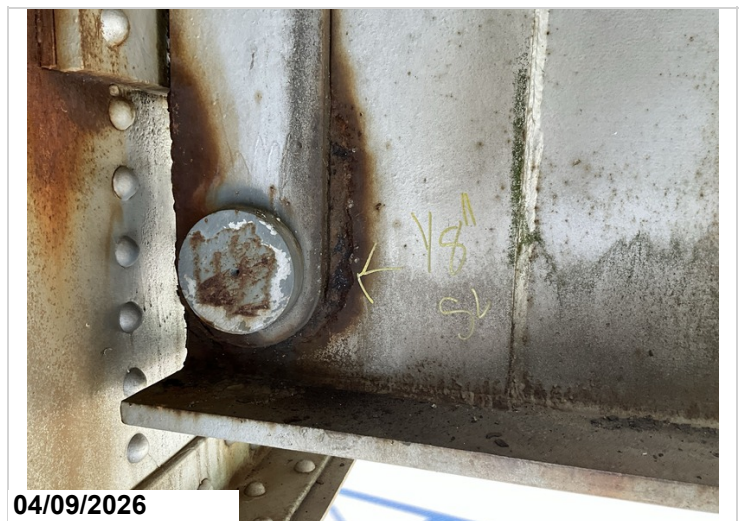
Span 15, Stringer 3, Floorbeam 71: Active corrosion with section loss up to 3/16" to the built-up stringer web plate. 1LF CS3 corrosion.

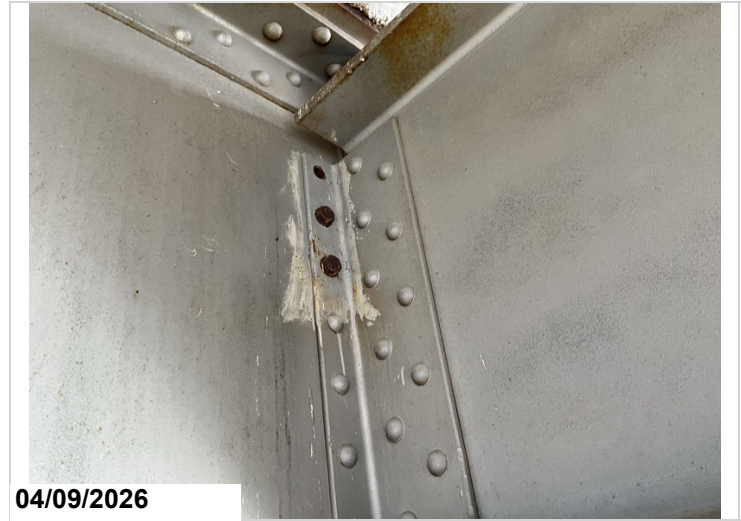
Span 13, Stringer 2, Floorbeam 41, Ahead: Sheared rivet head, one on the back side as well. 1LF CS3 connection.

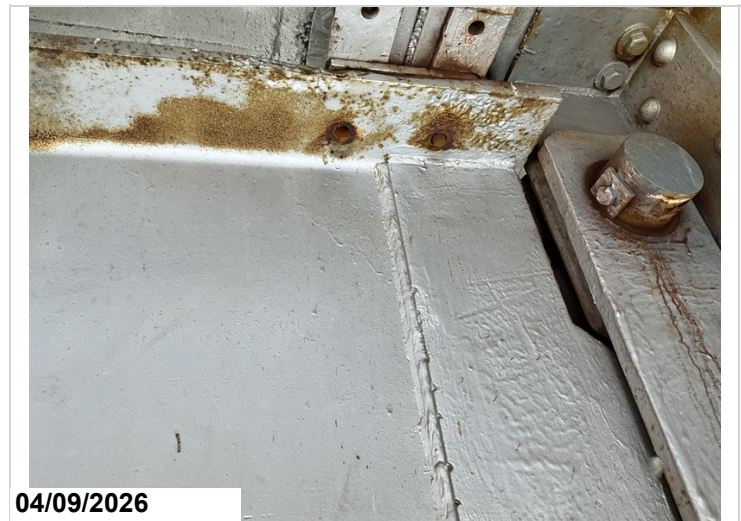
Span 13, Stringer 2, Floorbeam 36, Ahead: One sheared rivet head. 1LF CS3 connection.

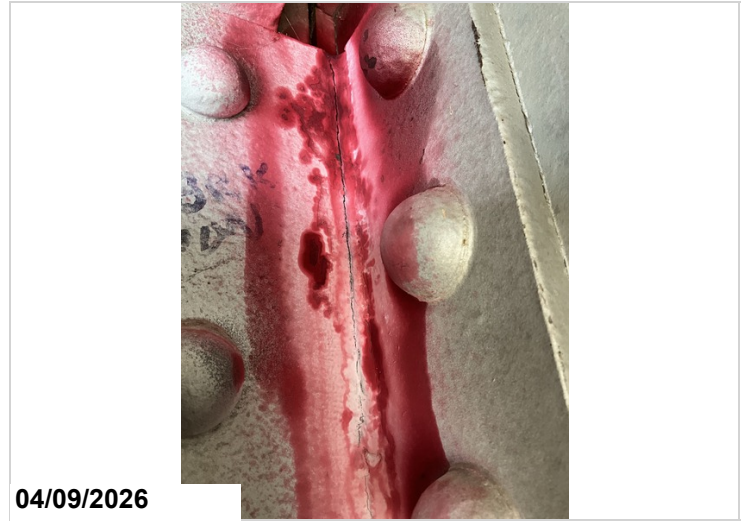
Span 12, Stringer 2 to Floorbeam 28 Connection, Ahead: 11" crack in the welded connection. 1LF CS3 crack.

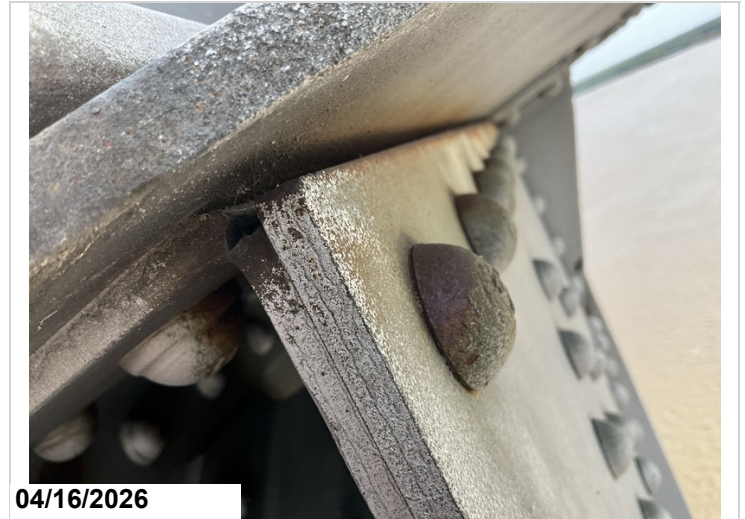
Span 14, Truss 2, PP52, Upper Chord to lateral bracing connection: Connection angle at Upper Chord has a crack in the bend of the angle, approximately 1/4" long. Does not appear to be a working crack. 1LF CS3 crack.

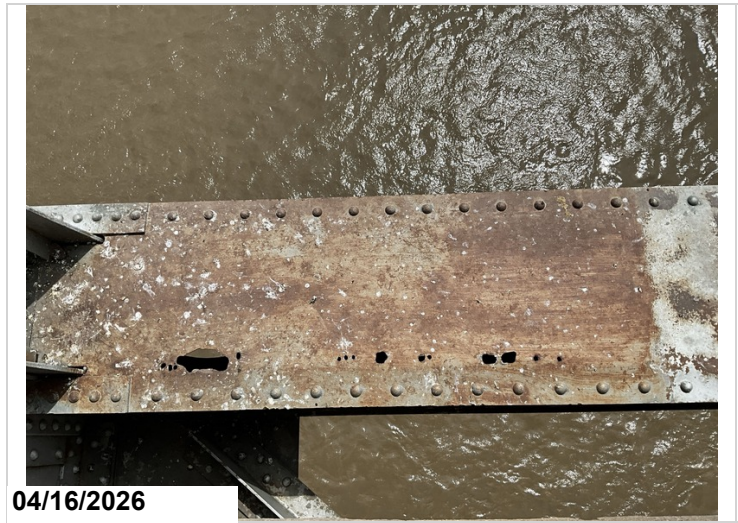
Span 13, Truss 2, PP 44, Upper Chord to Vertical connection gusset: 2 Cracked tack welds, self arrested. 1LF CS2 crack.

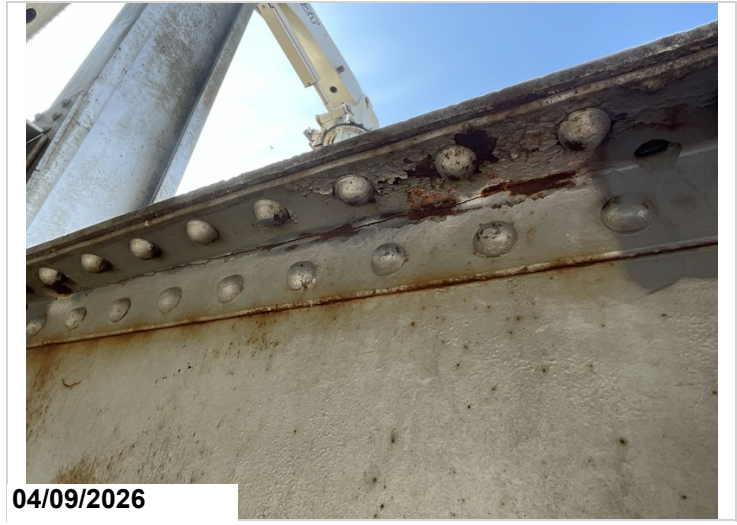
Span 14, Truss 2, Lower Chord, Left, PP61, Back, Top flange to web Angle connection: Arrested crack in angle. 3LF CS2 crack.

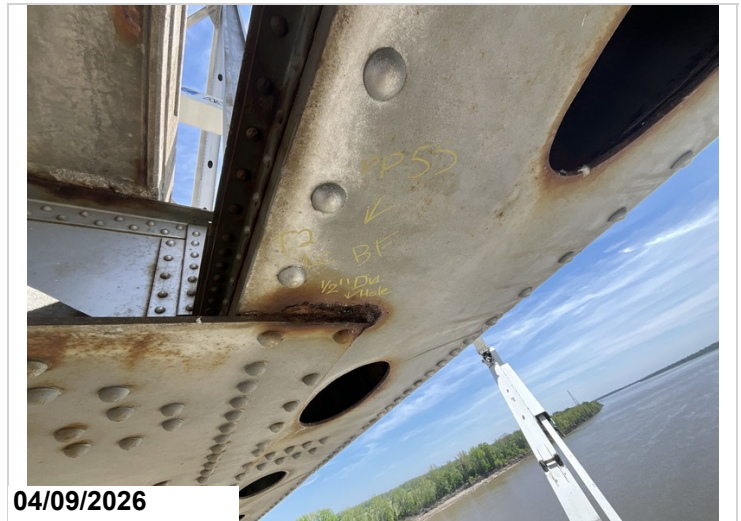
Span 14, Truss 2, Lower Chord, PP55: Active corrosion with a 1/2" diameter hole in the Bottom Flange at the lateral Gusset Plate connection. 1LF CS4 corrosion.

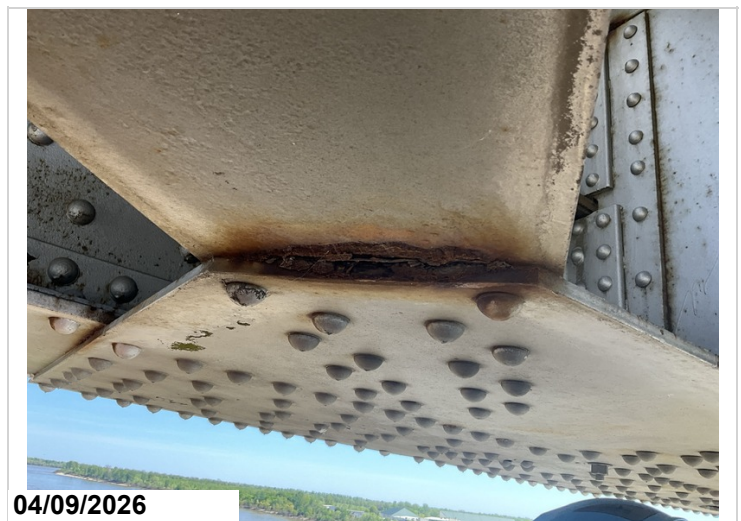
Span 14, Truss 2, Lower Chord, PP52, Starting at first portal back of 52: Active corrosion with heavy section loss to Inside left web and 13 rivets. 10LF CS3 corrosion.

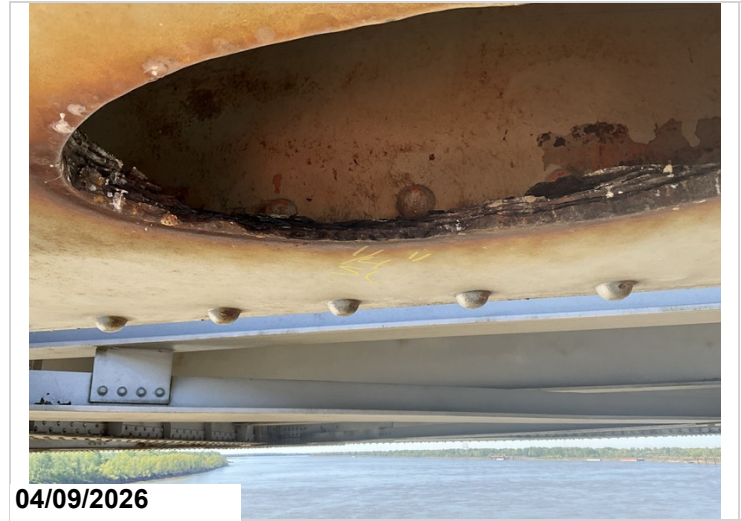
Span 14, Truss 1, Lower Chord, PP50, Back: Active corrosion with section loss up to 3/8" to the Bottom Flange at two portals. 8LF CS3 corrosion.

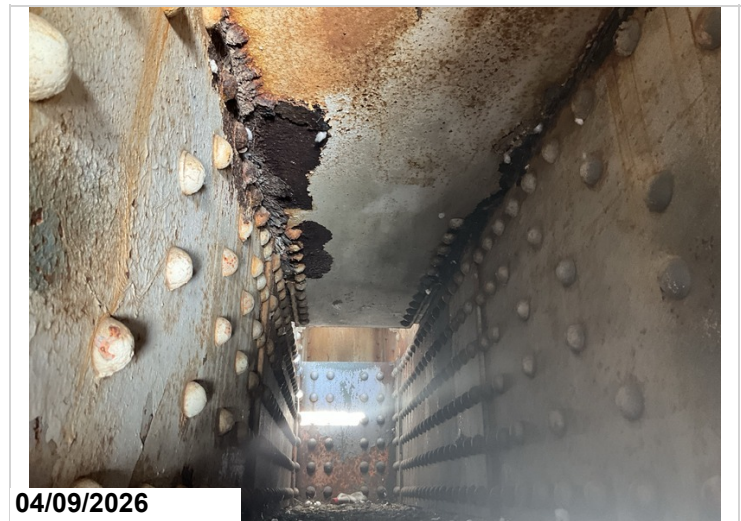
Span 14, Truss 1, Inside of the lower Chord, PP48 - PP49: Active corrosion with flaking rust to the flanges and the webs. 8LF CS3 corrosion.

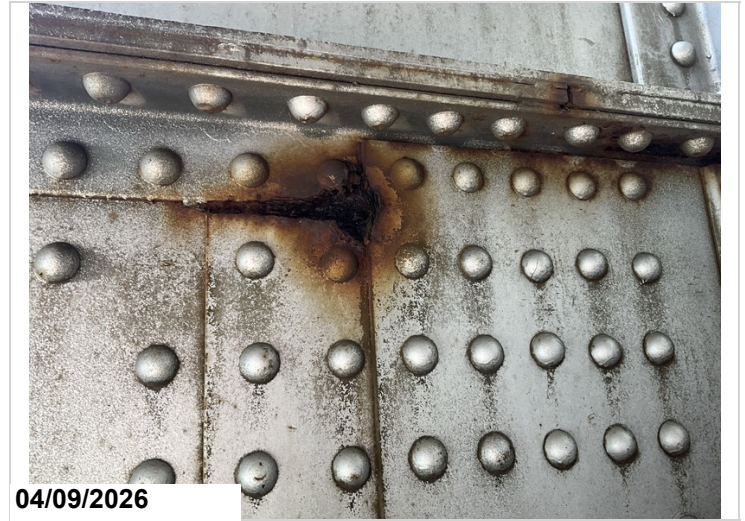
Span 13, Truss 2, Lower Chord, PP34, Left: Active corrosion with crevice corrosion along the built up members adjacent to the floorbeam connection. 1LF CS3 corrosion.

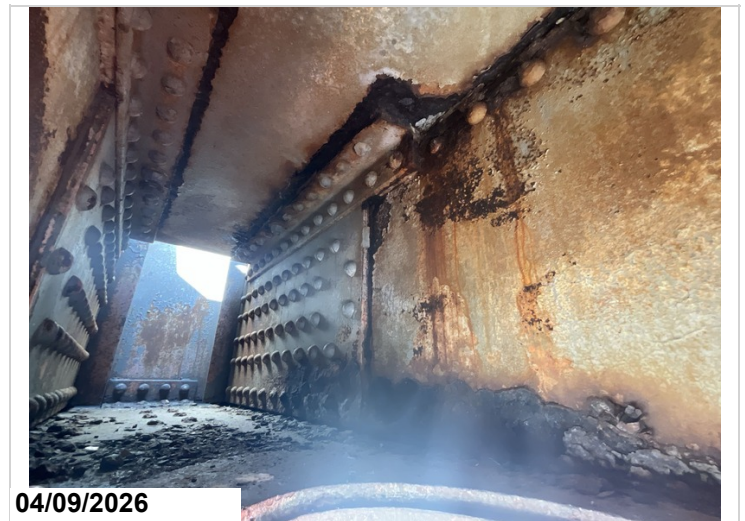
Span 13, Truss 2, Inside of the lower chord, PP32: Active corrosion with section loss up to 3/16" adjacent to the angle connection plates along the top flange. 4LF CS3 corrosion.

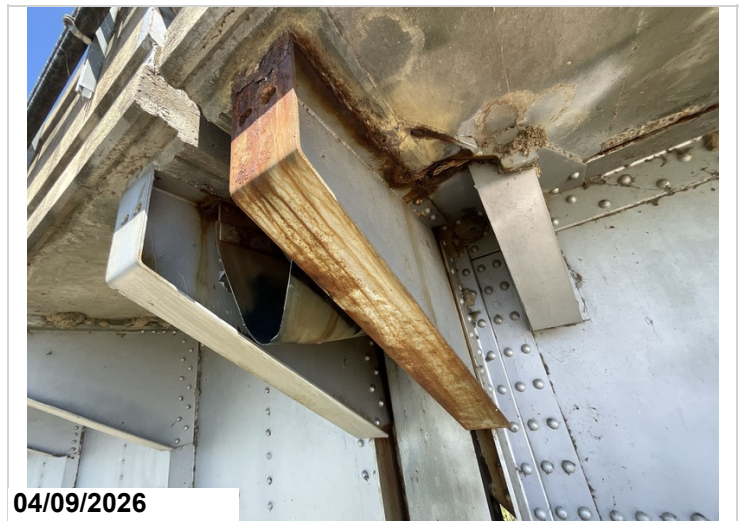
Span 7, Right Cantilever on Ahead side of Pin and Hanger Assembly: Typical active corrosion at the Pin and Hanger locations. CS3 corrosion.

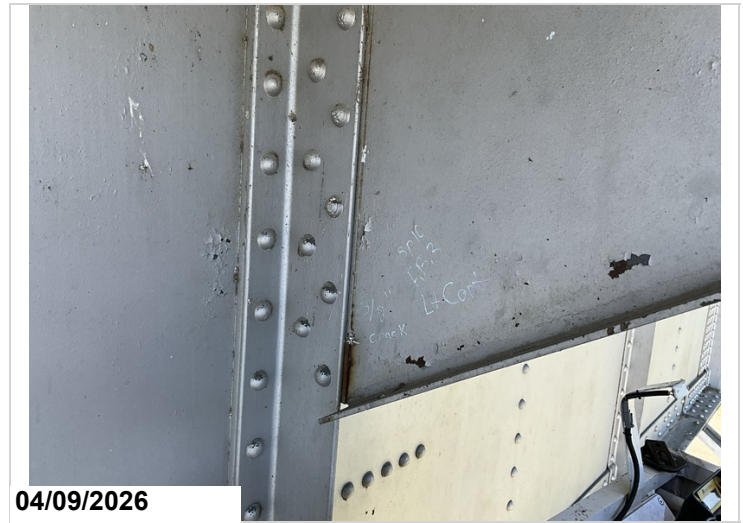
Span 10, Floorbeam 3, Left Cantilever: 3/8" crack in the bottom tack weld at the girder stiffener plate. 1LF CS3 crack.

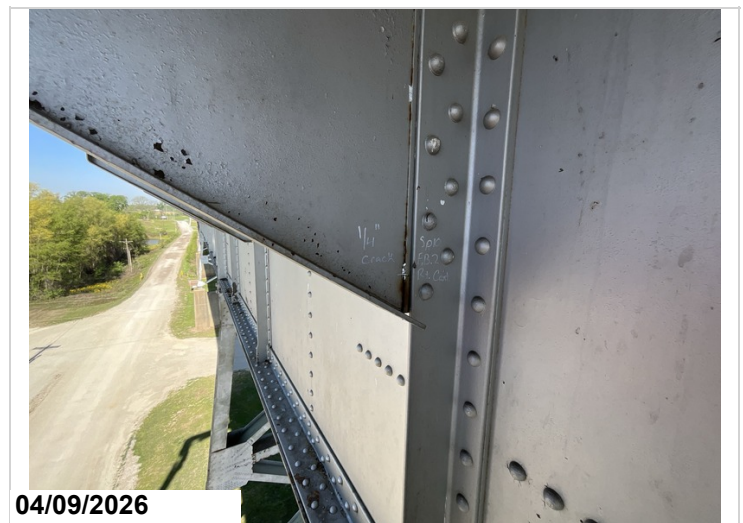
Span 10, Floorbeam 2, Right Cantilever: 1/4" crack in the bottom tack weld at the girder stiffener plate. 1LF CS3 crack.

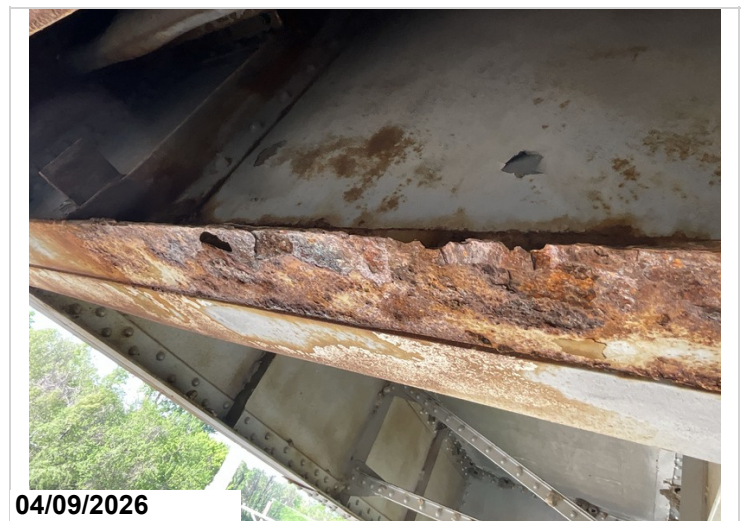
Span 4, Cross-Girder, Back of Assembly Joint: Active corrosion with a 2" X 1" hole in the Bottom Flange along with a 12" area of the bottom flange at a knives edge remaining thickness. 2LF CS4 corrosion.

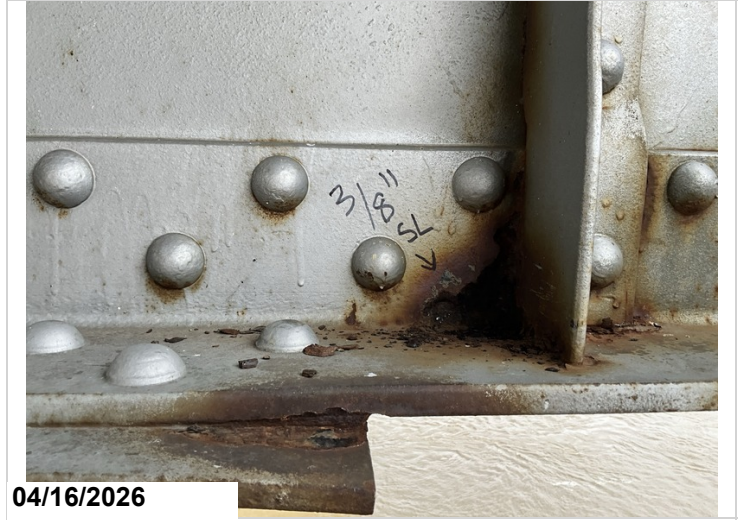
Span 13, Back Floorbeam at PP43, Back, Adjacent to Stiffener 9: Active corrosion with section loss to the web to bottom flange angle up to 3/8". 1LF CS3 corrosion.

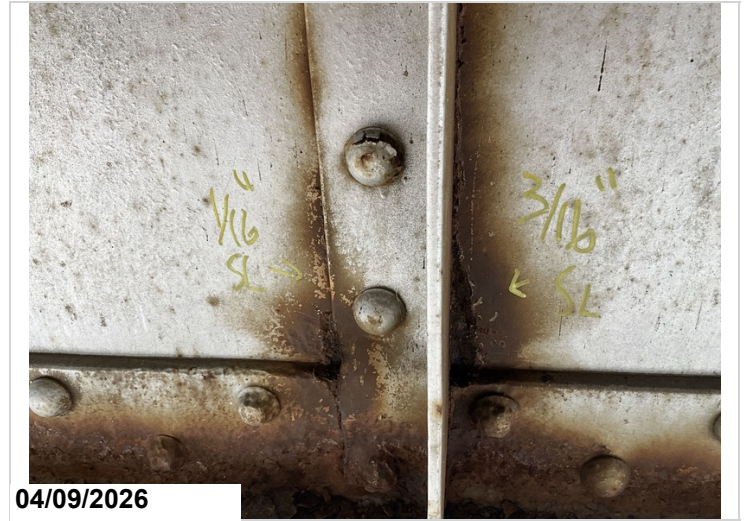
Span 14, Floorbeam 62, Back, Adjacent to Stiffener 3: Active corrosion with section loss up to 3/16" to the web. 1LF CS3 corrosion.

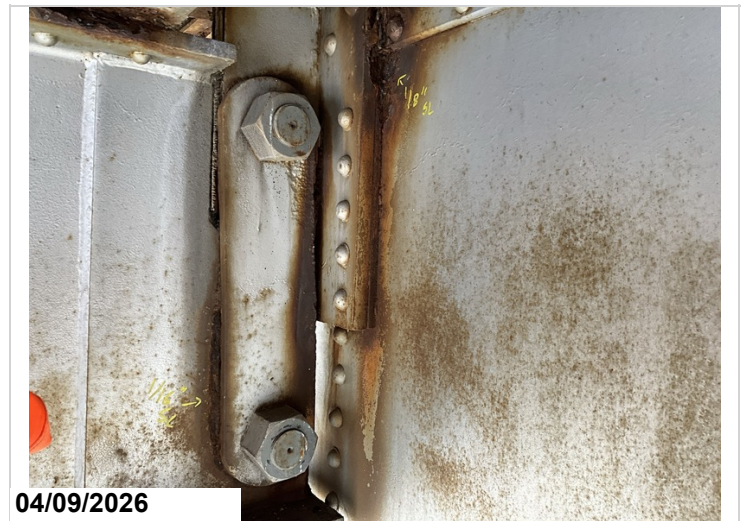
Span 14, Floorbeam 62 to Stringer 2 Connection: Active corrosion with section loss up to 1/8" to Floorbeam web and 1/16" to stringer webs. 1LF CS3 corrosion.

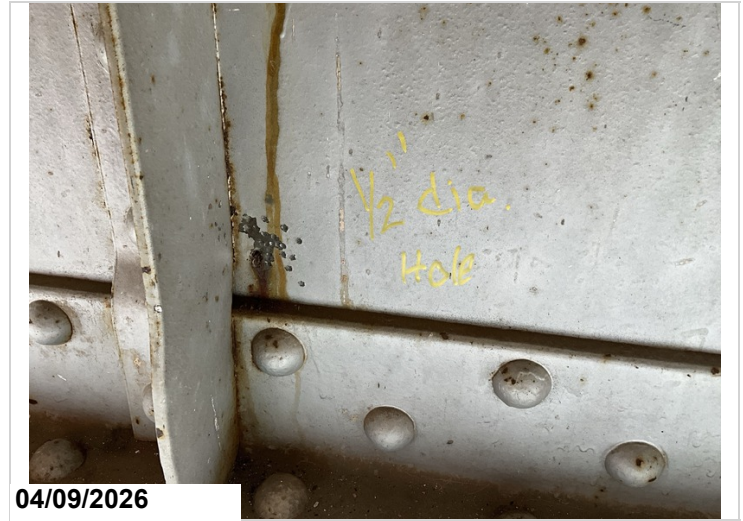
Span 14, Ahead Floorbeam at PP59, adjacent to Stiffener 7:  
Active corrosion with two 1/2" diameter holes in the web.  
1LF CS4 corrosion.

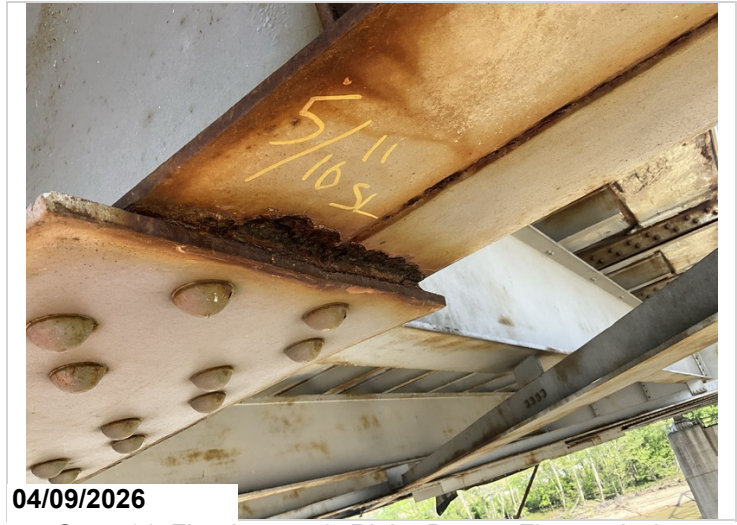
Span 14, Floorbeam 58, Right, Bottom Flange: Active corrosion with section loss up to 5/16" to the bottom flange. 1LF CS3 corrosion.

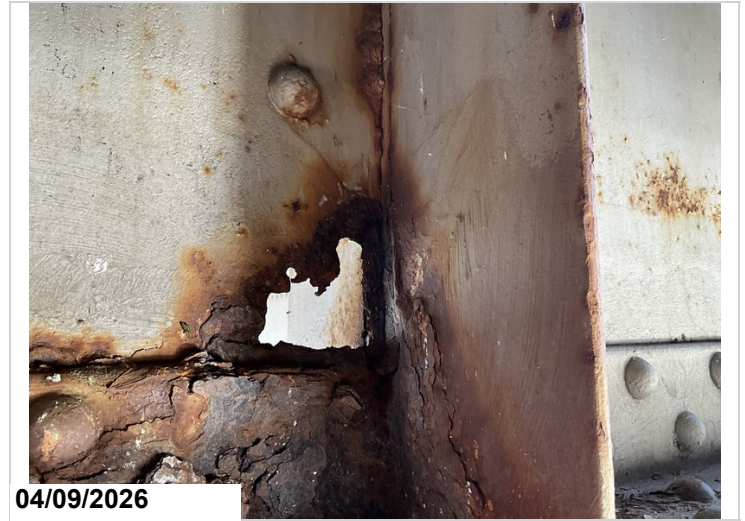
Span 12, Ahead Floorbeam at PP25, Adjacent to Stiffener 8: Active corrosion with a 4" X 3 1/2" hole in the web

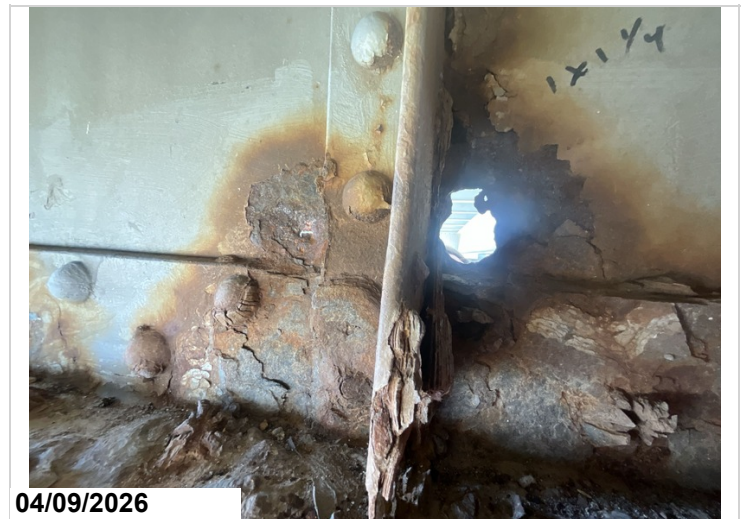
Span 12, Back Floorbeam at PP25, Adjacent to Stiffener 6: Active corrosion with a 2 1/2" X 1 1/2" hole and a 1/2" diameter hole in the web. 1LF CS4 corrosion.

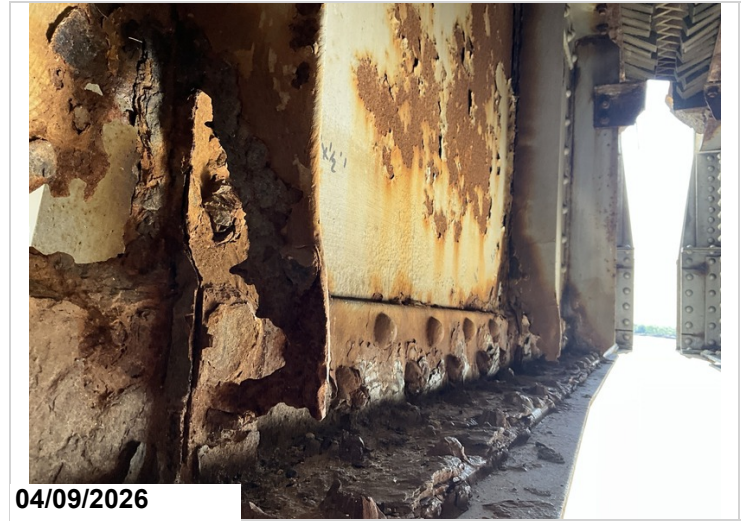
Span 12, Ahead Floorbeam at PP25, Stiffeners 6 and 7:  
Active corrosion with holes in the stiffeners.

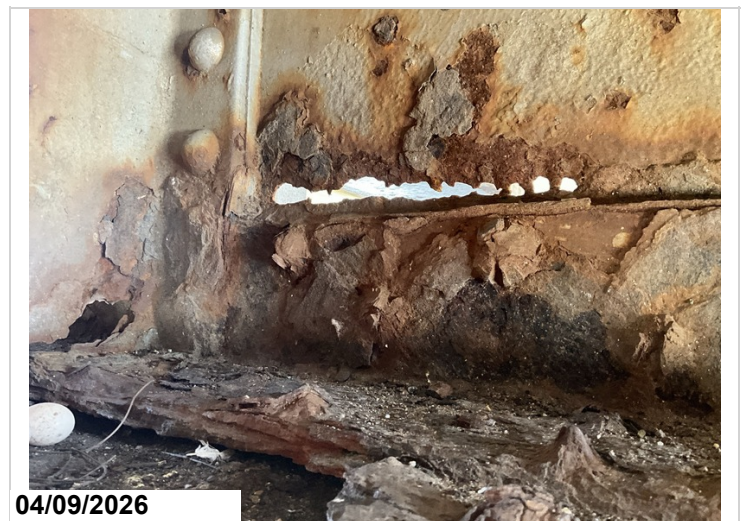
Span 12, Ahead Floorbeam at PP25, Adjacent to Stiffener 5:  
Active corrosion with a 10" X 1/2" hole in the web. 1LF CS4 corrosion.

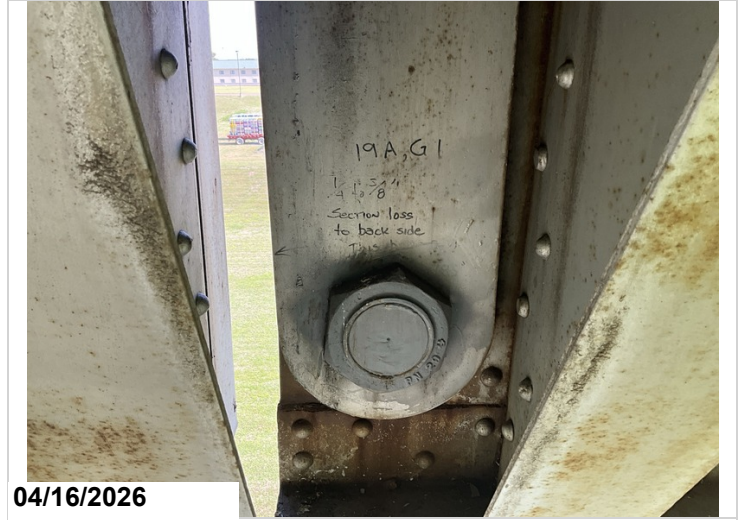
Span 19, Girder 1, right hanger of pin and hanger assembly: corrosion with up to 3/8" section loss to back side of hanger bar at lower pin section. 1EA CS3 corrosion.

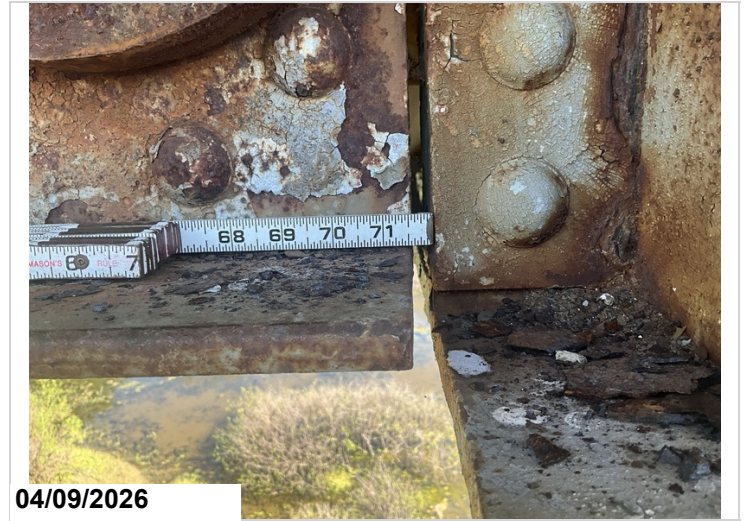
Span 4, Girder 2, Pin and Hanger Assembly: 7/16" gap between Girder 1 and Floorbeam 1 in Span 4. 66 degree air temperature.

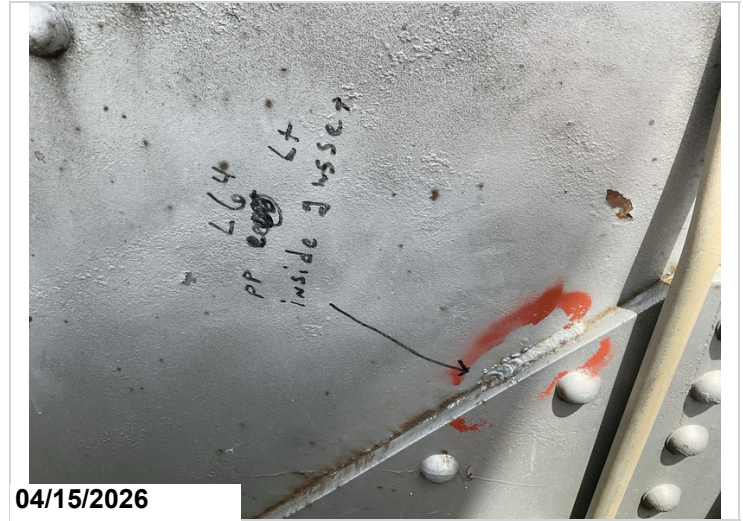
Span 15, Truss 1, L64, Inside Gusset Plate: Cracked tack weld. 1LF CS3 crack.
