# Bridge Inspection Report

**06433**  
**SH 28-Scott Co.**  
**over**  
**Line Creek**

Structure Number: 06433

Facility Carried: SH 28-Scott Co.

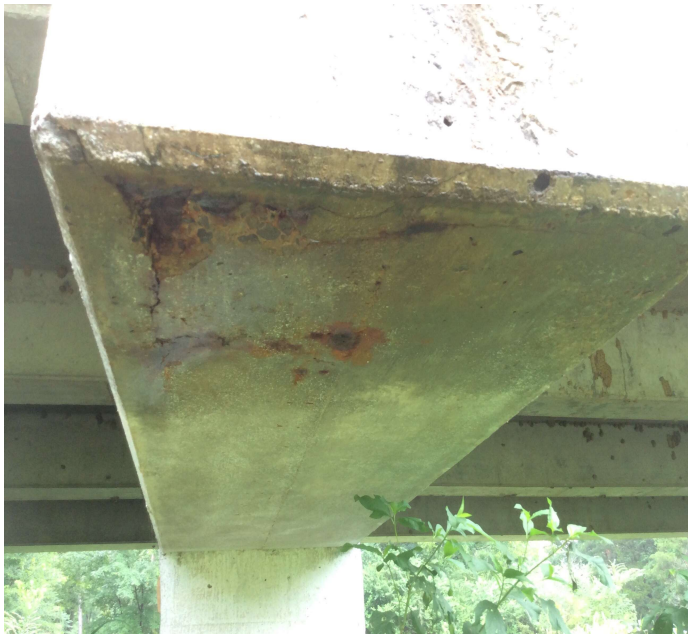
Shallow spalling with exposed reinforcing steel on the undersurface of the caps at Bents # 2 & 4.

PHOTO 1      Description      Spalling with exposed reinforcing steel on the under surface of the cap at Bents 2.

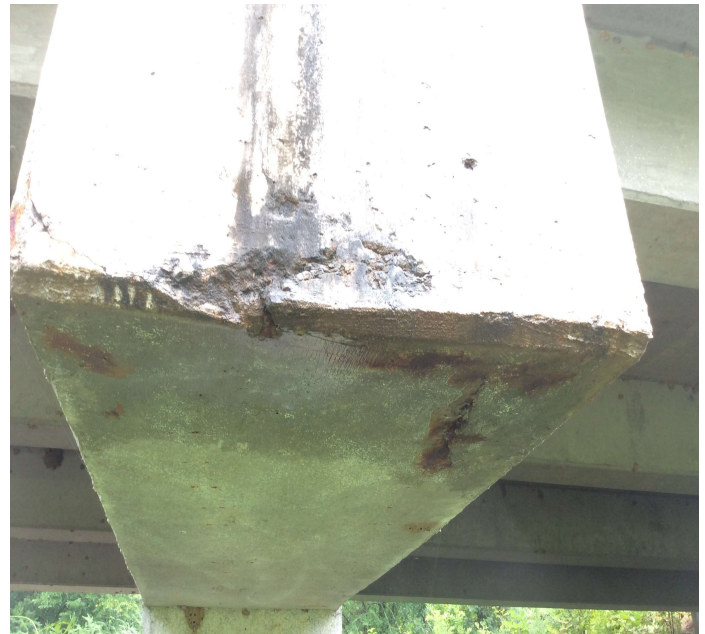
PHOTO 2      Description      There are two delaminated areas in the Rt end of Bent 4 cap.

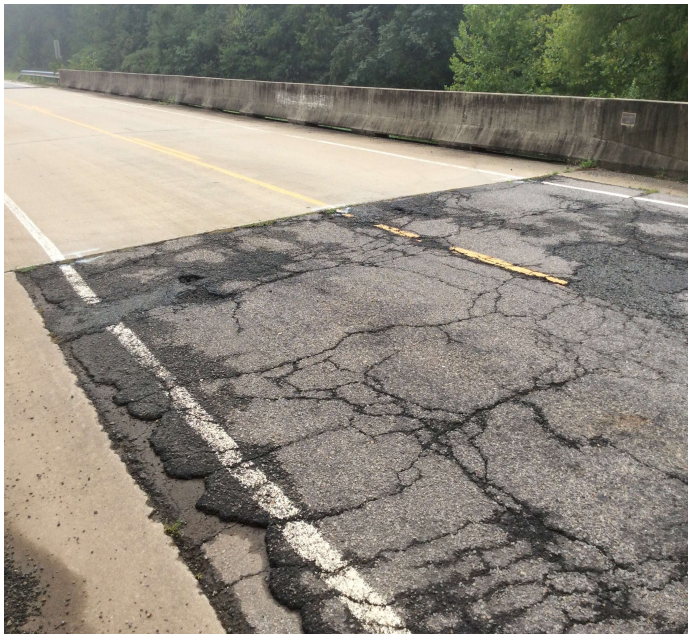
Minor asphalt settlement at the approaches.

PHOTO 1      Description      Minor asphalt settlement at the approaches.

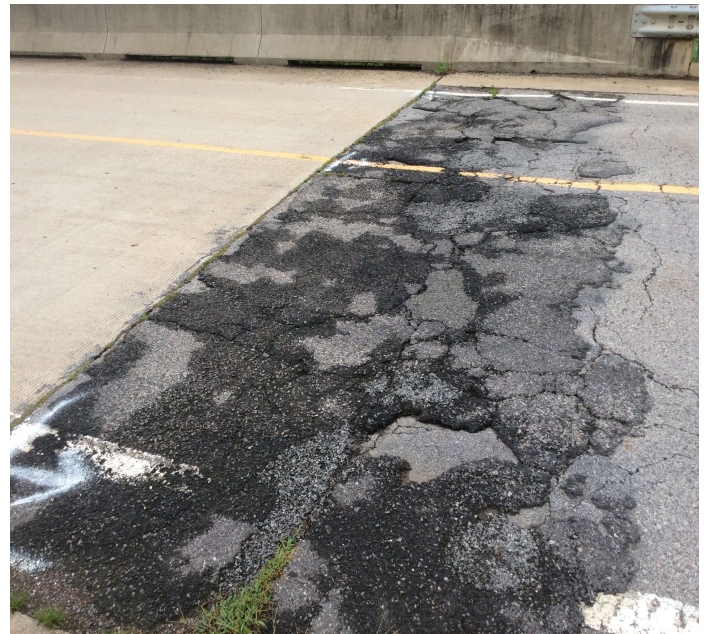
PHOTO 2      Description      Minor asphalt settlement at the approaches.

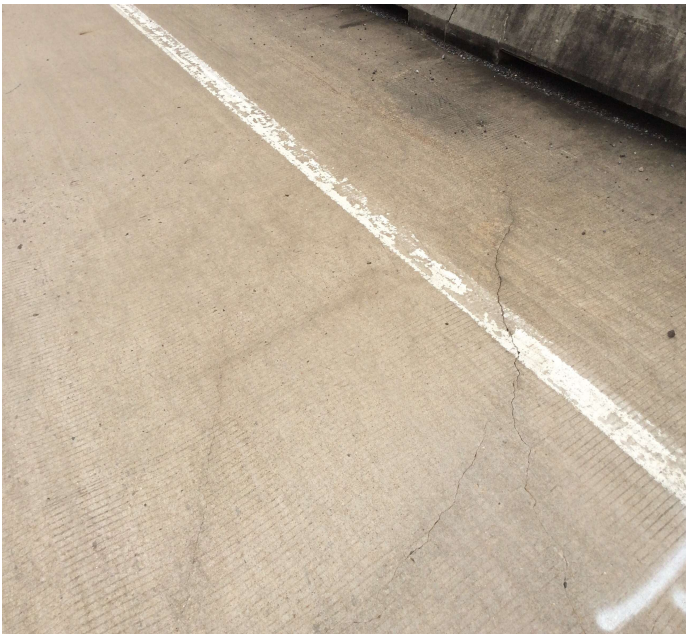
Sealable cracking on the driving surface of the deck.

PHOTO 1      Description      Sealable cracking on the driving surface of the deck.

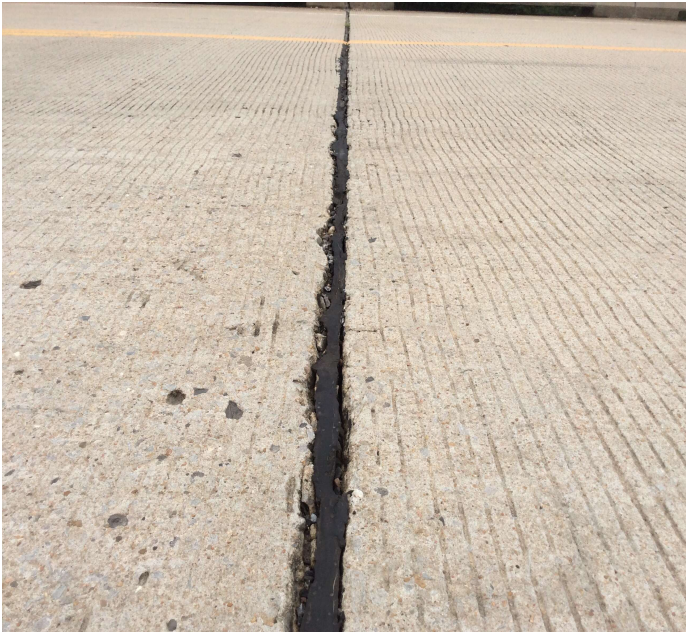
The deck joints seals are deteriorated and leak water.

PHOTO 1      Description      The deck joints seals are deteriorated and leak water.
