# Bridge Inspection Report

**06434**

**SH 28-Scott Co.**

**West Fork Shadley Cr.**

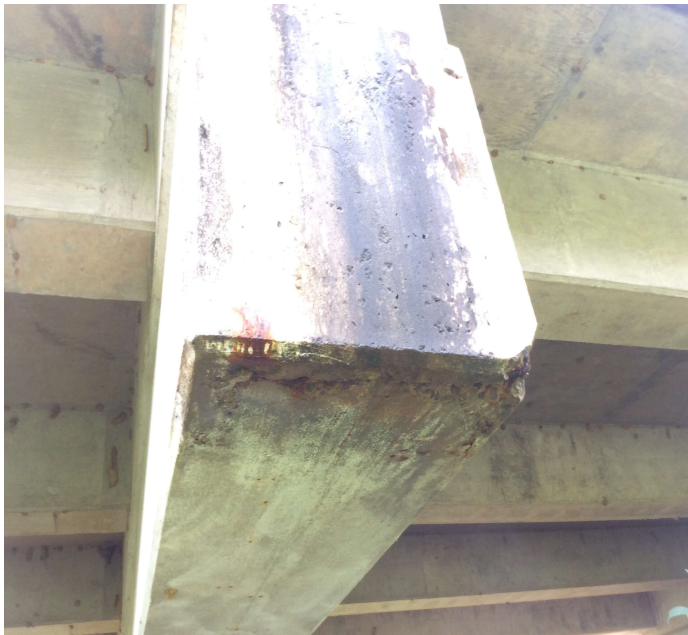
The Left and Right ends of Bents # 2, 4, and 5 caps have delaminated areas and spalls with exposed reinforcing steel. The Right end of Bent # 3 cap has a delaminated area in the end of the cap. No apparent section loss to the exposed reinforcing steel.

PHOTO 1      Description      The Lt and Rt ends of Bent 2 cap has delaminated areas and spalls with exposed reinforcing steel.

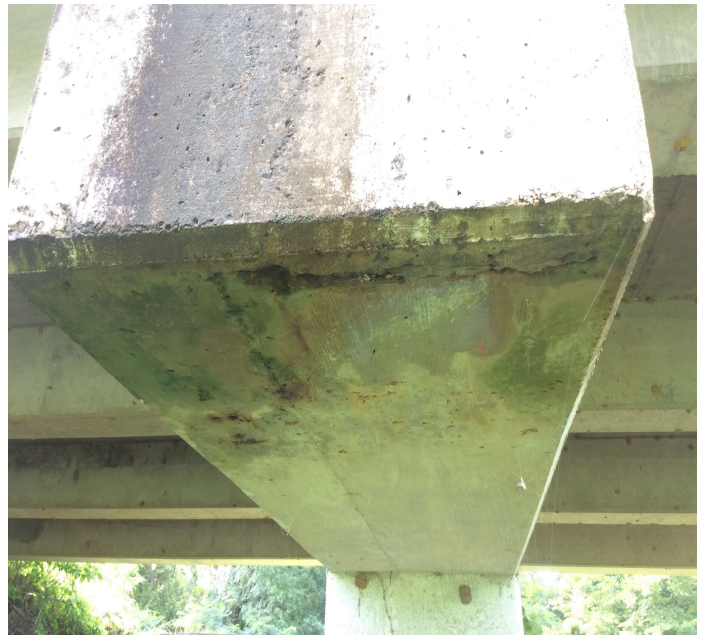
PHOTO 2      Description      The Lt and Rt ends of Bent 5 cap has delaminated areas and spalls with exposed reinforcing steel.

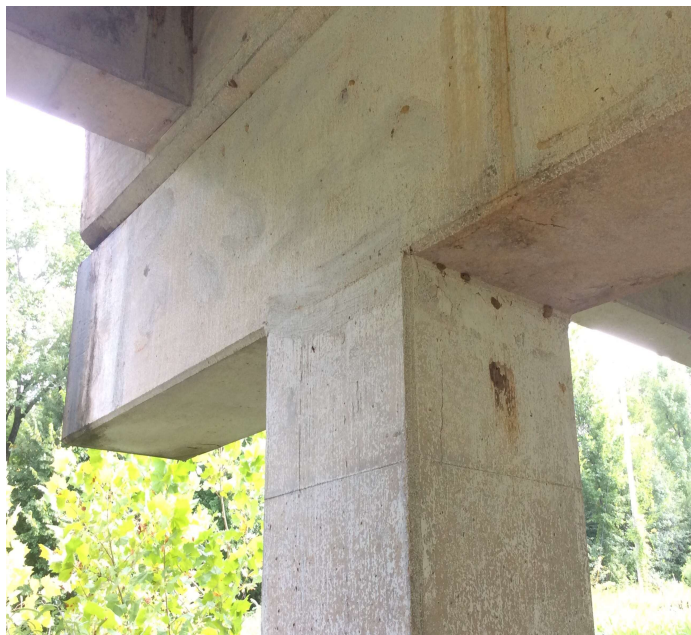
**PHOTO 3**      **Description**      The Lt and Rt ends of Bent 4 cap has delaminated areas and spalls with no exposed reinforcing steel.

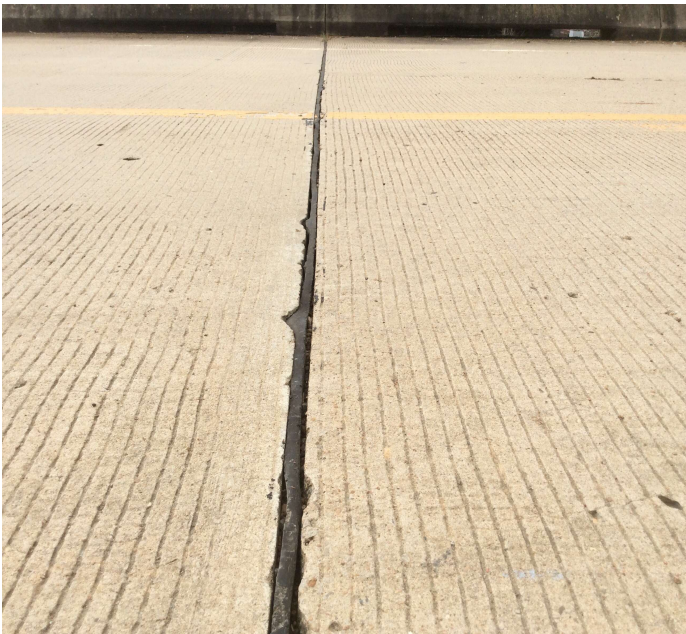
The deck joints have adhesion failure and appear to leak water.

PHOTO 1      Description      The deck joints have adhesion failure and appear to leak water.
