Bridge Inspection Report

06435
SH 28-Scott Co.
over
East Shadley Creek

Structure Number: 06435

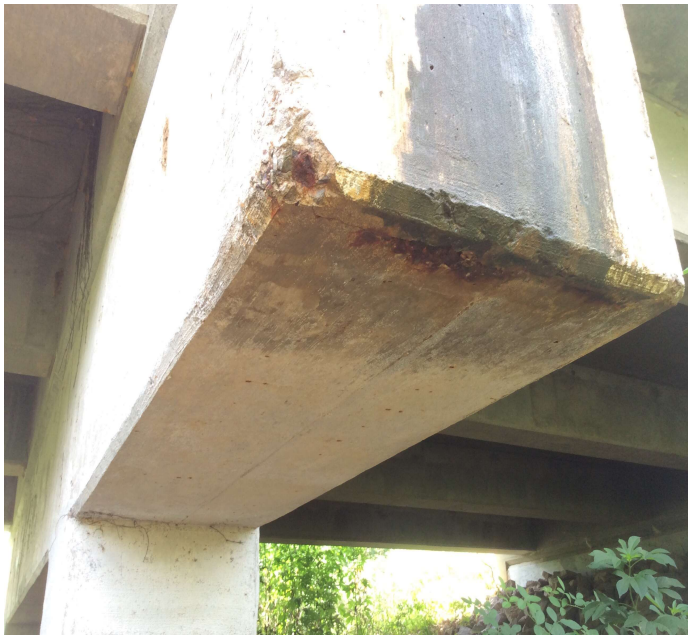
The Left end of Bents # 2 and 3 have delaminated areas with cracks and rust stains in the end of caps. The Right end of Bent # 4 cap has shallow 24" long spalls with exposed reinforcing steel (Stirrups). Exposed reinforcing steel has active corrosion with initial section loss at this inspection.

PHOTO 1 Description The Lt end of Bent 2 cap has delaminated areas with cracks and rust stains in the end of caps.

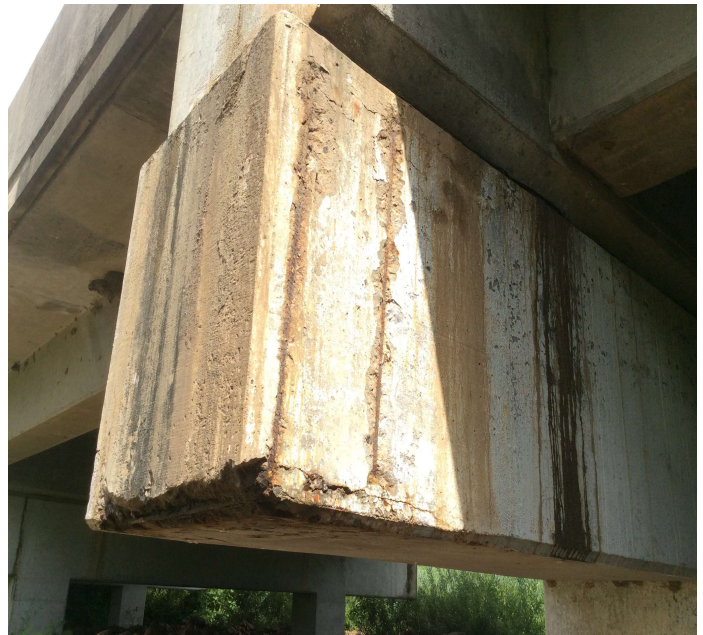
PHOTO 2 Description The Rt end of Bent 4 cap has shallow 24" long spalls with exposed reinforcing steel (stirrups). Exposed reinforcing steel has active corrosion with initial section loss at this inspection.

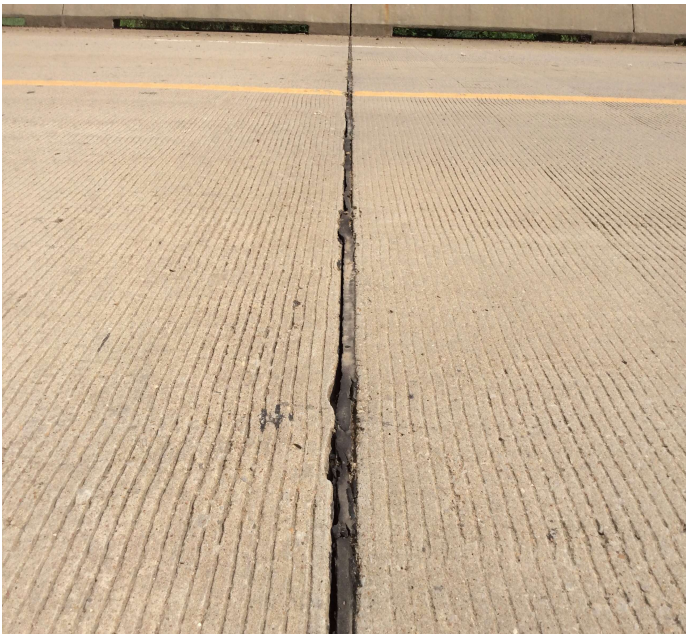
The compression deck joint seals are deteriorated and leak water on the substructure.

PHOTO 1	Description	The compression deck joint seals are deteriorated and leak water on the substructure.
---------	-------------	---

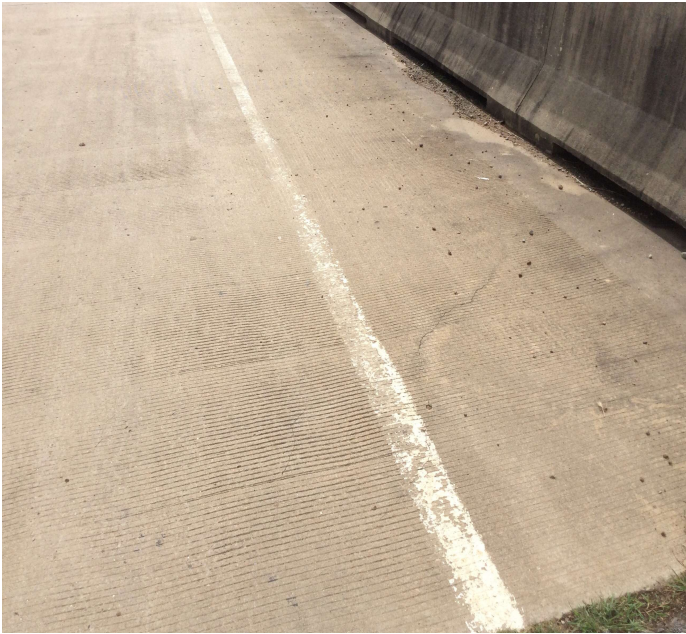
The driving surface of the deck has sealable cracks.

PHOTO 1 Description The driving surface of the deck has sealable cracks.
