# Bridge Inspection Report

**06436**  
**SH 28-Scott Co.**  
**over**  
**Two Mile Creek**

## Bridge Inspection Report

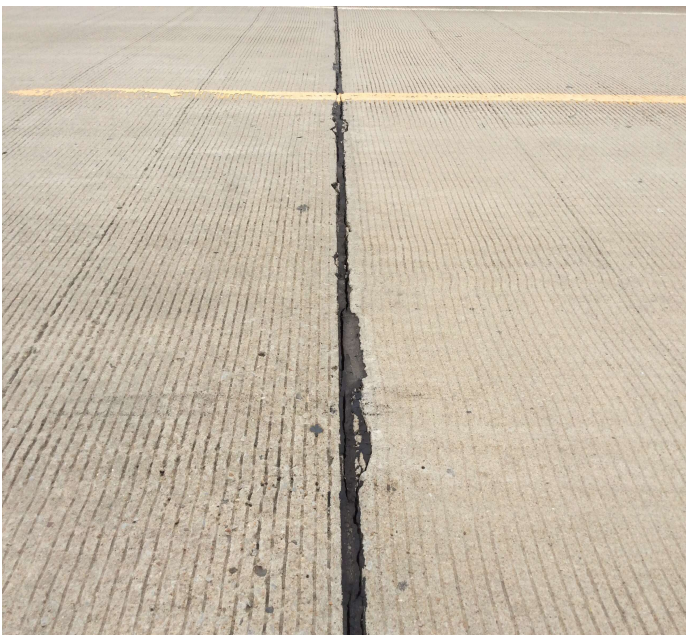
The compression deck joint seals are deteriorated and leak water.

PHOTO 1      Description      The compression deck joint seals are deteriorated and leak water.
