Bridge Inspection Report

M0683
SH 28-Scott Co.
over
Lookout Creek

Structure Number: M0683

Facility Carried: SH 28-Scott Co.

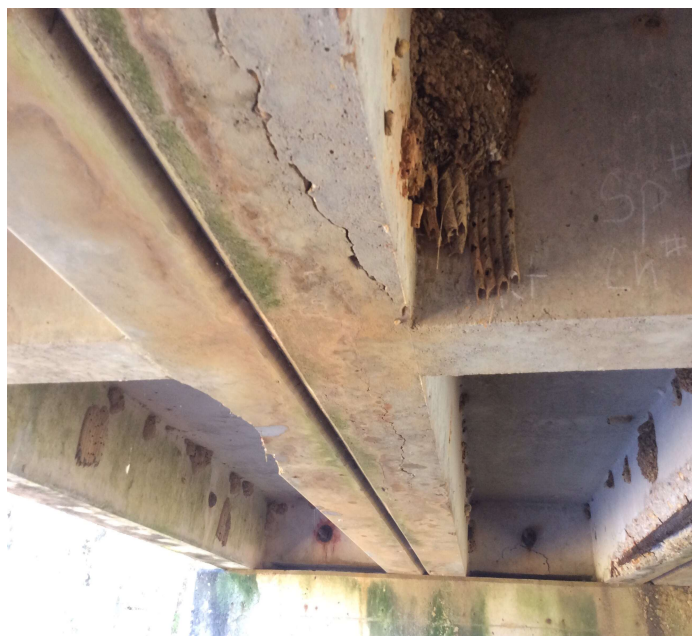
Superstructure has longitudinal cracks and concrete spalls with exposed primary longitudinal reinforcing steel. Exposed reinforcing steel has active corrosion.

PHOTO 1 Description Numerous areas with longitudinal cracking visible on the bottom surface of the channel Unit legs.

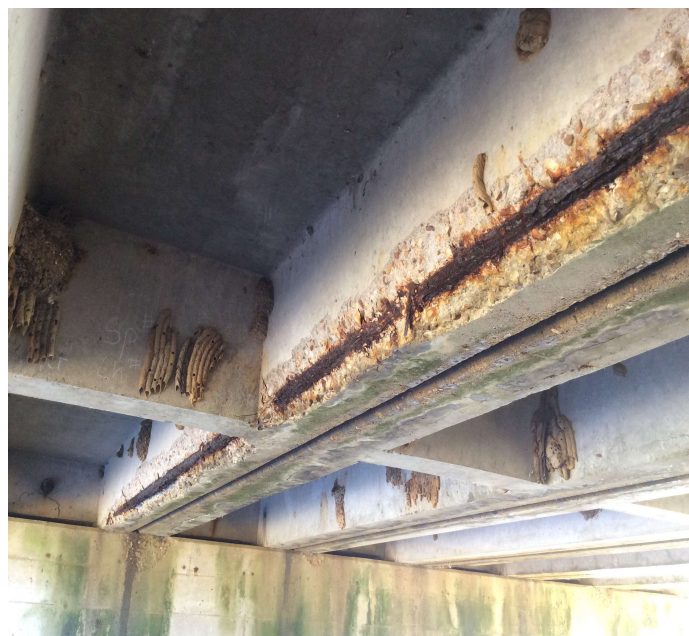
Numerous areas with longitudinal concrete cracking, spalling, & delamination in the stems of Channels. The most extreme examples are located as follows:

PHOTO 2 Description Numerous areas with longitudinal concrete cracking, spalling with exposed reinforcing steel & delamination in the stems of Channels.
-Span 1-Rt Leg of Channel 2 pictured.

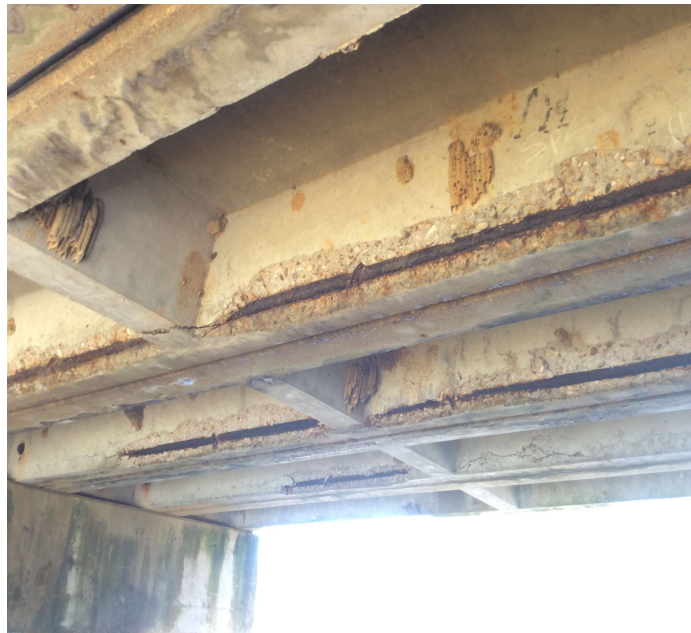
PHOTO 3 Description Numerous areas with longitudinal concrete cracking, spalling with exposed reinforcing steel & delamination in the stems of Channels.
-Span 2-Lt Leg of Channel 2
-Span 2-Lt Leg of Channel 3
-Span 2-Lt Leg of Channel 4

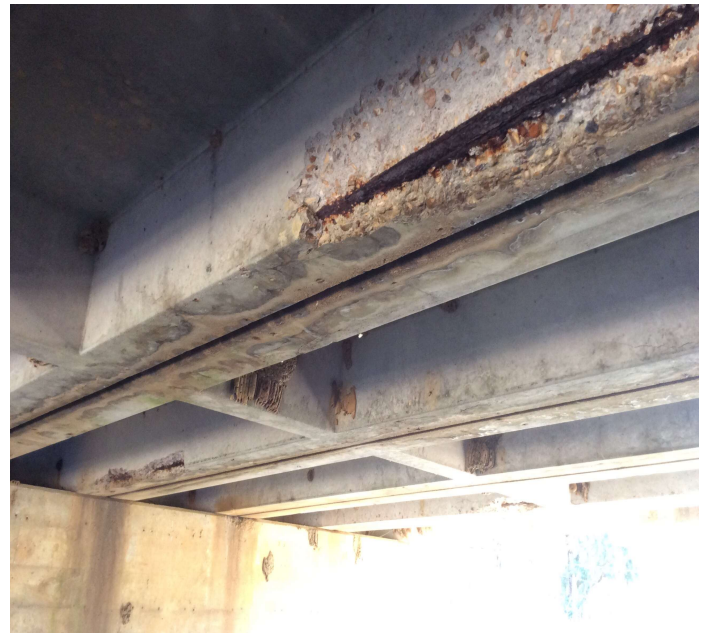
PHOTO 4 Description Numerous areas with longitudinal concrete cracking, spalling with exposed reinforcing steel & delamination in the stems of Channels.
-Span 4-Rt Leg of Channel 3
-Span 4-Rt Leg of Channel 4
-Span 4-Rt Leg of Channel 6

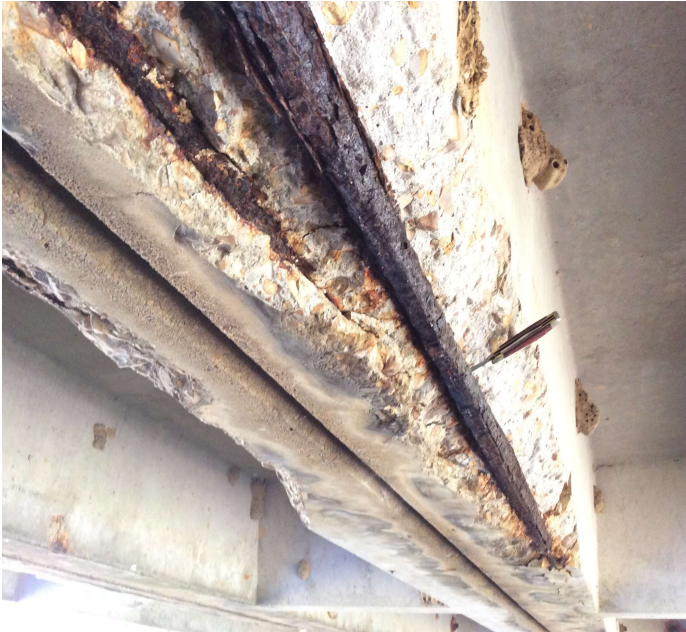
-Unit 4 of Span 3 has exposed reinforcing steel that has caulking smeared over the reinforcing steel as a type of repair. Up to 1/16" section loss to exposed primary longitudinal reinforcing steel.

PHOTO 5 **Description** Span 3, Unit 4 has exposed reinforcing steel that has caulking smeared over the reinforcing steel as a type of repair. The exposed primary longitudinal reinforcing steel in the stem of Span 3, Channel 4 measured 1/16" at this inspection and lost its bond with the concrete along a 5' long area.

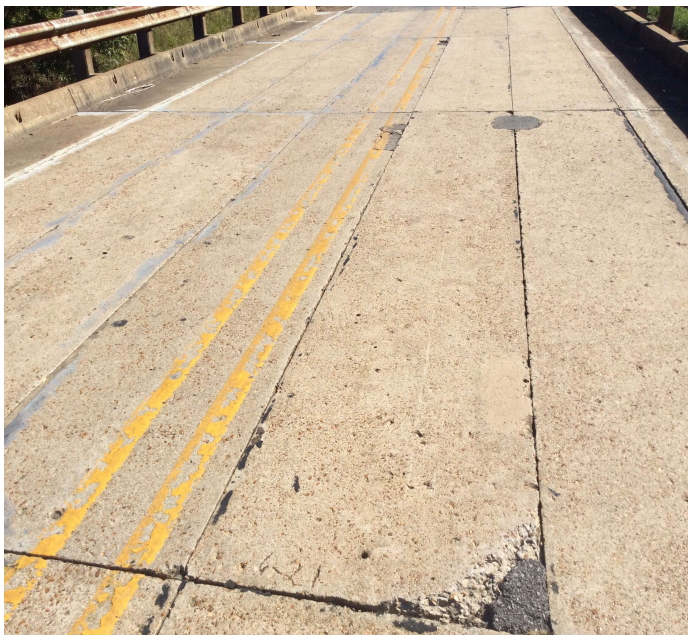
Pre-cast concrete channels have spalls on the driving surface of the deck. Deck joints between units leak water.

PHOTO 1 Description Pre-cast concrete channels have spalls on the driving surface of the deck. Span 2 Units 4 & 5 pictured.

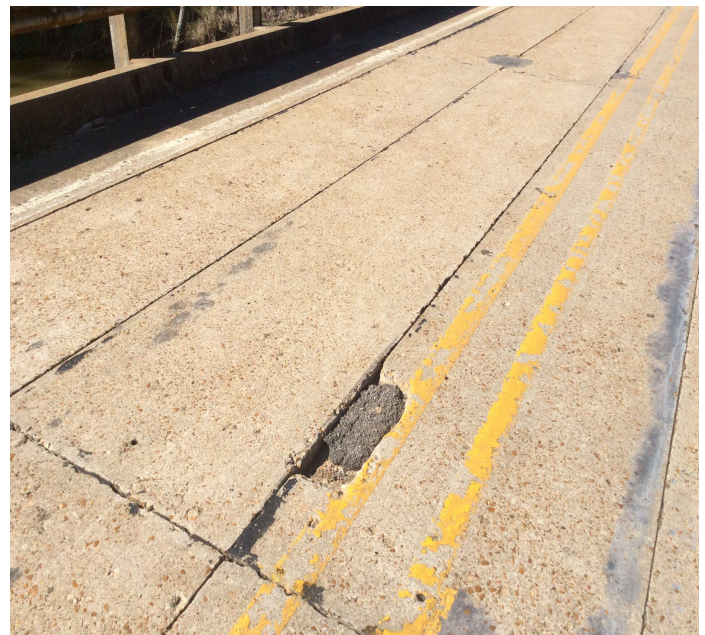
PHOTO 2 Description Pre-cast concrete channels have spalls on the driving surface of the deck. Span 3, Unit 4 at Bent 4 pictured.

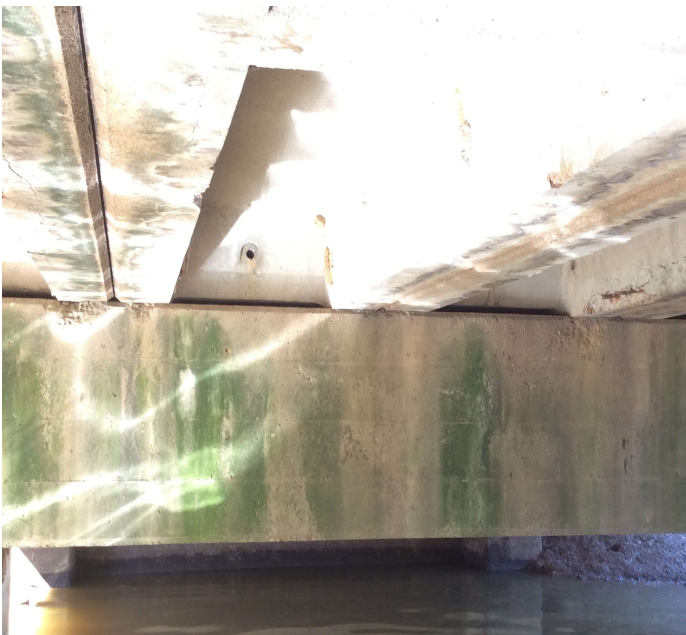
Spalling in the bearing area of some units.

PHOTO 1 Description Shallow spalls in the bearing areas under the stems of channels. Bent 2 in Span 2 pictured.

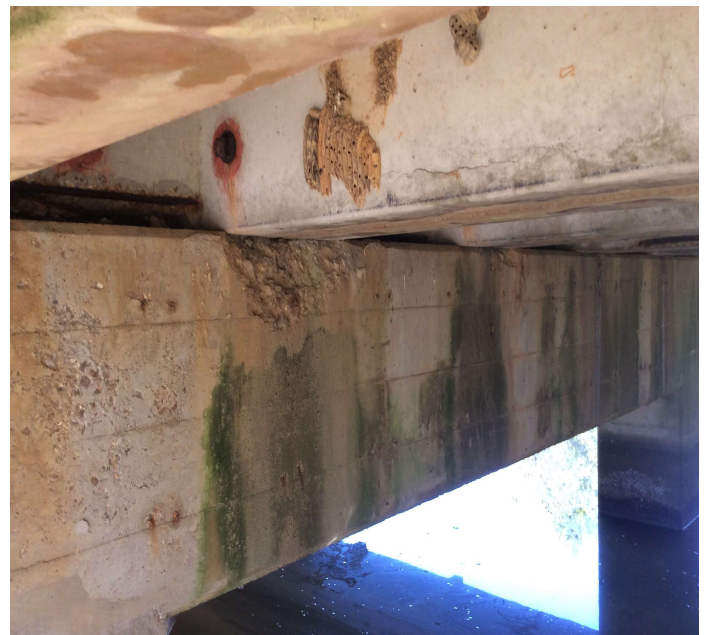
PHOTO 2 Description Shallow spalls in the bearing areas under the stems of channels. Bent 3 in Span 3 pictured.

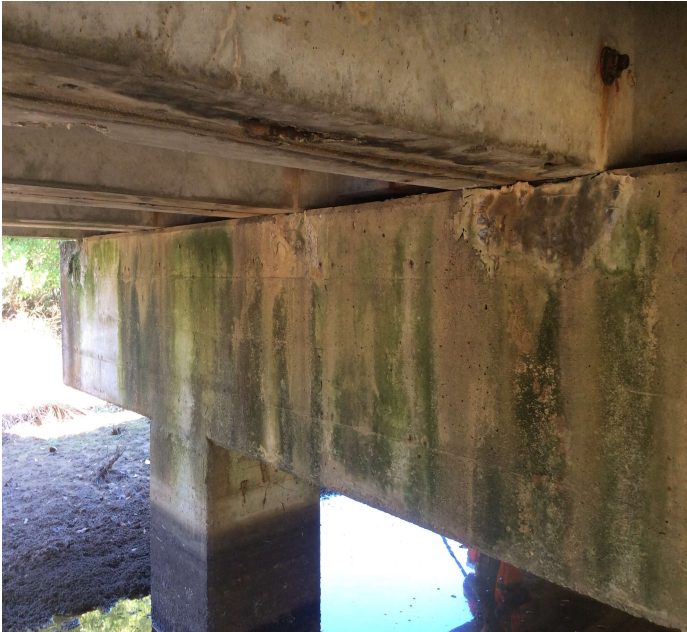
PHOTO 3 Description Shallow spalls in the bearing areas under the stems of channels. Some spalls have been covered with caulking by maintenance forces as a type of repair. Bent 4 in Span 3 pictured.

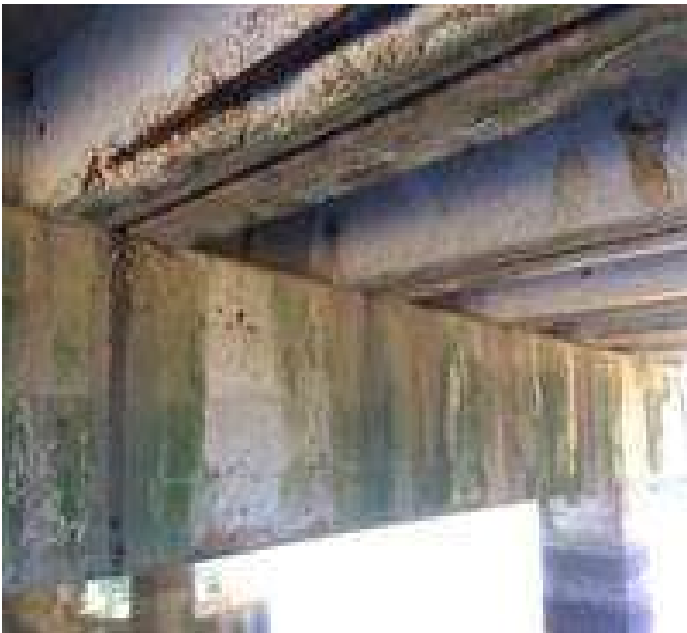
PHOTO 4 Description Shallow spalls in the bearing areas under the stems of channels. Bent 2 in Span 1 pictured.
