Bridge Inspection Report

M3111

State Highway 28

Six Mile Creek-Scott Co.

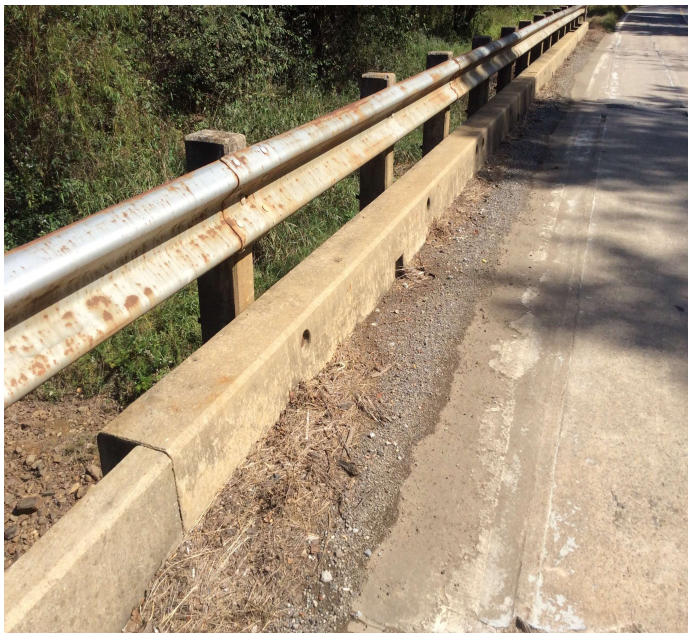
Dirt and debris along the gutters.

PHOTO 1 Description Dirt and debris along the gutters. Lt side pictured.

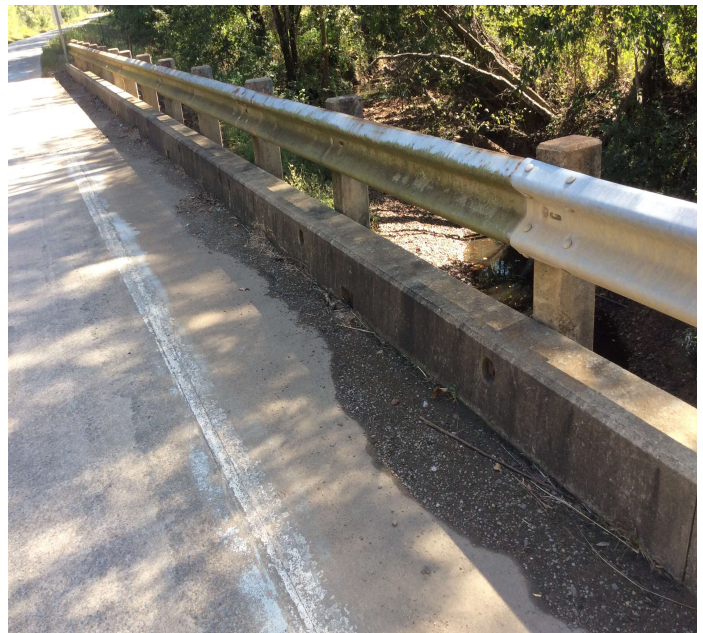
PHOTO 2 Description Dirt and debris along the gutters. Rt side pictured.

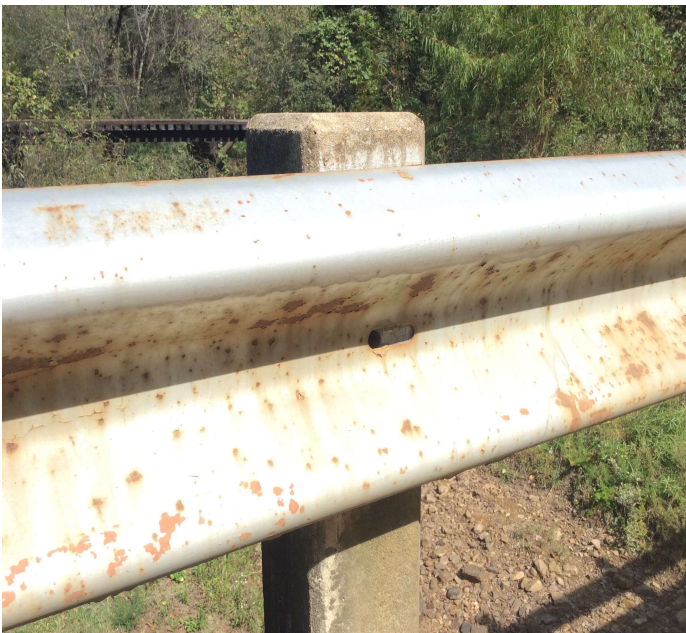
330 - Metal Bridge Railing	1- Ben.	200	ft.	100	100	0	0
	-Superficial rust is showing through the protective steel coating. -The Lt bridge railing has two missing anchor bolts at Span 1, Post 4 and at Span 3, Post 4.						
1000 - Corrosion		100			100		
515 - Steel Protective Coating		400	sq. ft.	200	100	50	50
3440 - Effectiveness (Steel Protective Coatings)		200			100	50	50

The Lt bridge railing is missing 2 anchor bolts at Span 1 and Span 3.

PHOTO 1 Description The Lt bridge railing is missing 2 anchor bolts at Span 1 and Span 3. Span 1, Post 4 pictured.

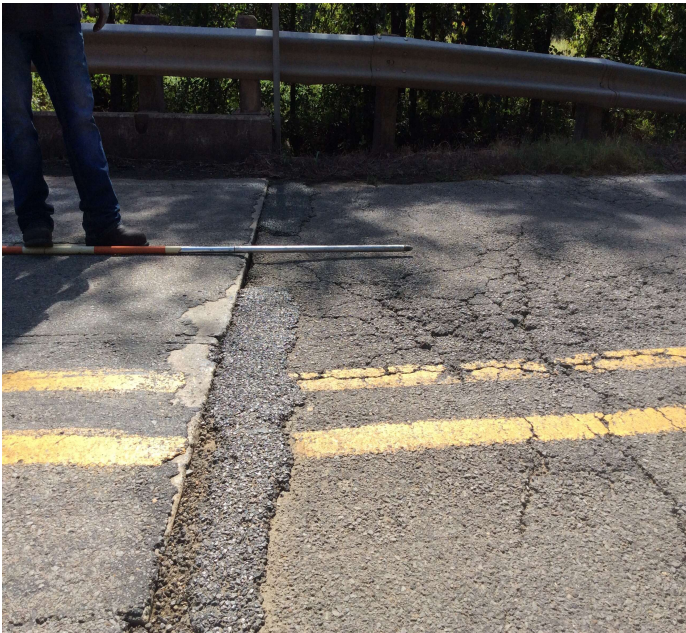
The asphalt approach roadway at both bridge ends has settled and has map cracking.

PHOTO 1 Description The asphalt approach roadway at both bridge ends has settled and has map cracking. Bent 1 pictured.

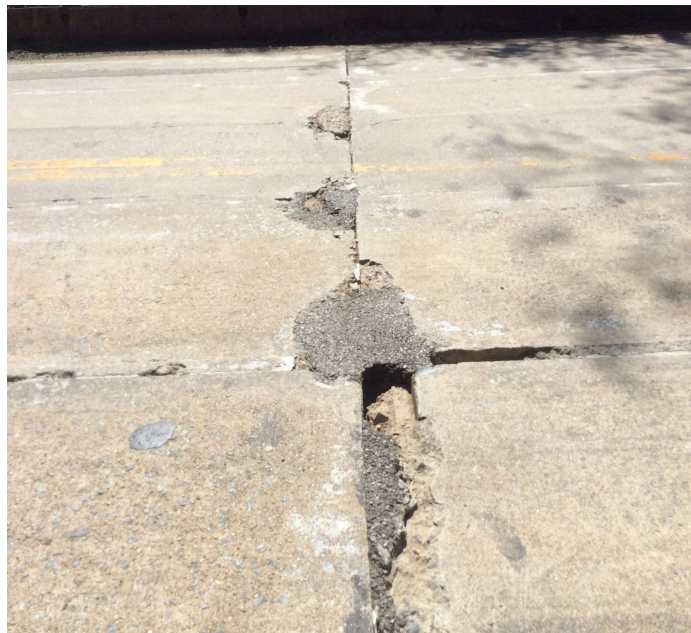
Environment	Total Quantity	Units	Condition State 1	Condition State 2	Condition State 3	Condition State 4
12 - Reinforced Concrete Deck	1- Ben.	2420	sq. ft.	1718	685	17	0
	-The ends of the channels have concrete repairs that are deterioration and causing potholes to form over the intermediate bents. -The epoxy repairs appear to be failing. -The grout joints appear to leak water that is contributing to the cracking in the stems of the channels in Spans 1 & 4. -The driving surface has light wear. -The driving surface has areas with light superficial cracking.						
1080 - Delamination/Spall/Patched Area		52			35	17	
1130 - Cracking (RC and Other)		350			350		
1190 - Abrasion/Wear (PSC/RC)		300			300		
110 - Reinforced Concrete Open Girder/Beam	1- Ben.	700	ft.	490	0	210	0
	-Span 1 & 4 has cracking in the stems of the channels. -Isolated areas of shallow baseball size spalls in the bottom of the stems of some units with exposed reinforcing steel stirrups visible with section loss to reinforcing steel. -Concrete spalling with exposed reinforcing steel in the ends of Channel 1 in Span 1 and Channels 1 & 2 in Span 4. Initial section loss to reinforcing steel. -Vertical hairline flexure cracking at approximately 12" centers in the stems of channels.

The concrete repairs over the intermediate bents is failing and causing potholes on the driving surface

PHOTO 1 Description The concrete repairs over the intermediate bents is failing and causing potholes on the driving surface. Bent 4 pictured.

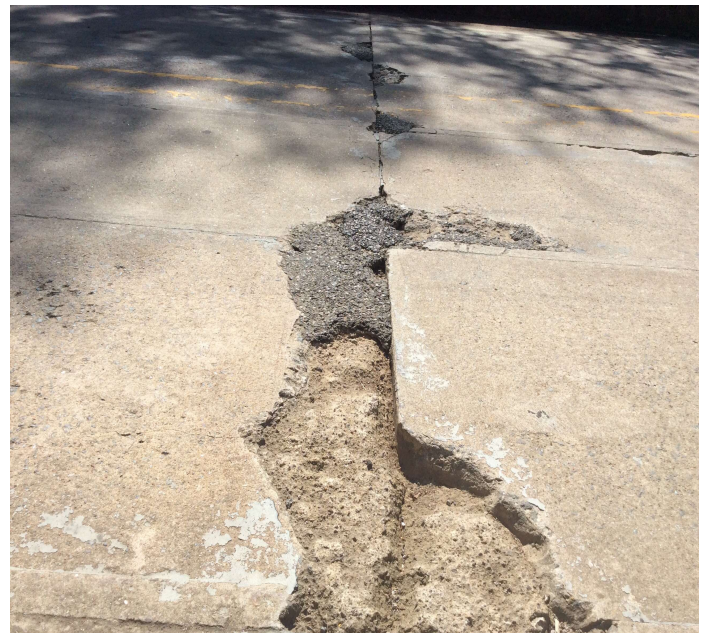
PHOTO 2 Description The concrete repairs over the intermediate bents is failing and causing potholes on the driving surface. Bent 2 pictured.

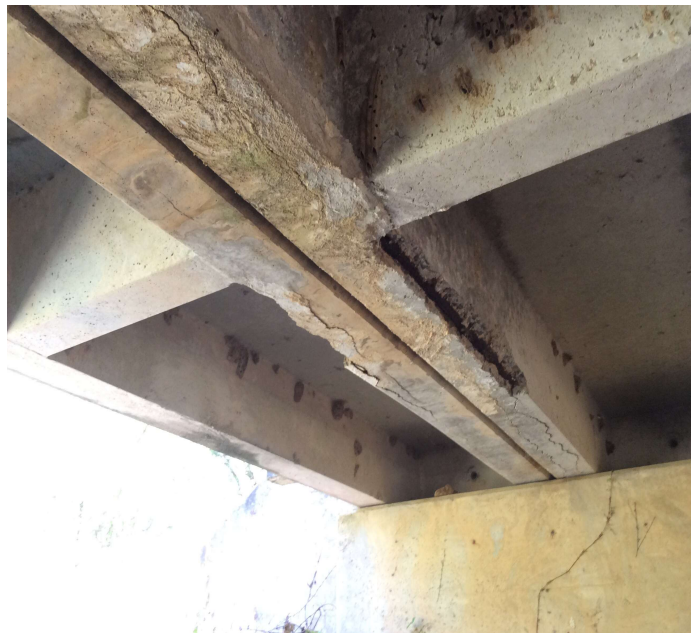
Spans 1 & 4 have longitudinal cracks, delaminated areas, and spalls with exposed reinforcing steel.

PHOTO 1 Description Spans 1 & 4 have longitudinal cracks, delaminated areas, and spalls with exposed reinforcing steel. Span 4, Unit 2 pictured.

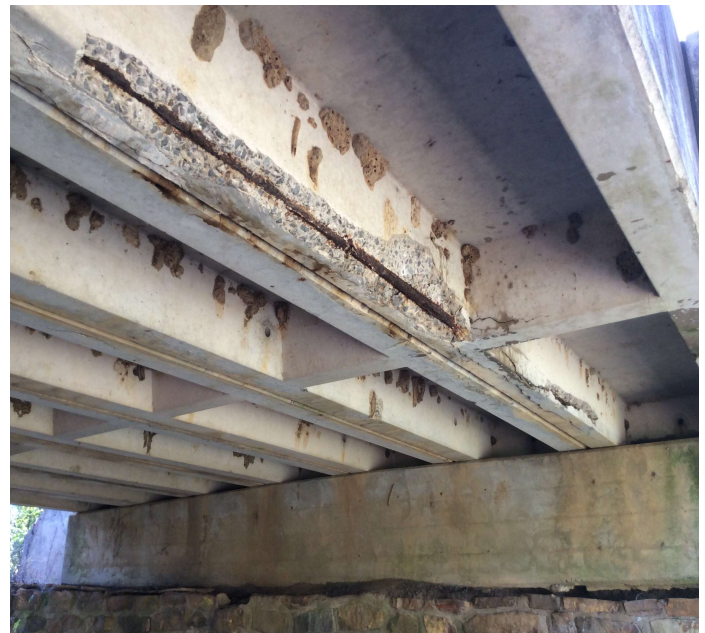
PHOTO 2 Description Spans 1 & 4 have longitudinal cracks, delaminated areas, and spalls with exposed reinforcing steel. Span 1, Unit 1 pictured.

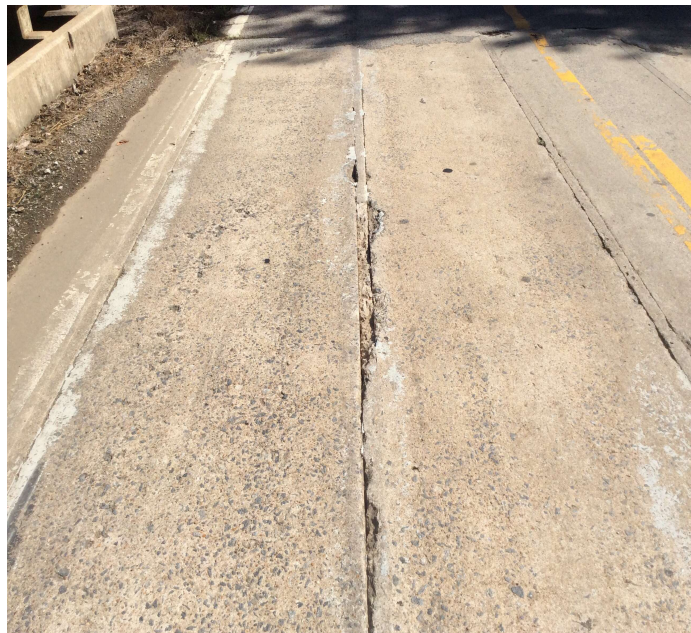
The grout joints between the units are deteriorating and appear to leak water on the superstructure and substructure.

PHOTO 1 Description The grout joints between the units are deteriorating and appear to leak water on the superstructure and substructure. Span 4 at Units 2 & 3.

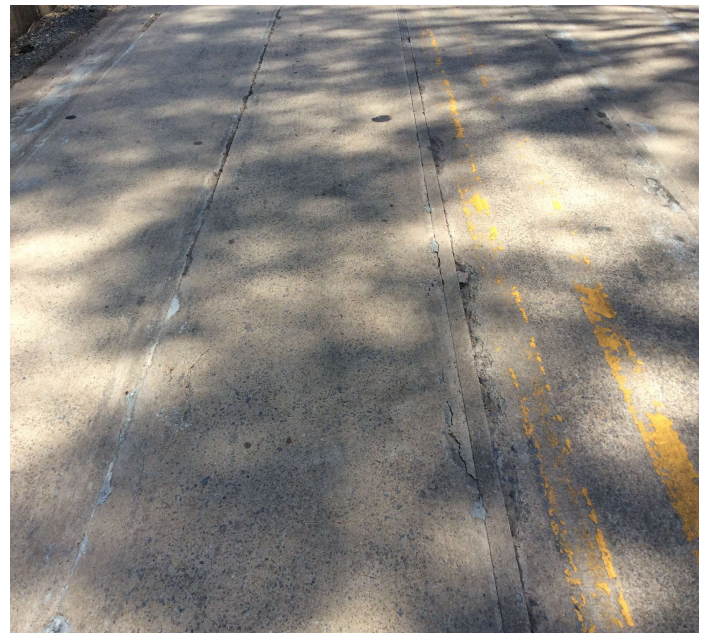
PHOTO 2 Description The grout joints between the units are deteriorating and appear to leak water on the superstructure and substructure. Span 2 at Units 2 & 3.

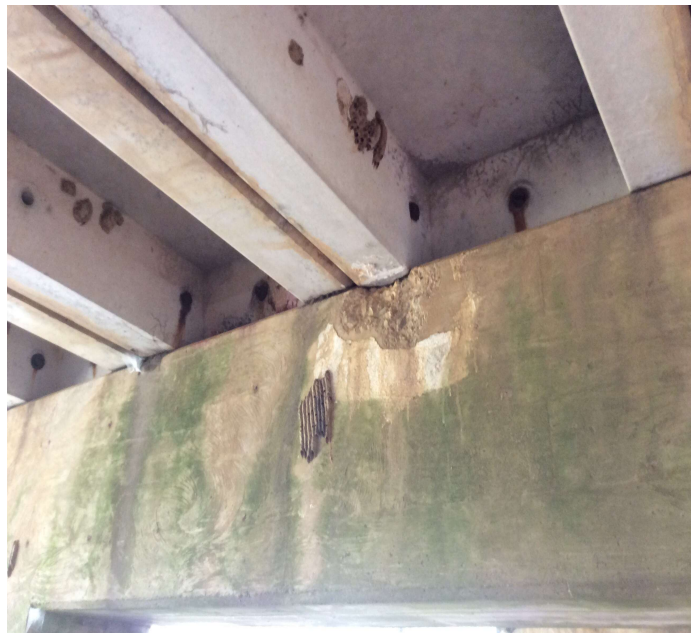
Intermediate substructure caps have shallow spalling in the bearing area under the units.

PHOTO 1 Description Intermediate substructure caps have shallow spalling in the bearing area under the units. Bent 2, Span 1 pictured.

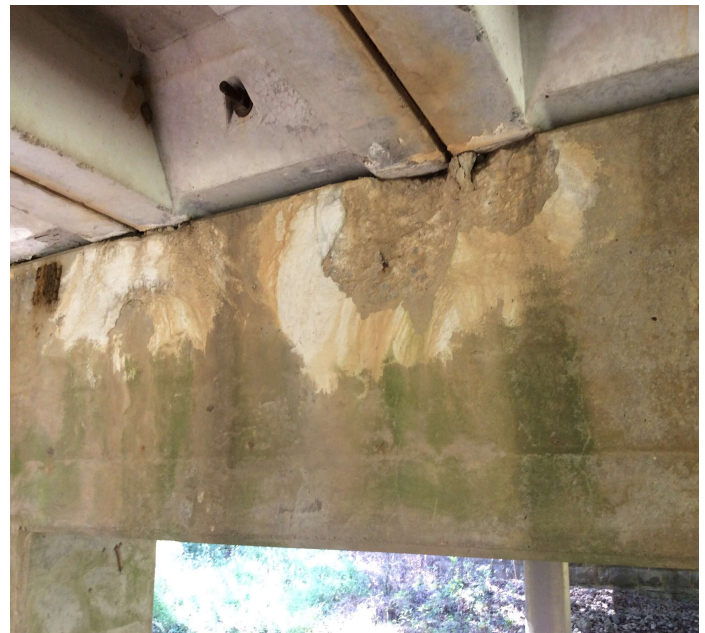
PHOTO 2 Description Intermediate substructure caps have shallow spalling in the bearing area under the units. Bent 3, Span 3 pictured.
