**Asset #04335**(Routine, Underwater type 2)

**GanderStreetRd-CR over Flag Lake Sough**

**Location: 0.3 Mi N Main St-Gillett**

**Team Lead: Greg Loomis, Inspection Date: 03/16/2022**

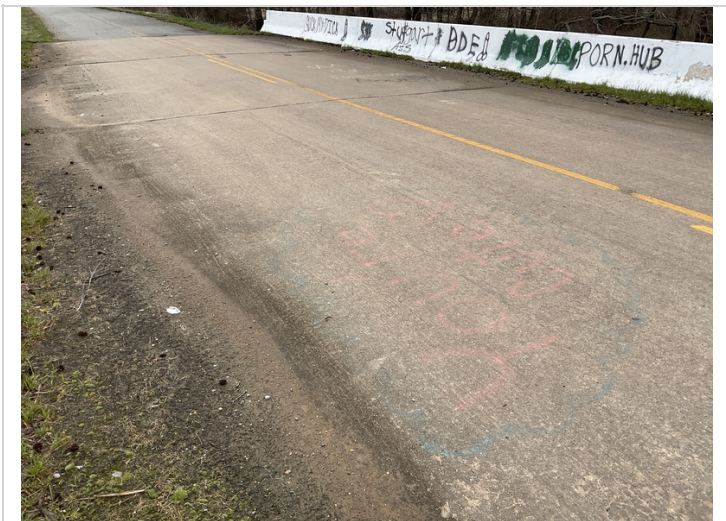
ELEMENTS	DESCRIPTION	UNITS	TOTAL	CS1	CS2	CS3	CS4
38	RC Slab	SF	2300	0	2025	275	0
1130	Cracking (RC and Other)	SF	2300	0	2025	275	0
(38) Deck: 30'-8" wide x 75' long = 2300 sqft. All spans: Scattered minor- to moderate-size longitudinal and transverse cracking, heaviest close to bents (heaviest at Bents 1 & 2). Light map-cracking throughout deck surface. Soffit: Hairline-sized cracks throughout most of spans.

Deck - Spans 1-3: Typical

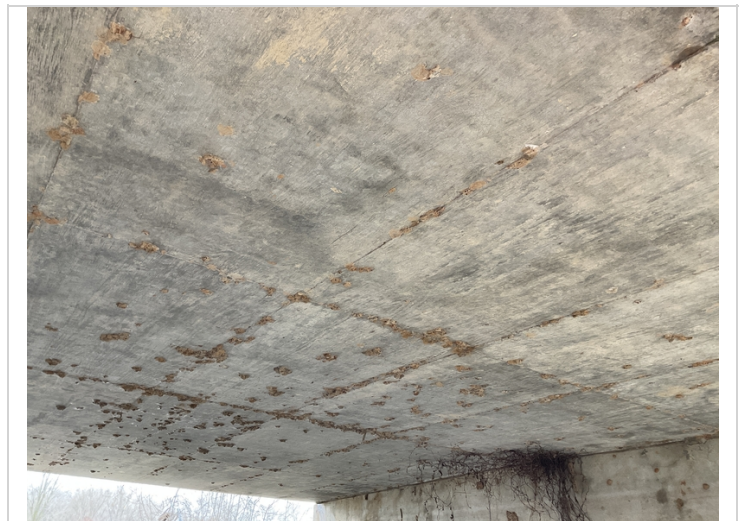
Soffit - Span 2: Typical

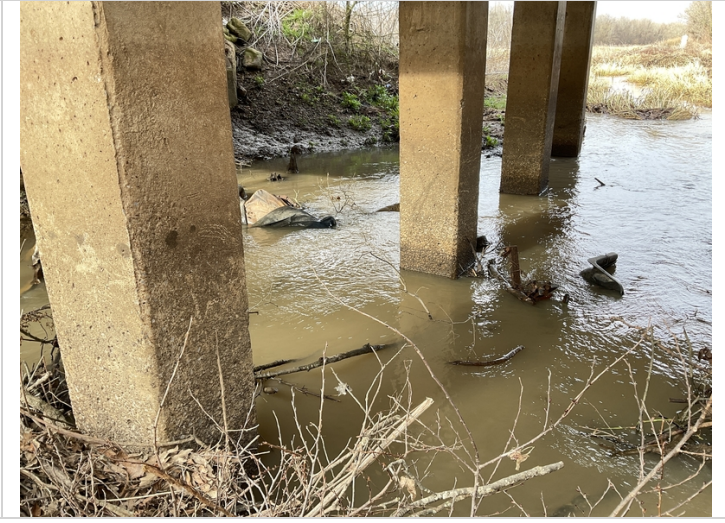
(227) Piling: 4 per bent / Bents 2-3. Bent 2: Some moderate abrasive wear - loss of mortar and a few aggregates - CS3 abrasive wear x 4. Bent 3: Some minor abrasive wear - loss of mortar - CS2 abrasive wear x 4.							
234	Reinforced Concrete Pier Cap	LF	62	0	31	31	0
1130	Cracking (RC and Other)	LF	62	0	31	31	0

Piling - Bent 2: Abrasive wear

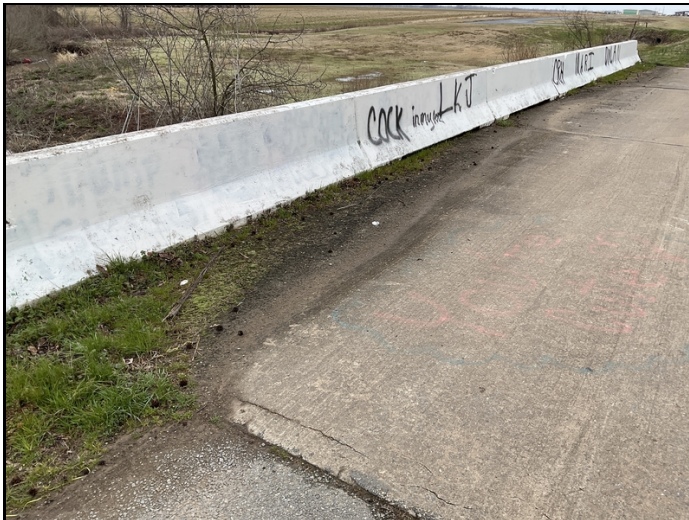
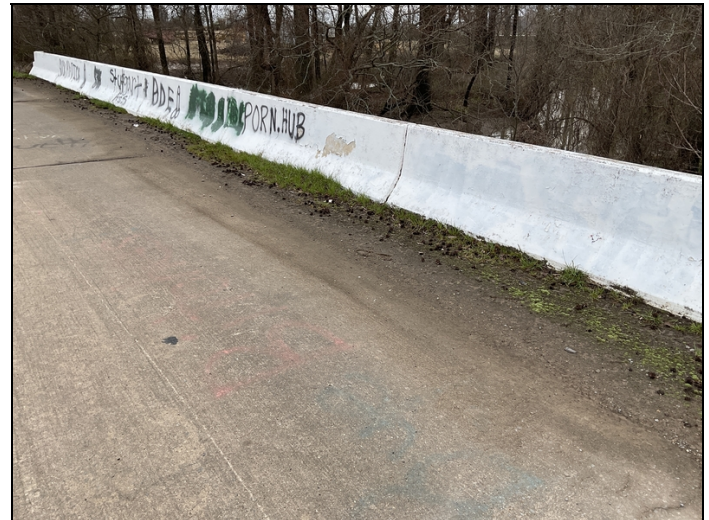
Gutter-lines - both sides: Build-up of dirt, sand, and other debris blocking drains and restricting stormwater from flowing off bridge.

Gutter-line - left side: Debris build-up

Gutter-line - right side: Debris build-up

**Type of Work:** (Inactive) (Inactive) 1 - Clean

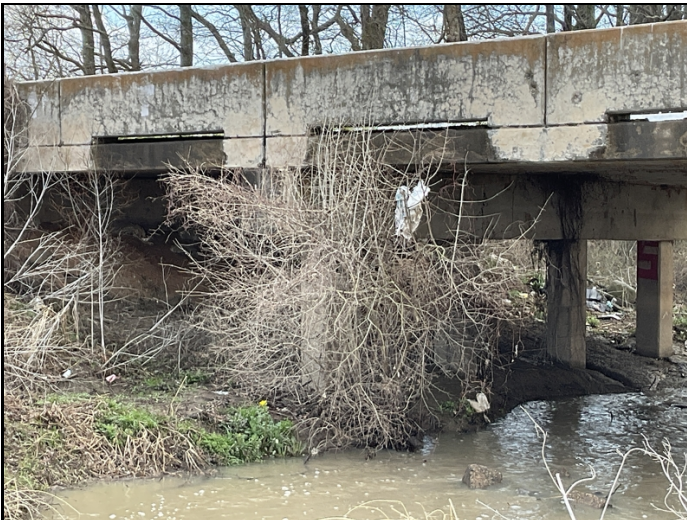
Channel - Bent 3 left: Bush/small tree growing up close to Pile 1.

Channel - Bent 3 left: Vegetation

**Type of Work:** (Inactive) (Inactive) 1 - Clean

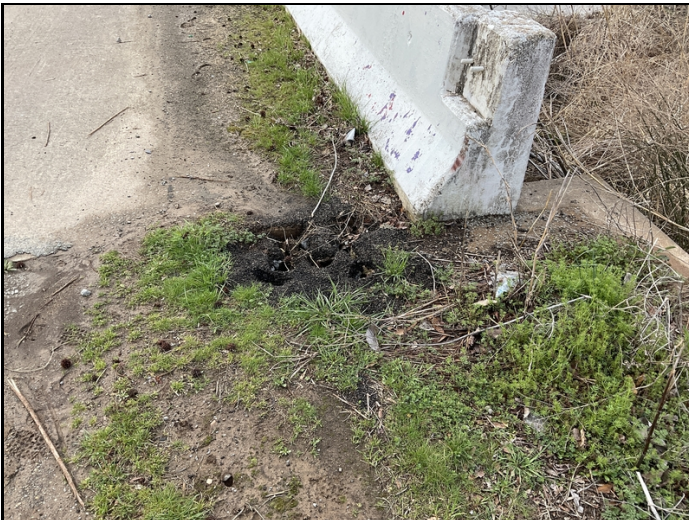
Approach roadway - Bent 4 left: Some erosion with a hole beginning to wash out just inside parapet railing. Stormwater seems to be flowing through hole and eroding material at bridge end and on end slope.

Approach roadway - Bent 4 left: Erosion

**Type of Work:** Repair (General)
