Asset #21890(Routine, NSTM)
Lodge CornerRd-CR1 over Slough
Location: 2.3 Mi W US 165-LodgeCnrr

Lodge Corner Rd-CR1 over Slough

NSTM Inspection Report and Procedure
Bridge No. 21890 2.3 Mi W US 165-LodgeCnr

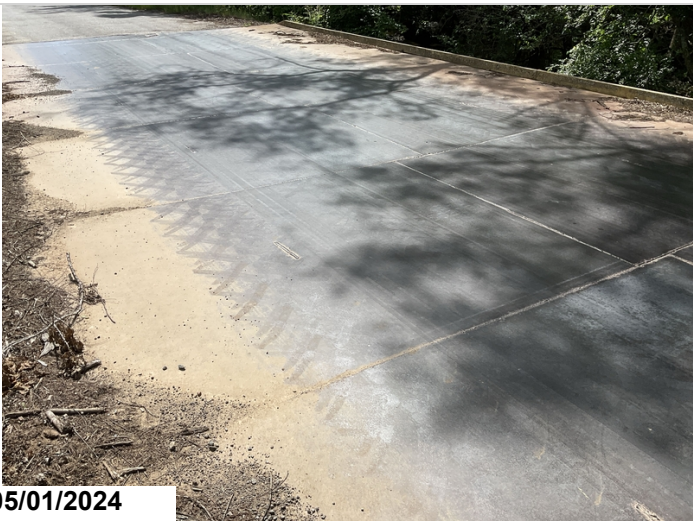
Deck is in good condition with some minor cracking of wearing surface (steel plates).

Deck - Span 1: Typical

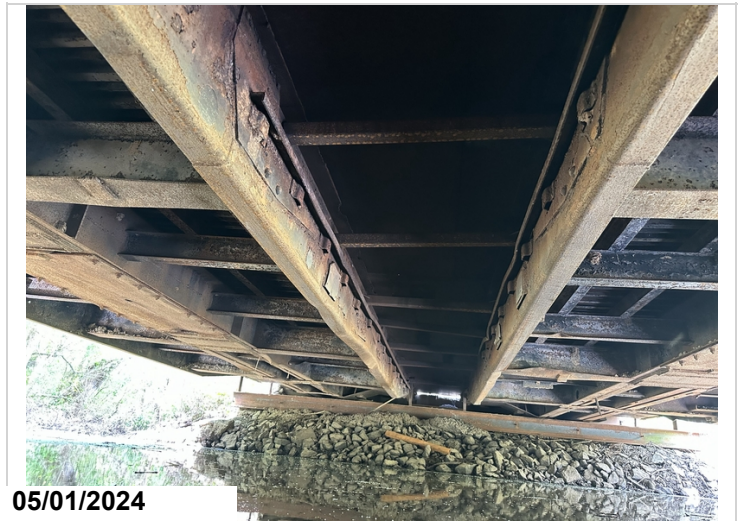
Superstructure is in satisfactory condition with some corrosion and section loss, mainly on right car.

Undersurface - Span 1: Typical

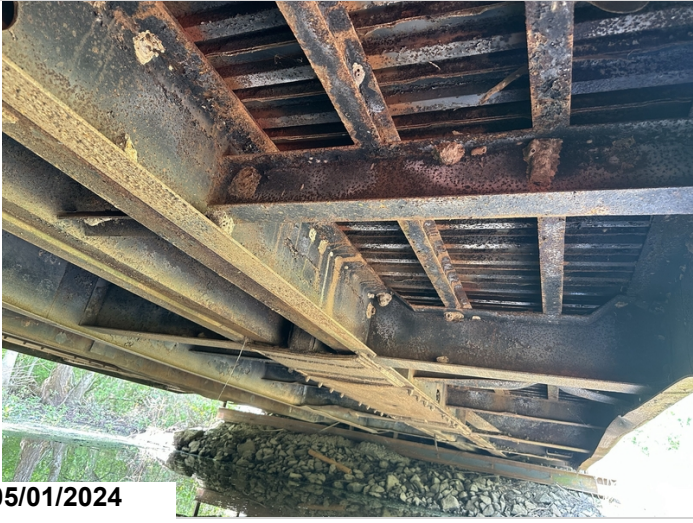
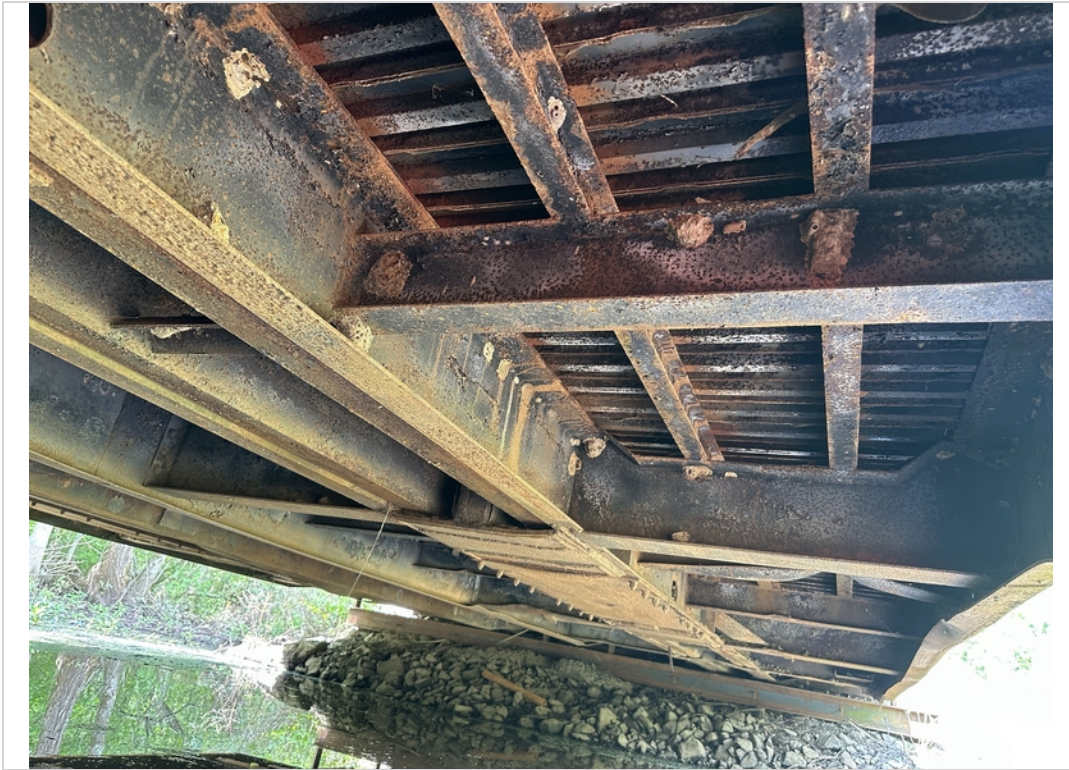
NSTM's are in satisfactory condition with some corrosion and section loss, mainly on right car.

NSTM - Left car

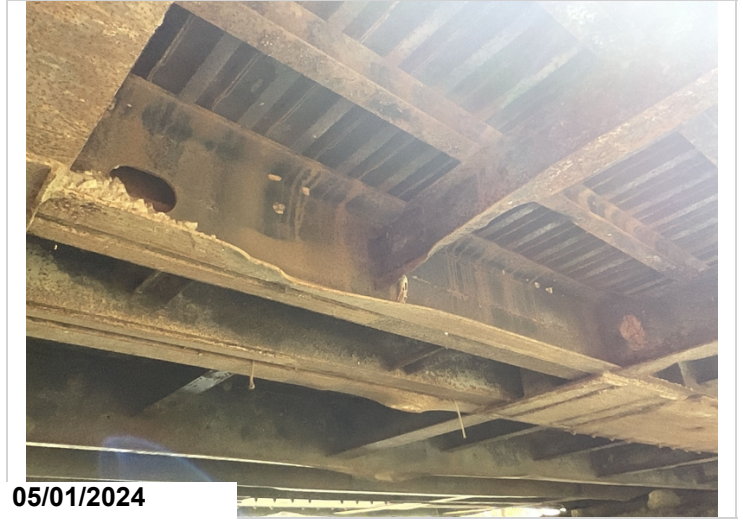
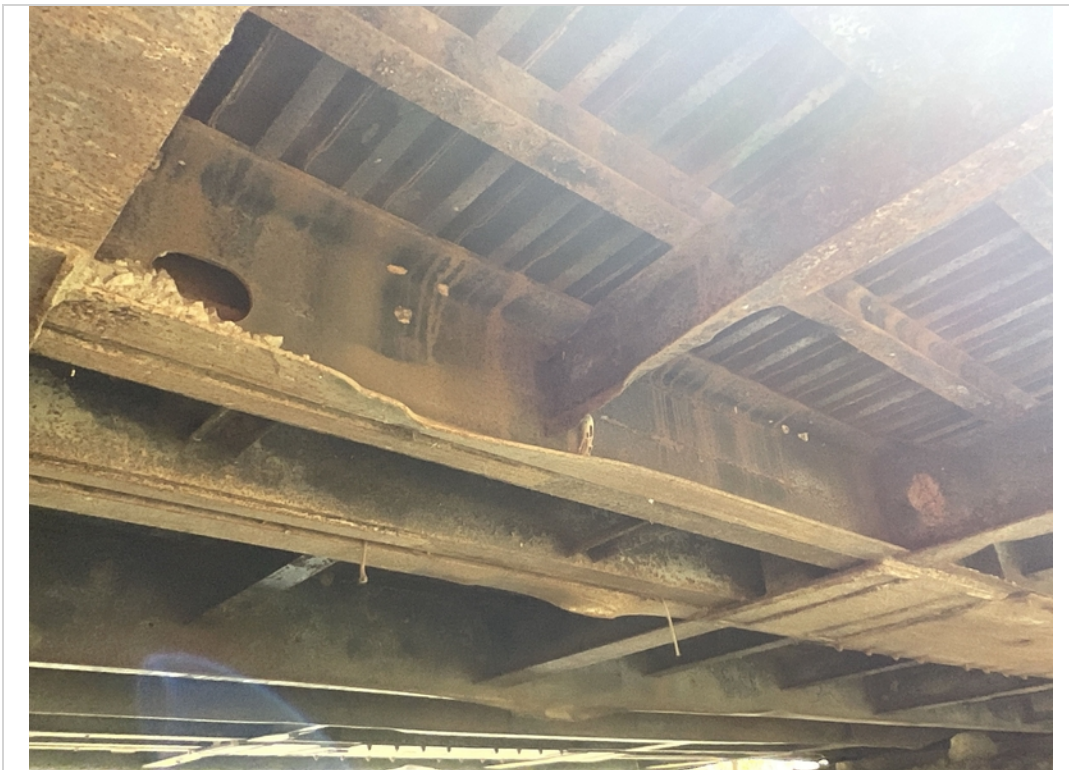
NSTM - Right car

NSTM's are in satisfactory condition with some corrosion and section loss, mainly on right car.

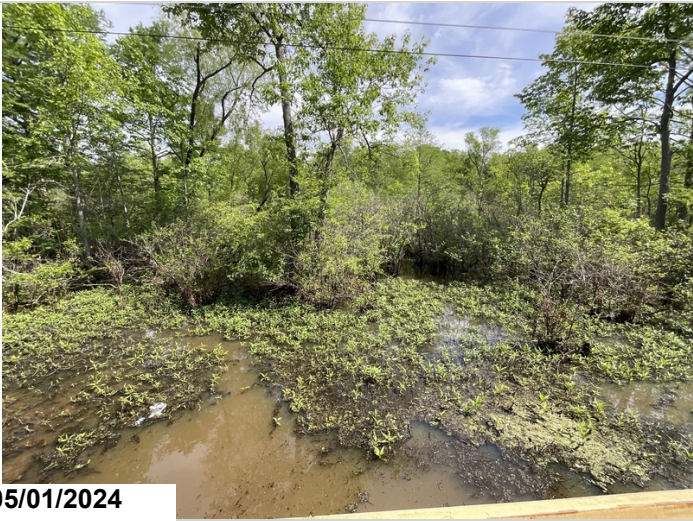
Channel is in very good condition with no notable problems.

Channel - left side

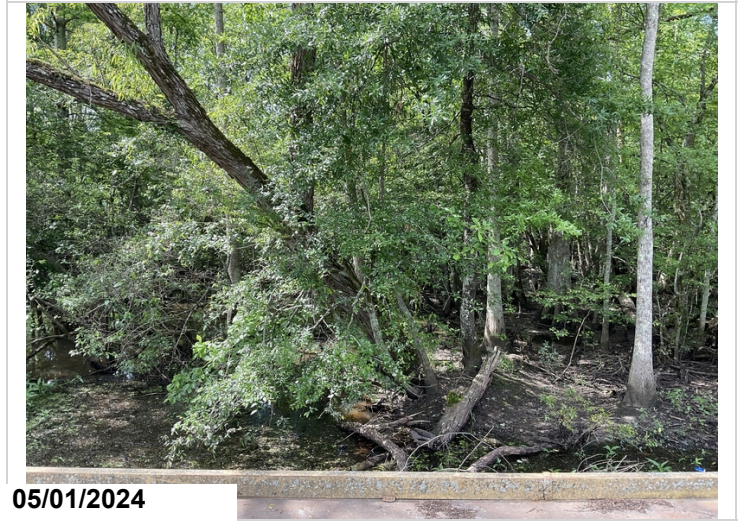
Channel - right side
