Asset #21891(Routine, NSTM)
Lodge CornerRd-CR1 over Creek
Location: 0.6 Mi W US 165-LodgeCnrr
Team Lead: Greg Loomis Inspection Date: 05/01/2024

NSTM Inspection Report and Procedure
Bridge No. 21891 0.6 Mi W US 165-LodgeCnrr

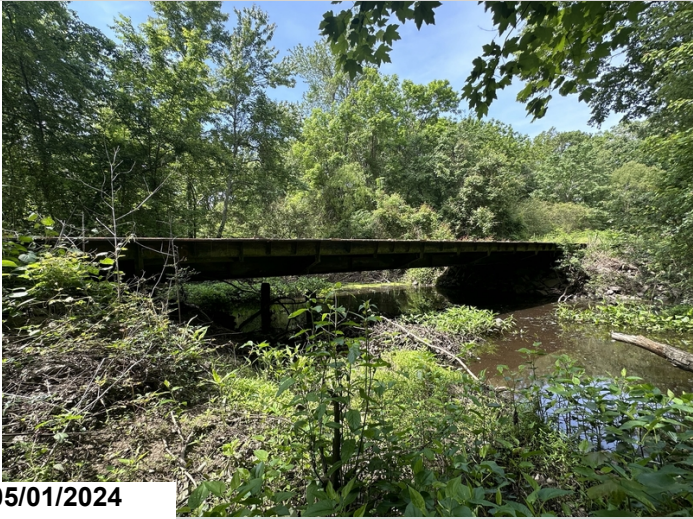
Left side view

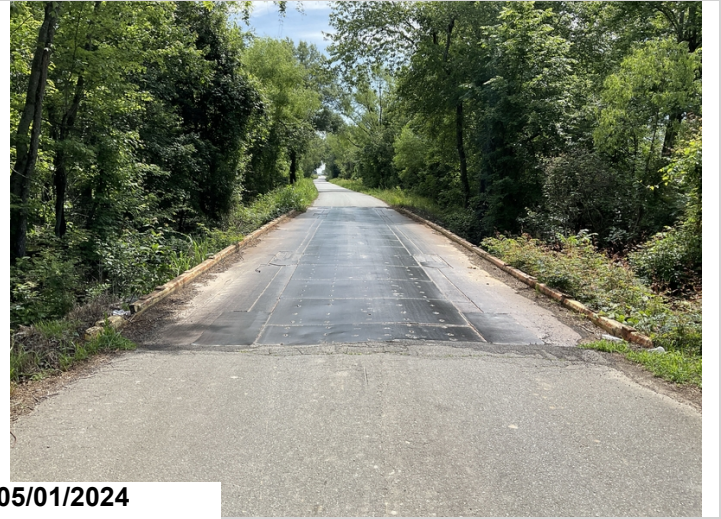
Roadway view

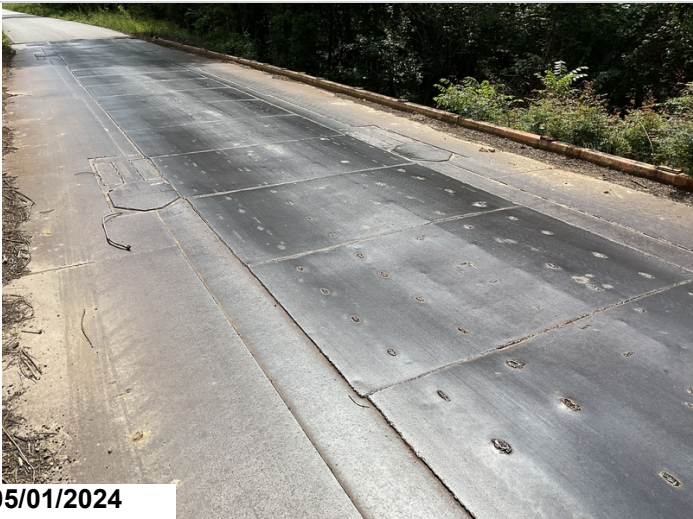
Deck is in good condition with some minor cracking on wearing surface.

Deck - Span 1: Typical

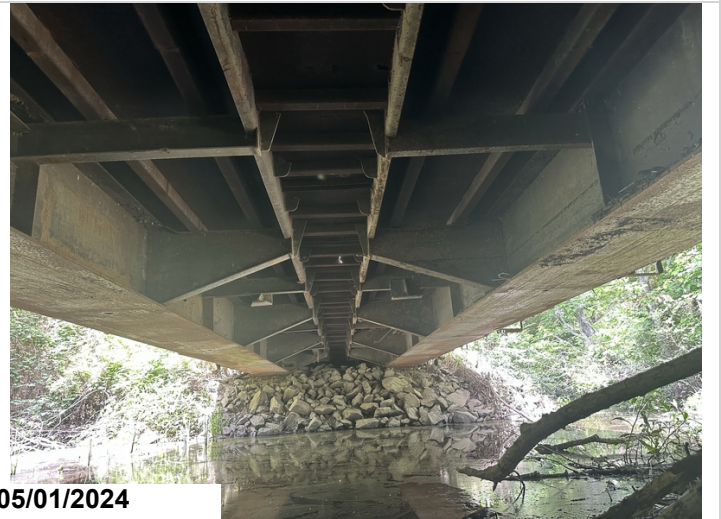
Superstructure is in good condition with some minor corrosion.

Undersurface - Span 1: Typical

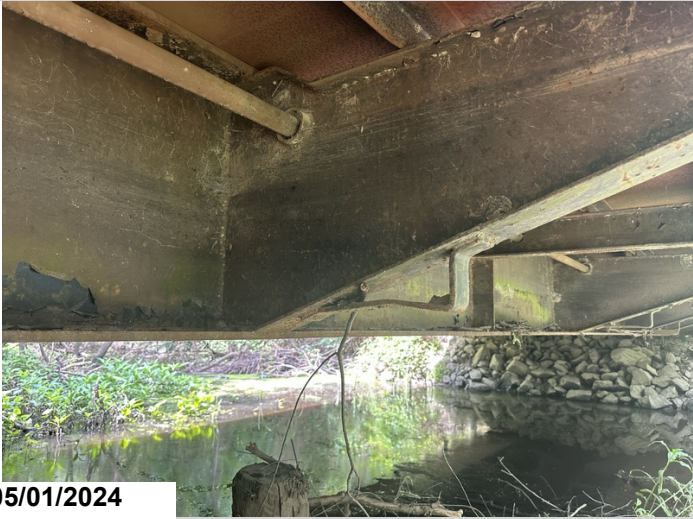
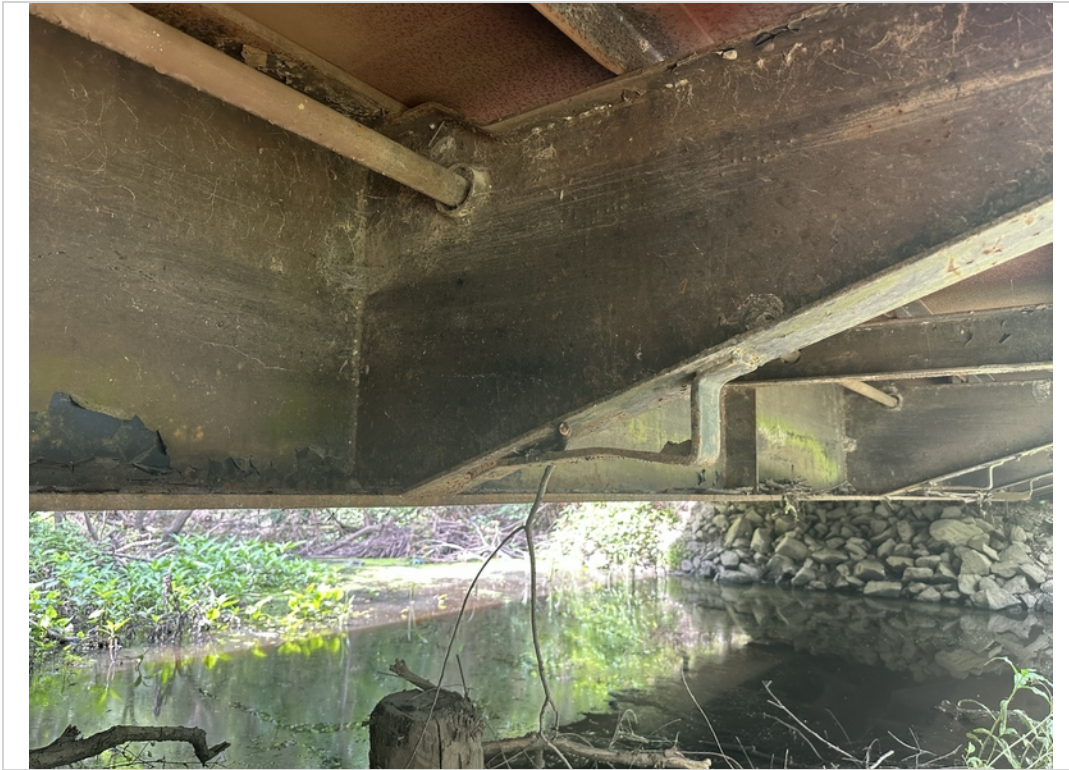
NSTM's are in good condition with some light surface corrosion.

NSTM - Left car

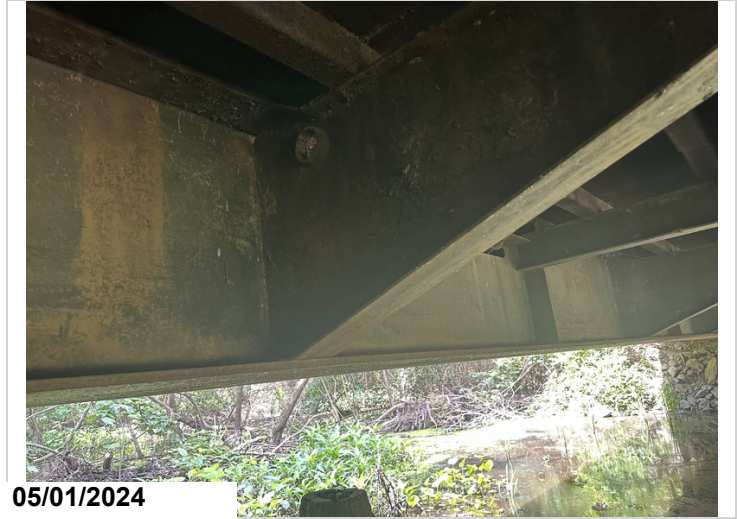
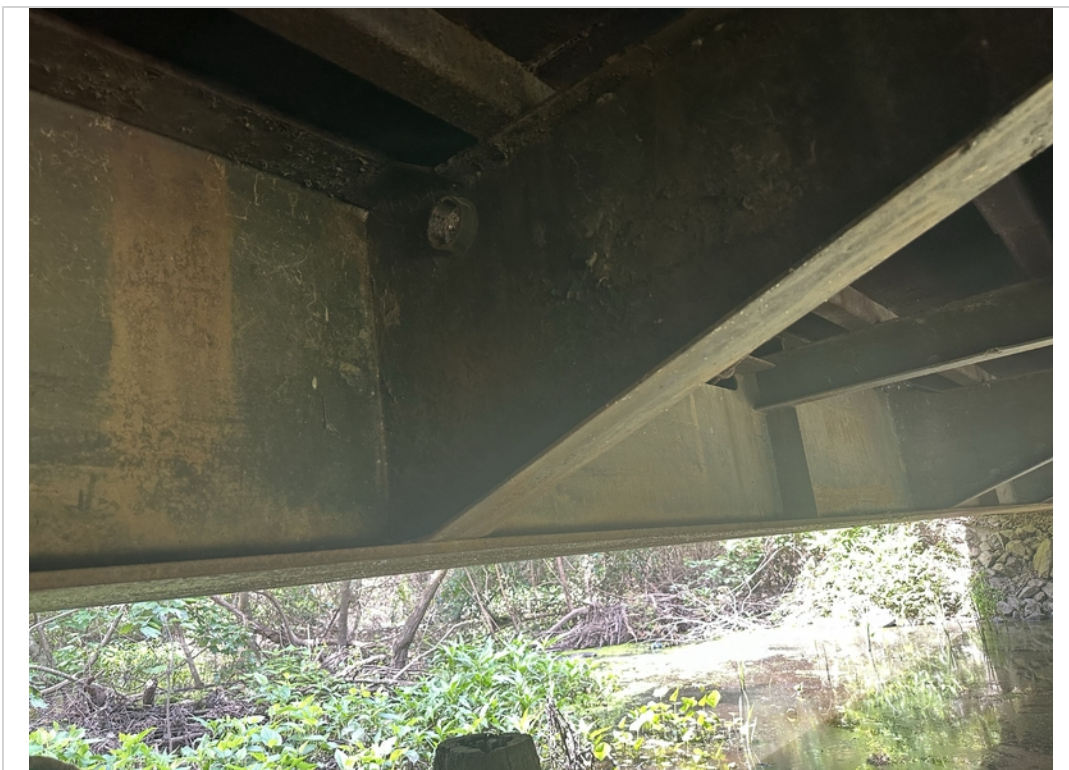
NSTM - Right car

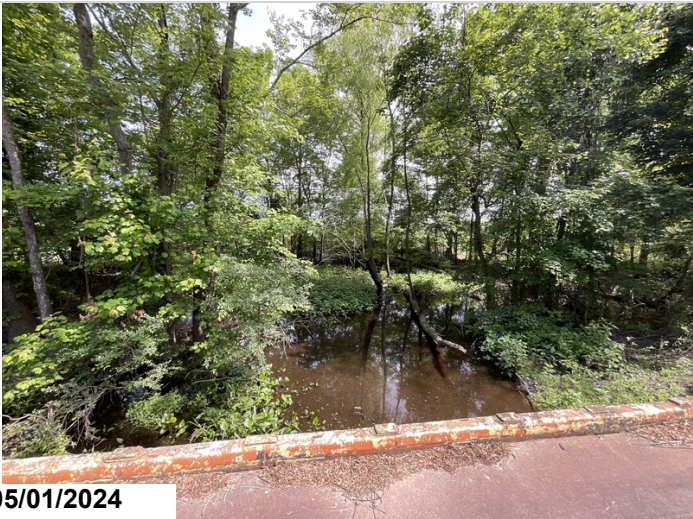
Channel is in very good condition with no notable problems.

Channel - left side

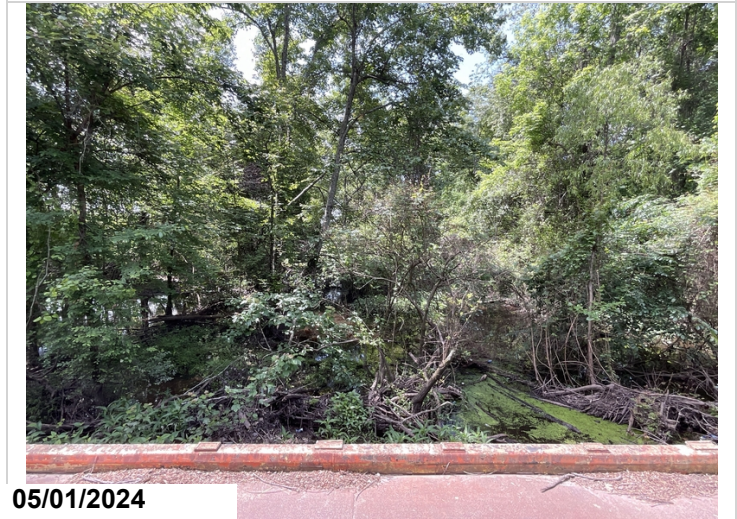
Channel - right side
