Bridge #23167(Routine, Underwater type 2)

Bethel Blacktop Rd over Illinois River - Wash.

Team Lead: Bob McEntyre Inspection Date: April 14, 2020

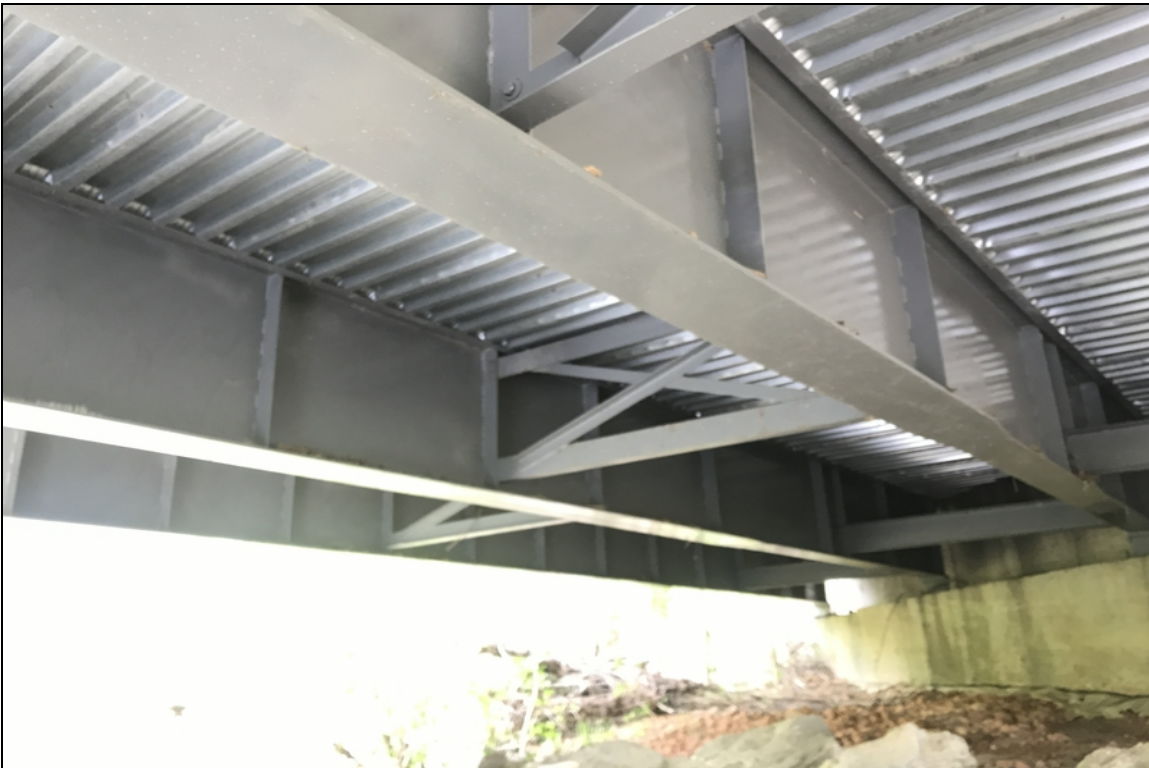
The beams in span 2 have been painted from mid-span to abutment 2.

- Superstructure is constructed from salvaged beams from Bridge # 02470 that has been replaced over the White River.
 - The exterior side of beam # 4 has scuff marks from apparent drift impacts during high water events.
 - The beams have areas of paint peeling in Isolated areas. The beams in span # 2 have been painted from abutment # 2 to mid-span since last inspection.
 - Cross frames have minor out of plane bending to the bottom angles in some locations.
 - There is a 5' area of paint missing in the exterior web of Beams # 1 & 4 in Span # 1. The area has a light rust coating at this inspection.
-

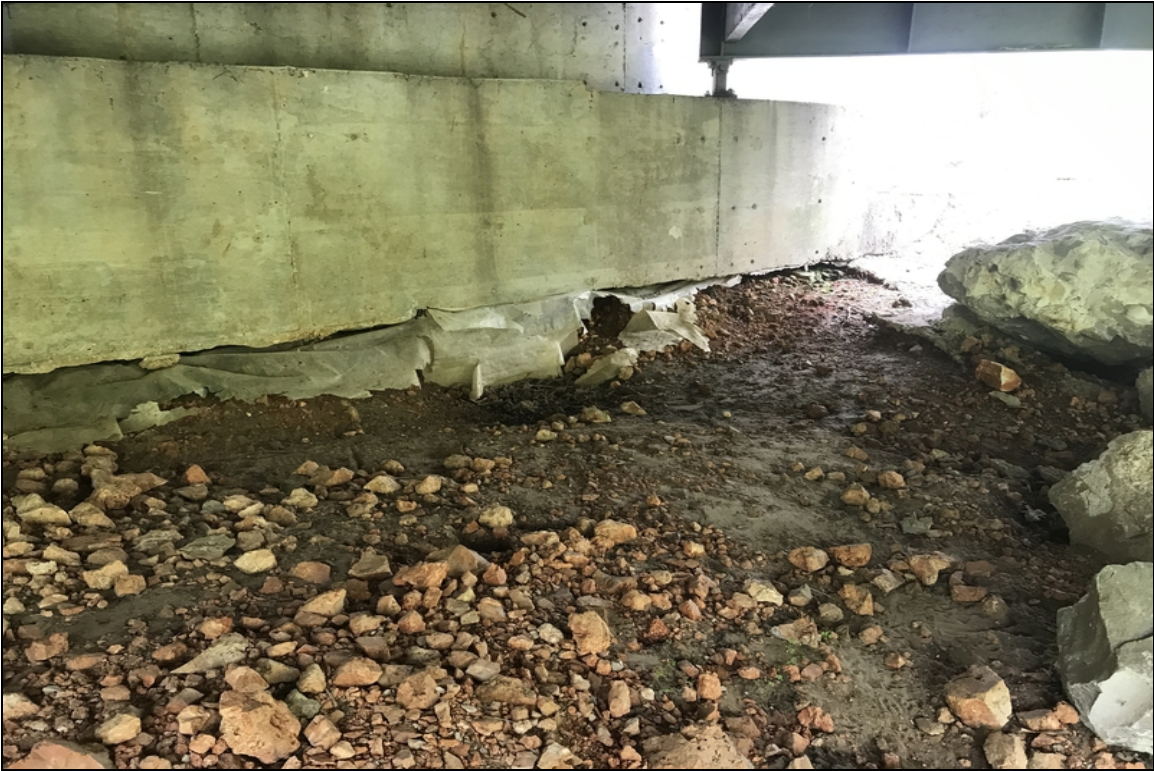
The East embankment at the base of abutment # 2 has minor earth settlement / erosion.

- The East embankment at the base of abutment # 2 has minor earth settlement / erosion.
- The top of the columns of abutment # 1 spill through type abutment is exposed at this inspection.

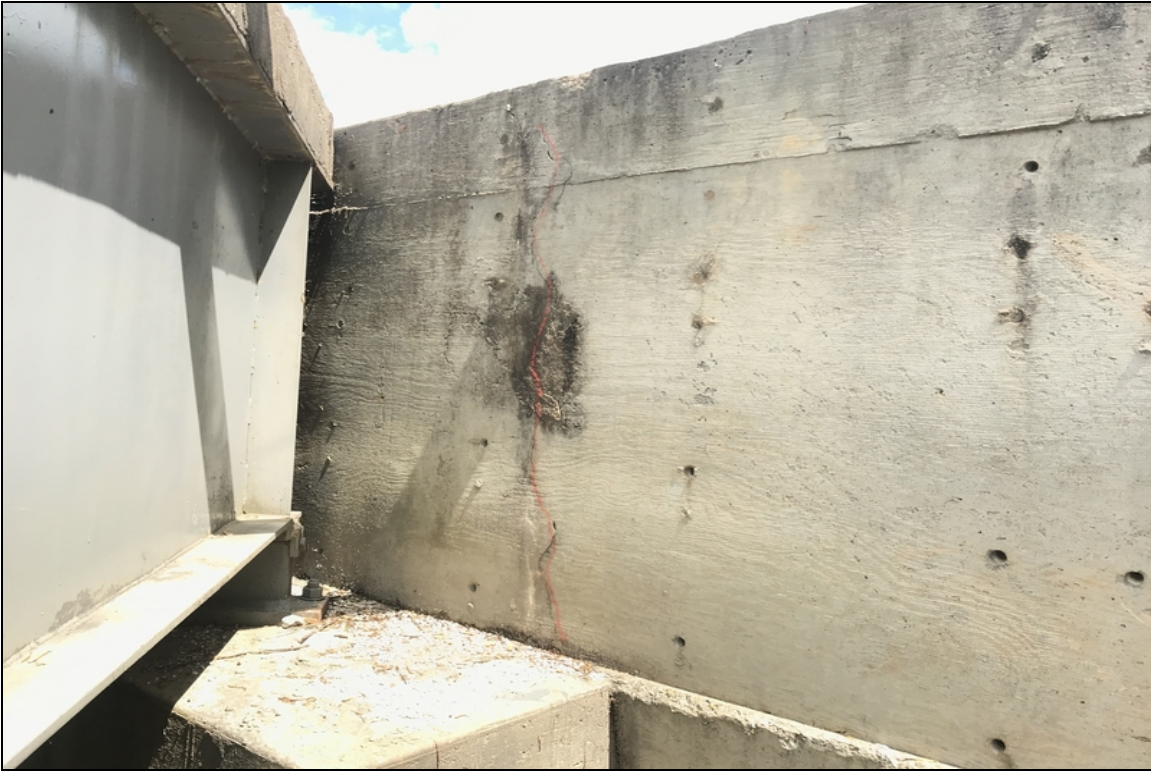
The right exterior side of abutment 2 backwall has a vertical and diagonal crack.

- Transverse cracking typical in the top of the back walls at Bents # 1 & 3 that are visible from the driving surface of the deck.
- The right exterior side of abutment 2 backwall has a vertical and diagonal crack.

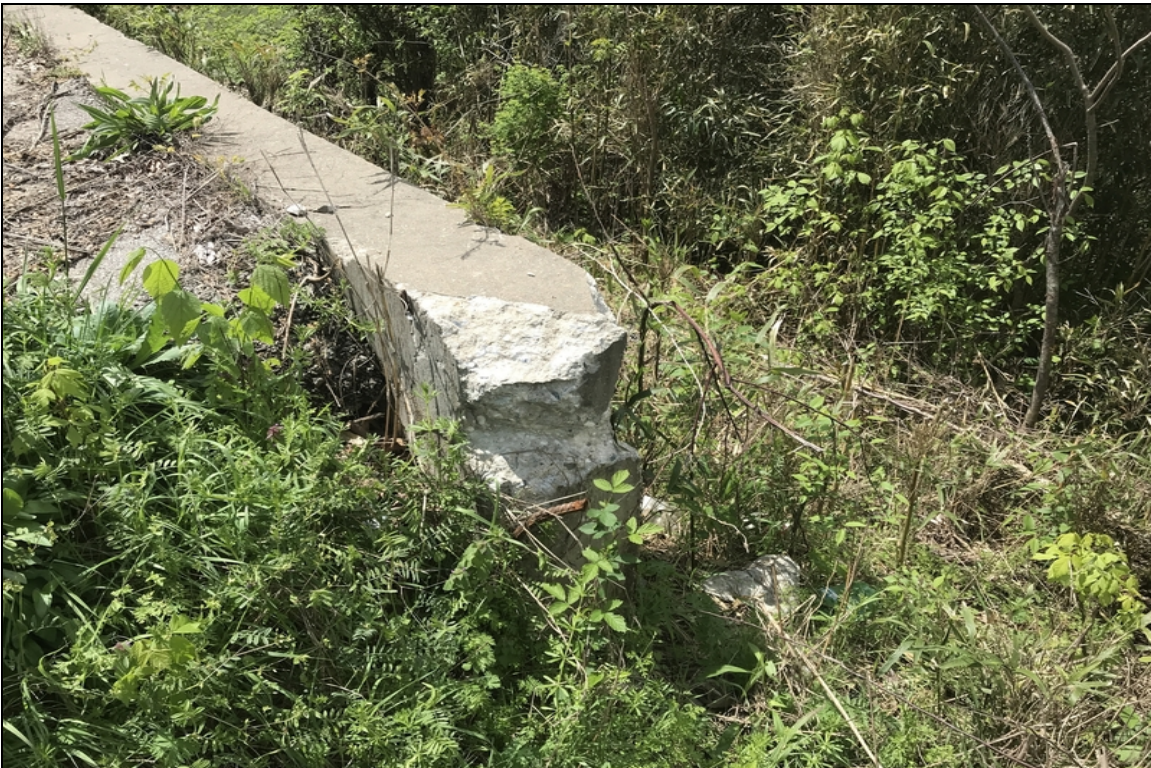
Spall to end of Northeast wing wall.

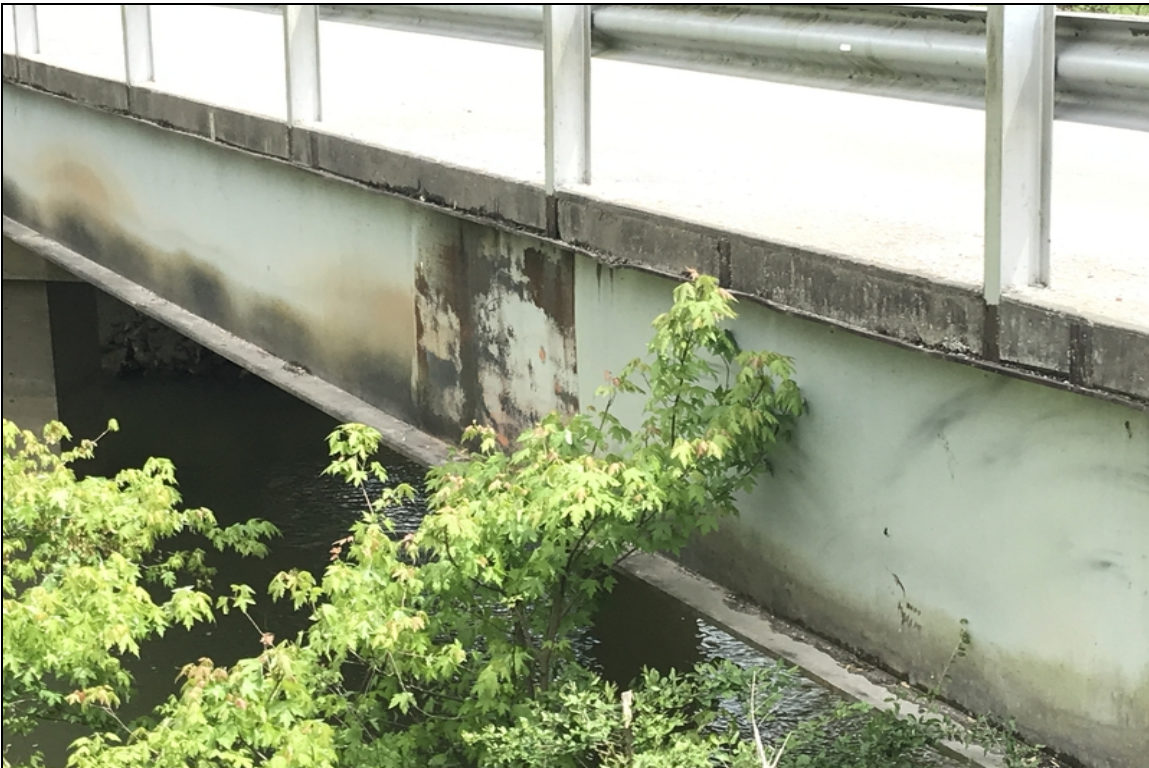
Span 1, beam 1-Rust forming.

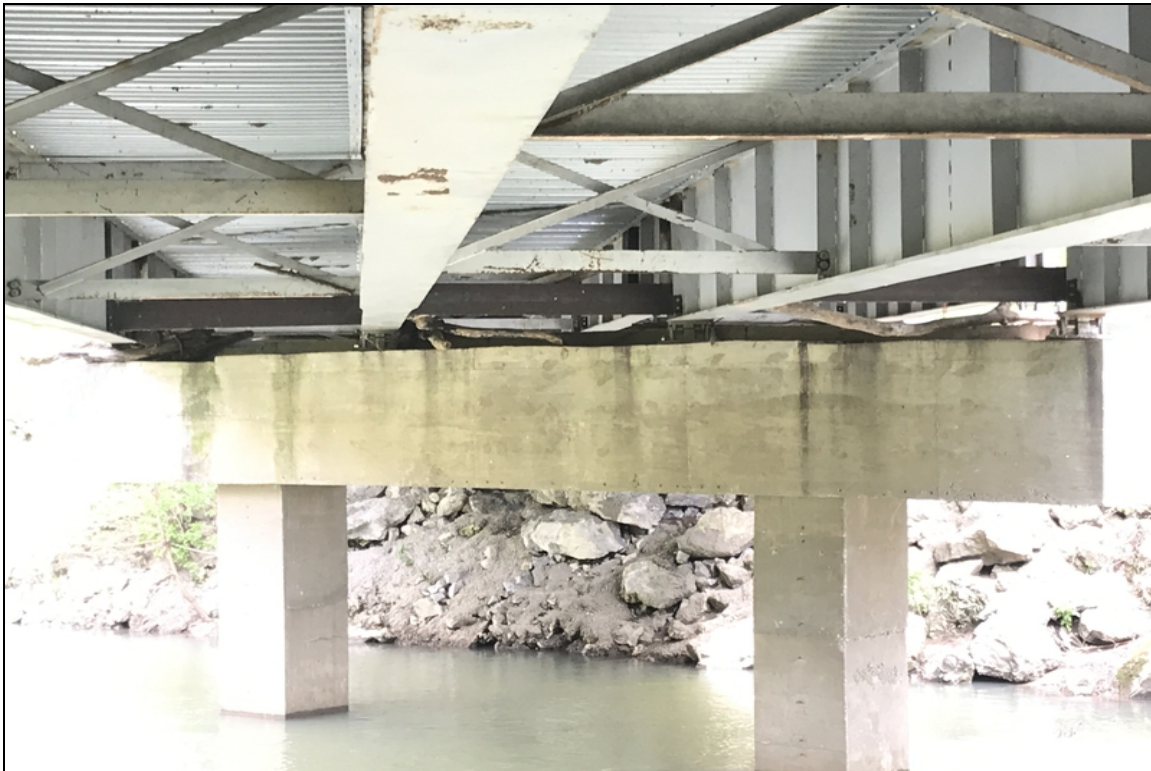
Drift accumulation on bent 2 cap.

- Minor drift accumulation on the top of the cap at Bent # 2.

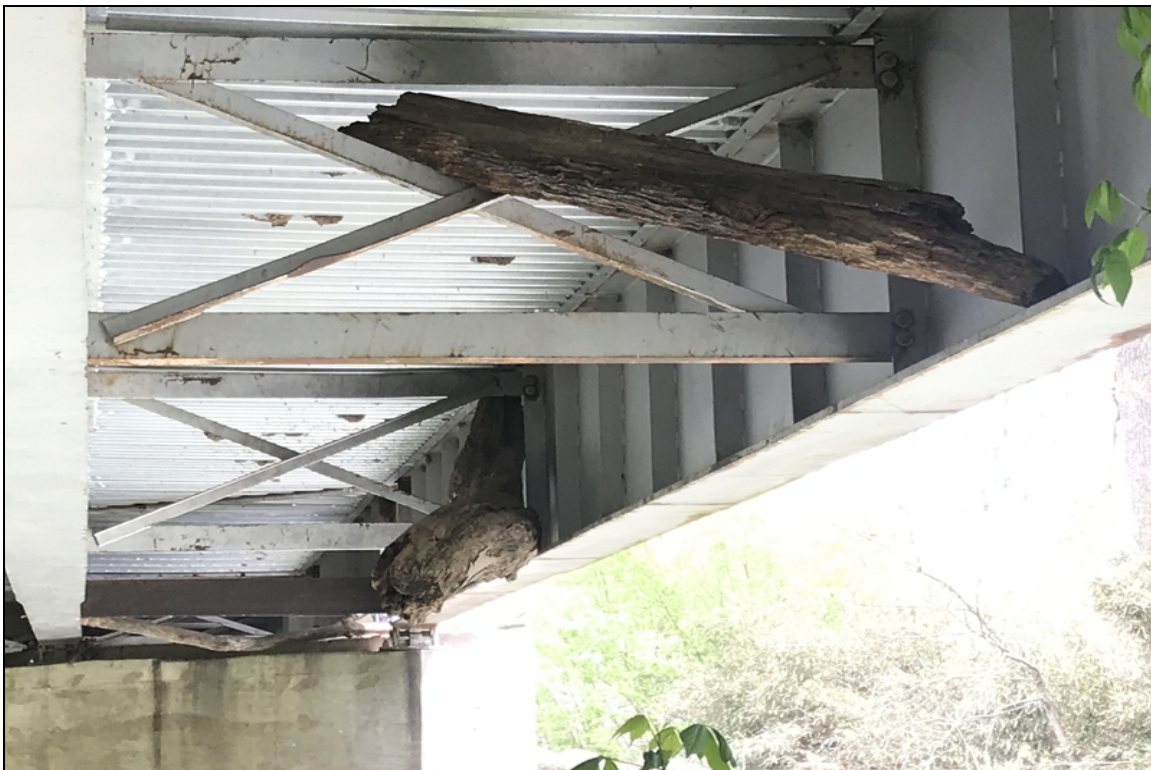
Span 1-Drift in superstructure.

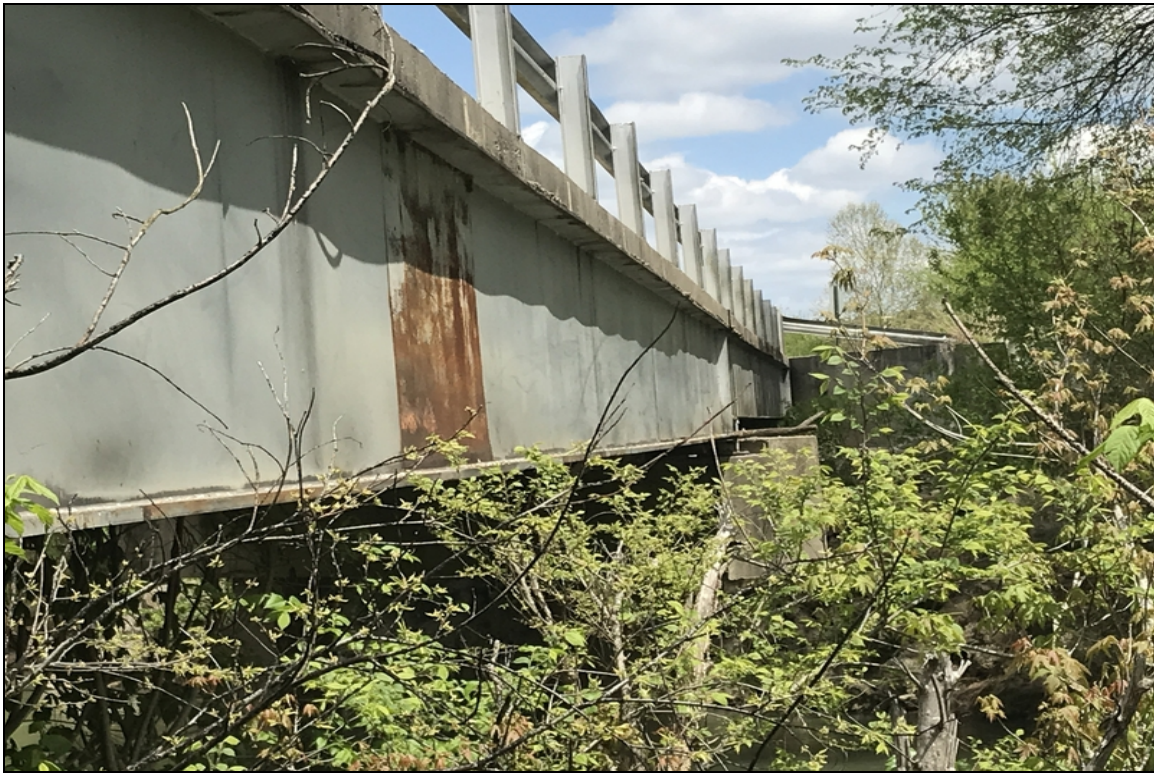
Span 1, Beam 4-Area of paint failure with rust coating.

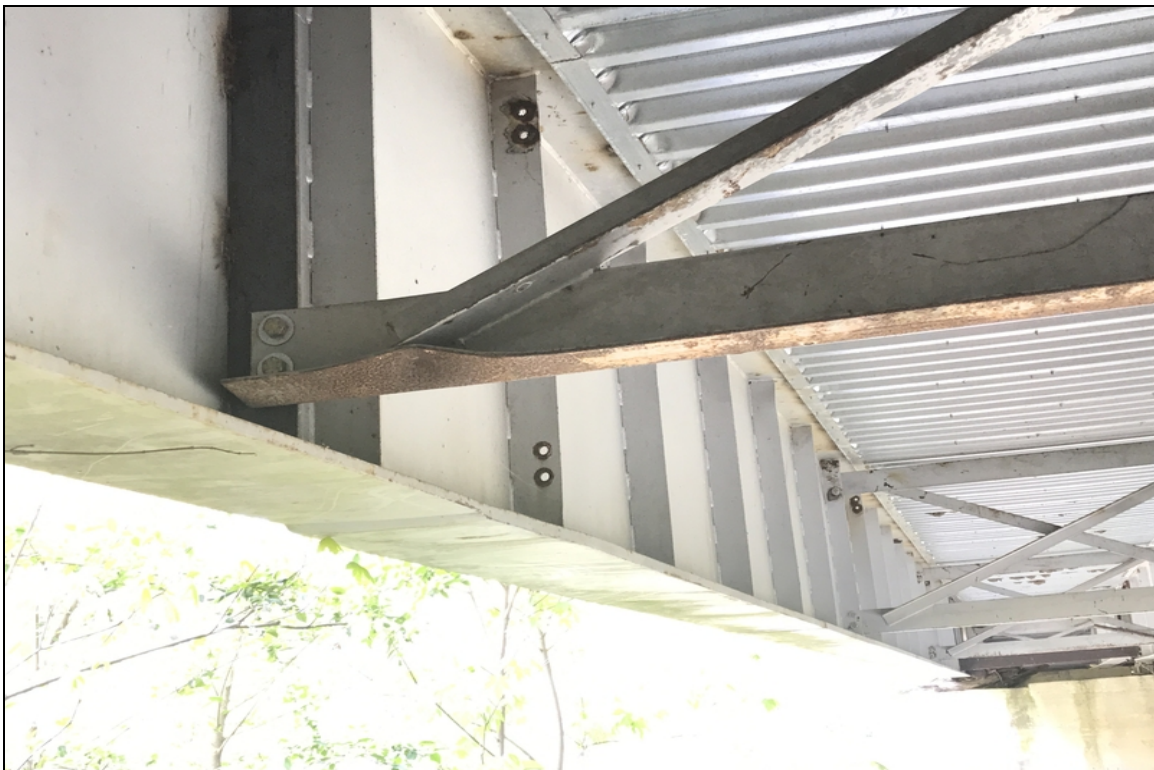
Cross frames have minor out of plane bending to the bottom angles in some locations.

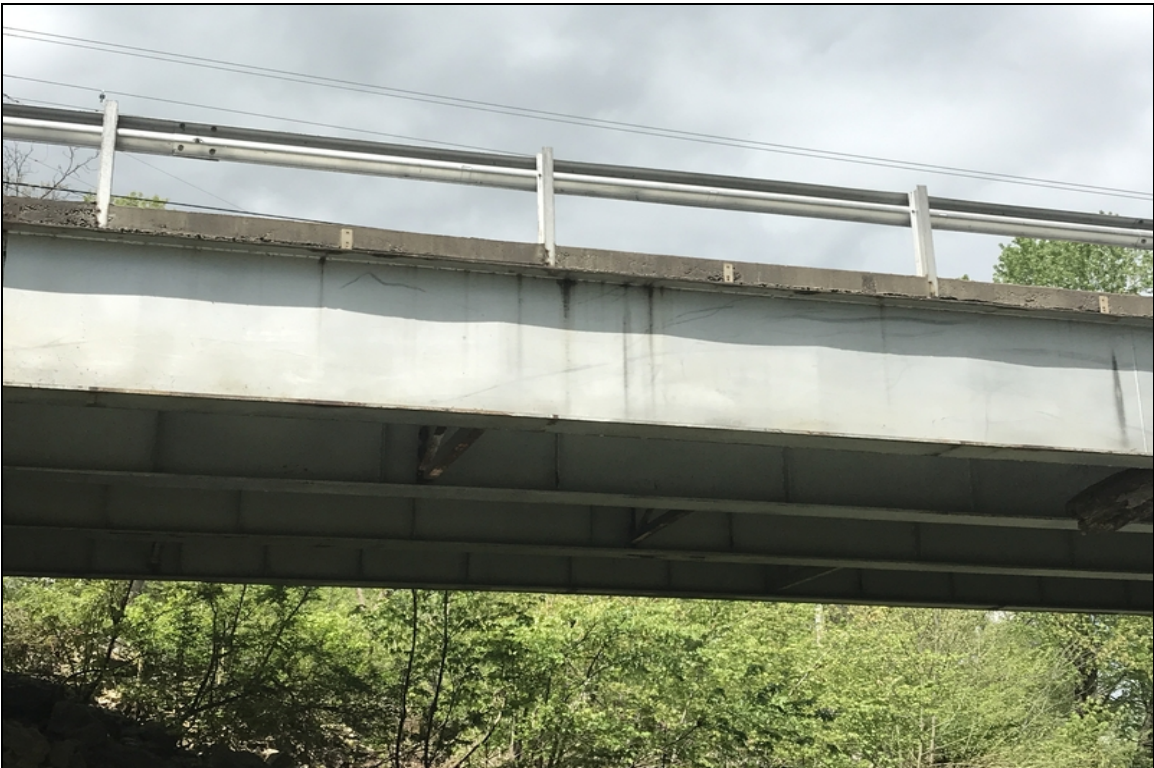
Beam 4 of span 1-Scuff marks from drift impacts.

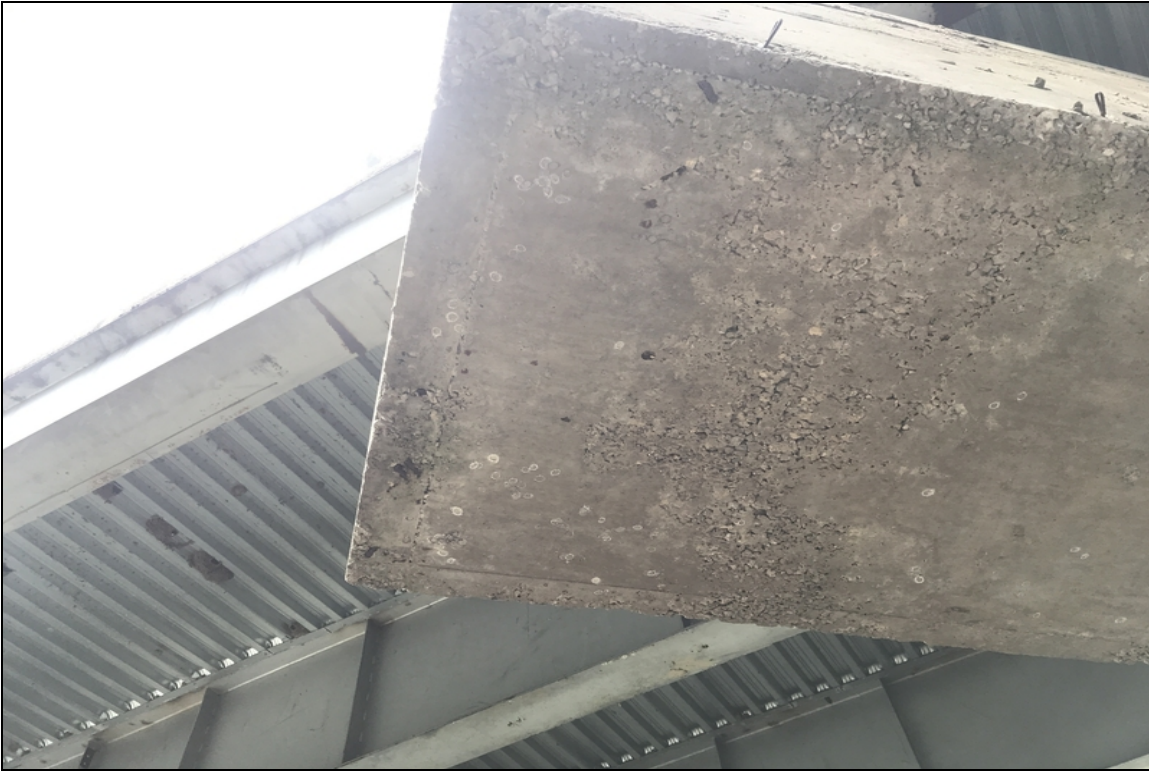
Bent 2 cap, right undersurface-Honeycombing with exposed secondary steel.

- Bent # 2 cap has honeycombing with exposed secondary reinforcing on the underside of cap adjacent to column # 2.
- Bent # 2 cap has short duration vertical cracks in the ahead face at the step downs.

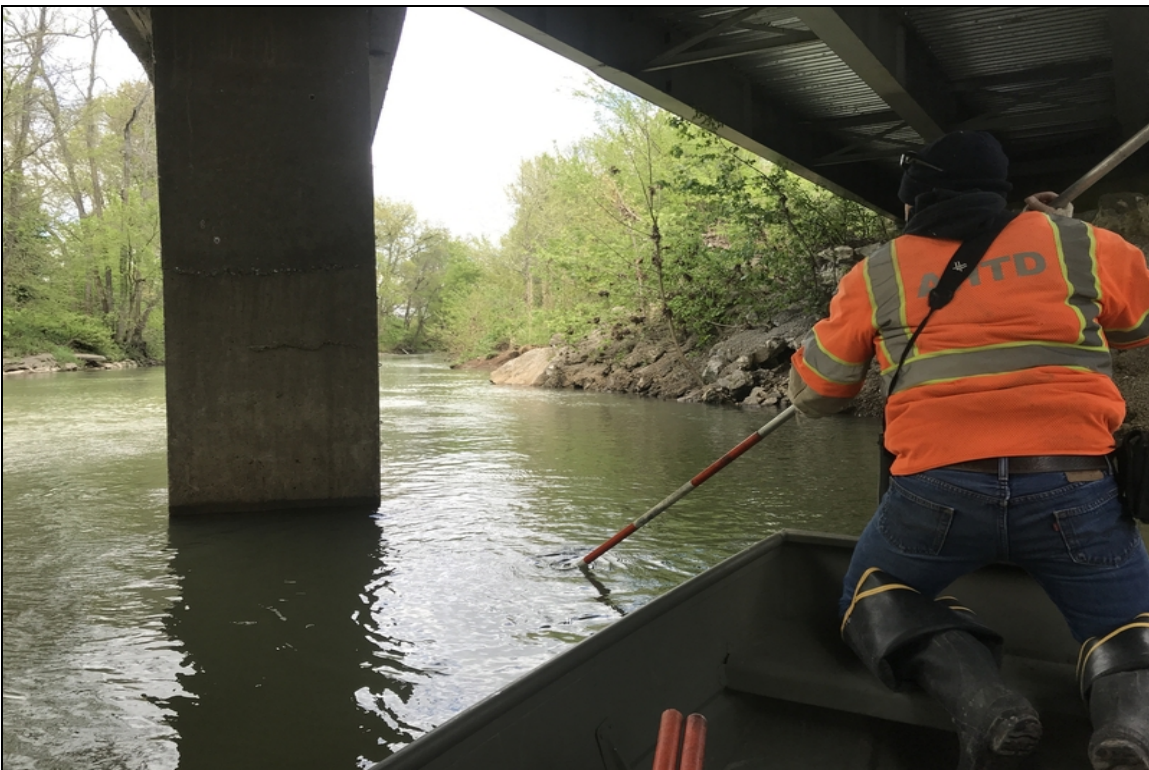
Probing bent 2.

04/14/2020 - RSM & SPC -Underwater Type II inspection: Probing from a boat in deep water conditions indicated that the tops of footings are exposed at Bent # 2, but have no apparent undermining at this inspection.

- Probing from a boat revealed that the tops of footings are exposed at Bent # 2 but have no apparent undermining at this inspection. Previous inspection notes indicated that the footings appeared to be cast on a solid rock channel that was visible in some areas.

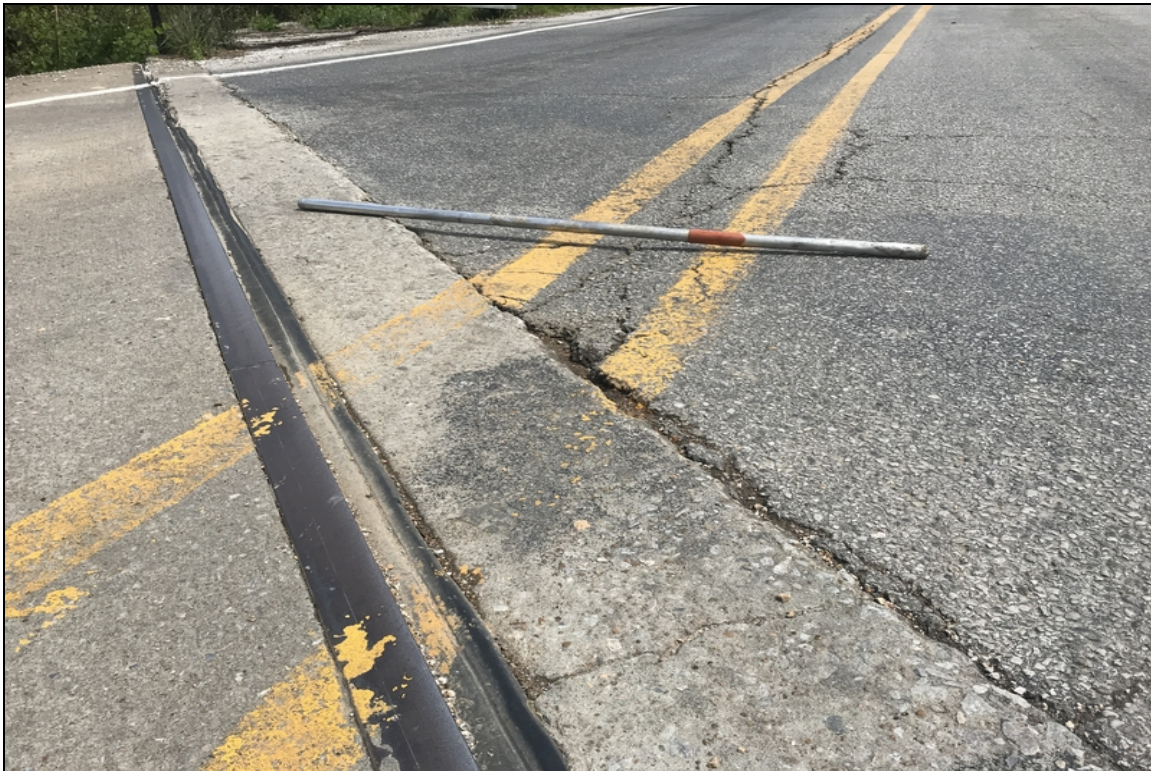
Settlement in East approach roadway at centerline.

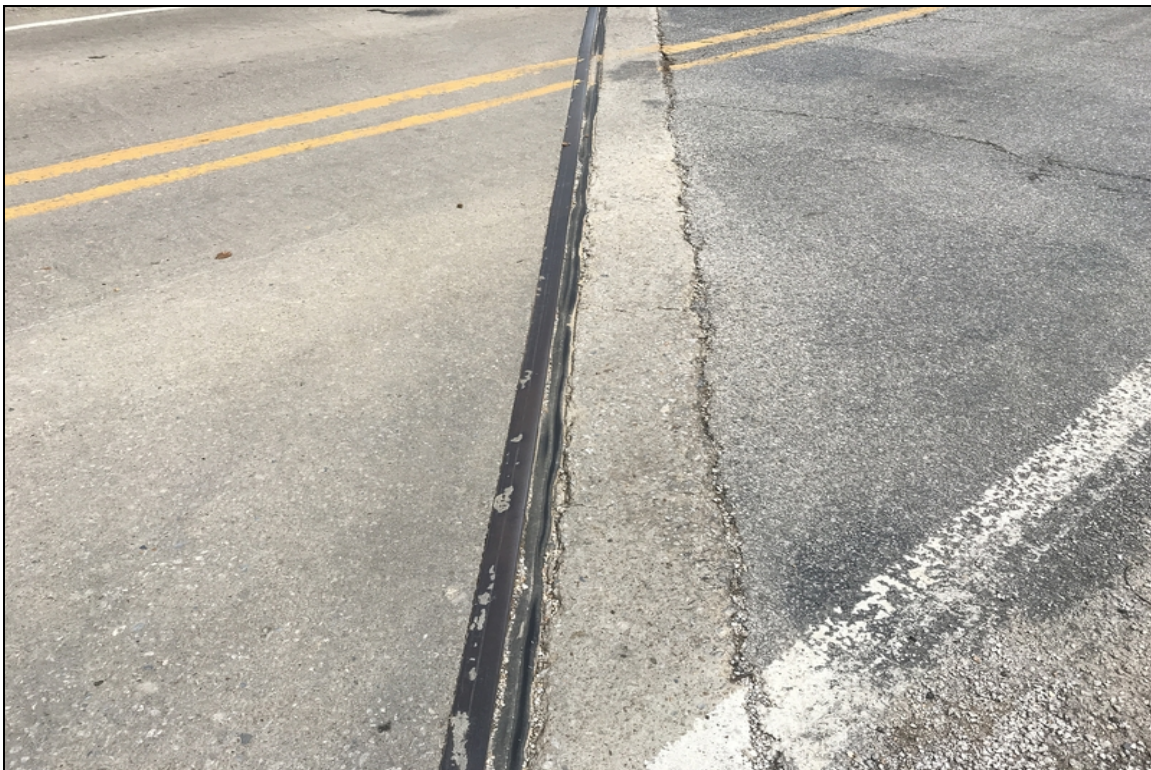
Abutment 2-Transverse cracks.

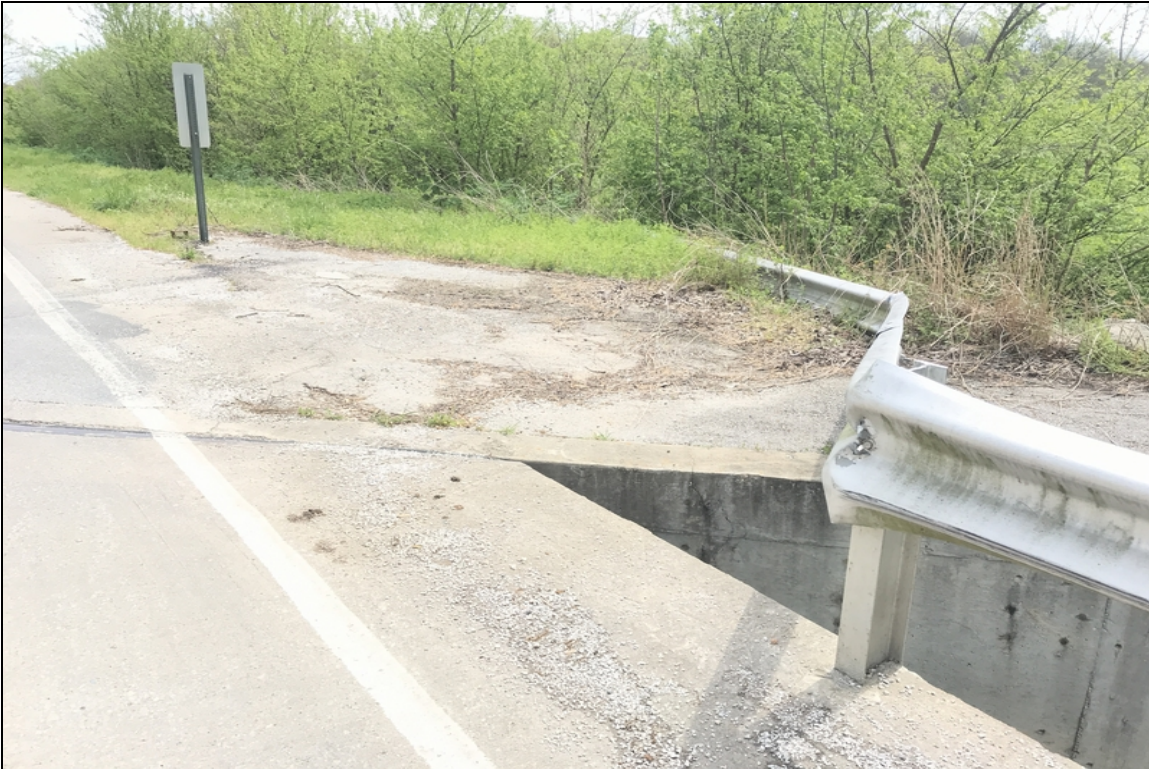
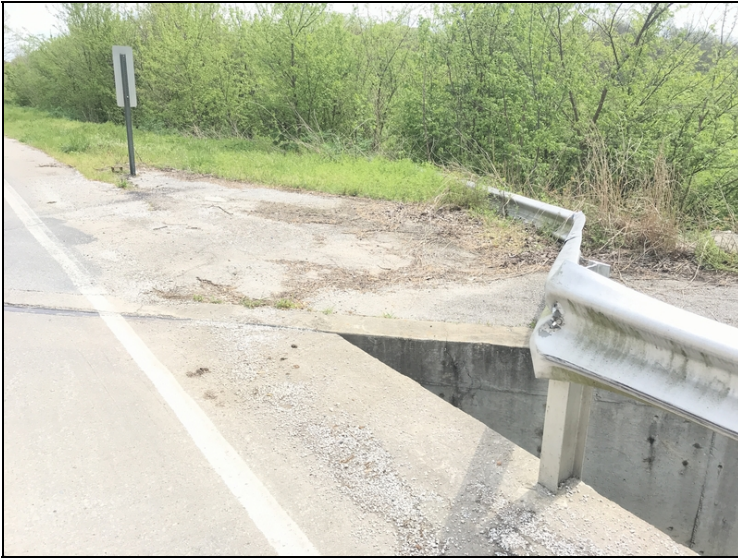
The Southeast approach railing has collision damage that has broken the railing loose from the ground anchorage and destroyed the turndown section of railing.

- Left bridge railing in span # 1 has collision damage over bent # 2 that has created a "pocket" in the railing and has fractured / spalled a 2' long area of the edge of the deck where the railing post was incorporated into the deck.
 - The Southeast approach railing has collision damage that has broken the railing loose from the ground anchorage and destroyed the turndown section of railing.
-

Date Reported: 04/14/2020
Priority: B - Pressing; 6 month completion goal
Type of Work: Repair
Status: Open
Component: Miscellaneous

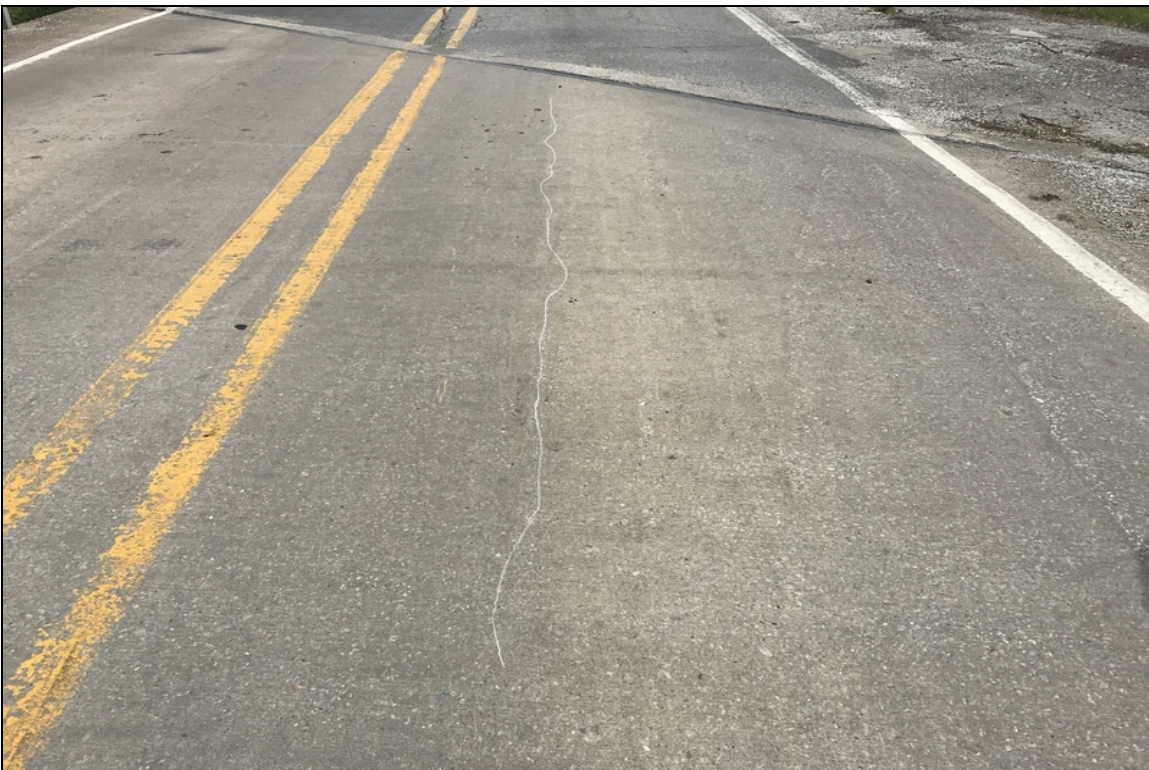
Span 2, right lane-Longitudinal cracking.

- The driving surface of both spans have a longitudinal hairline crack in the Right lane.
- Minor areas of light wear developing in the driving surface in isolated areas.
- Bent # 2 expansion joint has areas of rips, tears and adhesion failure.

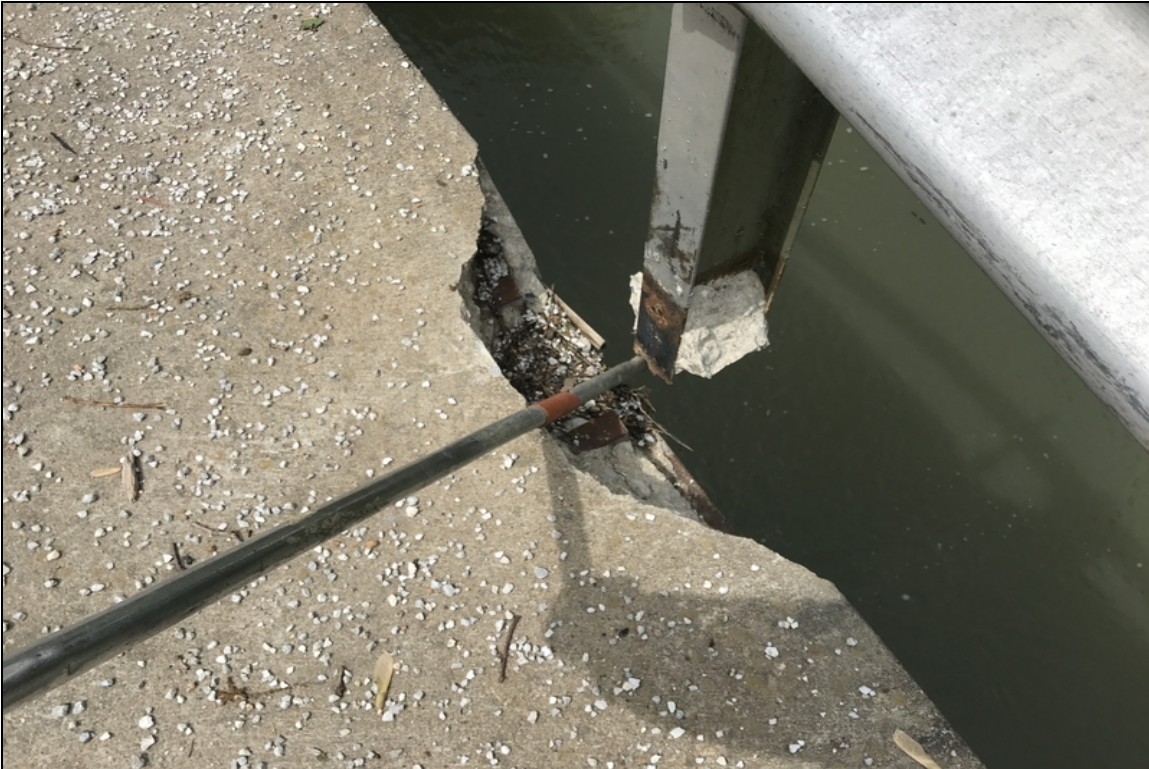
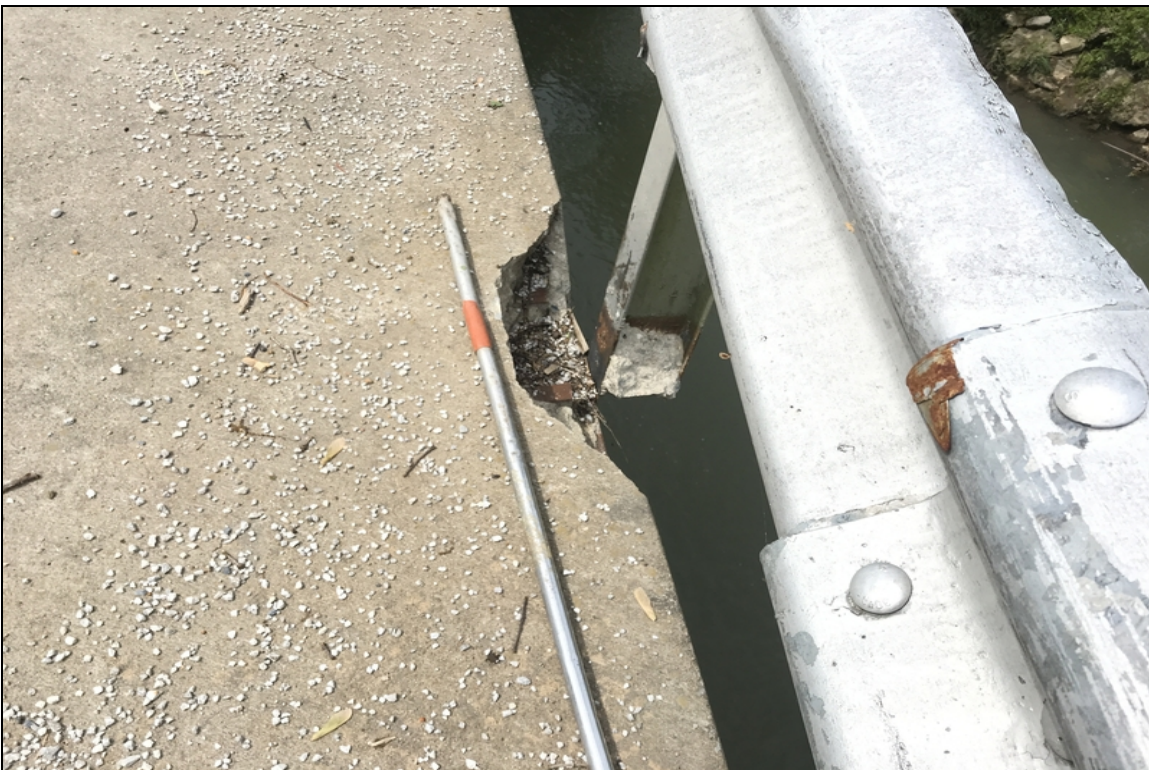
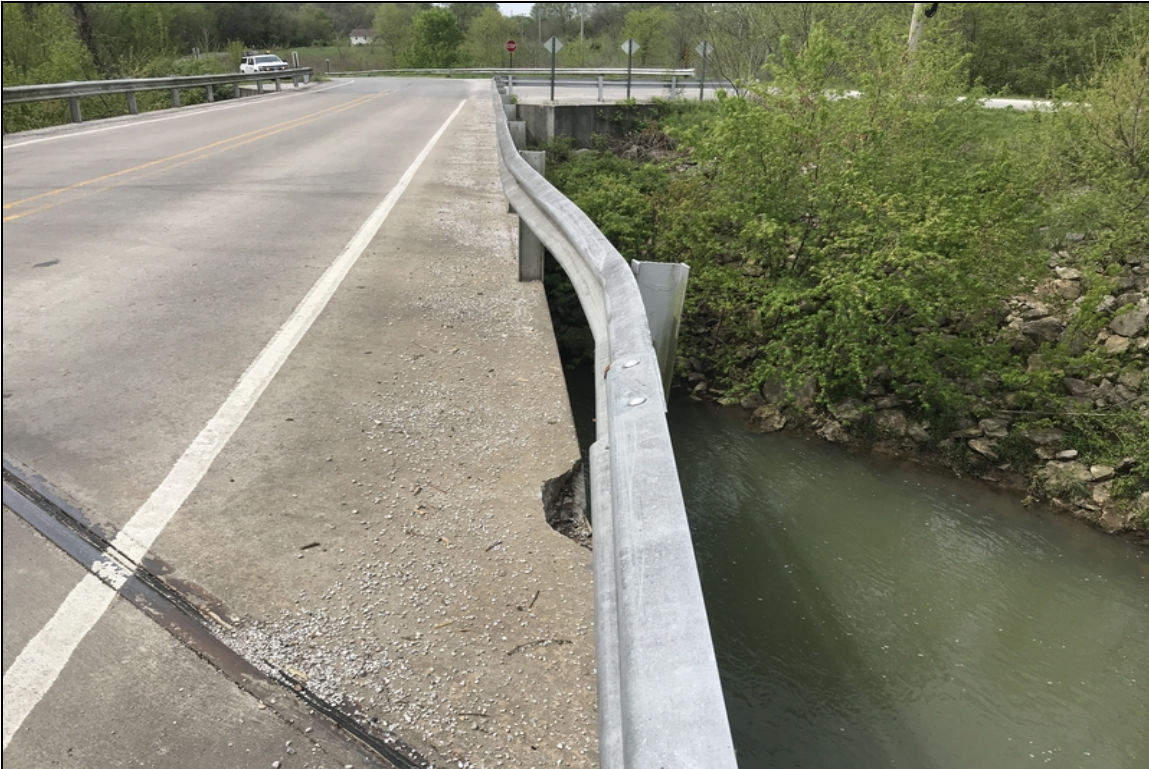
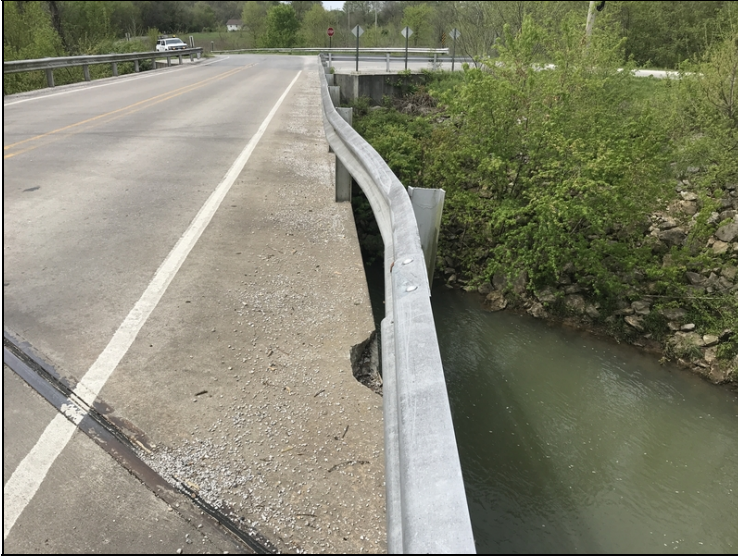
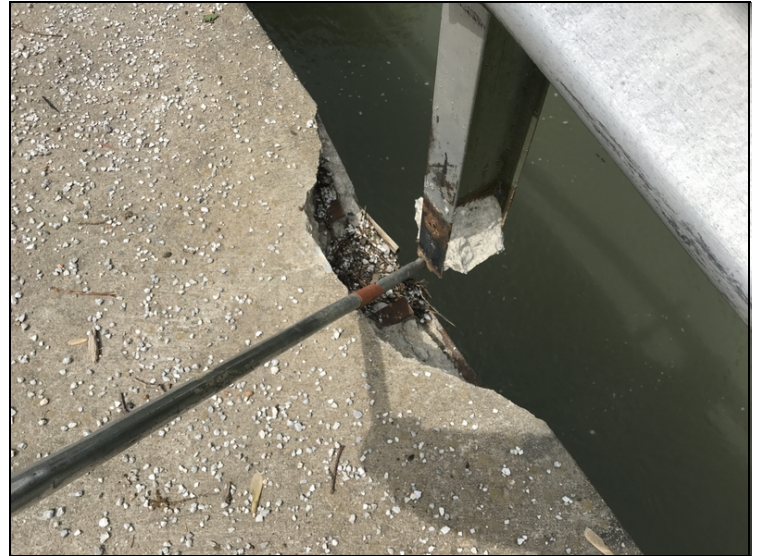
Left bridge railing in span # 1 has collision damage over bent # 2 that has created a locket in the railing and has fractured / spalled a 2' long area of the edge of the deck where one of the railing post was incorporated into the deck.

Left bridge railing in span # 1 has collision damage over bent # 2 that has created a "pocket" in the railing and has fractured / spalled a 2' long area of the edge of the deck where the railing post was incorporated into the deck.

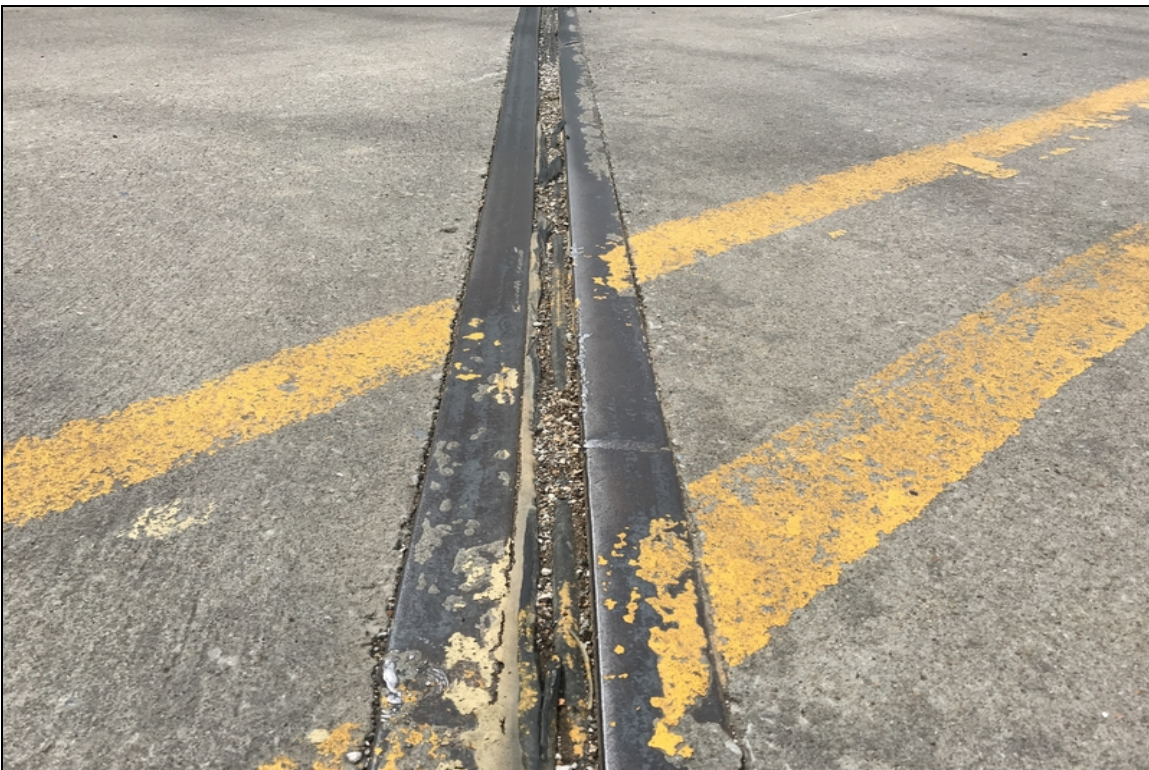
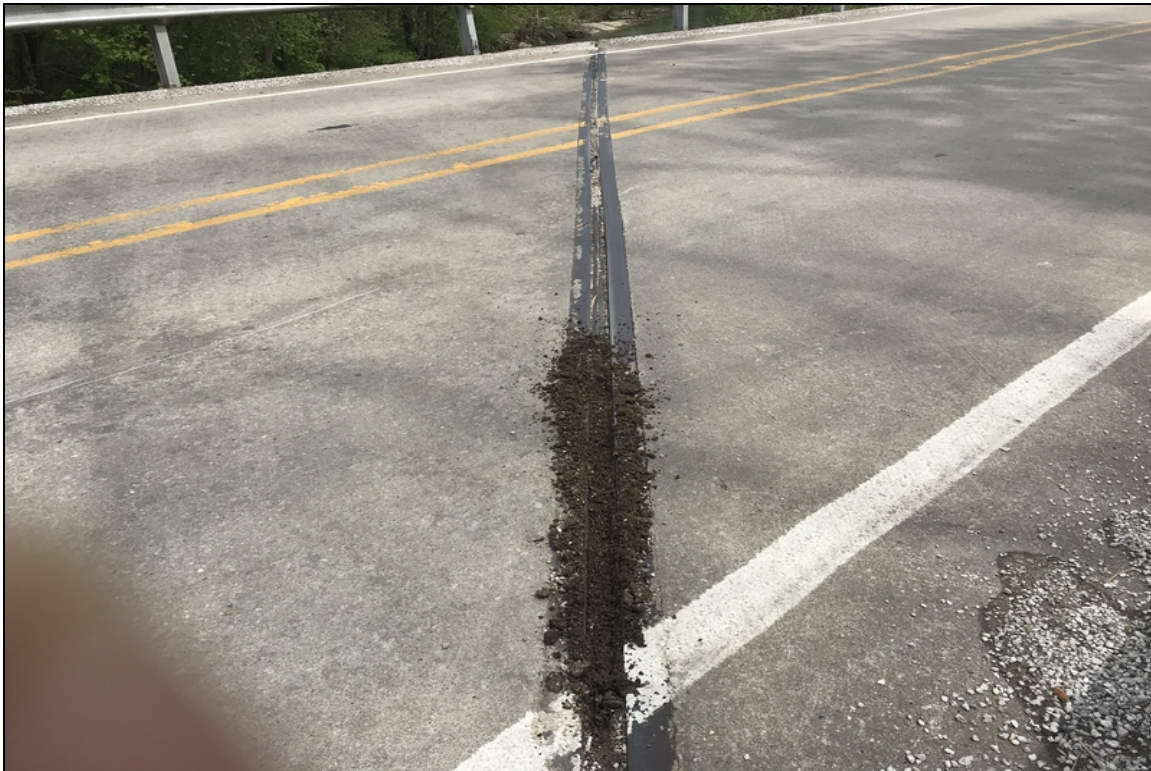
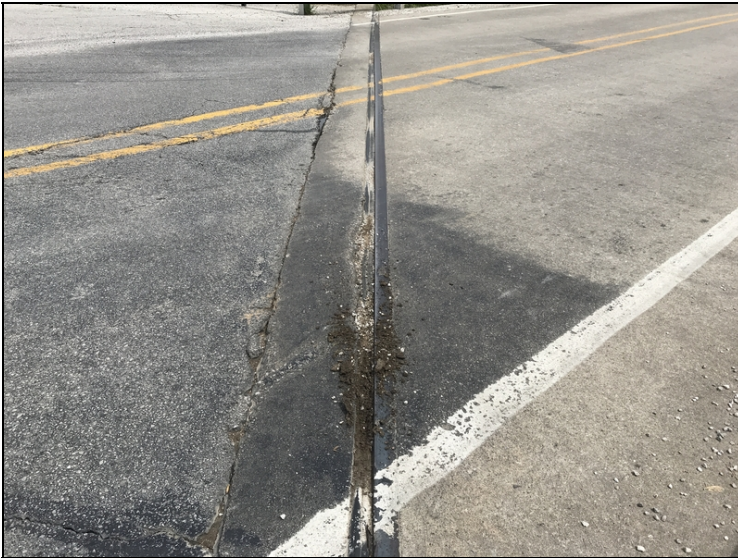
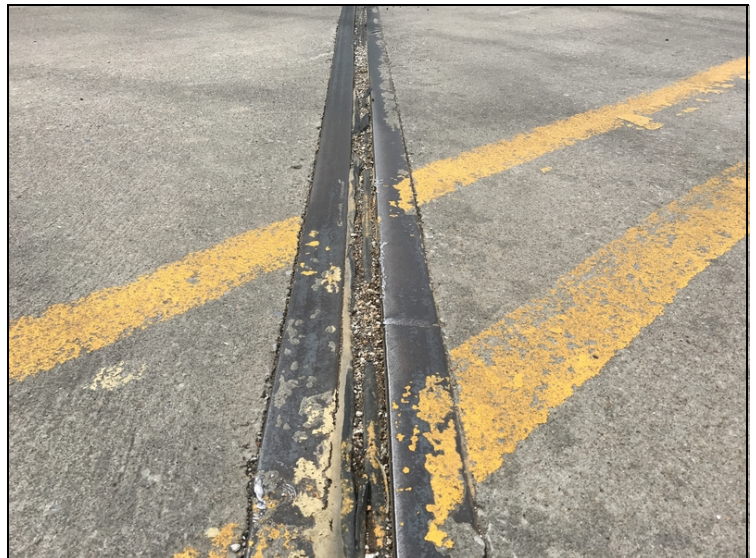
Bent 2 expansion joint has areas of rips, tears and adhesion failure.

Bent 2 expansion joint sagging in locations.

The expansion joint seals have areas of rips / tears and adhesion failure. Staining on the bent caps indicate that the joint seals leak.

Date Reported: 04/20/2020
Priority: D- Routine
Type of Work: Repair
Status: Open
Component: Miscellaneous

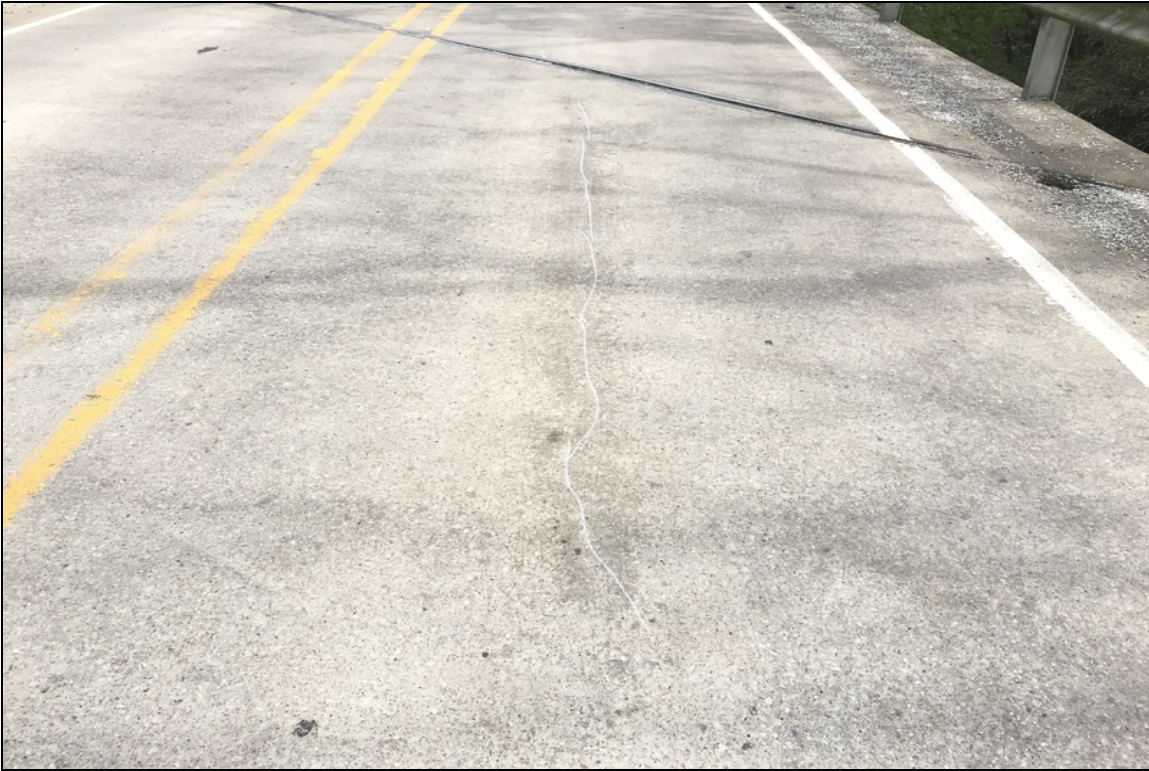
Span 1, right lane-Longitudinal cracking.
