Bridge #23167(Routine, Underwater type 2)

Bethel Blacktop Rd over Illinois River - Wash.

Team Lead: Bob McEntyre Inspection Date: April 14, 2020

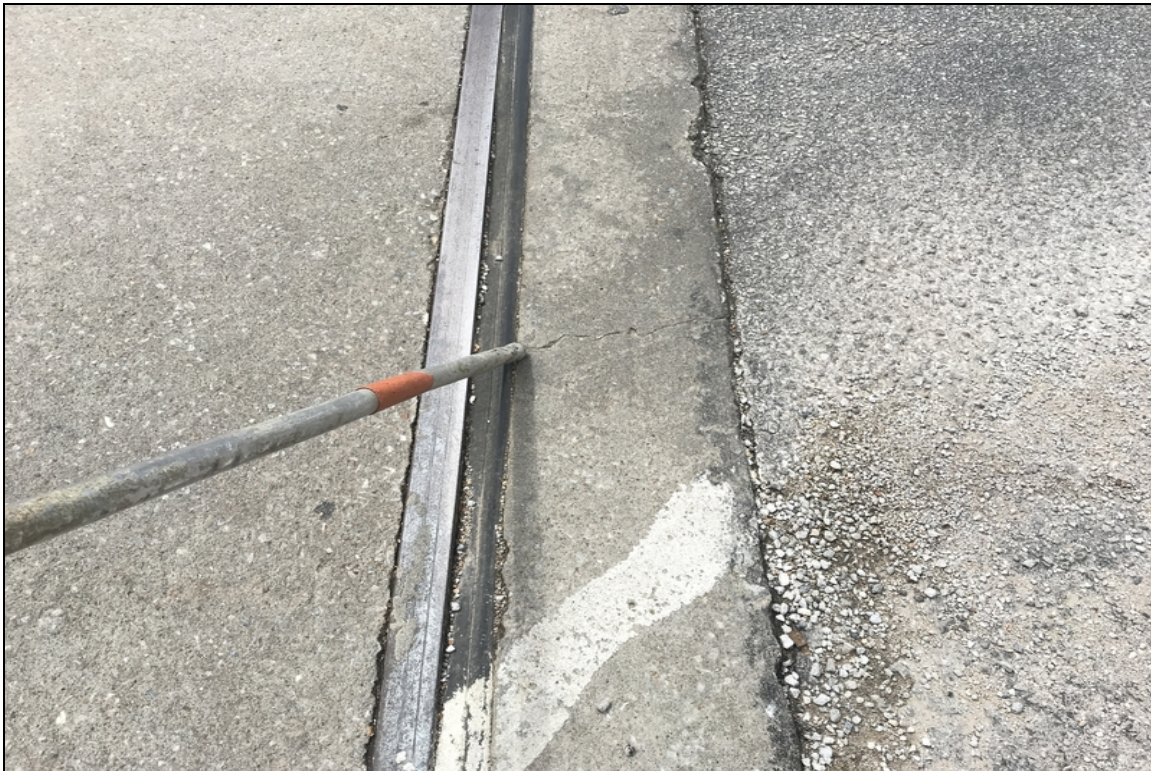
Abutment 1-Transverse cracking in top of backwall.

- Transverse cracking typical in the top of the back walls at Bents # 1 & 3 that are visible from the driving surface of the deck.
- The right exterior side of abutment 2 backwall has a vertical and diagonal crack.
