Bridge #23169(Underwater type 2, Routine)

Bethel Blacktop Rd over Illinois River Relief

Location: 2.91 M W Farmington

Team Lead: Eric West **Inspection Date:** February 07, 2022

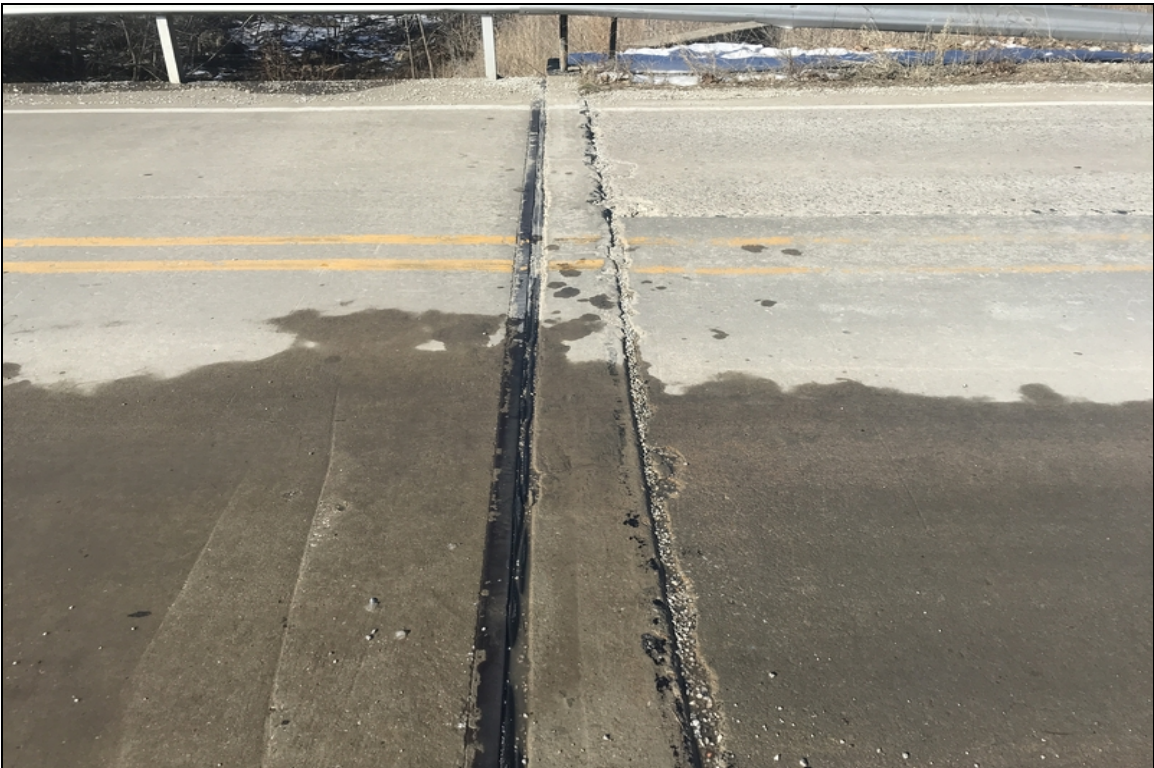
Abutment #2 top of the backwall spalling along the approach slab.

- Stem walls have random areas of honeycombing from the construction process.
- Transverse cracks typical in the top of the back walls.
- Abutment #1 has two vertical hairline cracks in the stem wall. One of the cracks has light efflorescence.
- Abutment #2 top of the back wall at the East abutment has minor shallow spalling with no exposed reinforcing steel adjacent to the approach slab.
- Bridge seats have minor debris / drift accumulation from high water events that cover portions of the bridge seat with no apparent noteworthy deficiencies at this inspection.

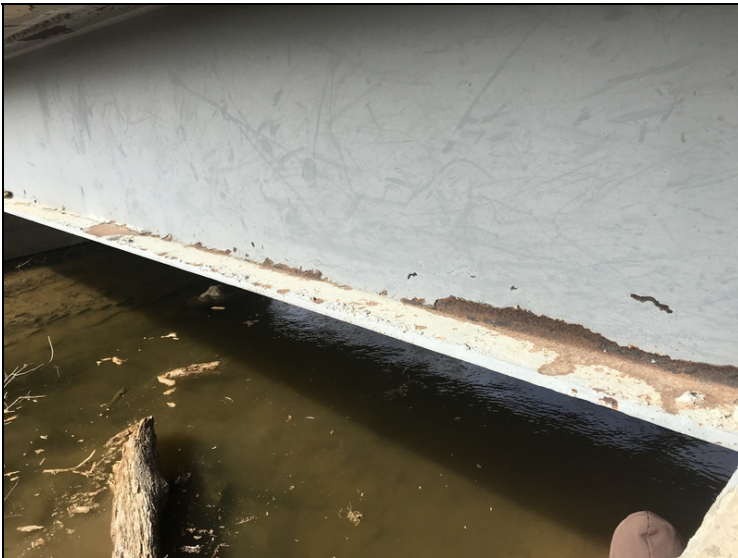
Superstructure -
The superstructure has areas with flaking paint with rust forming.

Paint system failure.

- Paint system is peeling primarily on exterior beams top and bottom flanges. Paint was applied over rusted areas. Rust coating now visible in a few areas.

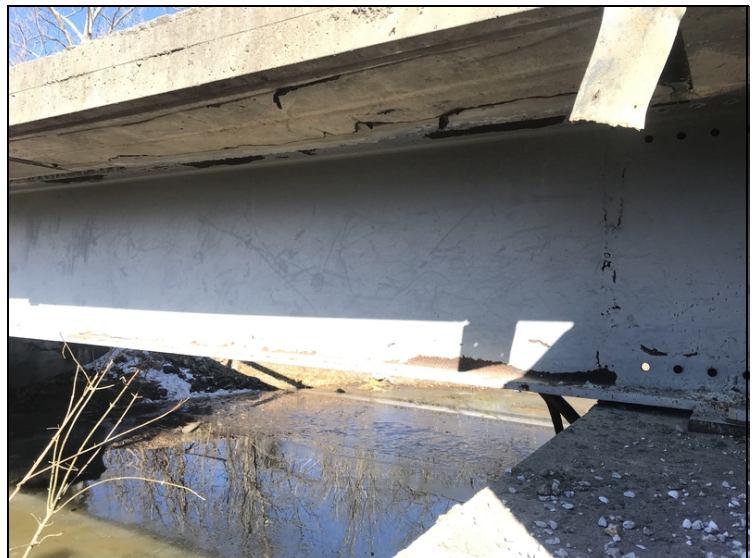
Beam 4-Failing paint with rust forming.

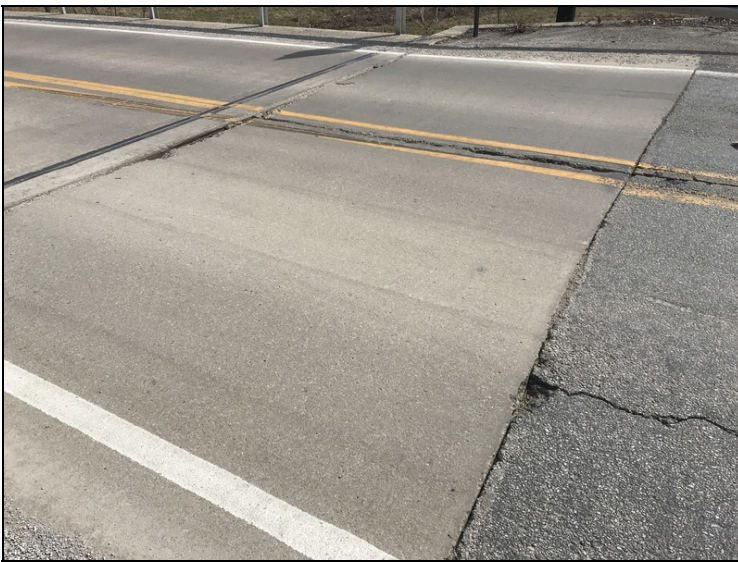
Approach Roadway -
The concrete approach slabs have minor settlement at this inspection.

The concrete approach slabs have minor settlement at this inspection.

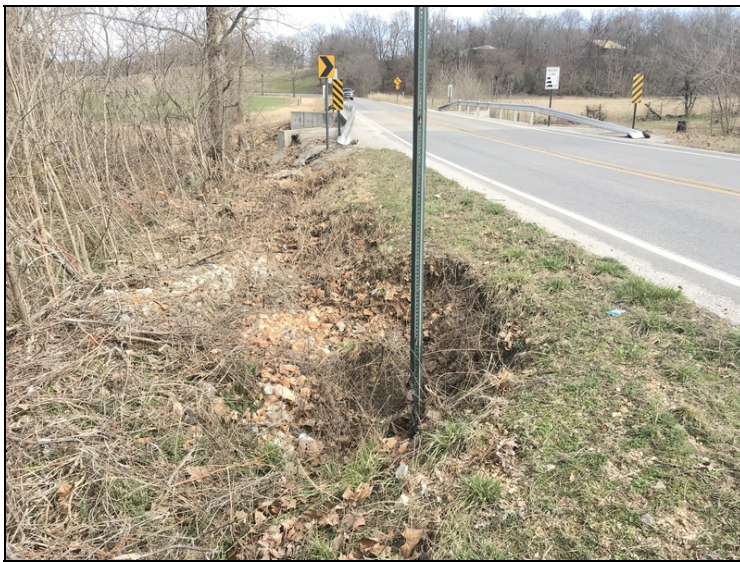
The North embankment of the West approach roadway has erosion that is nearing the edge of approach roadway.

The North embankment of the West approach roadway has erosion that is nearing the approach roadway.

- The North embankment at the West approach roadway has erosion that is nearing the approach roadway. No apparent changes or repairs since last inspection.

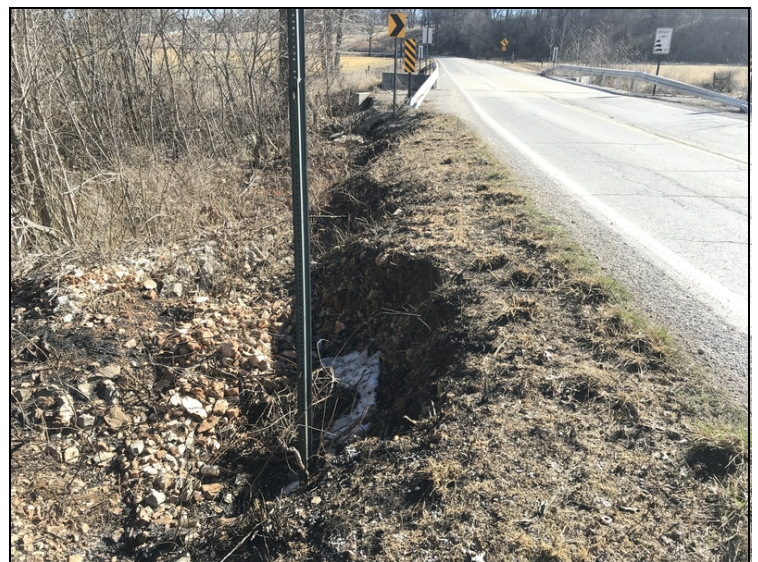
The North embankment of the West approach roadway has erosion that is nearing the edge of approach roadway.
