Asset #04244(Routine, Underwater type 2)

CR 40-Benton Co. over LITTLE SUGAR CREEK

Location: .5 M E HWY 71

Team Lead: Anthony Wood Inspection Date: 01/13/2025

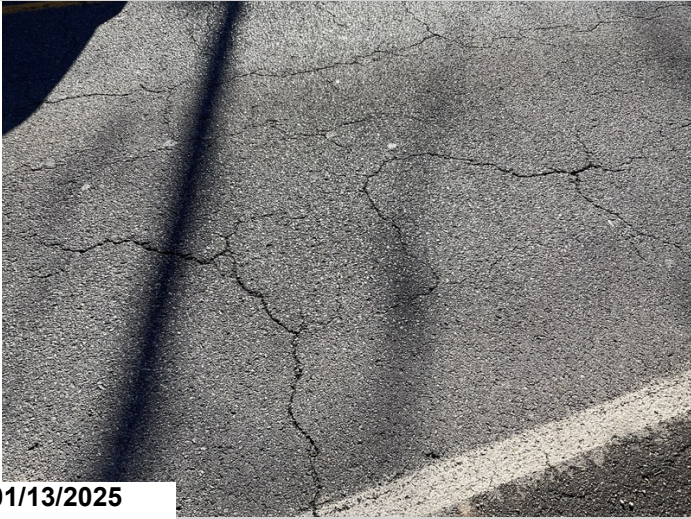
Overall, the deck is in satisfactory condition with moderate cracking in the wearing surface.

Spans 1 - 8, Wearing Surface: Moderate cracking.

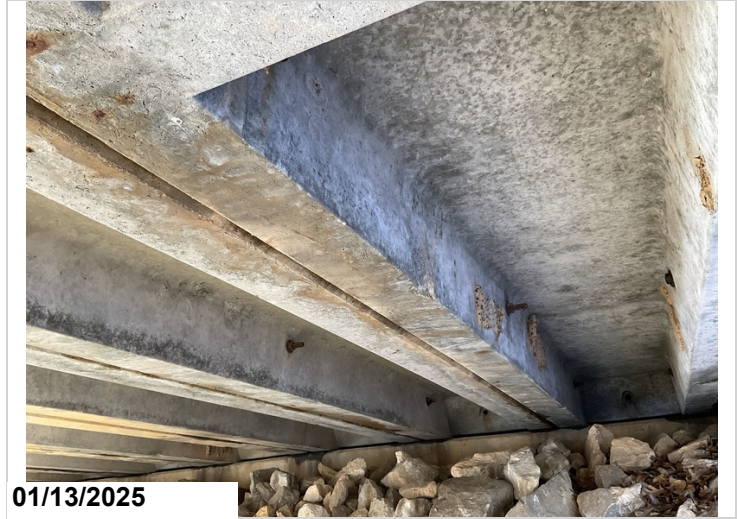
Span 1, Channel 2 & 6, Right Leg: Spalling.

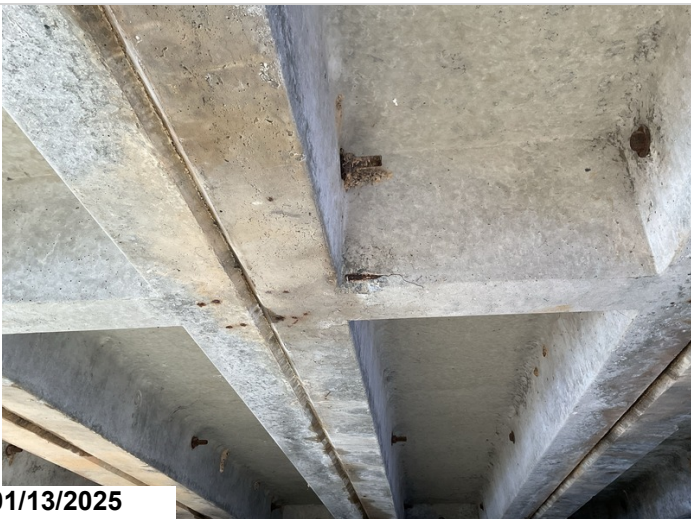
Span 1, Channel 3, Diaphragm: Spalling with exposed reinforcing steel with section loss.

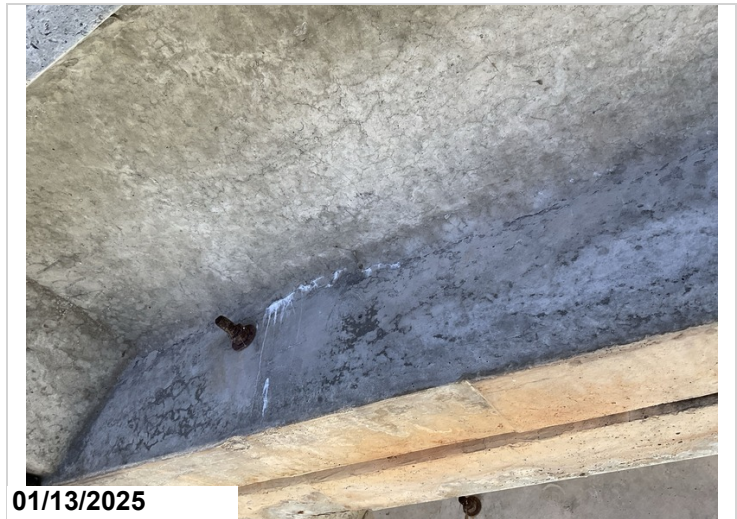
Span 1, Channel 2, 4 & 6: Longitudinal cracking with efflorescence.

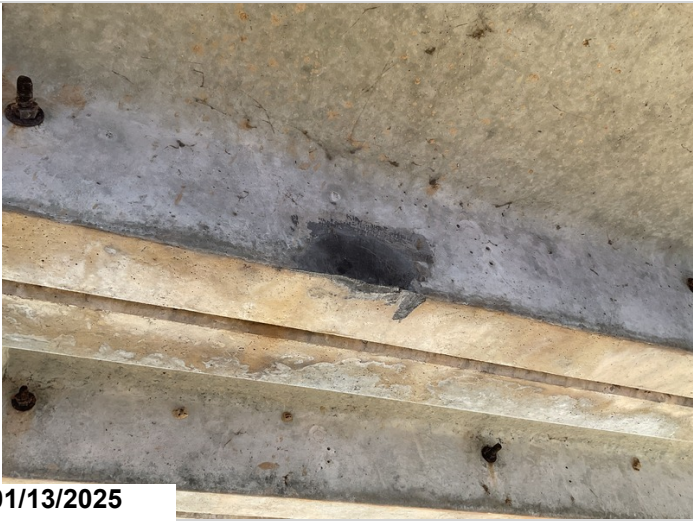
Span 2, Channel 3: Failing repair.

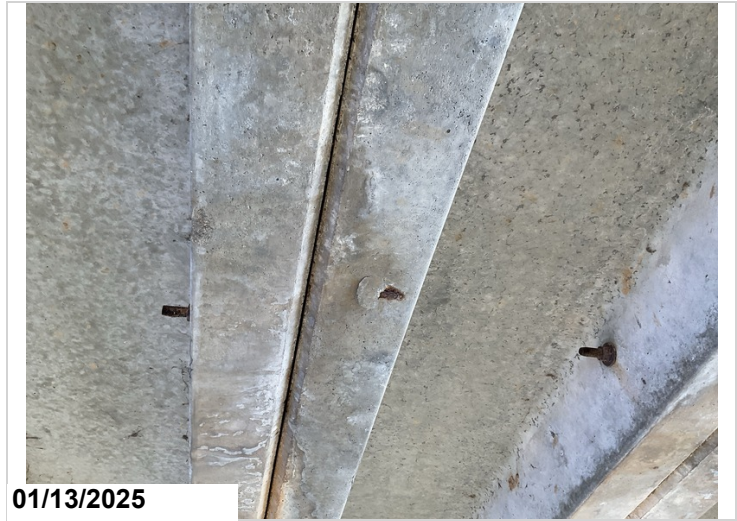
Span 2, Channel 4, Left Leg: Spalling with exposed reinforcing steel with section loss.

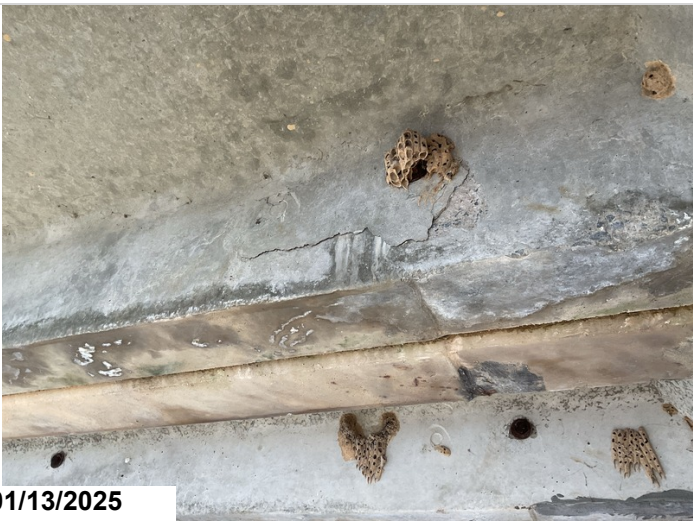
Span 6, Channel 5, Left Leg: Delam.

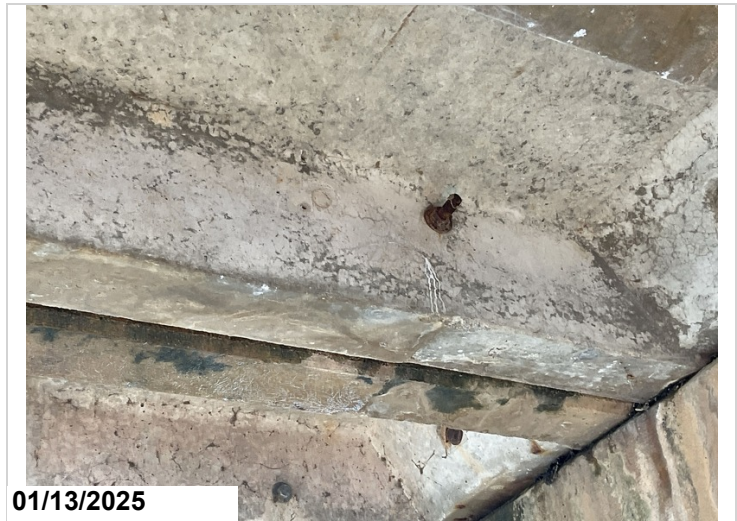
Span 6, Channels 2 - 7, Near Bolts: Cracking with efflorescence.

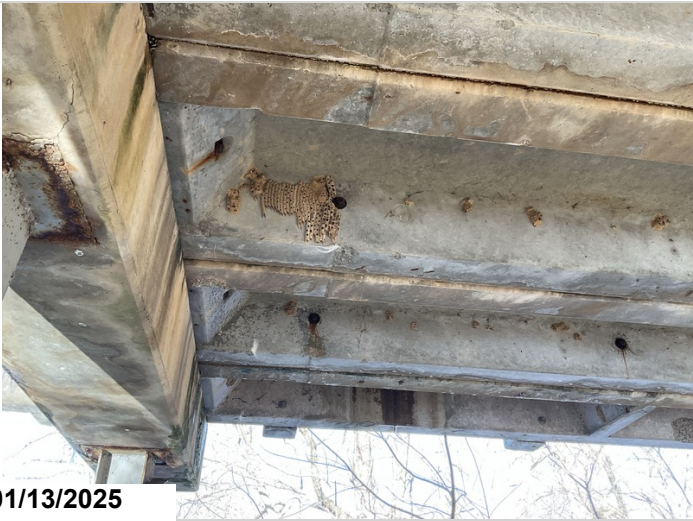
Span 6, Channels 1 - 6: Spalling.

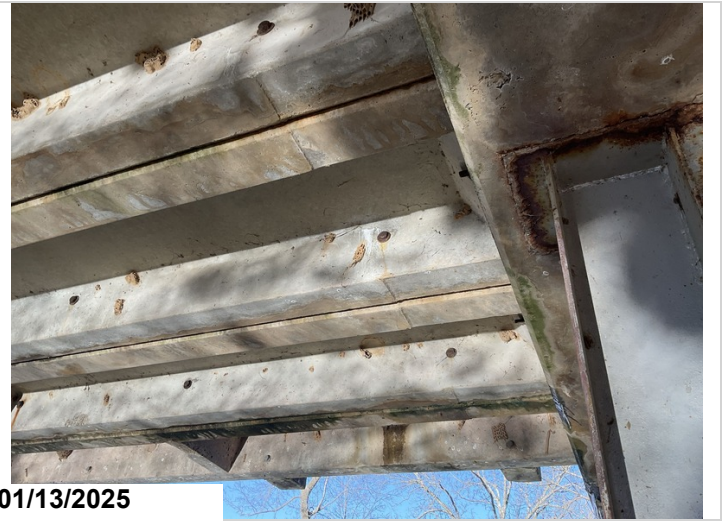
Span 5, Channel 2: Cracking with efflorescence with build up.

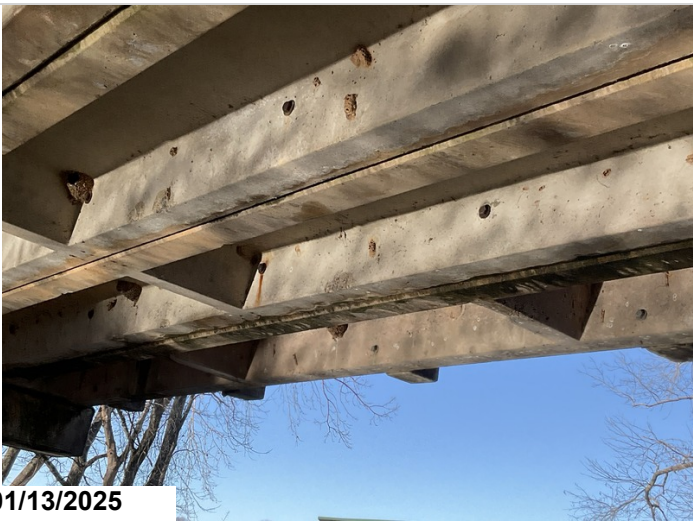
Span 5, Channels 2, 3, 6 & 8: Minor spalling.

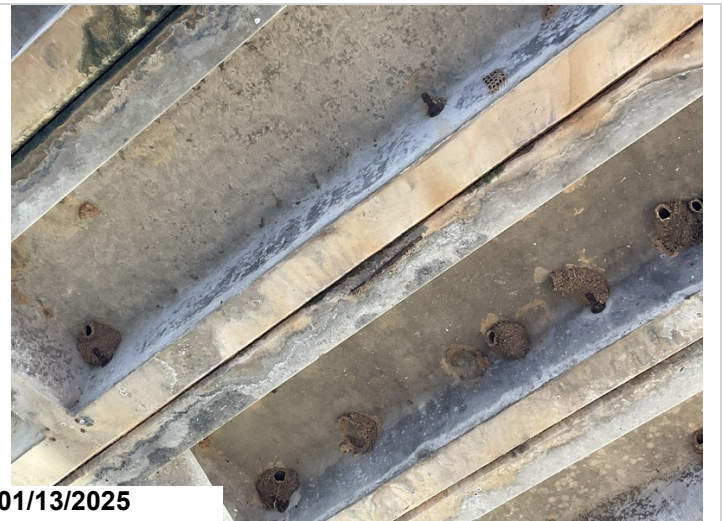
Span 4, Channel 3, 4 & 6: Spalling with exposed reinforcing steel with section loss.

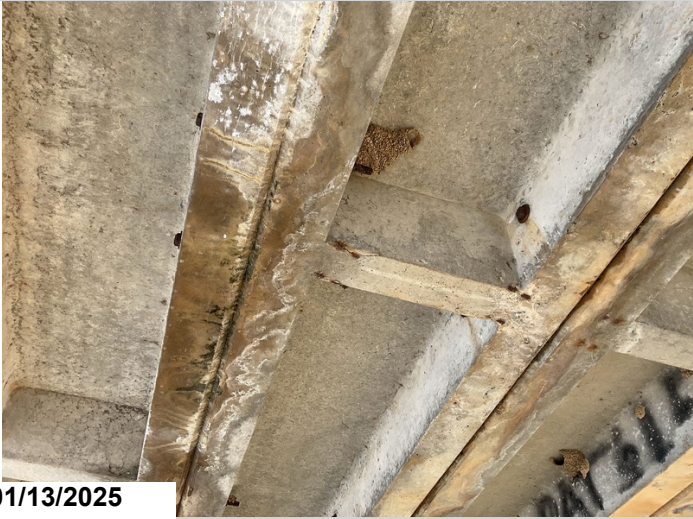
Span 3, Channel 7, Diaphragm: Delam.

Span 3, Channel 8, Diaphragm 1 & 2: Delam.

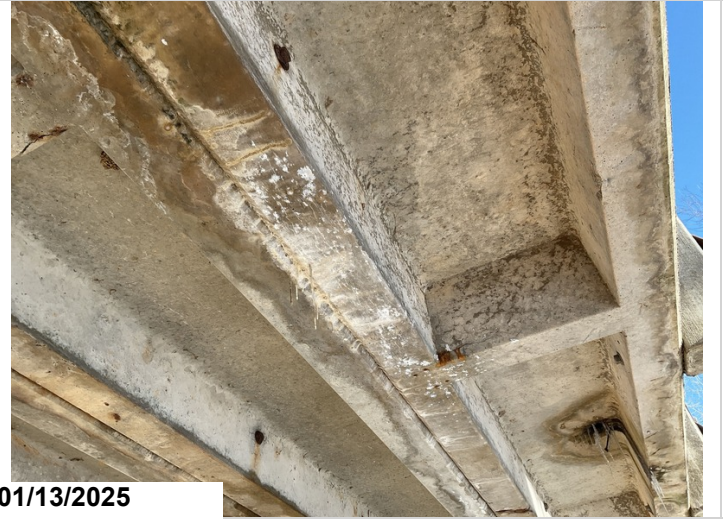
Span 3, Channel 8, Left Leg: Longitudinal cracking with efflorescence with build up.

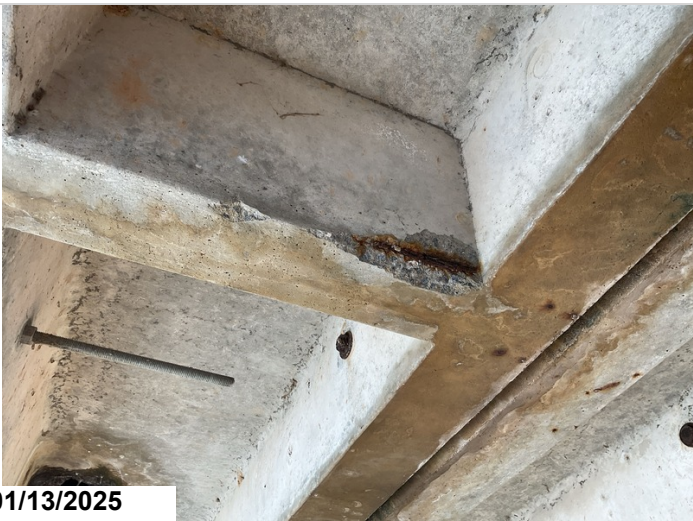
Span 2, Channel 8, Diaphragm: Spalling with exposed reinforcing steel with section loss.

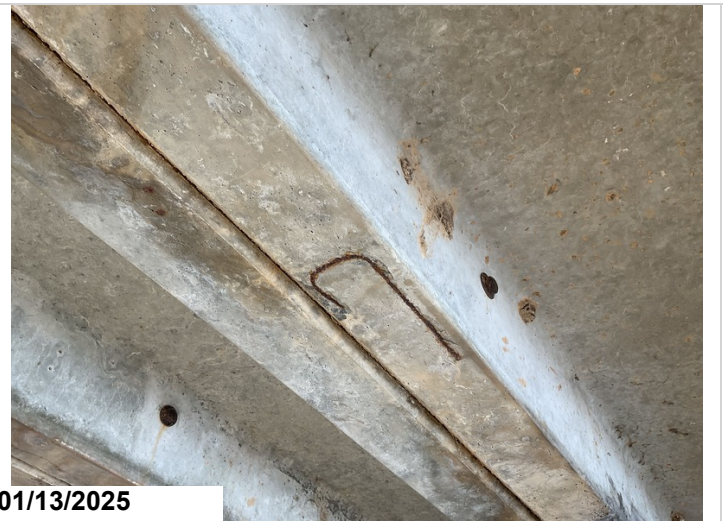
Span 2, Channel 6: Spalling with exposed reinforcing steel with section loss.

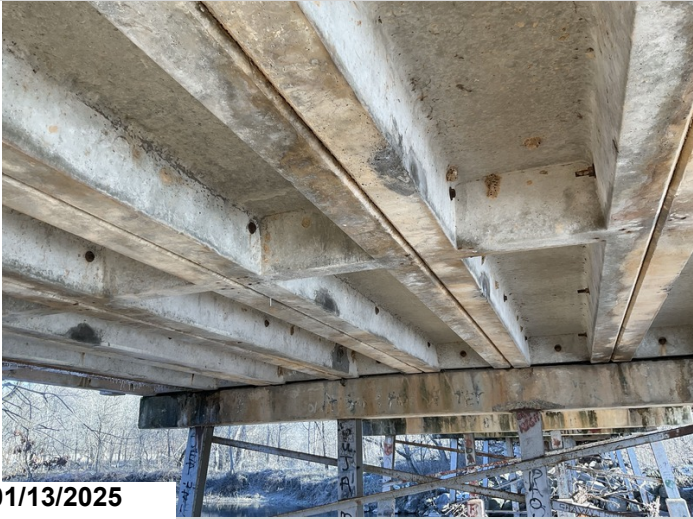
Span 2, Channels 4 - 8: Failing repairs.

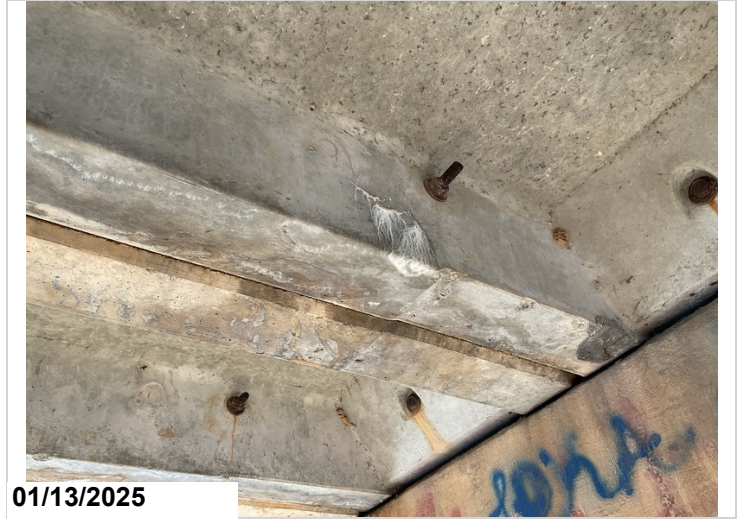
Span 2, Channel 5: Cracking with efflorescence with build up.

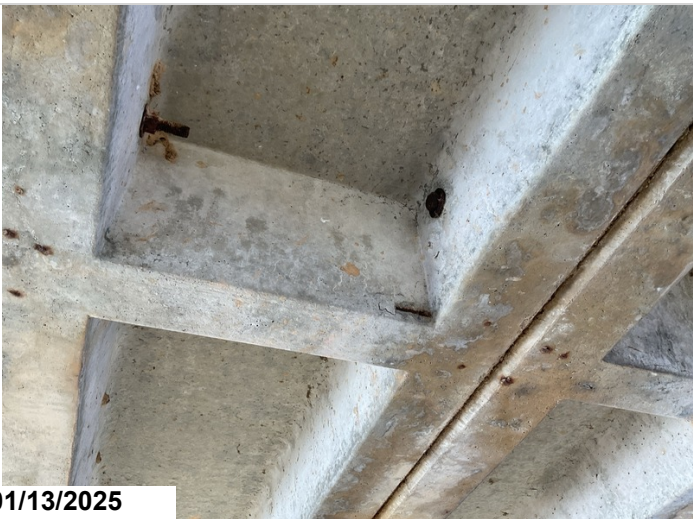
Span 2, Channel 4, Diaphragm: Spalling with exposed reinforcing steel with section loss.

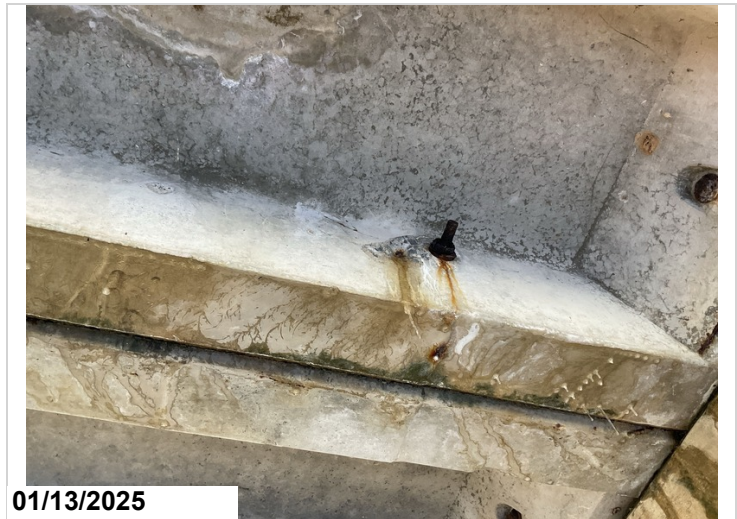
Span 7, Channel 1: Spalling with exposed reinforcing steel with section loss.

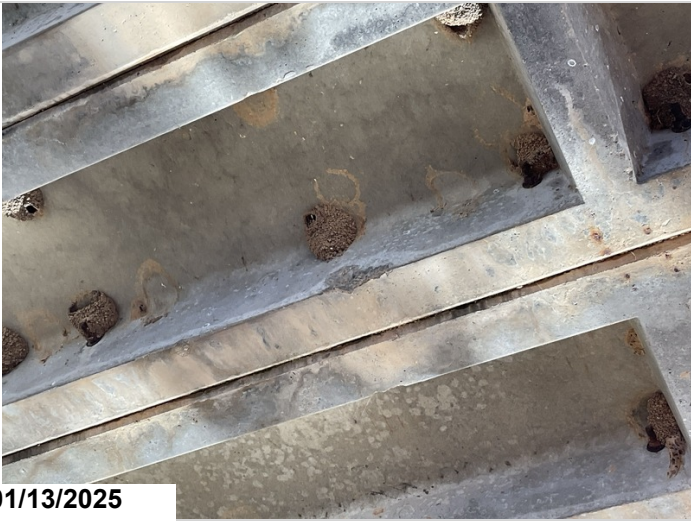
Span 4, Channels 3 & 5: Minor spalling.

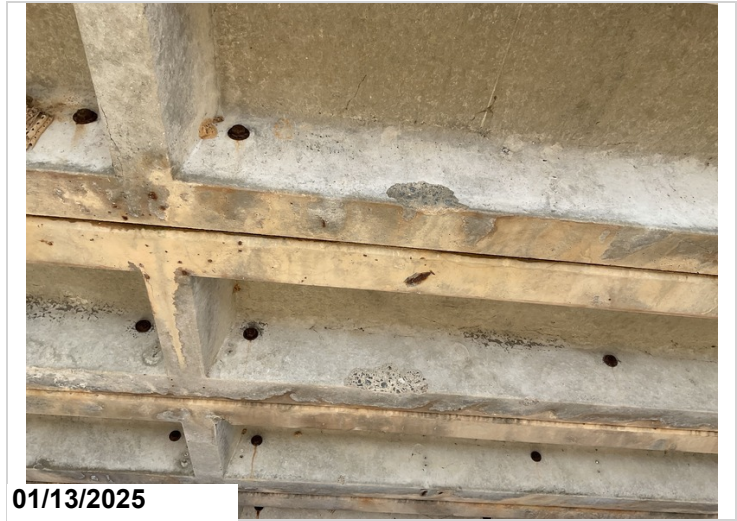
Span 7, Channels 1 & 3 - 8: Minor spalling.

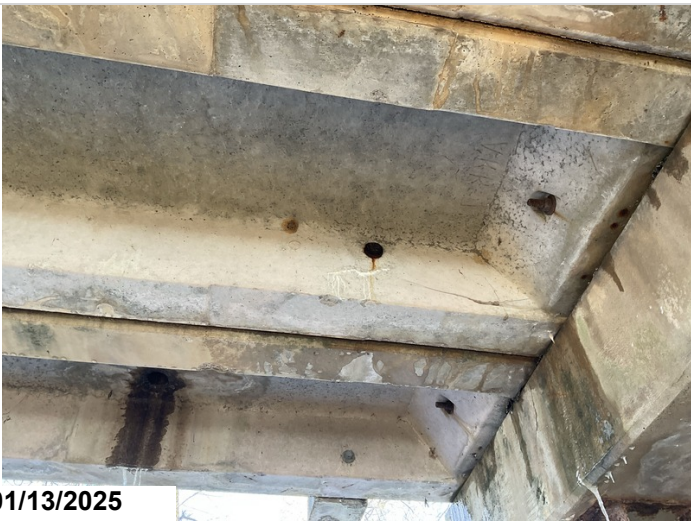
Span 7, Channels 2, 4 & 5: Cracking with efflorescence.

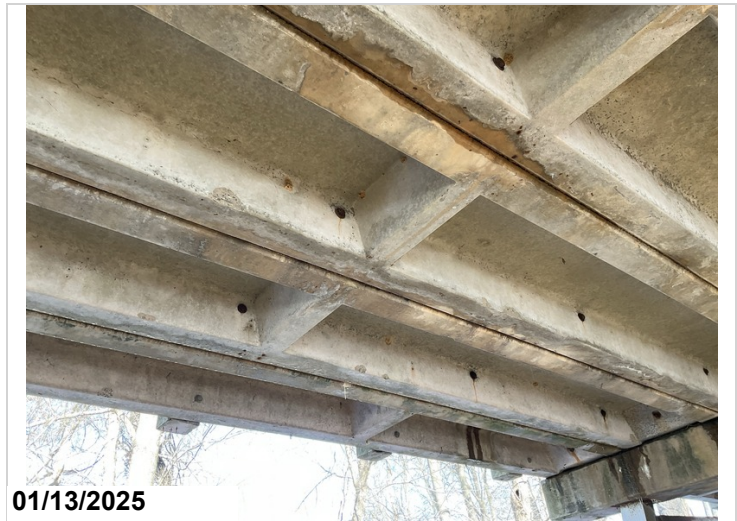
Span 8, Channels 1, 3, 5, 6 & 7: Minor spalling.

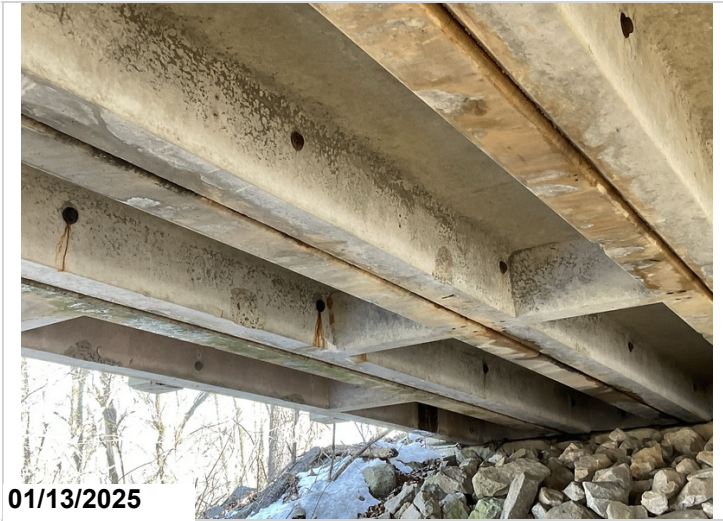
Span 9, Channels 1 - 8: Minor spalling.

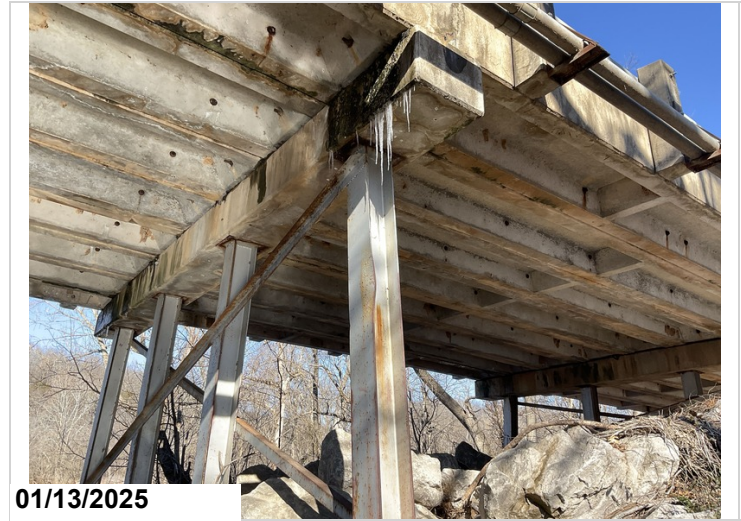
Bent 5, Pile 4: Minor damage.

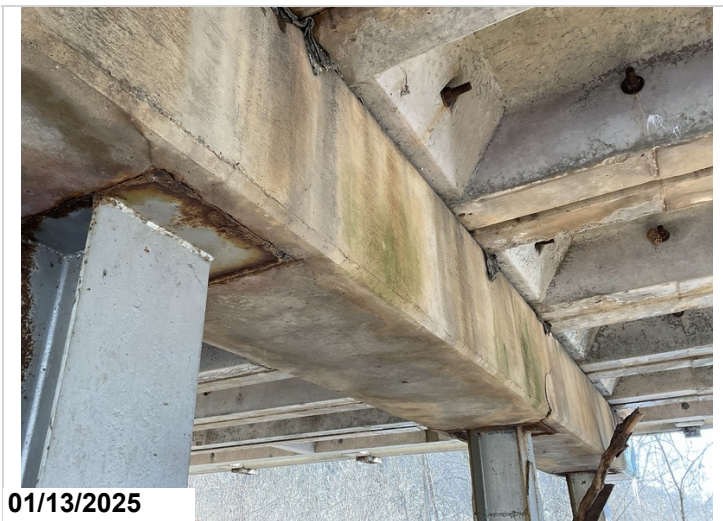
Bent 8, Piles 2 & 3, Ahead & Back: Delam.

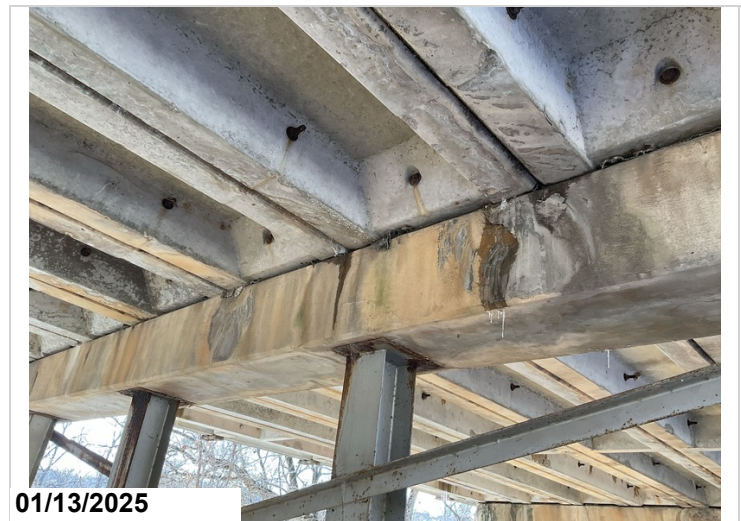
Bent 7, Channels 2 & 3, 4 & 5: Bearing Area: Spalling.

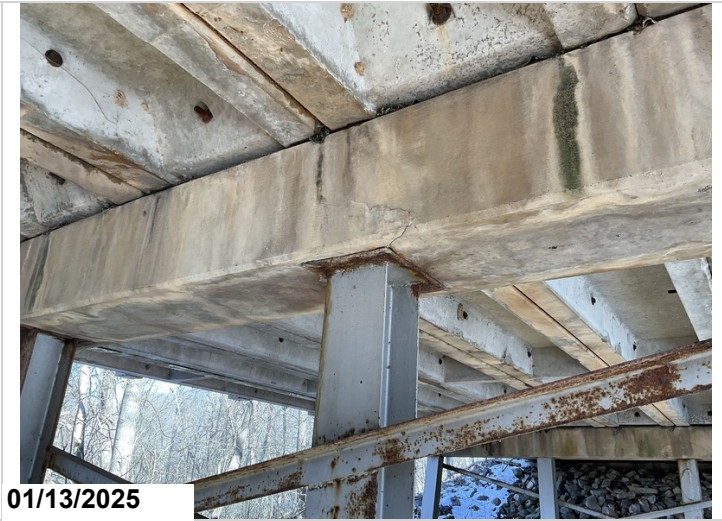
Bent 7, Piles 1 - 4: Active corrosion with flaking rust.

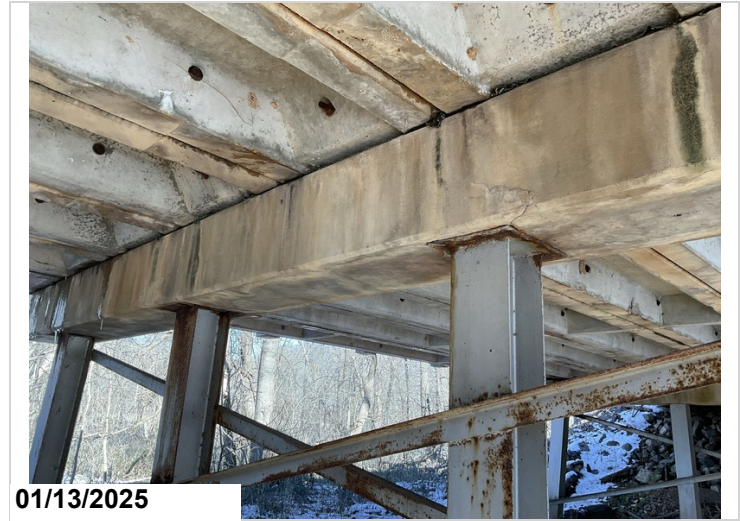
Bent 7, Piles 2 & 3: Delam.

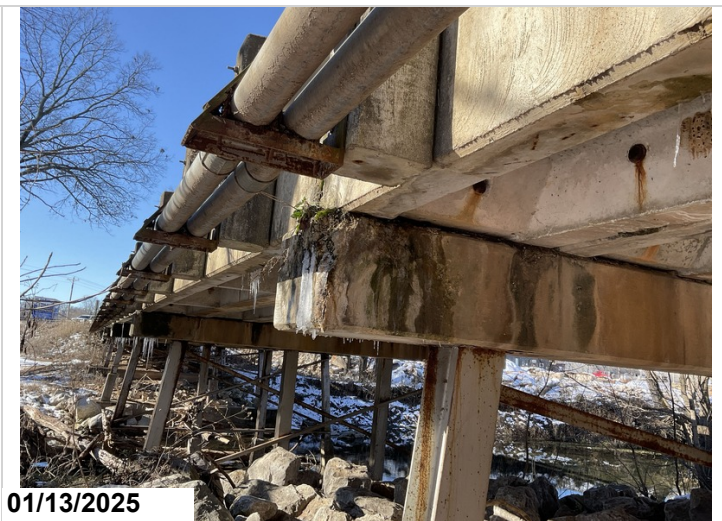
Bent 6, Right: Spalling.

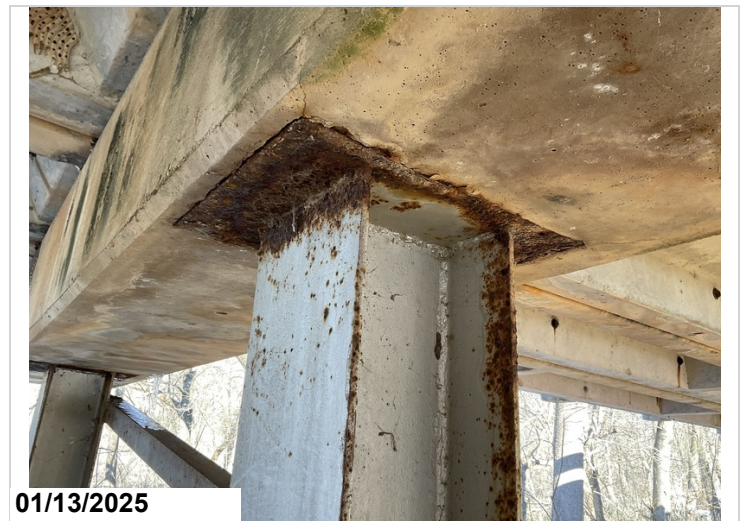
Bent 6, Piles 1 - 4: Active corrosion with flaking rust.

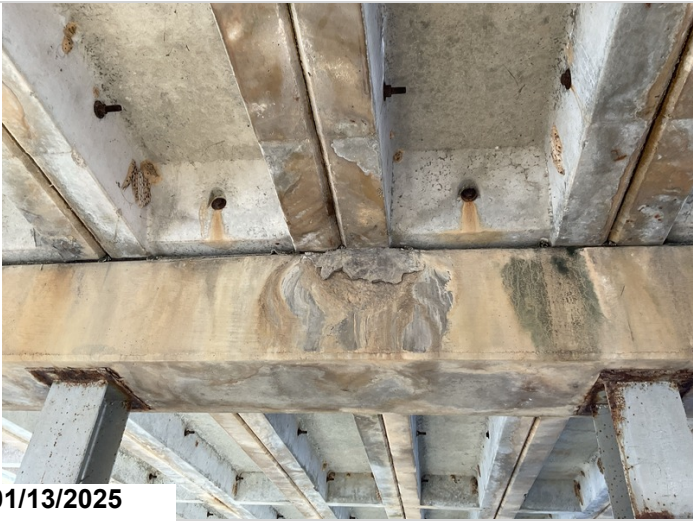
Bent 7, Channels 4 & 5, Bearing Area: Spalling.

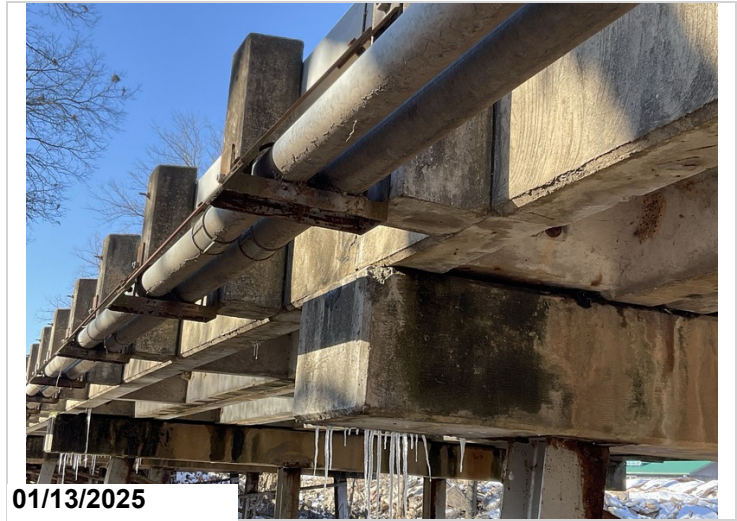
Bent 5, Right: Spalling.

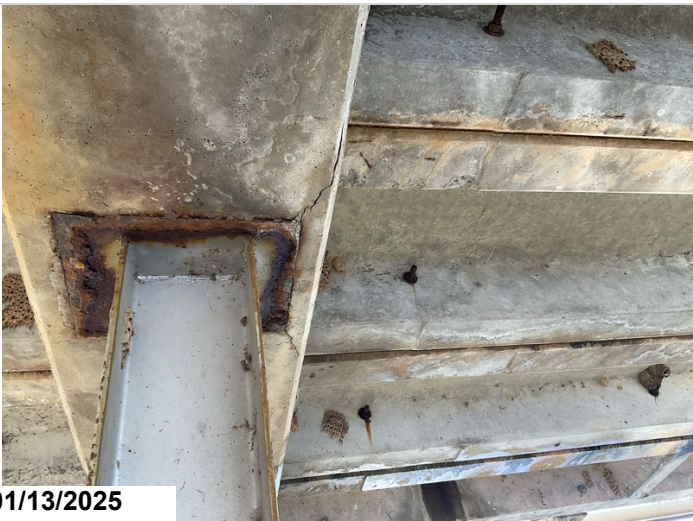
Bent 5, Pile 2, Ahead: Delam.

Bent 5, Pile 3, Back: Delam.

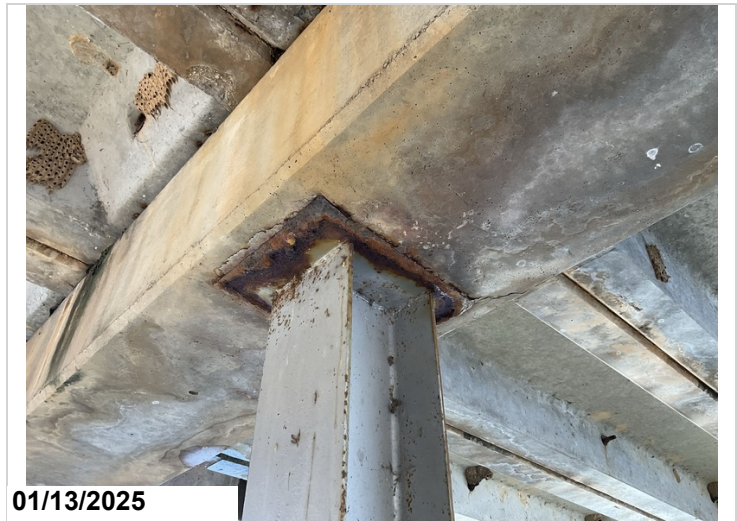
Bent 5, Piles 1 - 4: Active corrosion with flaking rust.

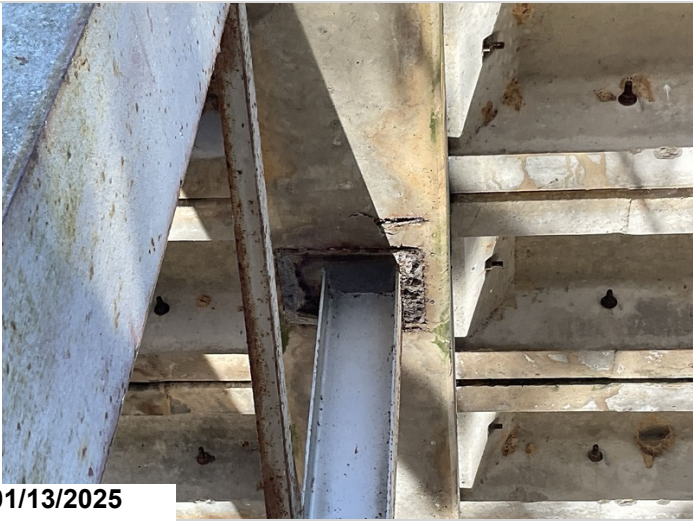
Bent 2: Spalling with exposed reinforcing steel with section loss.

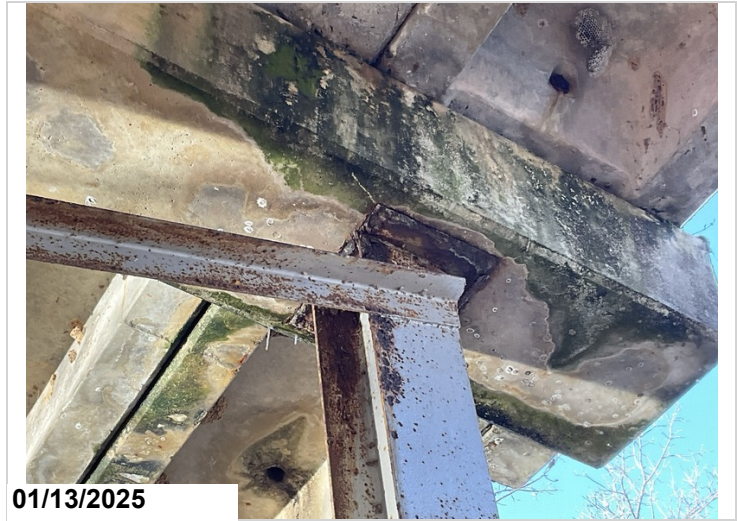
Bent 4, Piles 1 - 4: Active corrosion with flaking rust.

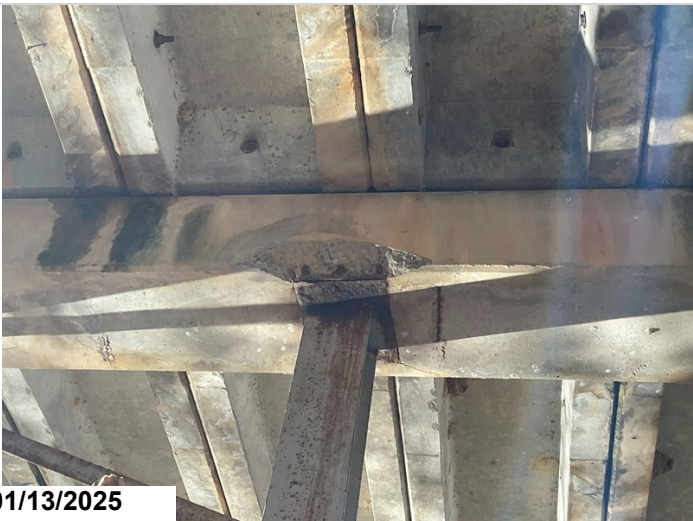
Bent 4, Pile 3, Ahead: Spalling with exposed reinforcing steel with section loss.

Bent 4, Pile 3, Back: Delam.

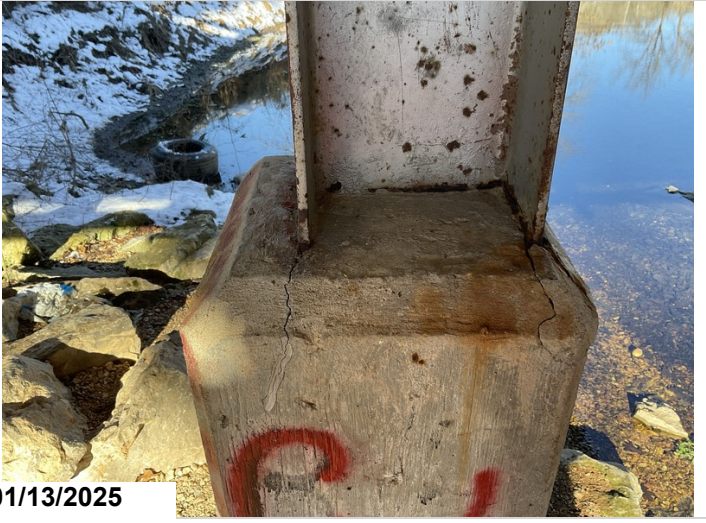
Bent 3, Piles 1 - 4, Concrete Encasement: Cracking.

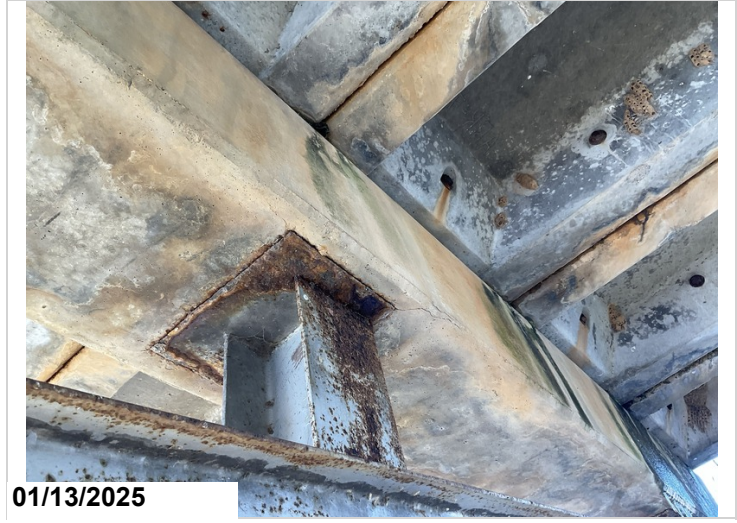
Bent 3, Pile 2, Ahead: Delam.

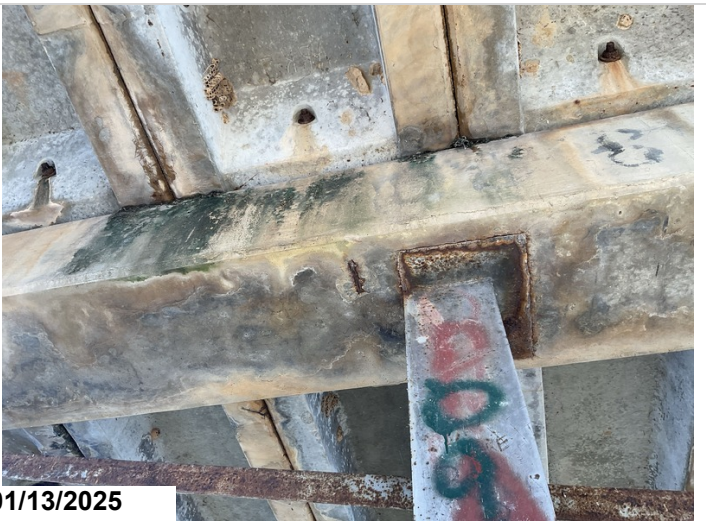
Bent 3, Adjacent to Pile 2: Spalling with exposed reinforcing steel with section loss.

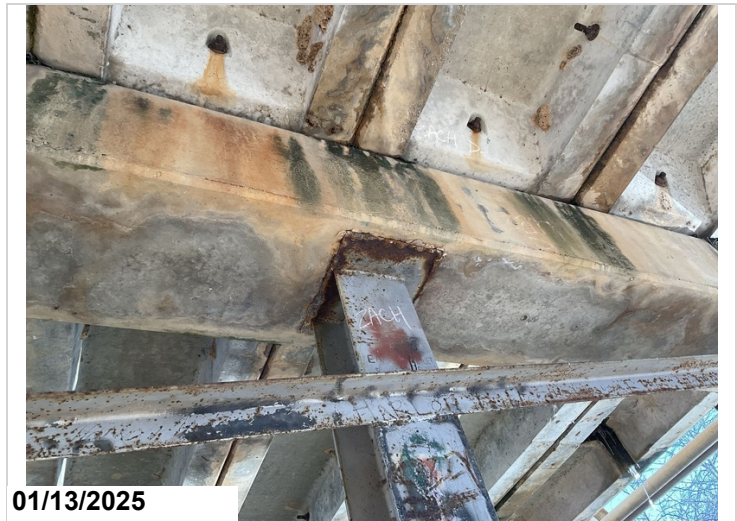
Bent 3, Piles 1 - 4: Minor active corrosion.

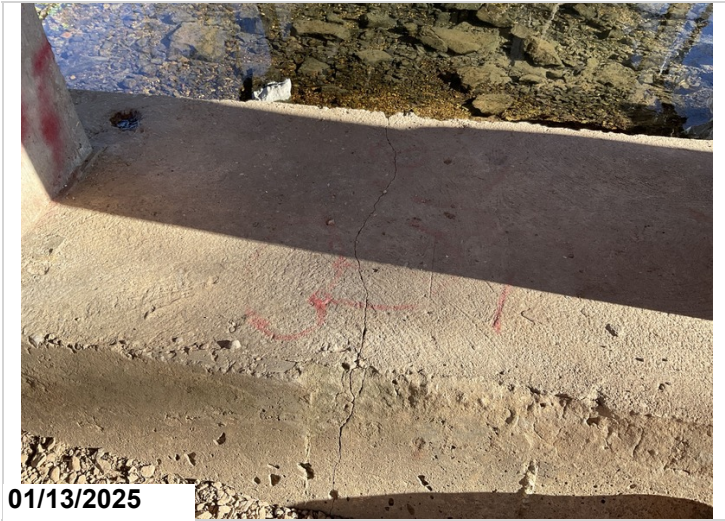
Bent 3, Between Piles 2 & 3, 3 & 4: Cracking.

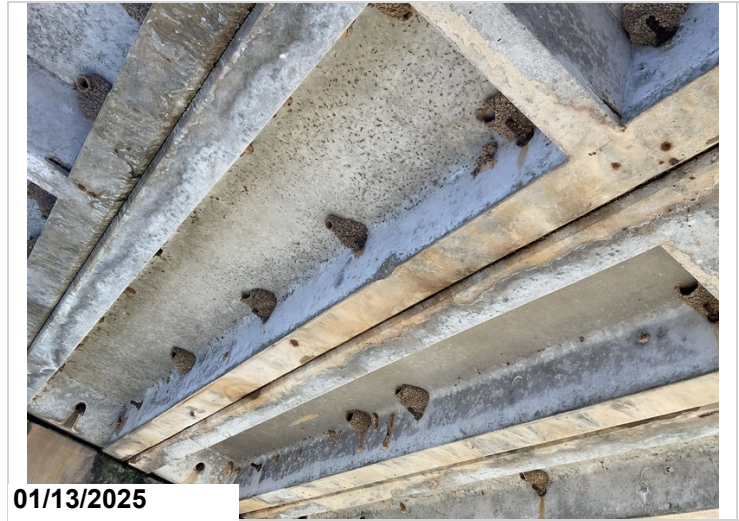
Span 3, Channels 2 - 5: Minor spalling.

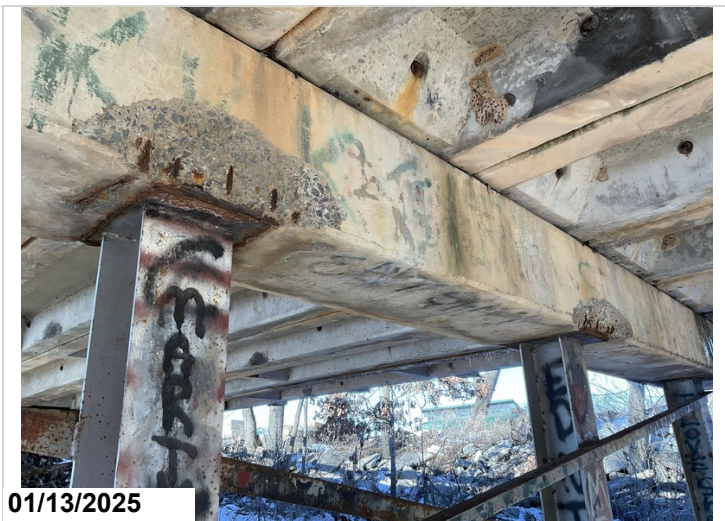
Bent 2, Piles 2 & 3, Ahead: Spalling with exposed reinforcing steel with section loss.

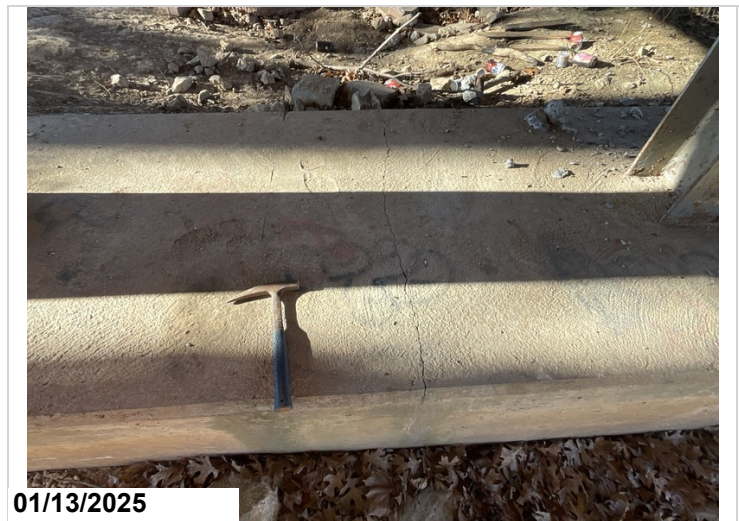
Bent 2, Footing: Cracking.

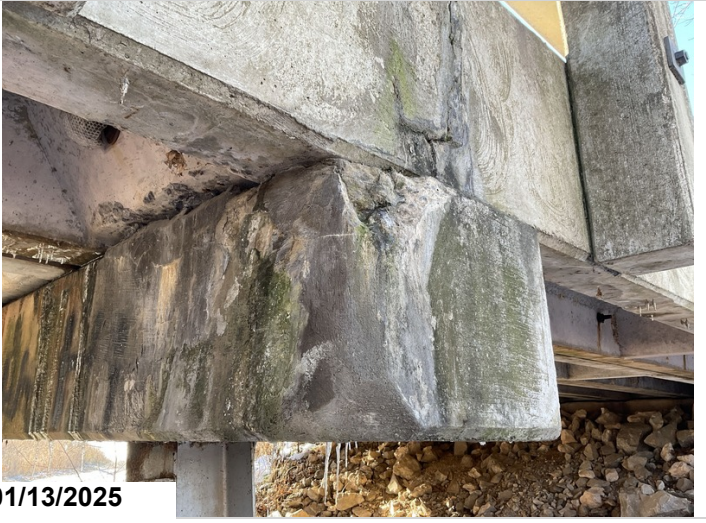
Bent 1, Left: Spalling.

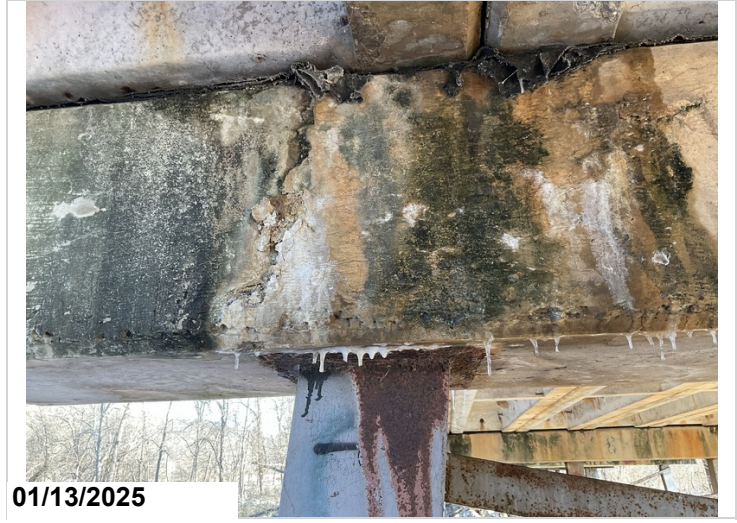
Bent 2, Back, Left & Right: Cracking with efflorescence with build up.

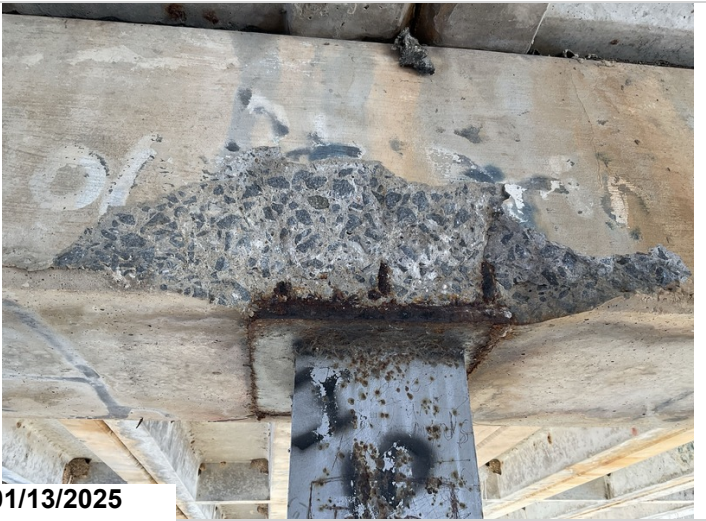
Bent 2, Pile 3, Back: Spalling with exposed reinforcing steel with section loss.

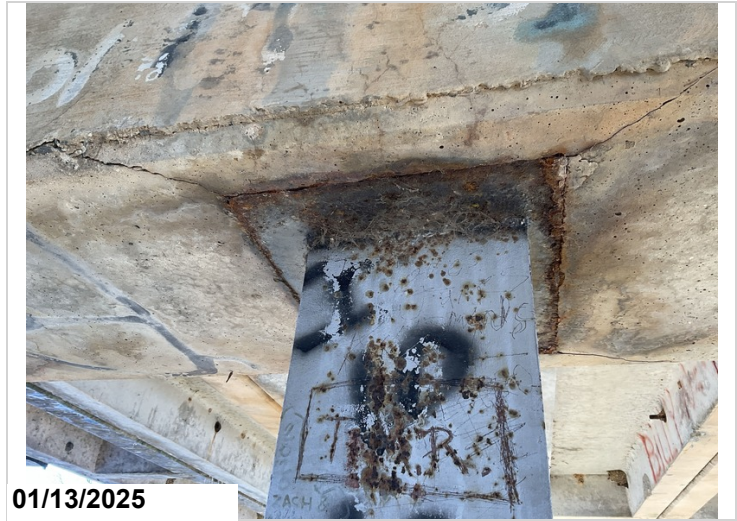
Bent 2, Piles 1 - 3: Minor active corrosion.

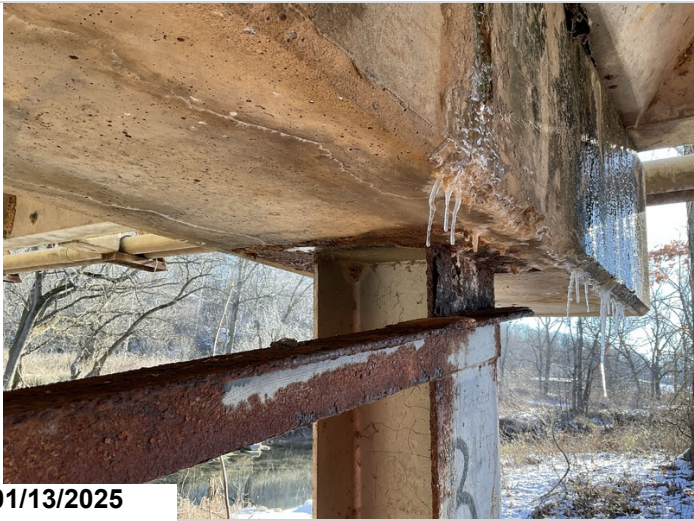
Bent 2, Pile 4: Active corrosion with flaking rust.

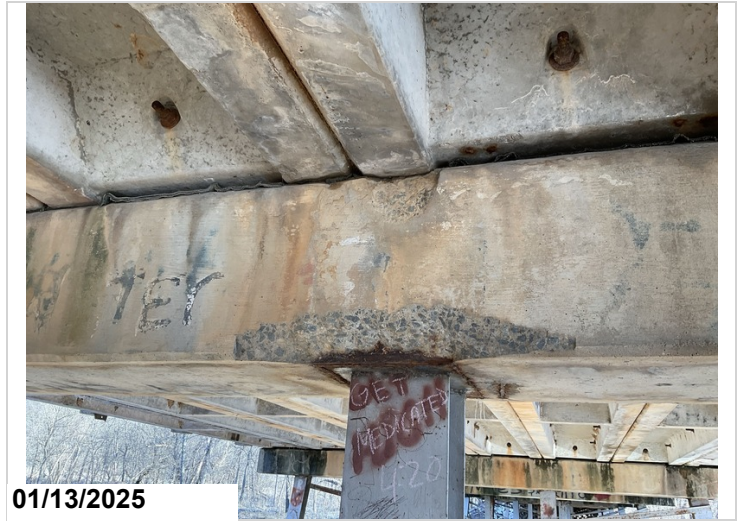
Bent 2, Pile 3, Back: Spalling.

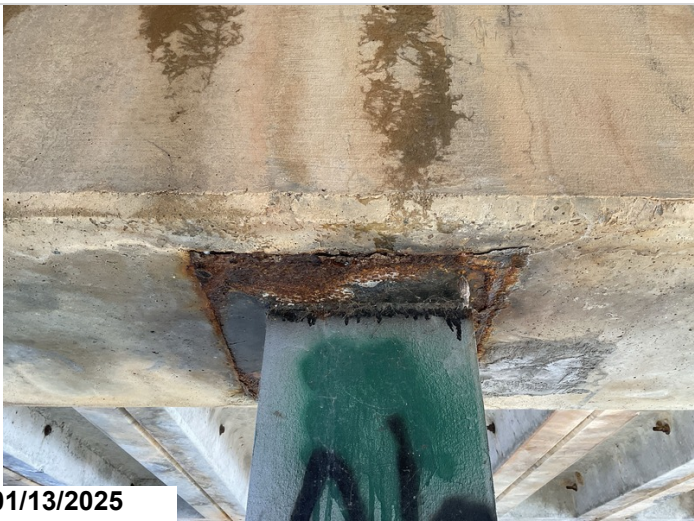
Bent 1, Pile 2 & 4: Minor active corrosion.

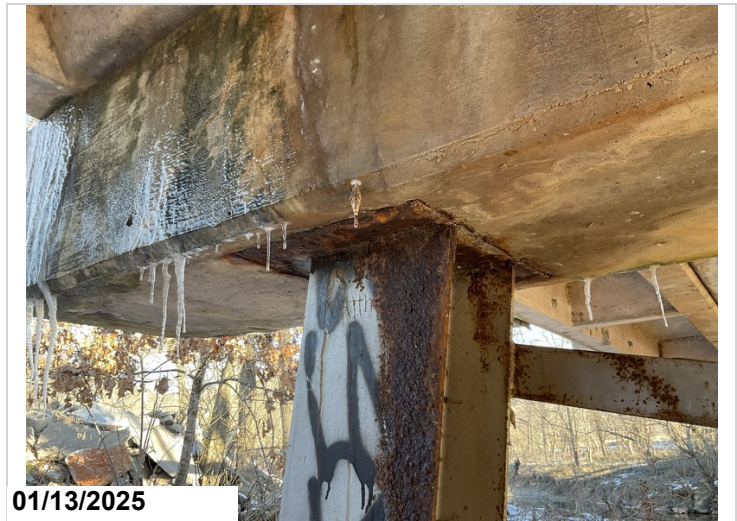
Bent 1, Pile 1: Active corrosion with flaking rust.

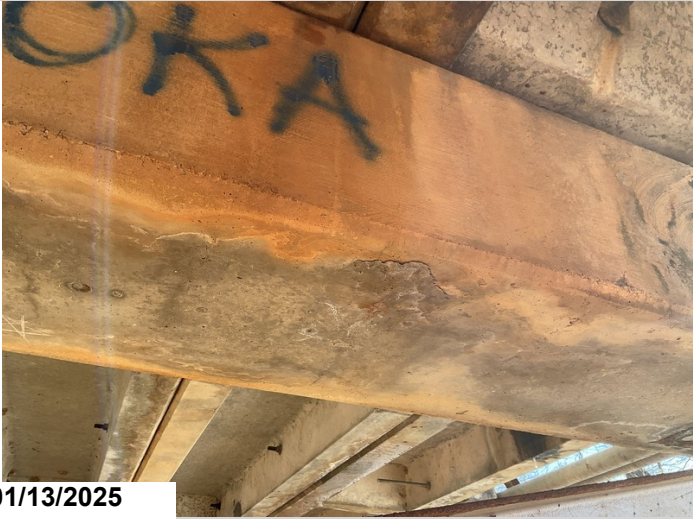
Bent 1, Right: Delam.

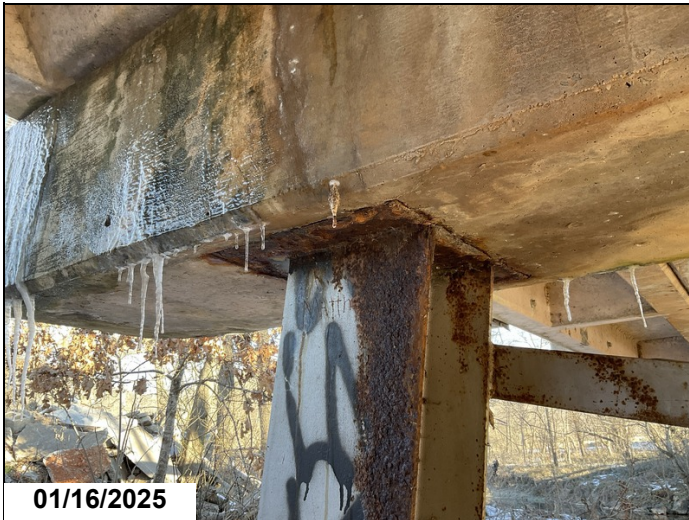
Bent 1, Pile 1: Active corrosion with flaking rust.

Type of Work: Substructure Repair

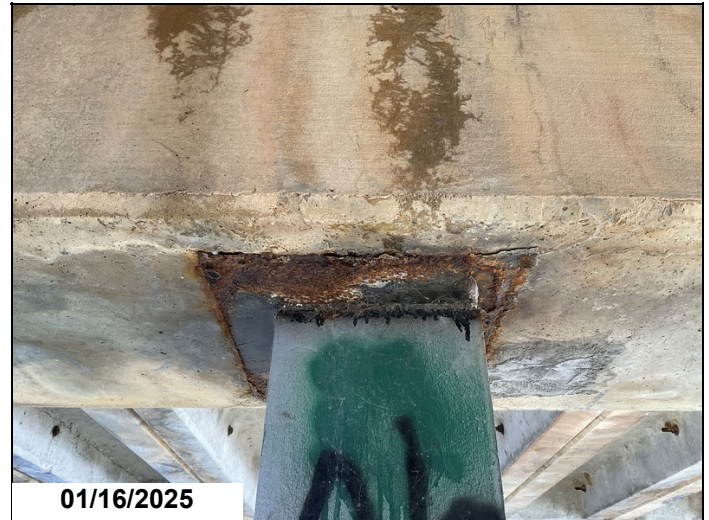
Bent 1, Pile 2 & 4: Minor active corrosion.

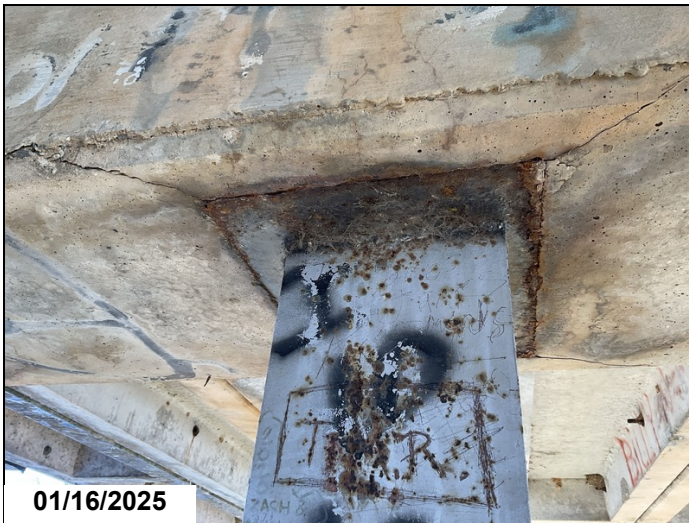
Bent 2, Piles 1 - 3: Minor active corrosion.
