Asset #04244(Routine, Underwater type 2)

CR 40-Benton Co. over LITTLE SUGAR CREEK

Location: .5 M E HWY 71

Team Lead: Anthony Wood Inspection Date: 01/13/2025

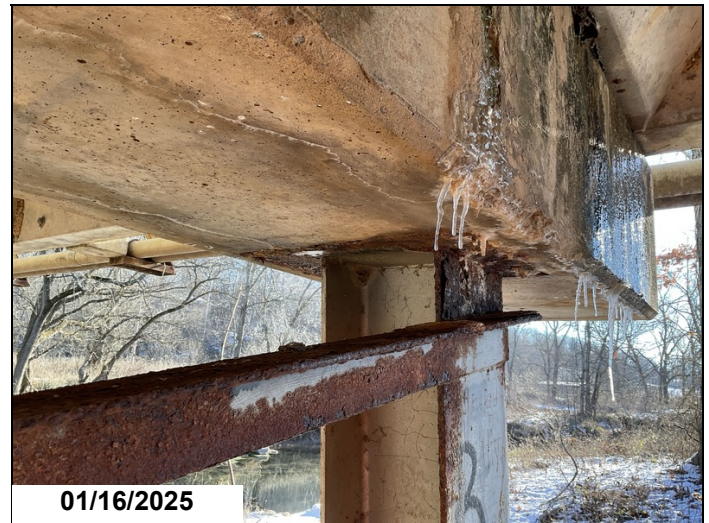
Bent 2, Pile 4: Active corrosion with flaking rust.

Type of Work: Substructure Repair

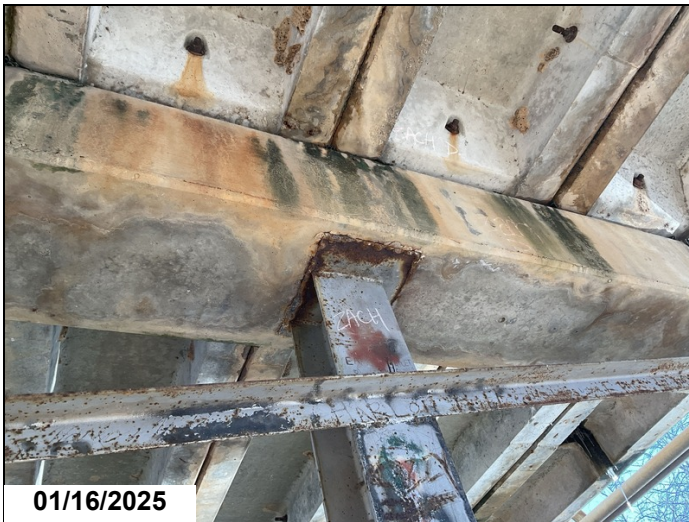
Bent 3, Piles 1 - 4: Minor active corrosion.

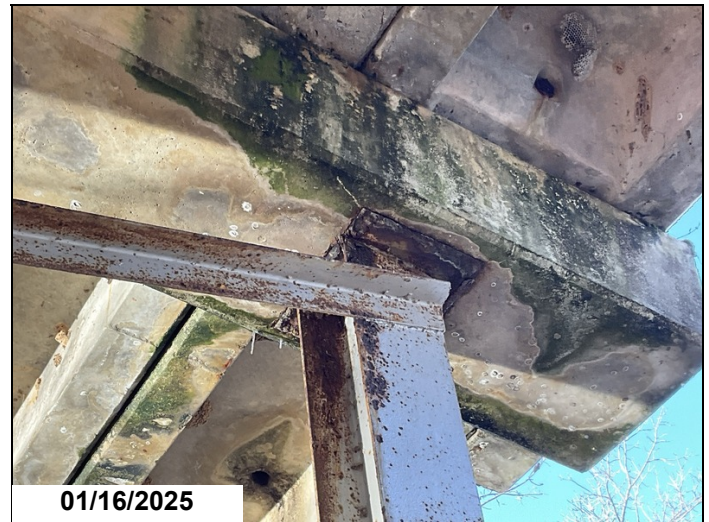
Bent 4, Piles 1 - 4: Active corrosion with flaking rust.

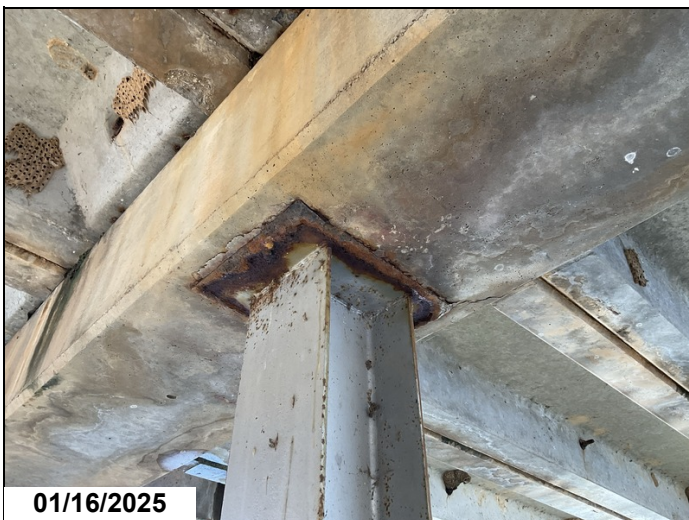
Bent 5, Piles 1 - 4: Active corrosion with flaking rust.

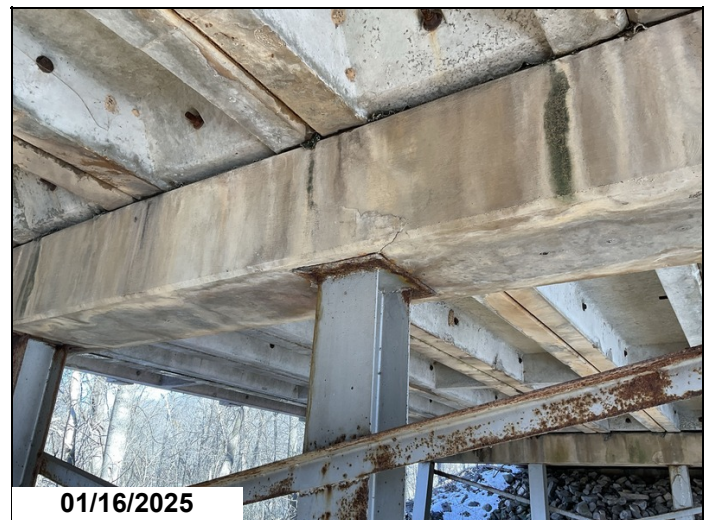
Bent 7, Piles 1 - 4: Active corrosion with flaking rust.

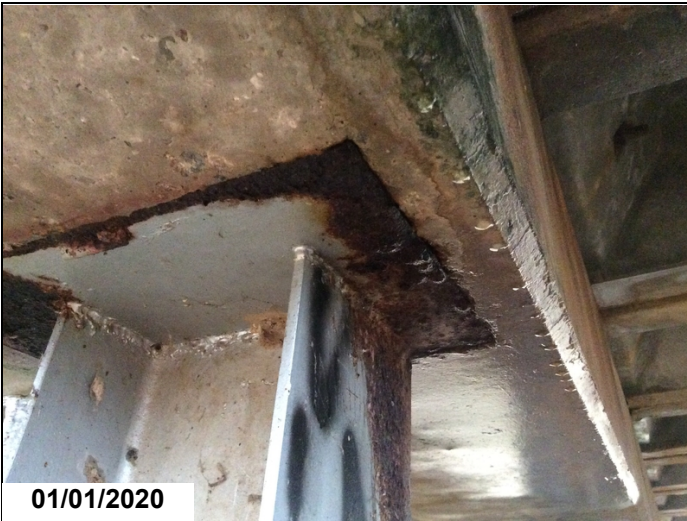
Bent #1, pile #1-Corrosion to top plate and piling.

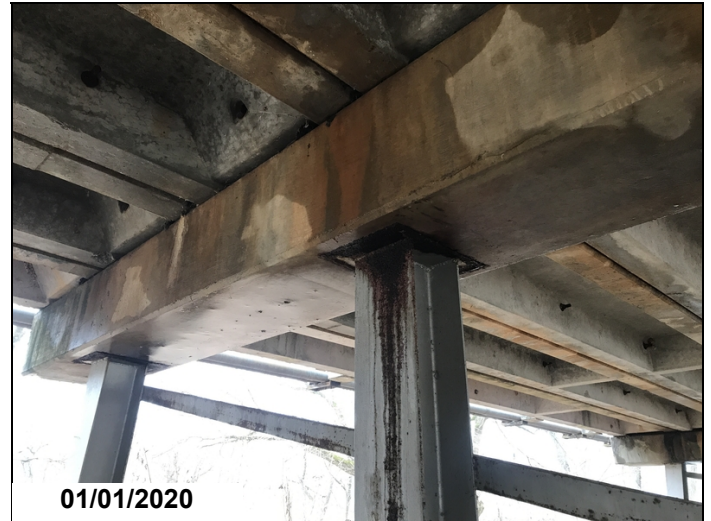
Typical failing paint system of steel piling.
