Bridge 04373 Inspection Report

National Bridge Inventory Data Sheet

Team Lead: Anthony Wood, Inspection Date: 02/11/2025

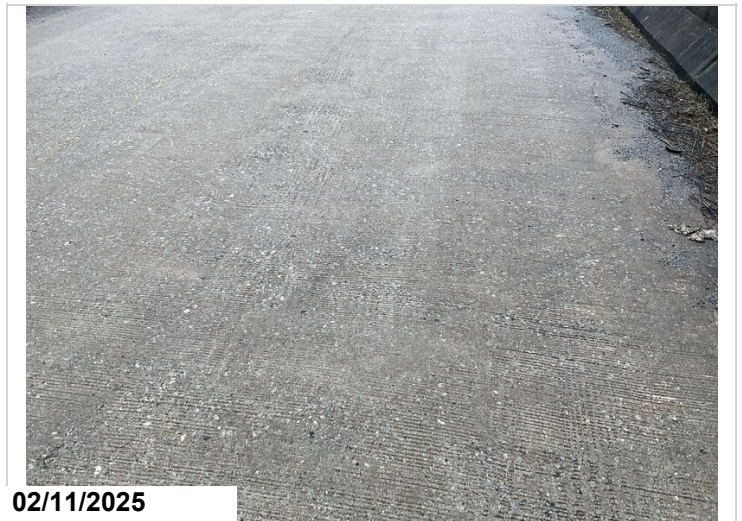
Spans 1 - 3: Minor abrasion.

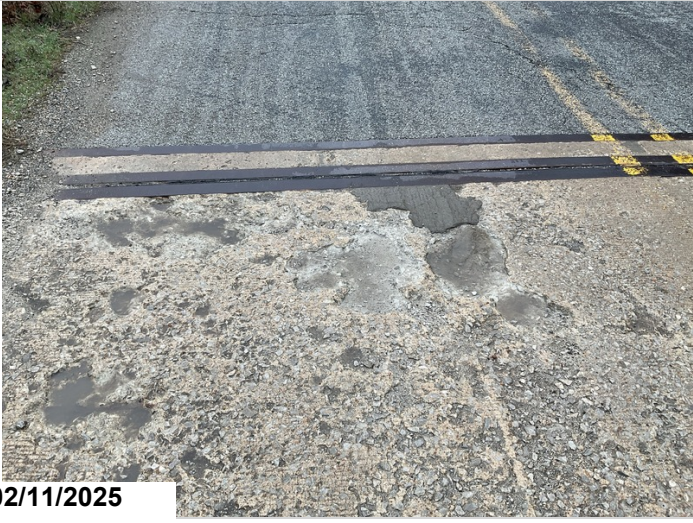
Span 1, Right: Spalling.

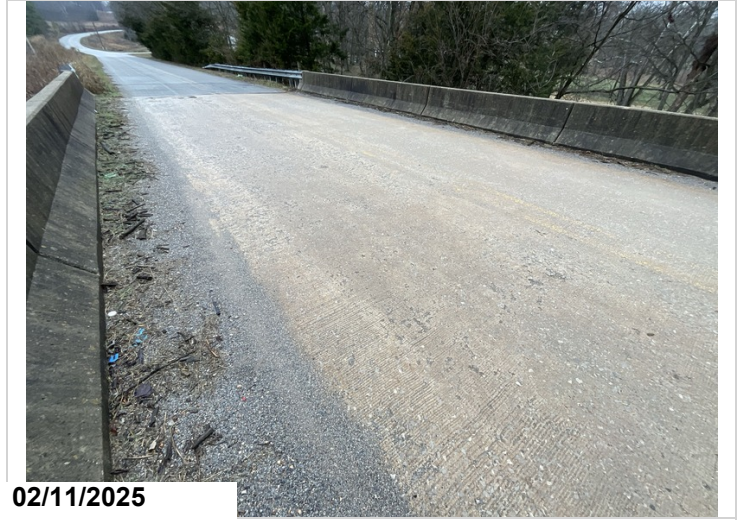
Span 1, Right Lane: Moderate abrasion.

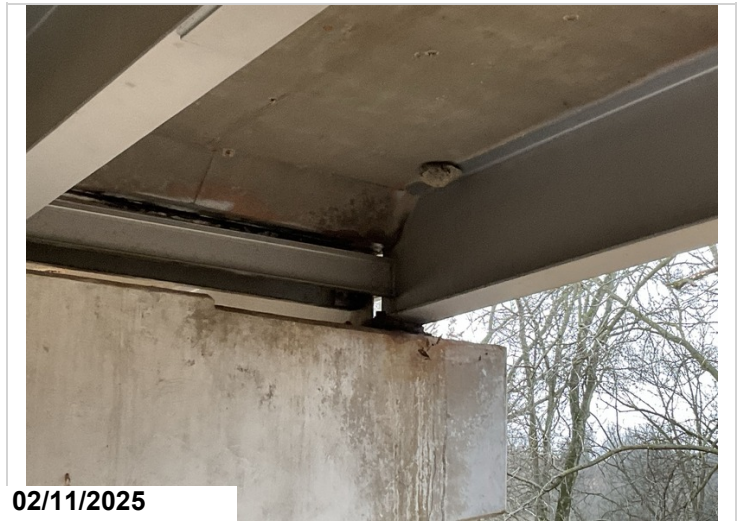
Overall, the superstructure is in satisfactory condition with active corrosion with flaking rust at joint locations.

Spans 1 - 3, Bents 1 & 2, Girders 1 & 4: Moderate active corrosion with flaking rust.

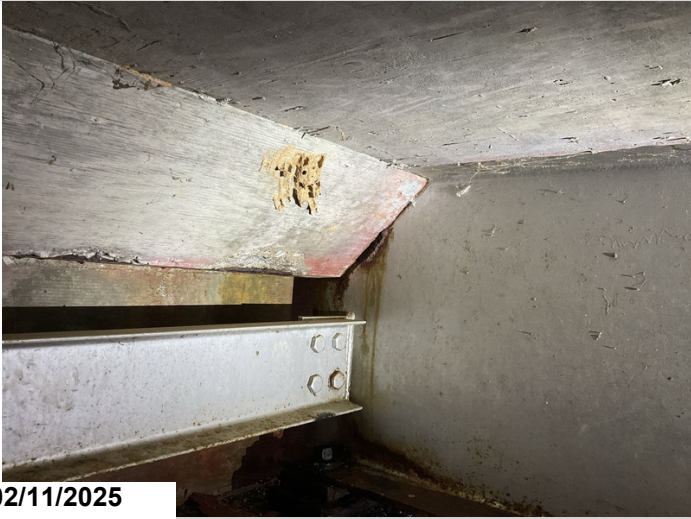
Abutment 1 & 2, Girders 1 & 4: Moderate active corrosion with flaking rust.

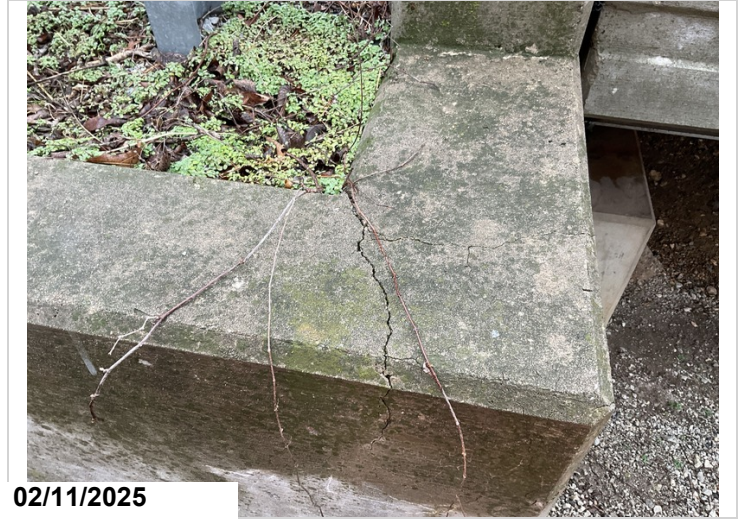
Overall, the substructure is in good condition with minor cracking at abutment 2.

Abutment 2, Left: Cracking.

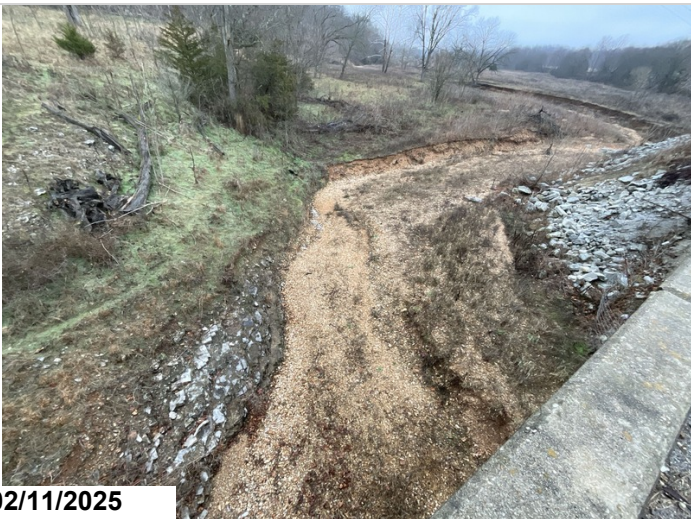
61 - Channel/Channel Protection (6 - Bank is beginning to slump. River control devices and embankment protection have widespread minor damage. There is minor stream bed movement evident. Debris is restricting the channel slightly.)
Overall, the channel is in satisfactory with bank slump and minor stream migration.

Channel, Right.

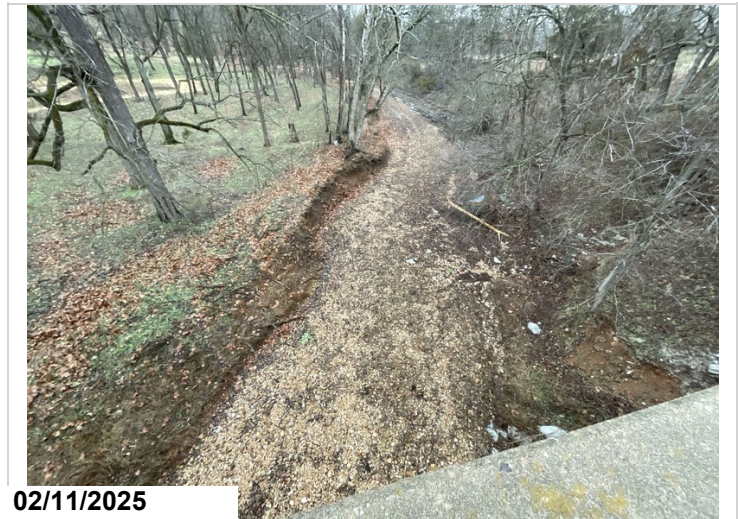
Channel, Left.

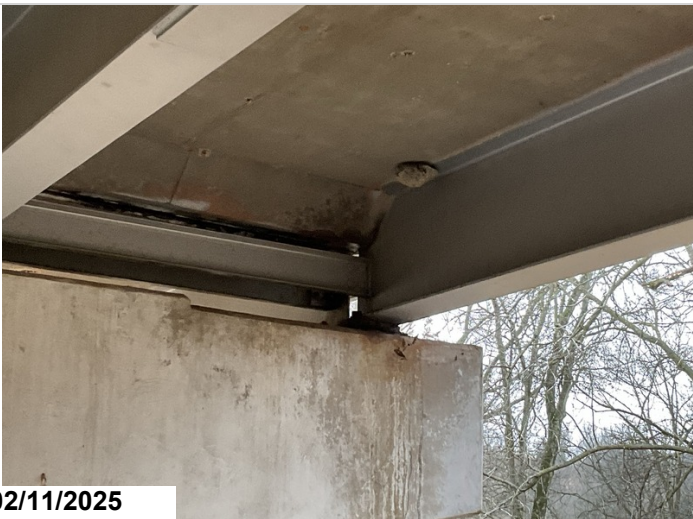
Overall, the bearings are in fair condition with pack rust due to leaking joints over bearings.

Spans 1 - 3, Bents 1 & 2, Girders 1 & 4: Moderate active corrosion with pack rust.

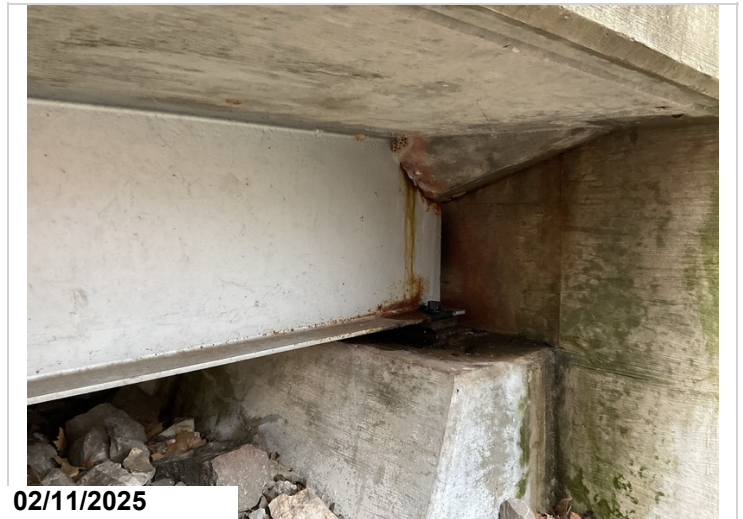
Abutment 1 & 2, Girders 1 - 4: Active corrosion with pack rust.

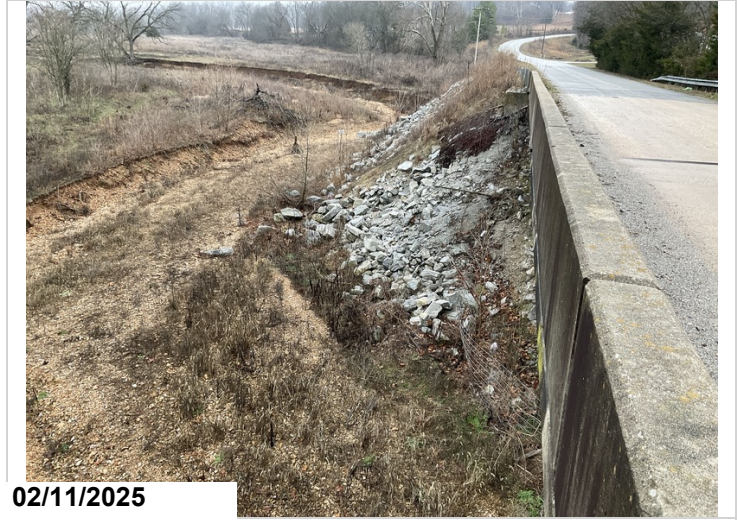
Overall, the scour condition is very good with large rock being placed to mitigate previous scour.

Large rock has been added to the channel.
