Bridge #22046(Routine)
CR 39-I (911=406) over POST OAK CREEK

Location: .75 Mi W of Rector

Team Lead: Richard Jones Inspection Date: March 01, 2021

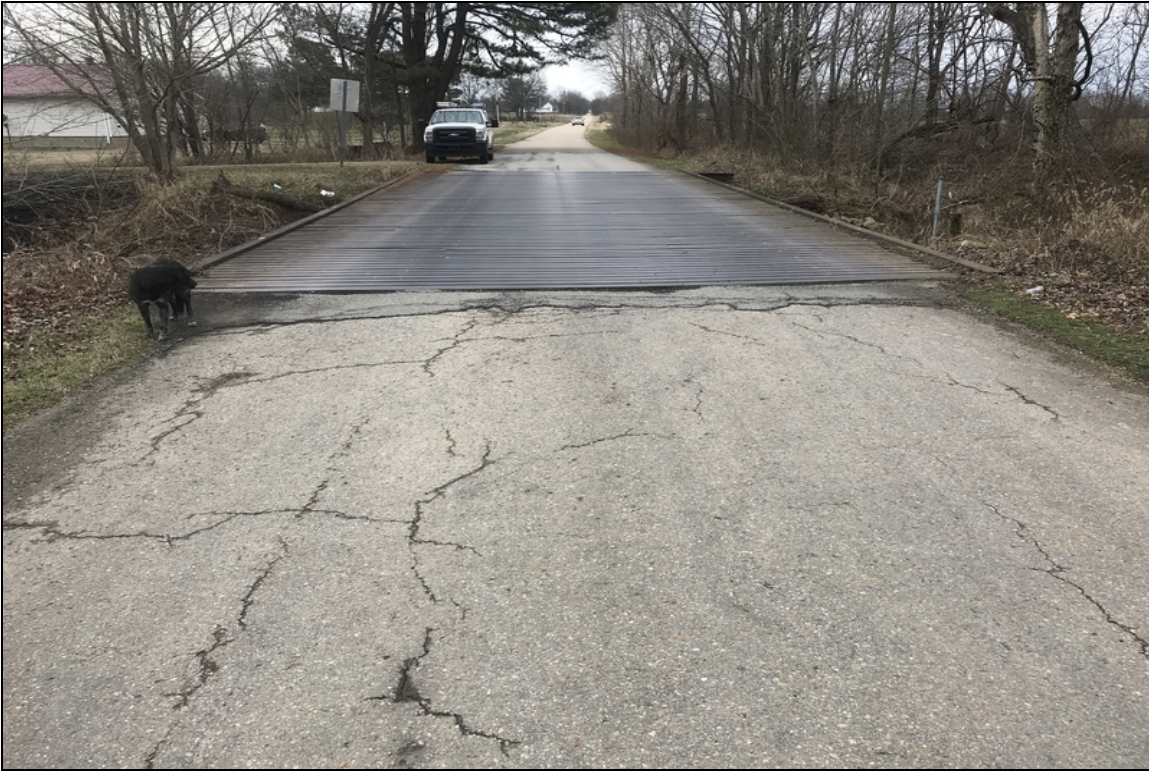
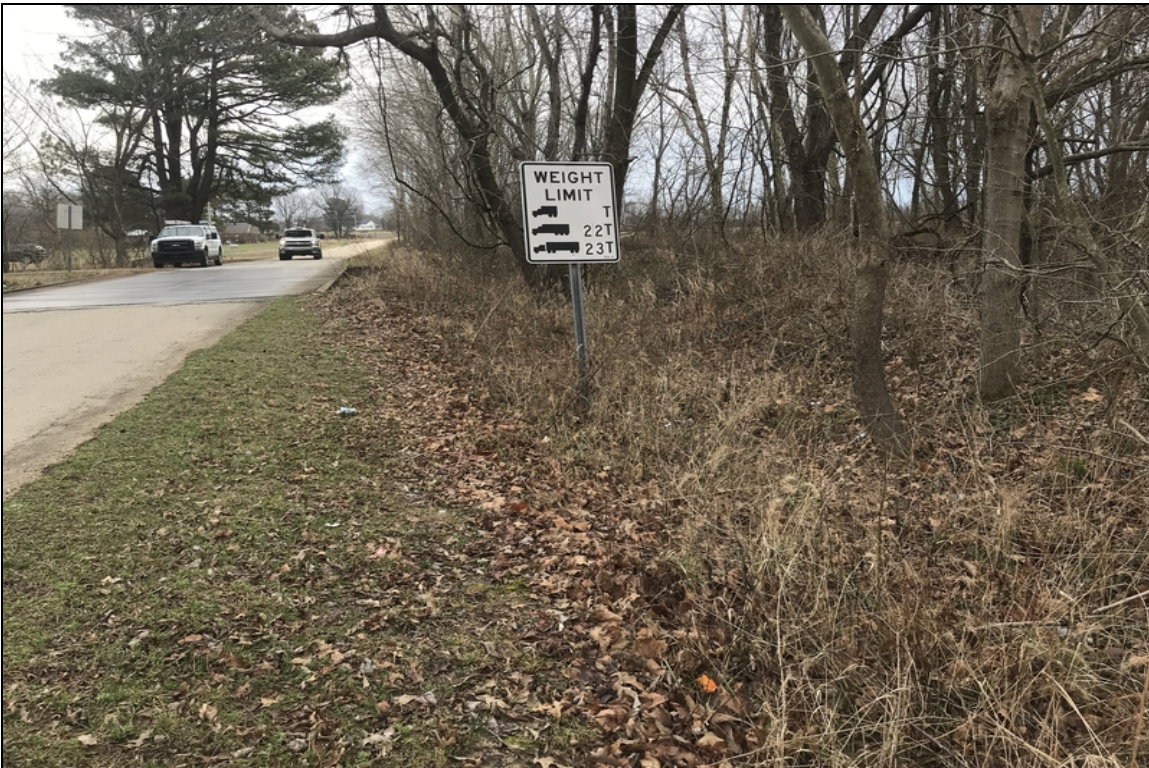
Load posting at beginning

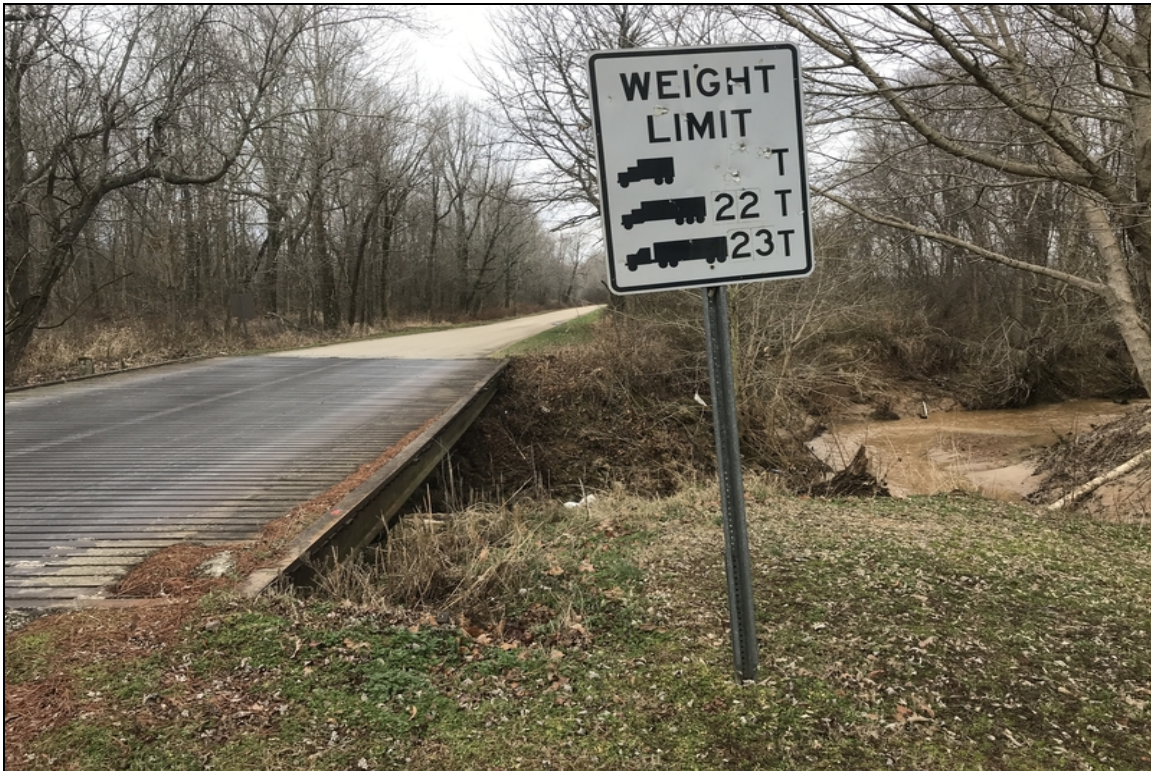
Load posting at end

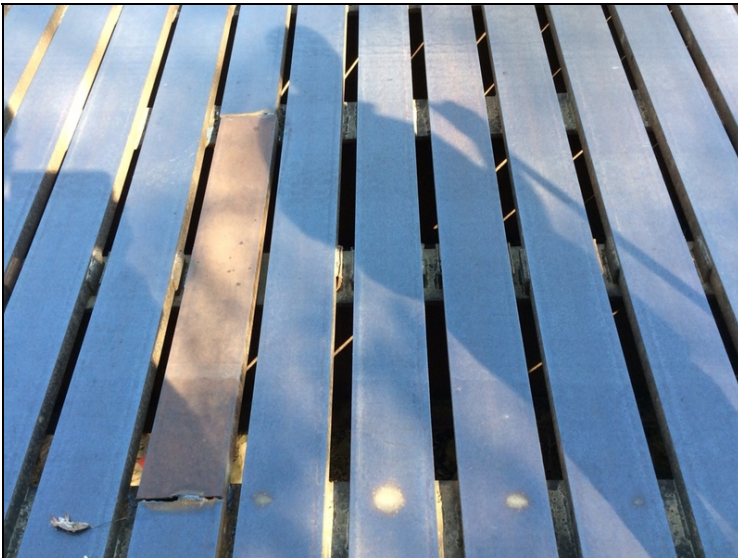
A few deck channels are cracked or have broken welds.

Several cracked welds at steel deck channels

Minor approach roadway settlement both ends.
Steel deck channels have surface rust throughout.
A few channels are cracked or have broken welds.

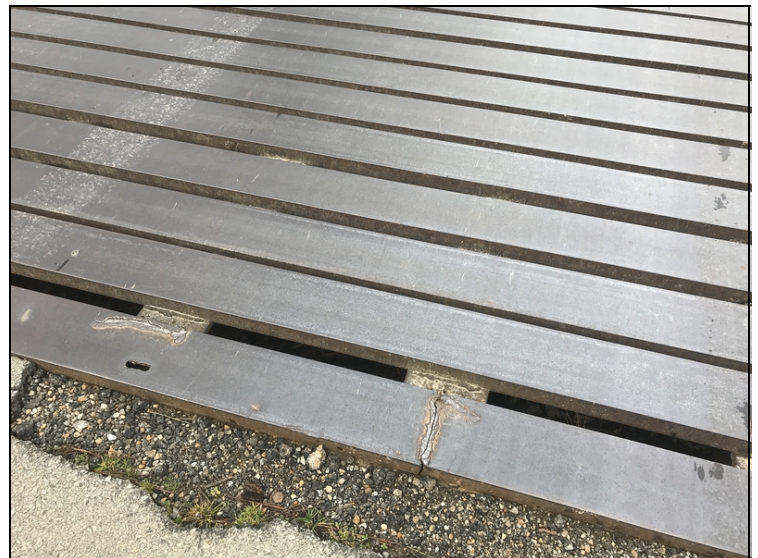
Cracked channels

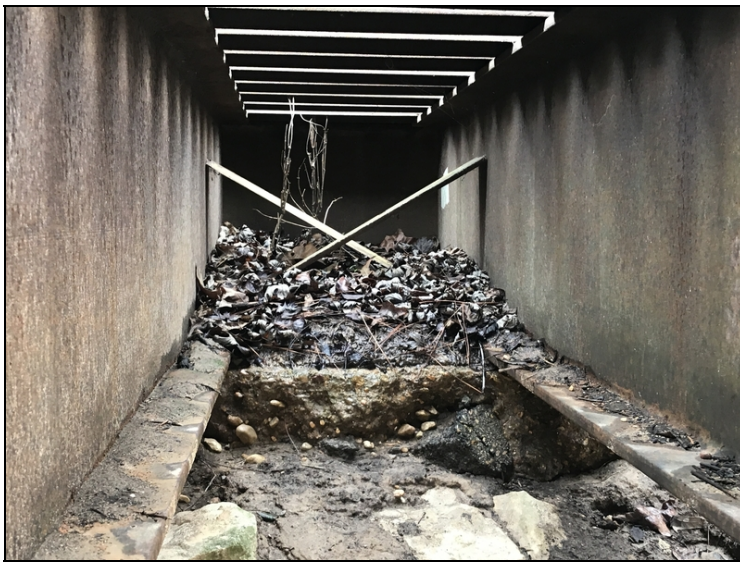
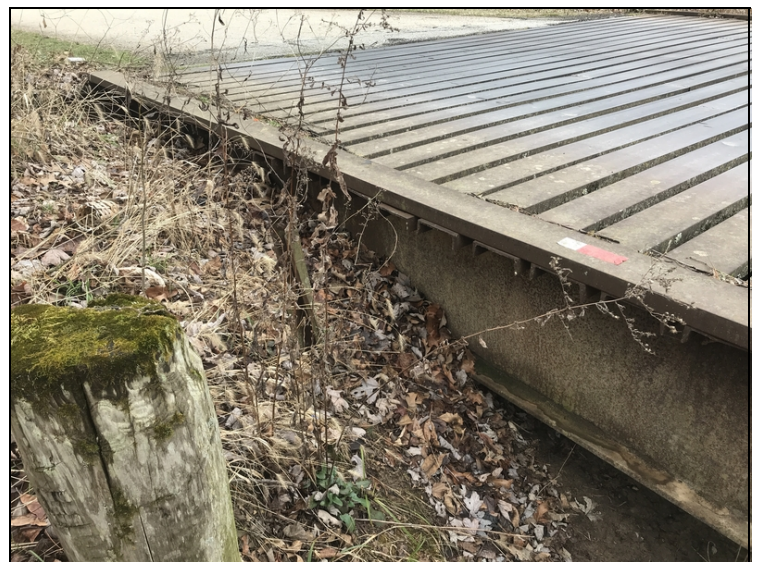
Ends of girders are covered with dirt and gravel.

Steel girders have surface rust throughout.
Ends of girders are covered with dirt and gravel.

Date Reported: 03/17/2021
Priority: D- Routine
Type of Work: Clean
Status: Open
Component: Superstructure
