Asset #04907 (Routine, Underwater type 2)
CR 53-I 911=450 over South Fork Big Creek

Location: 1 Mi E of CROCKETT

Team Lead: James Adams, Inspection Date: 06/21/2023

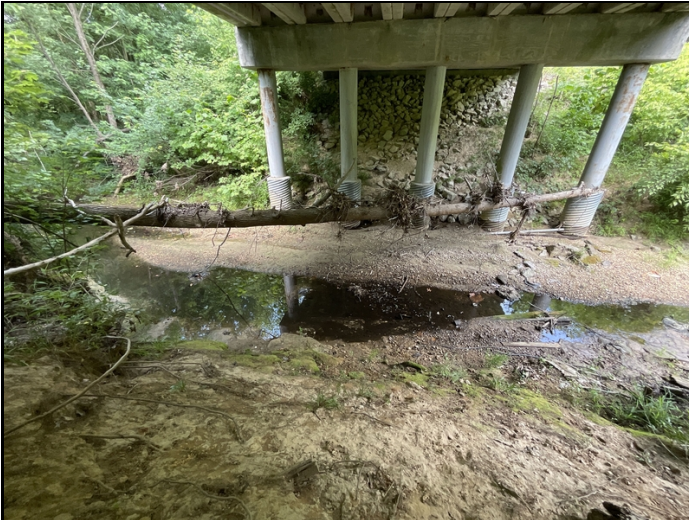
Log across span 2 channel.

Span 2 tree

A-64 - Vegetation Removal Requested (Yes)

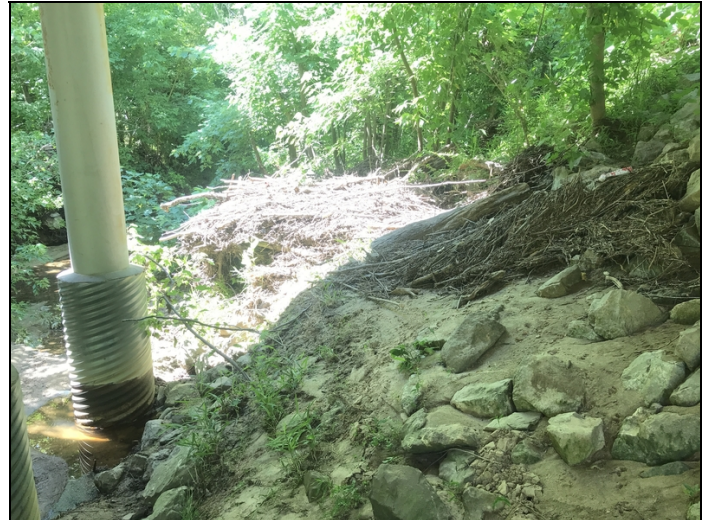
Minor erosion & drift under span 1.

Minor drift under span 1.

Span 1 drift

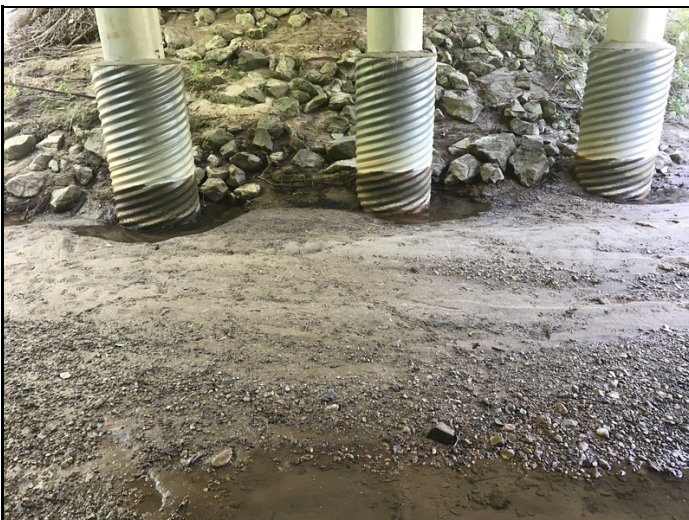
Some section loss to pile encasements at bent 2 near ground line.

Minor scour around bent 2 pile encasements.

Bent 2 encasement

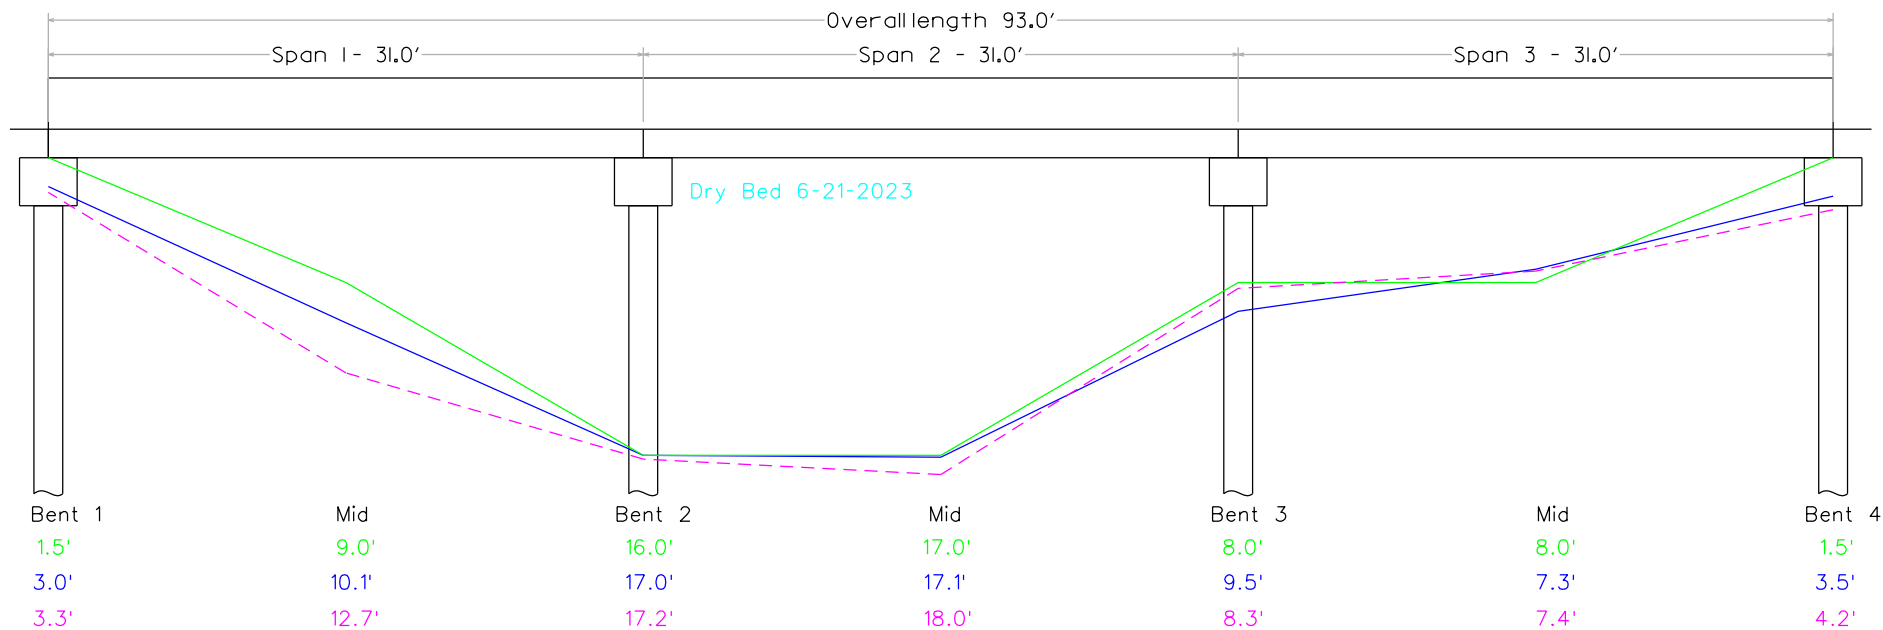
Channel sounded from top of deck downstream (RT) side

Green line readings taken on 9-24-2009

Pink dashed-line taken 6-21-2023
