Bridge Inspection Report

04380
CR 47-C (911=905)
over
MURRAY CREEK

Structure Number: 04380

Facility Carried: CR 47-C (911=905)

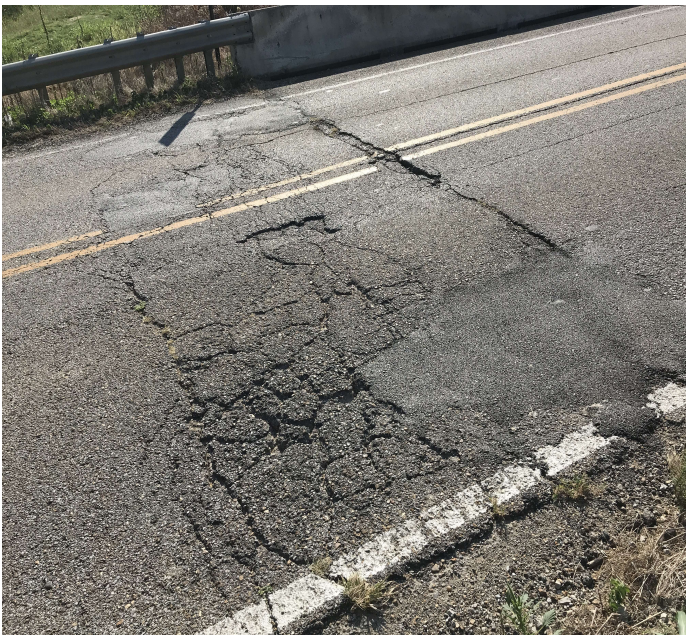
Approach roadways have settlement at each end of bridge. Approaches have cracks, potholes and a few patched areas.

PHOTO 1 Description Approach roadway
