Bridge Inspection Report

04381

**CR 47-C(Rogers Ch)
over
BRIDGER CREEK**

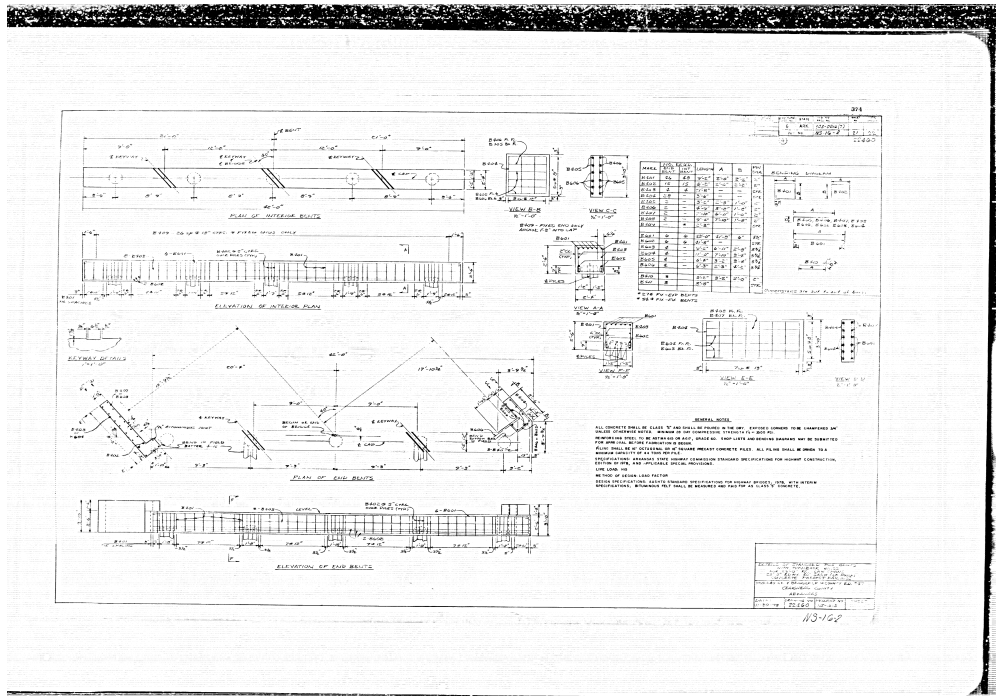
PHOTO 3

Description Layout

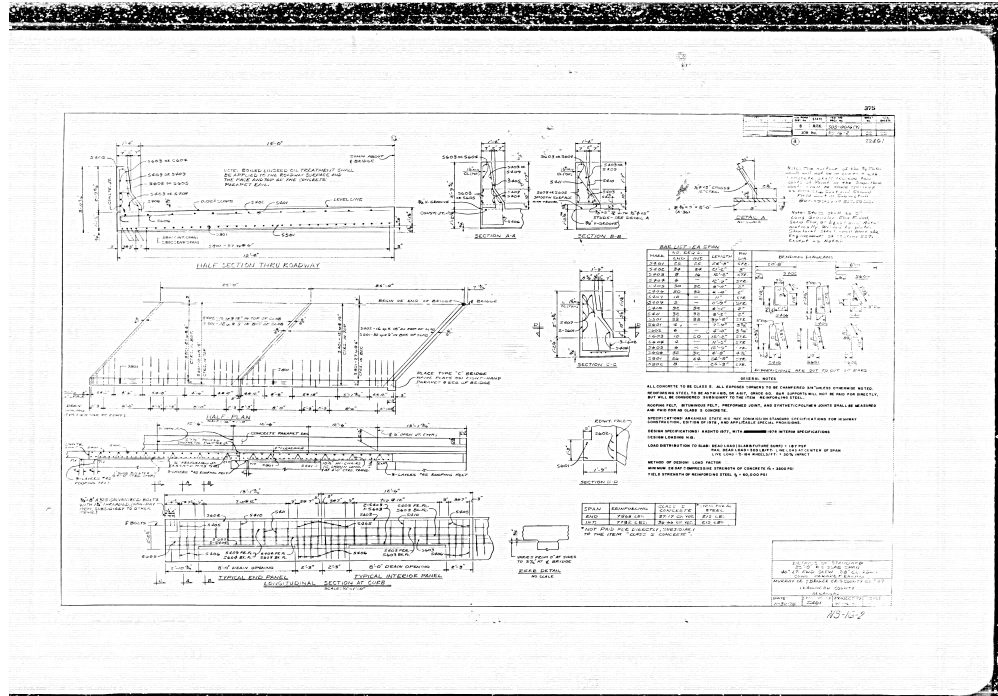
PHOTO 5

Description slab details

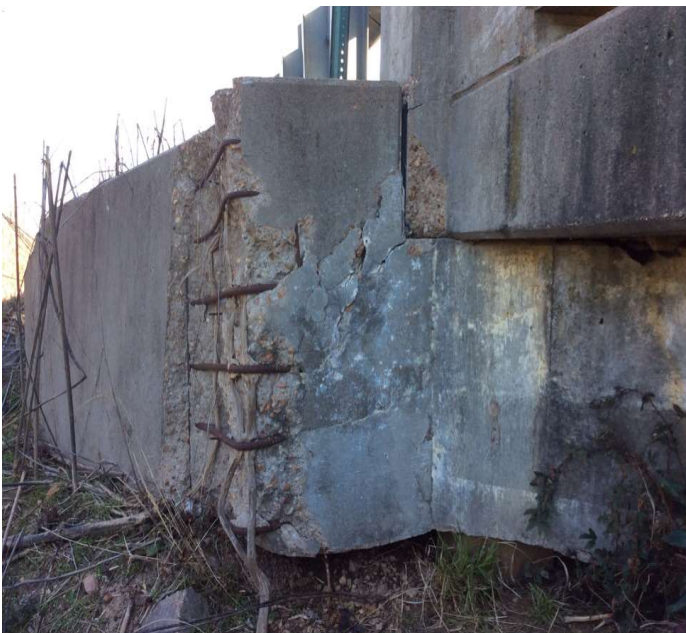
PHOTO 1 Description Bent 1 Rt

Northwest concrete wing wall
Wing wall has a large spalled area with exposed rebar.

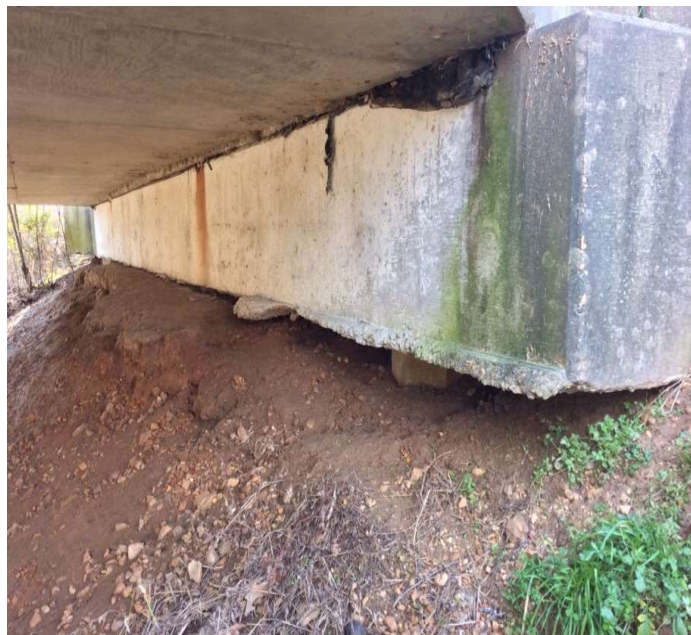
PHOTO 1 Description Bent 4 abumtent

Minor embankment erosion has undermined Lt end of bent 1 abutment up to 2' down and 2' back under. Bent 4 abutment is undermined for approximately 12' on each end up 2' below and 3' back under.
