Asset #22133(Routine, Underwater type 2)

CR 856-A over DRAINAGE DITCH

Location: 2.5 MI W OF CARAWAY

Team Lead: Brandon Sutton, Inspection Date: 07/05/2023

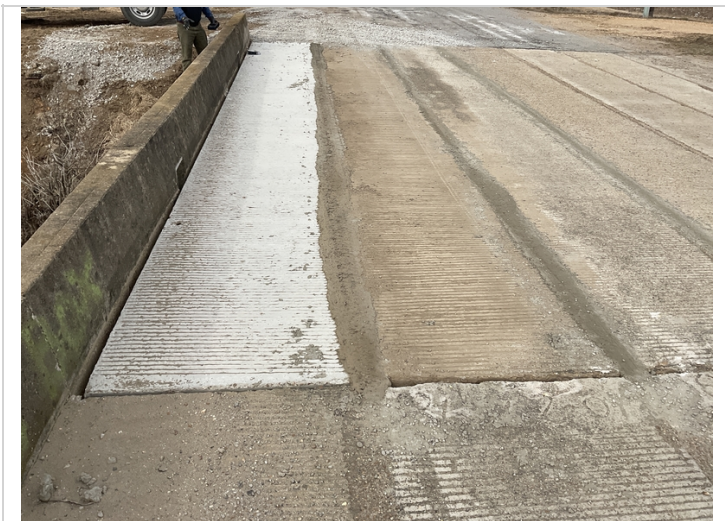
Span 2 unit 3 was replaced with span 2 unit 2, span 2 unit 2 was replaced with span 2 unit 1, and span 2 unit 1 is a new unit. Grout was replaced around units 2 and 3.

Span 2 unit 1 NEW
Span 2 unit 2 was moved from unit 1 position

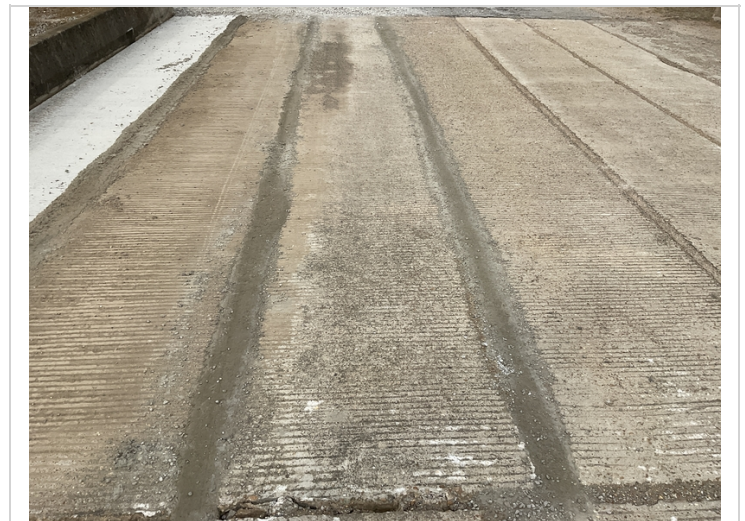
Span 2 unit 3 has a few small spalls on end.

Span 2 unit 3 was moved from unit 2

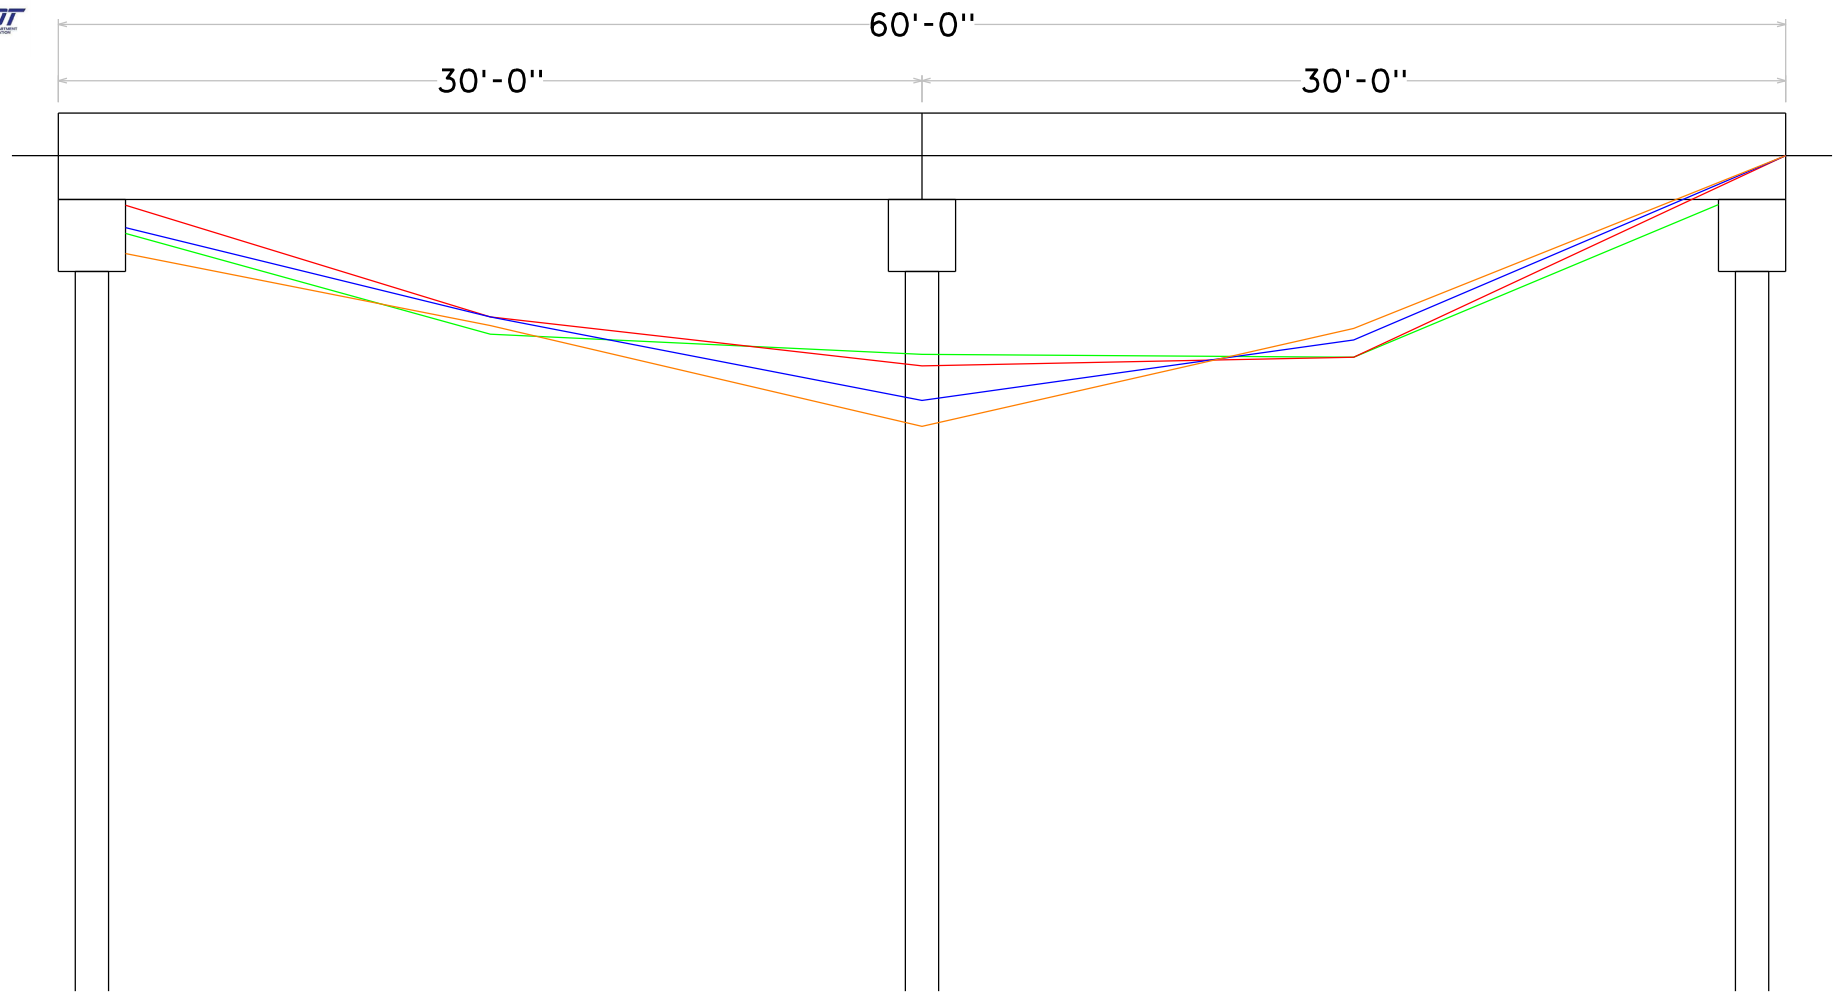
Bent 1
2.7'
1.0'
2.5'
3.4'

Mid
6.2'
5.6'
5.6'
5.9'

Bent 2
6.9'
7.3'
8.5'
9.4'

Mid
7.0'
7.0'
6.4'
6.0'

Bent 3
1.7'
0.0'
0.0'
0.0'

Channel profiled from top of deck on Lt side (downstream side)
 Green soundings taken on 10/13/1999
 Red soundings taken on 9/15/2011
 Blue soundings taken on 7/2/2019
 Blue soundings taken on 7/5/2023
