Asset #23074(Routine)

CR 494-D (911=745) over Creek

Location: .4 M S Jct. Pine Log Rd.

Team Lead: James Adams, Inspection Date: 08/24/2022

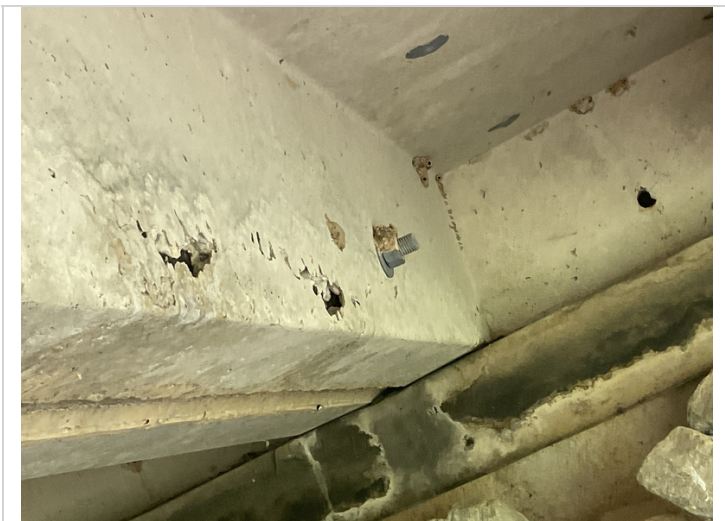
Unit 2 has a honeycombed area with exposed rebar near bent 1.

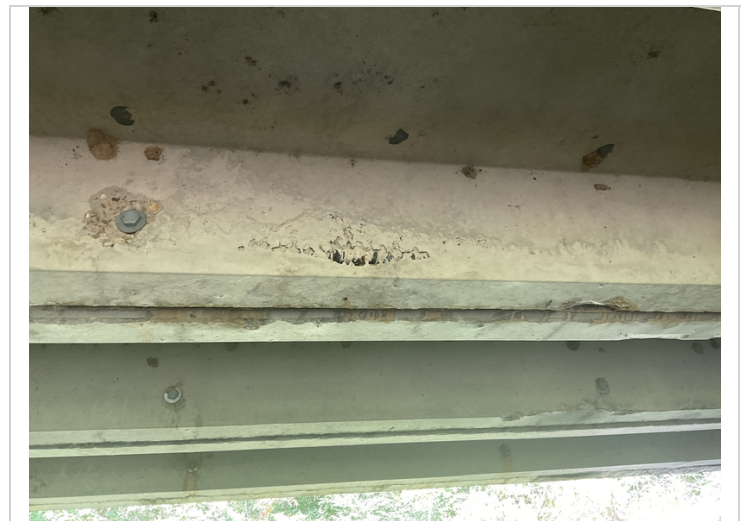
Unit 6 has a honeycombed area with exposed rebar near mid span.

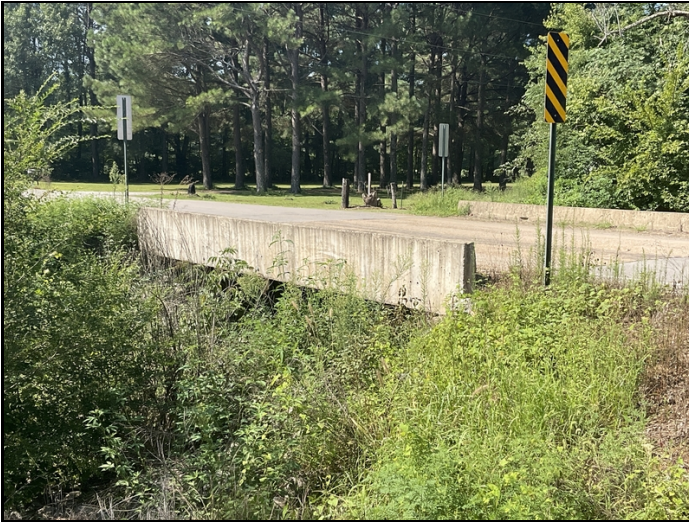
Brush & small trees growing under, beside bridge & on channel banks.

Type of Work: (Inactive) (Inactive) 1 - Clean

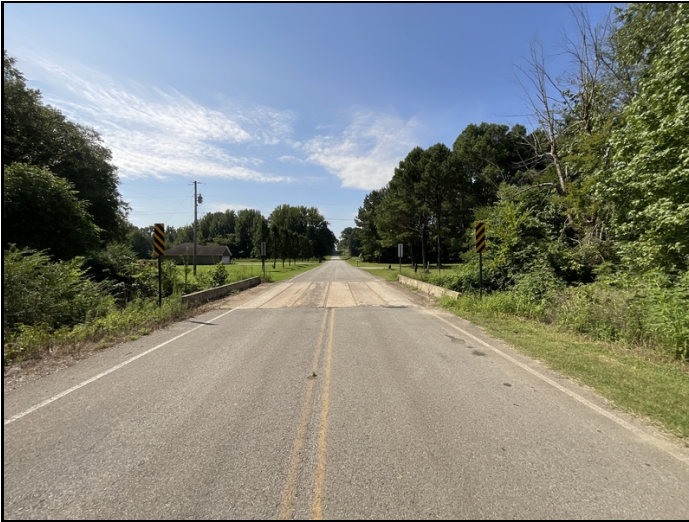
Dirt & debris buildup in gutterlines blocking deck drains.

Type of Work: (Inactive) (Inactive) 1 - Clean
