Asset #23258(Routine)

CR 62-D (911=745) over Creek

Location: 1.2 Mi S of Pine log Rd

Team Lead: James Adams, Inspection Date: 01/04/2023

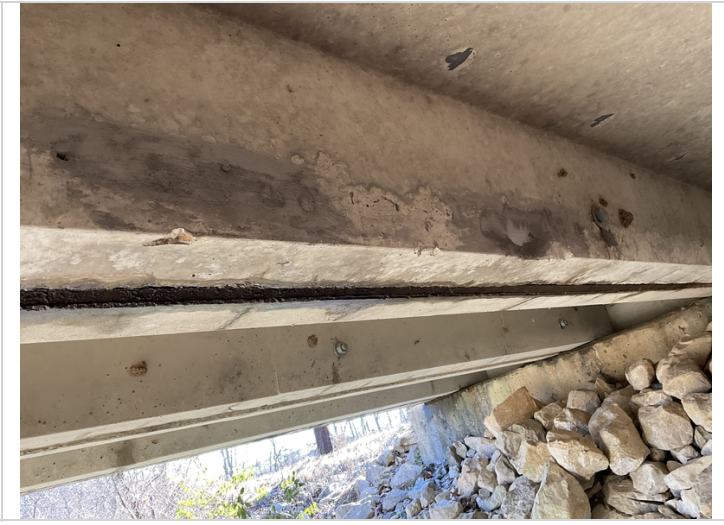
Unit 3 grouted 1-4-2023

A few units have honeycombed areas, some have exposed rebar. These areas have been grouted since previous inspection.

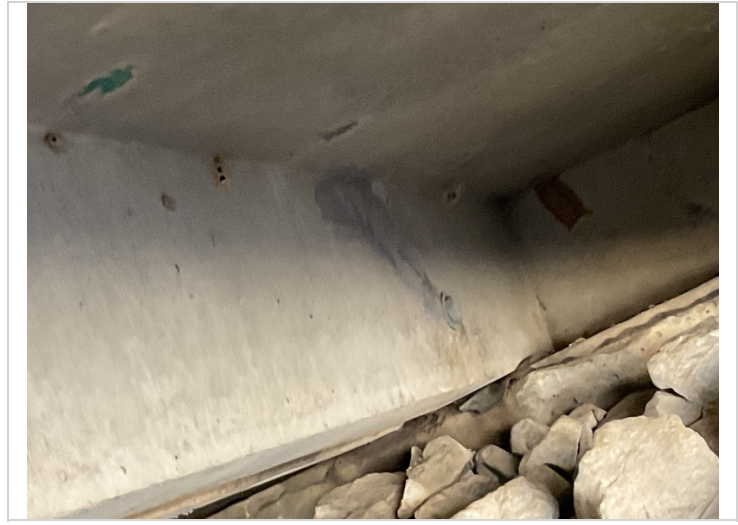
Unit 7 grouted 1-4-2023

Units 5, 6, and 7 have hairline to minor sized diagonal cracks with efflorescence at transverse bolt connections on left leg near bent 2. These cracks have been grouted since previous inspection.

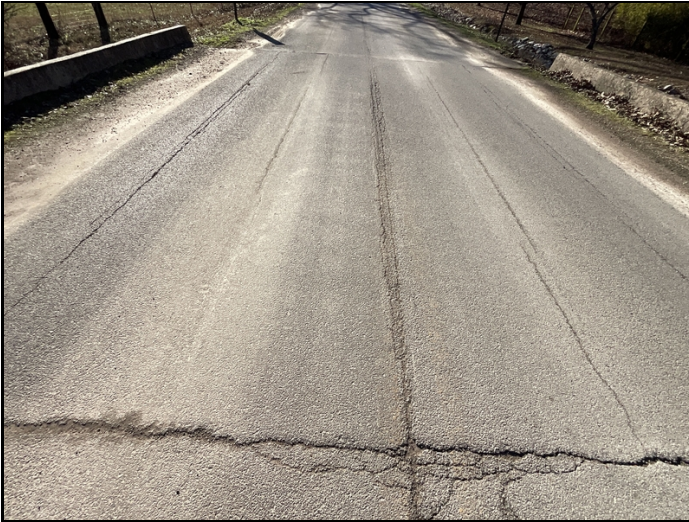
Deck 1-4-2023

Asphalt wearing surface has longitudinal cracks along joints between units, especially at centerline.
