Asset #23498(Routine)

CR 481-D (911=745) over Creek

Location: 1.4 MI S OF SCHOOL ST

Team Lead: James Adams, Inspection Date: 08/11/2022

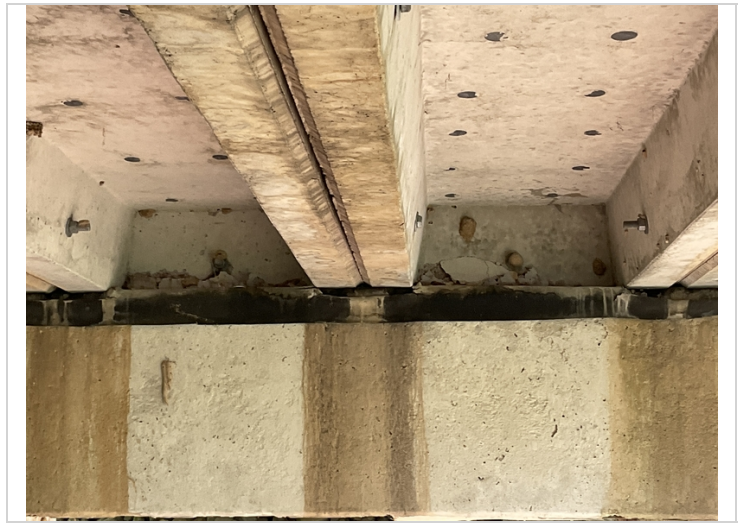
Span 2 Bent 2 unit 4&5 8-11-22

Span 1 unit 5 over bent 2 has an impending spall or crack in end diaphragm.

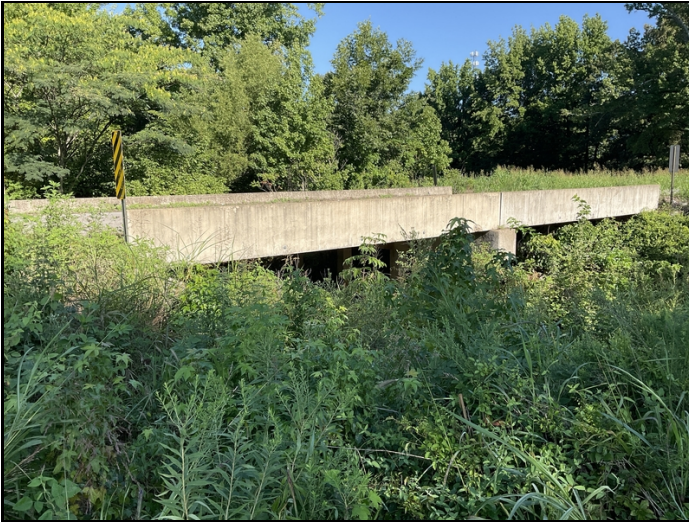
Elevation 8-11-22

Trees and brush in channel & under bridge restricting flow.

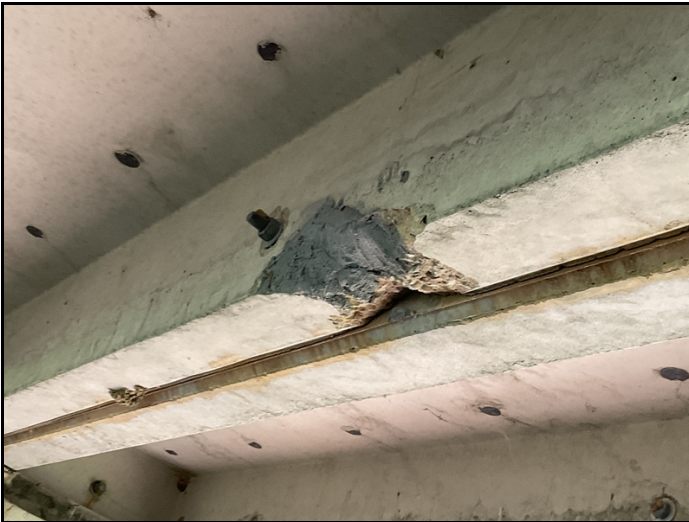
Span 2 unit 7 has a spall with 1ft. of exposed rebar near mid span that has been covered with grout.

*Span 2 unit 7 has a spall with 1' of exposed rebar near mid span.

Has been covered with grout, observed at inspection 08/11/2022 JFA/CWS

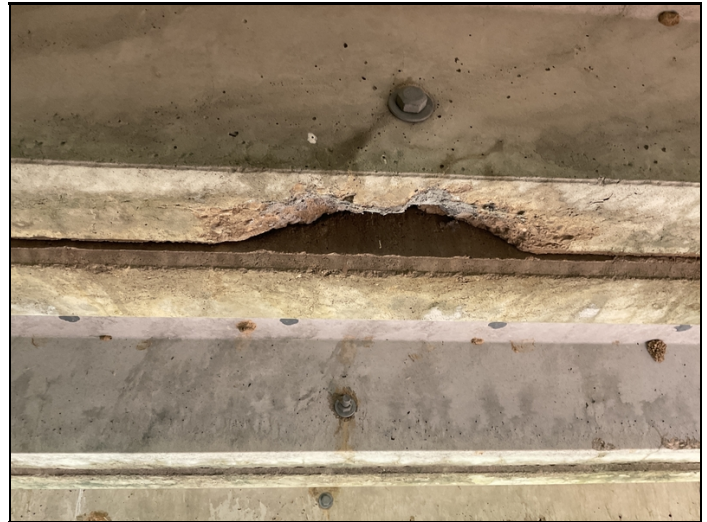
Span 1 unit 4 has a 4.5in. deep spall with 1ft. of rebar exposed near mid span.

Span 1 unit 4 has a 4.5" deep spall with 1' of rebar exposed near mid span.

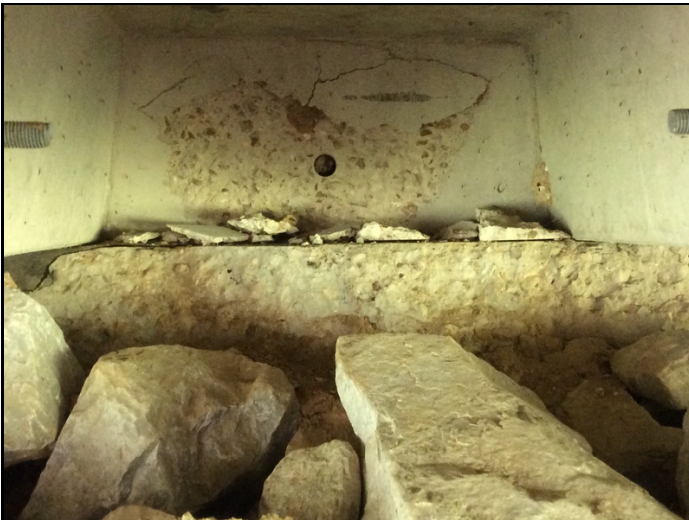
Bent 1 abutment has a 3.5' spall under unit 5.
