Asset #24204(Routine)

CR 745 over creek

Location: 1.0 MI S OF SCHOOL ST

Team Lead: Brandon Sutton, Inspection Date: 09/11/2023

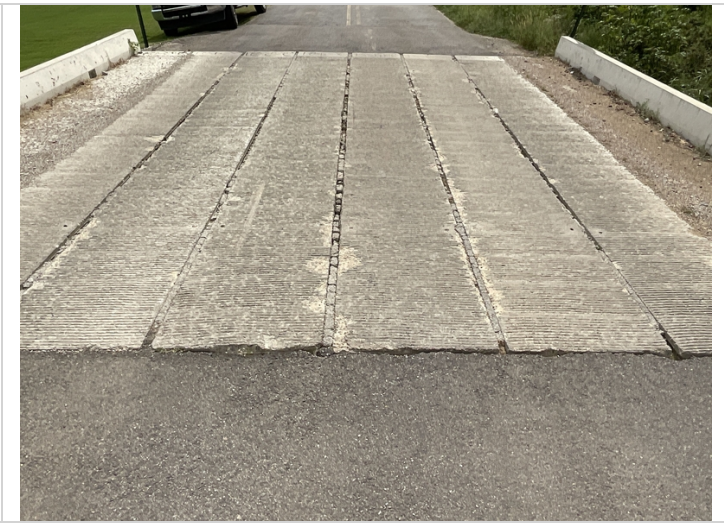
Shear key grout

Shear keys grout between units 2 through 7 are broken and ineffective. Grout between units 1 and 8 is in good condition.

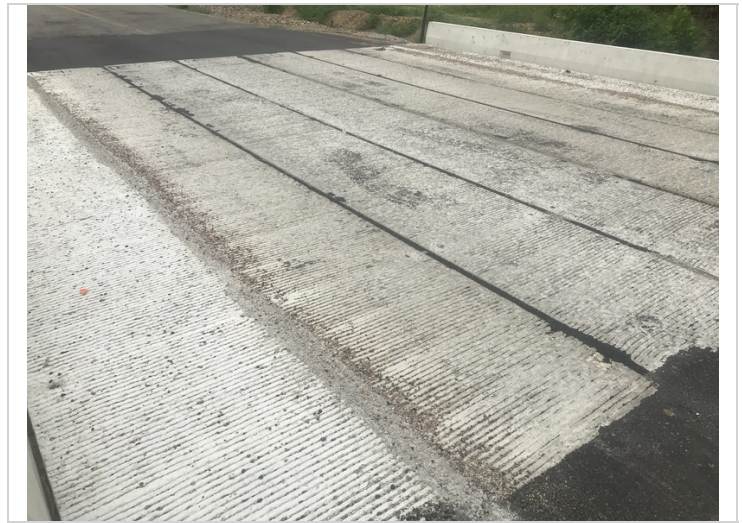
58 - Deck (7 - GOOD CONDITION - some minor problems.)

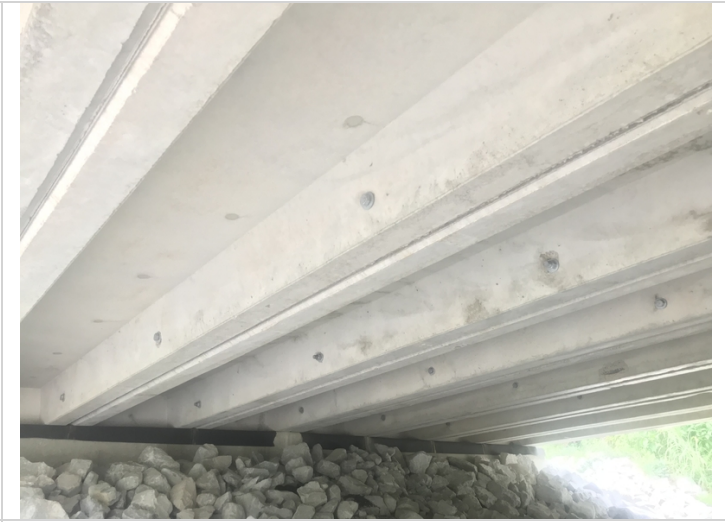
Soffit

Girder portion of units are in good condition with a few minor chips and spalls. A few transverse bolt connections are loose.

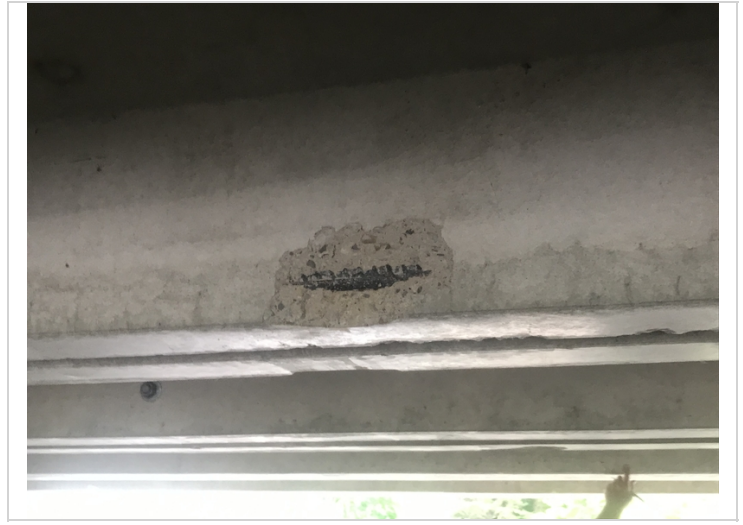
Unit 5

Span 1 unit 5 right leg has a 1' spall with exposed rebar at midspan.

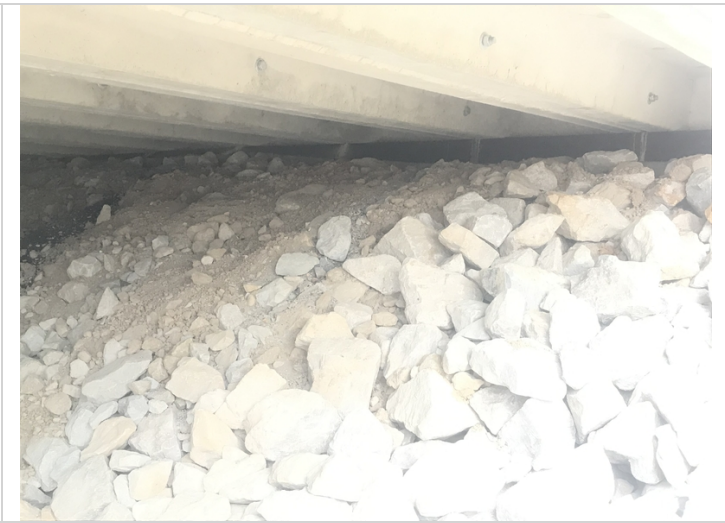
Bent 1

Abutments are in very good condition. Faces are only available for inspection.

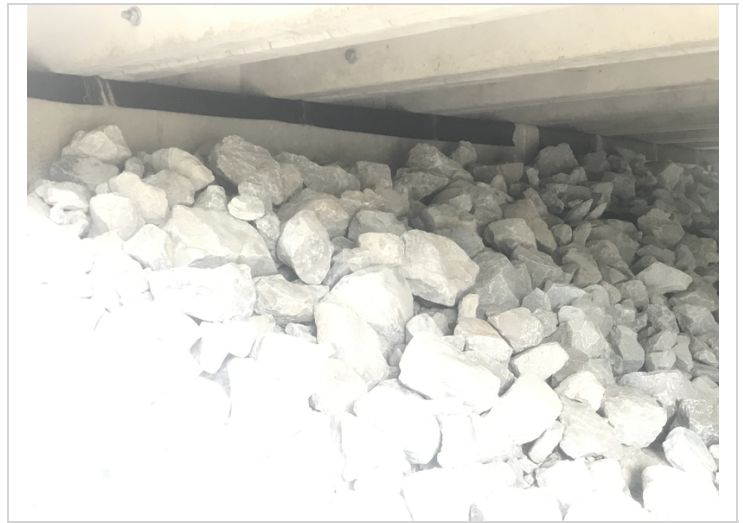
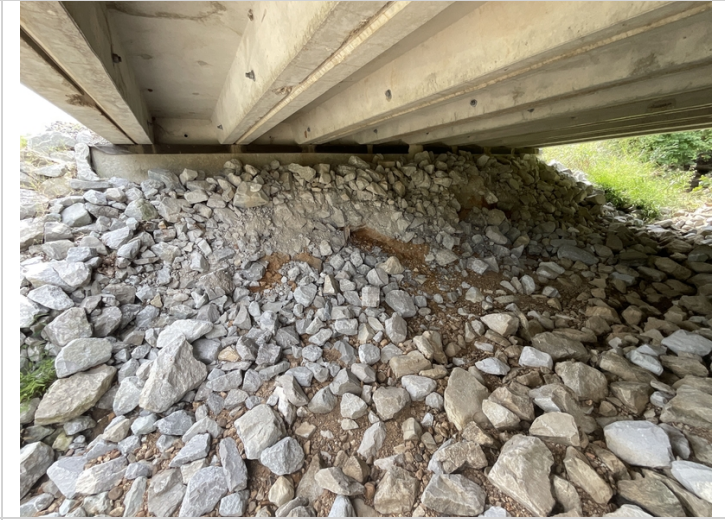
Bent 2 has some embankment erosion, displacing some rip rap.

Comment: Bent 2 has some embankment erosion, displacing some rip rap.
