Asset #22101(Routine, Underwater type 2)

CR 872 - A over DITCH NO 2

Location: 2.0 MI SW OF CARAWAY

Team Lead: Brandon Sutton Inspection Date: 05/01/2024

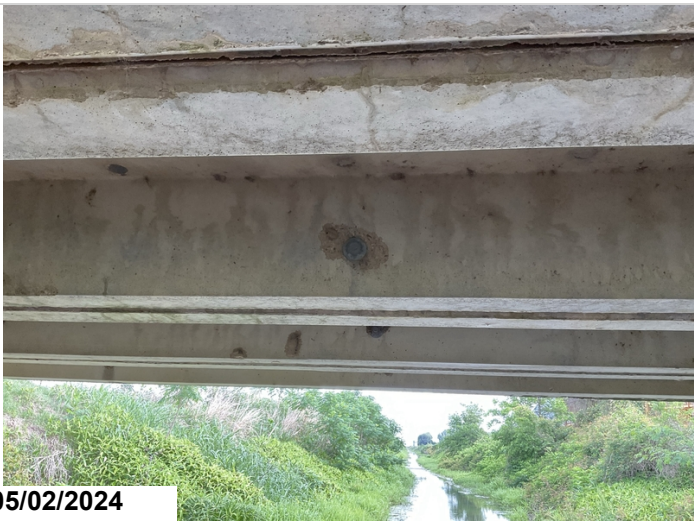
Left and right legs of precast units has several minor flexure cracks, some have light efflorescence. Legs have minor spalls, especially at transverse bolt connections.

Span 2 unit 6 spall at transverse bolt connection (typical).

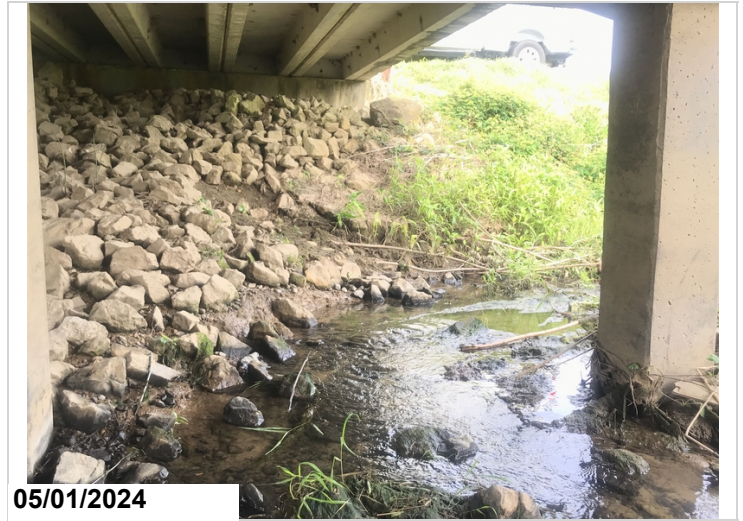
Span 2 right side has some embankment erosion and rip rap displacement

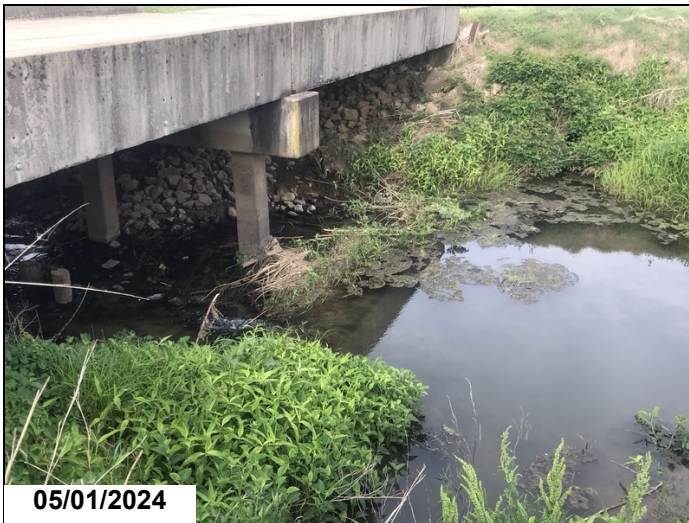
Channel has a beaver dam spanning across the entire channel.

Beaver dam upstream from bridge

**Maintenance Needs**

**Priority:** C - Important

**Type of Work:** Channel Work/Drift Removal

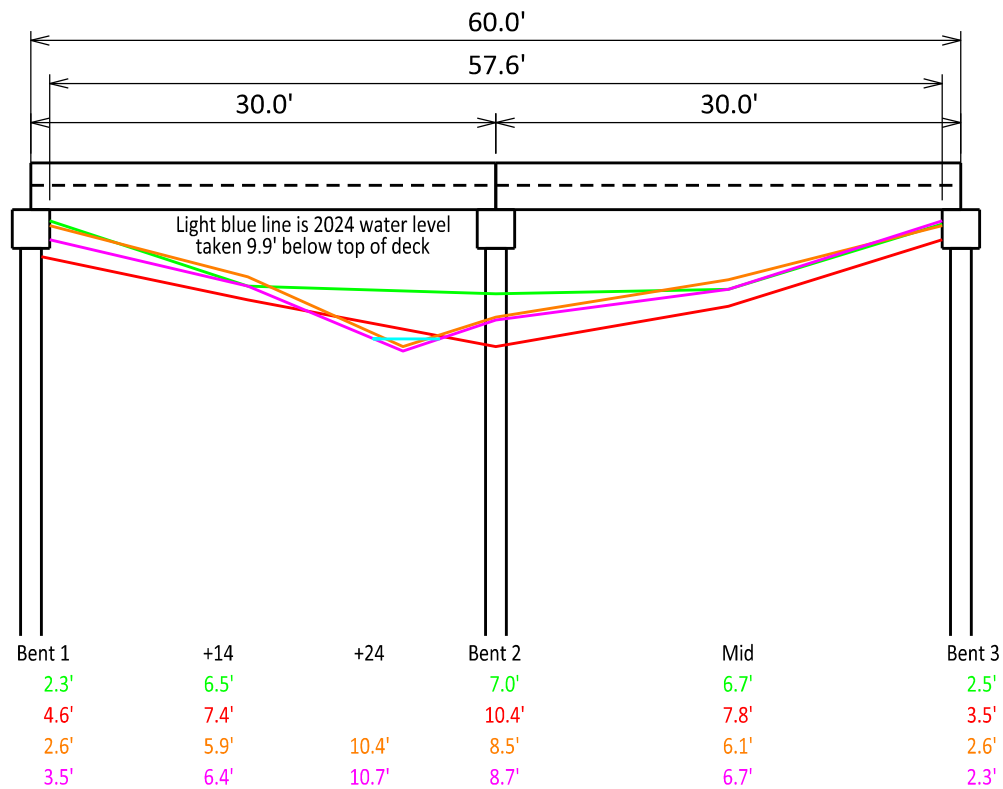
Channel profiled from top of deck on Lt side (downstream side)

Green line and soundings taken on 6/15/1999

Red line and soundings taken on 8/1/2016

Orange line and soundings taken on 5/19/2020

Pink soundings taken on 05/01/2024
