Asset #22902(Routine, Underwater type 2)

CR. 872- A over Drainage Ditch

Location: 2.5 Mi S & 2 Mi W Caraway

Team Lead: Brandon Sutton Inspection Date: 05/01/2024

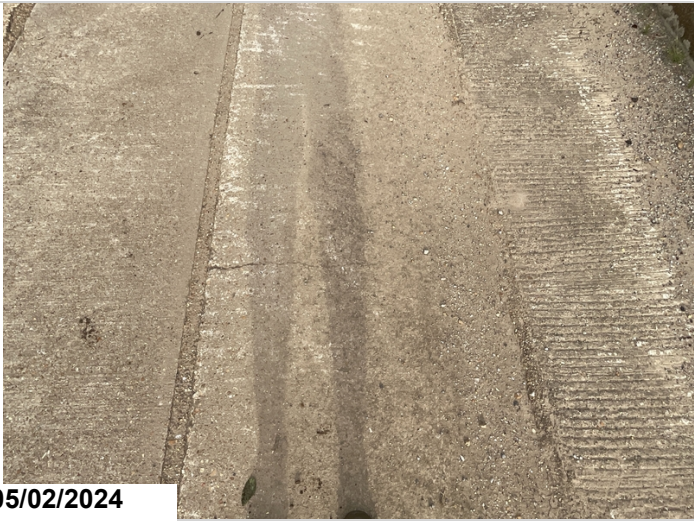
Span 1 unit 7 has a transverse crack near mid span. Under surface portion has efflorescence.

Span 2 unit 7 top flange crack

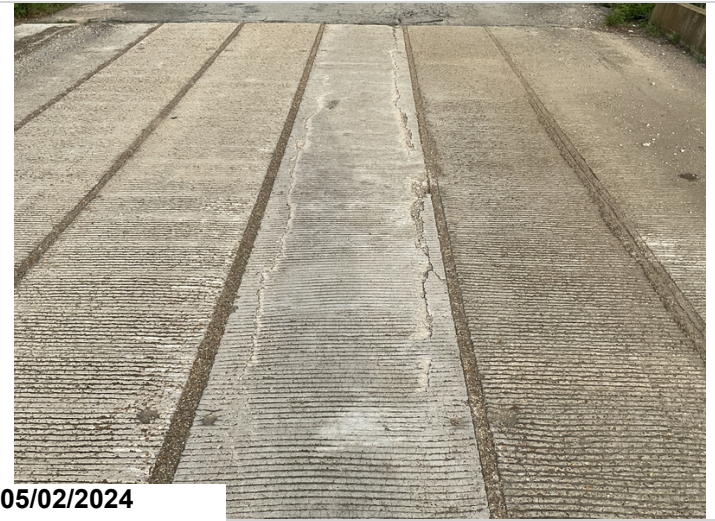
Span 2 units 5 and 6 have a few spalled and/or delaminated areas along shear keys.

Span 2 unit 5 top flange delaminated areas

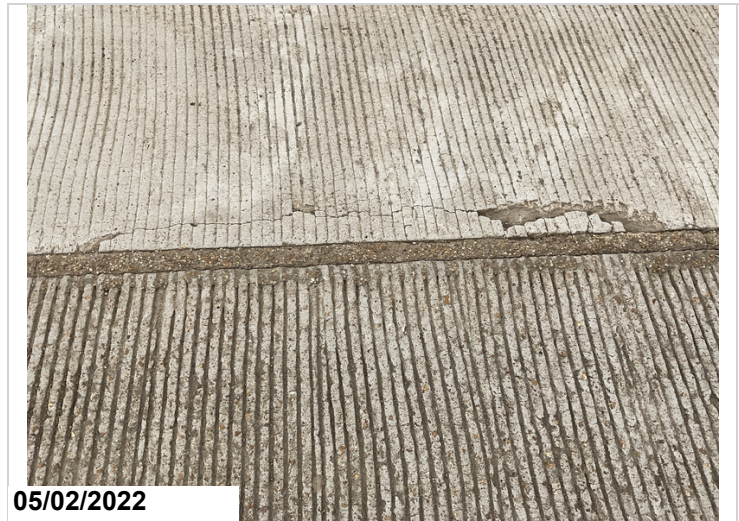
Span 2 unit 5 has minor sized map cracking.

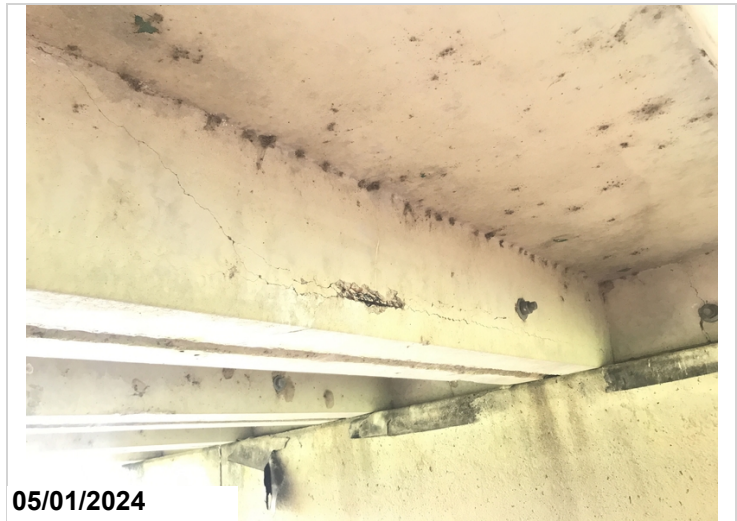
Span 2 unit 5 right leg has a 1' spall with exposed rebar. 5' of leg is cracked.

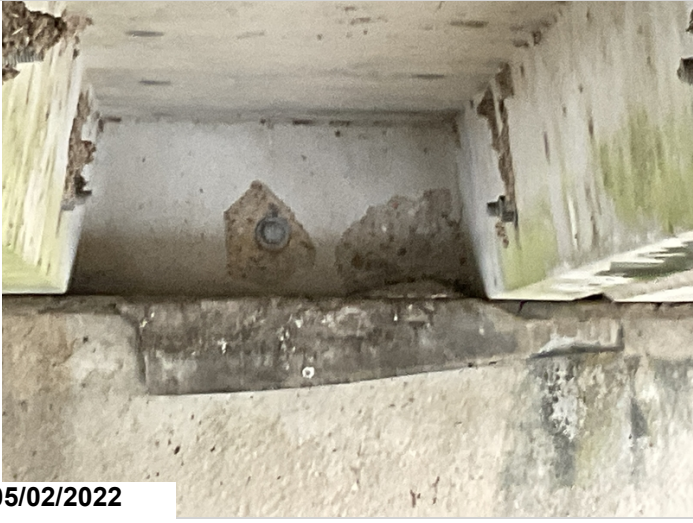
Span 1 unit 7 at bent 2

Span 1 unit 7 has a spall with exposed rebar in diaphragm portion of unit.

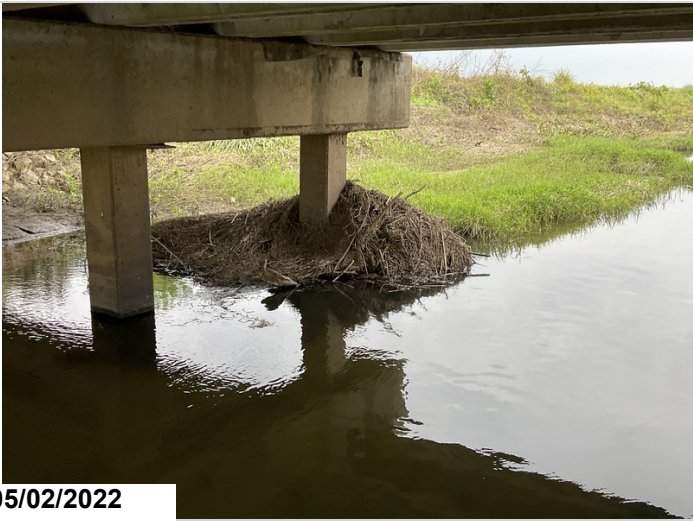
Bent 2 has minor drift buildup.

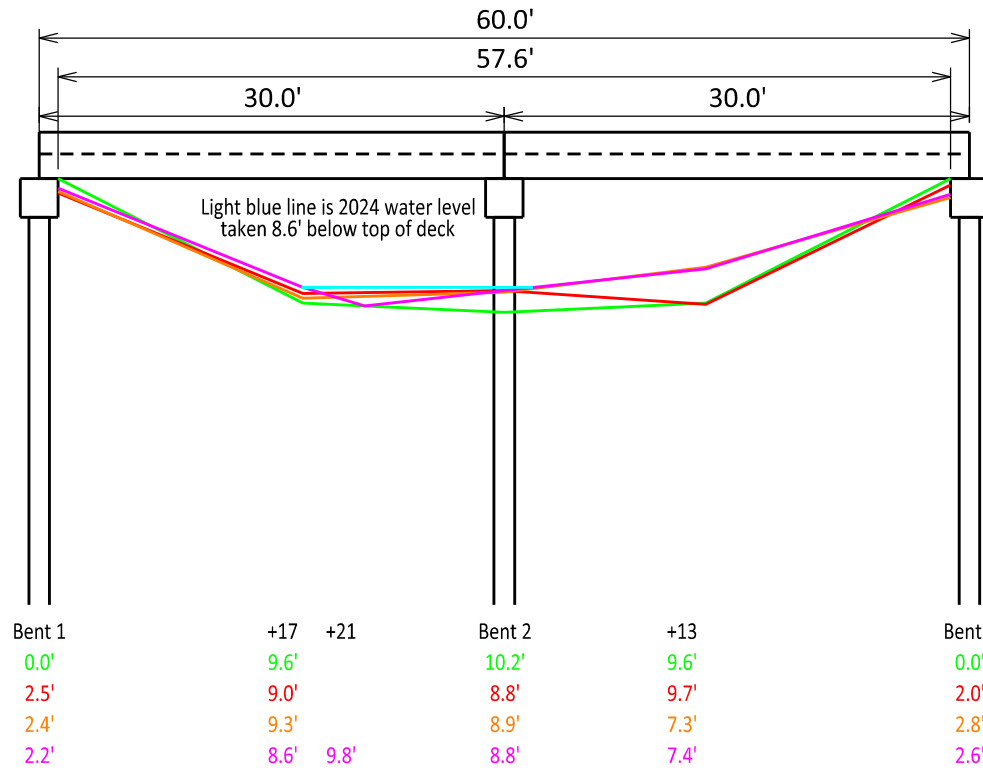
Channel profiled from top of deck on left side (downstream side)

Green line and soundings taken on 5/30/2006

Red line and soundings taken on 5/8/2012

Orange line and soundings taken on 5/19/2020

Pink soundings taken on 5/01/2024
