Asset #23814(Routine, Underwater type 2)

CR 874-A over Honey Cypress Ditch

Location: 2 miles South of Caraway

Team Lead: Brandon Sutton Inspection Date: 08/07/2023

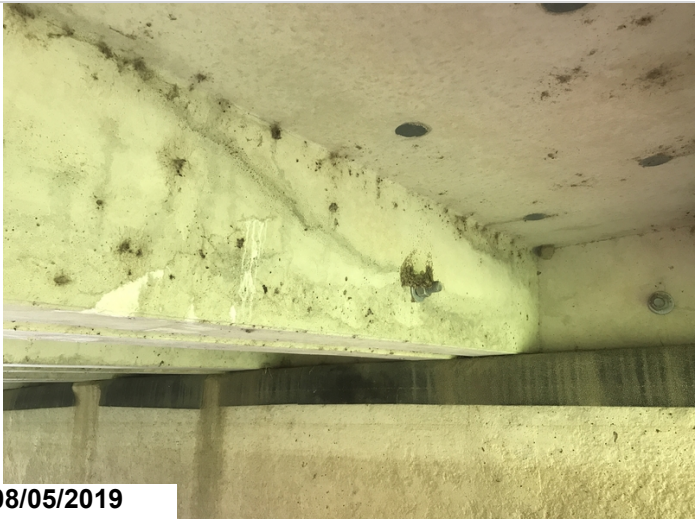
Precast units have several minor flexure cracks, some with light efflorescence. A few units have hairline diagonal cracks.

Typical diagonal cracks

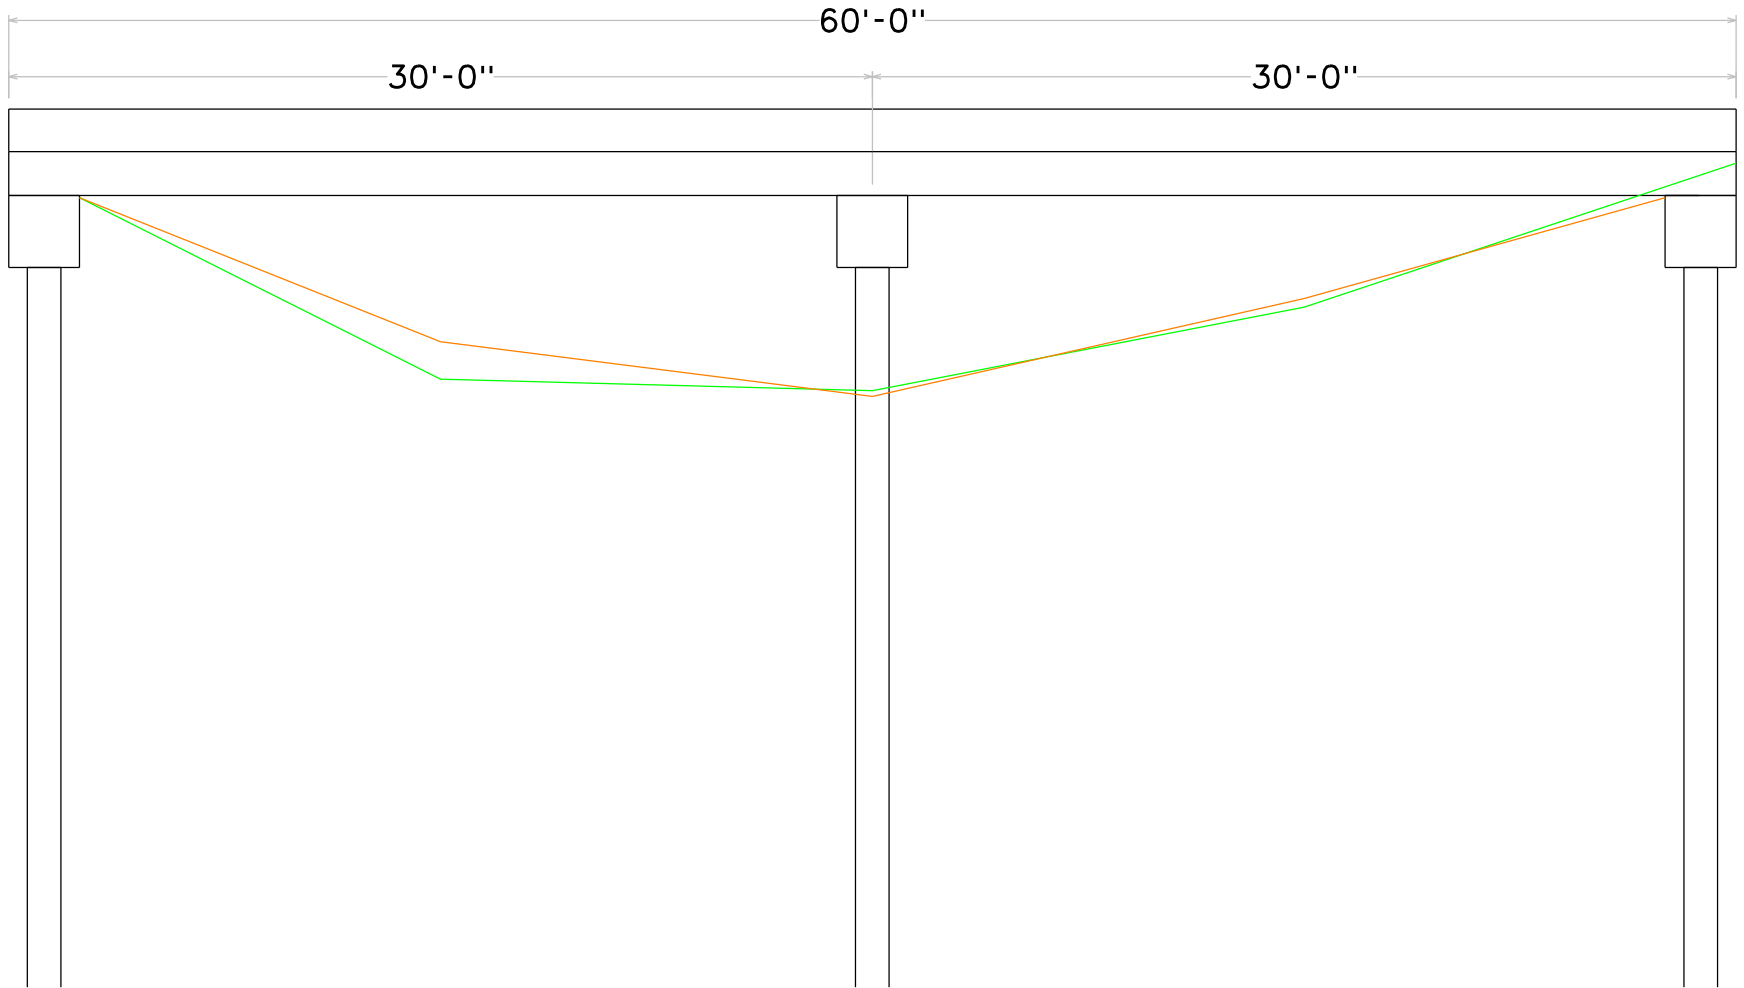
Channel profiled from top of deck on Lt side (down stream side)
Green soundings taken on 8/5/2019
Orange soundings taken on 8/7/2023
