Bridge 21161 Inspection Report

Asset #21161(Routine, Underwater type 2)

CR 324 - E over BIG CREEK DITCH

Team Lead: Richard Jones Inspection Date: 02/02/2026

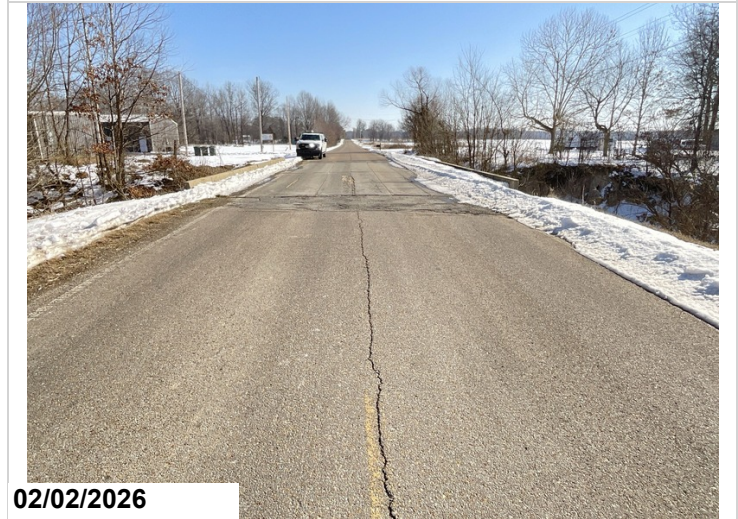
Approach roadways were shimmed in the past, but still have minor settlement.

Roadway

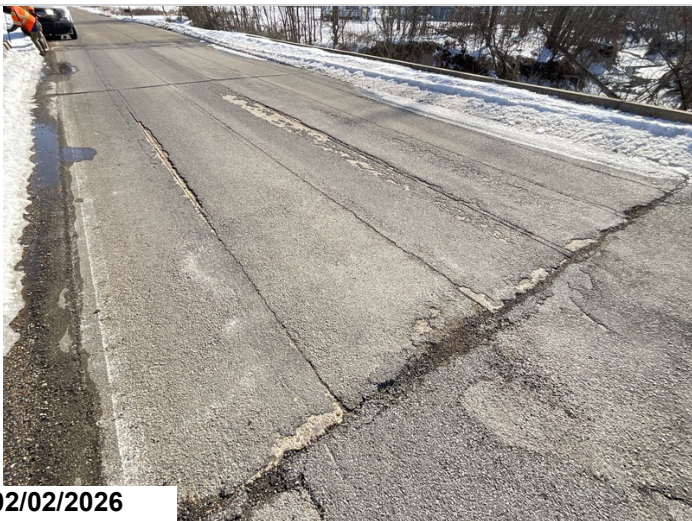
Wearing surface has cracks over joints between units and several spalled areas.

Wearing surface

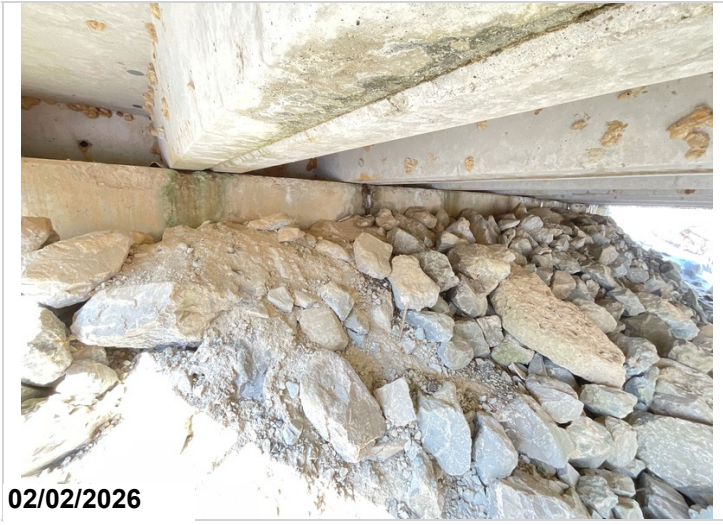
Legs of precast units have several minor flexure cracks and a few minor chips/spalls.

Bent 3 cap has a few minor spalls under units.

Minor chips/spalls under units

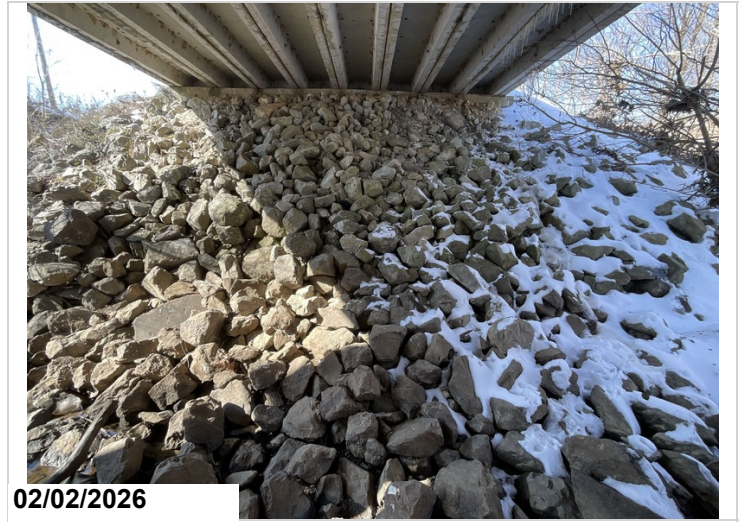
Stone riprap and broken concrete were placed on slopes after 2018 inspection. Span 2 slope has had some minor erosion since then.

Bent 1 slope

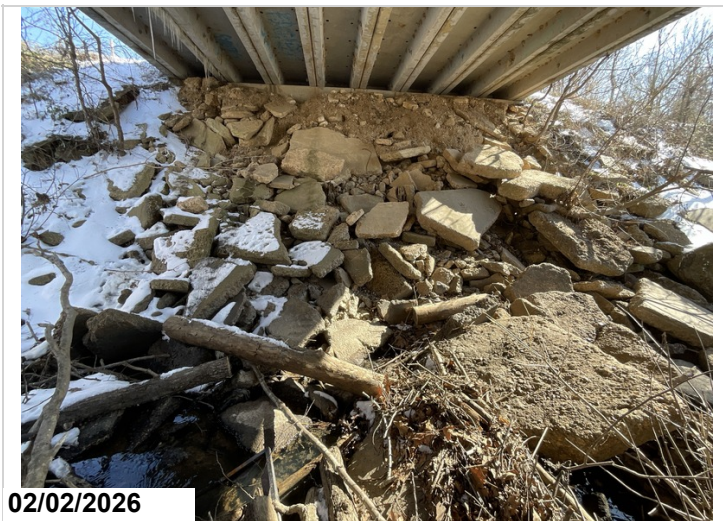
Bent 3 abutment left end has some undermining.

Bent 3 slope

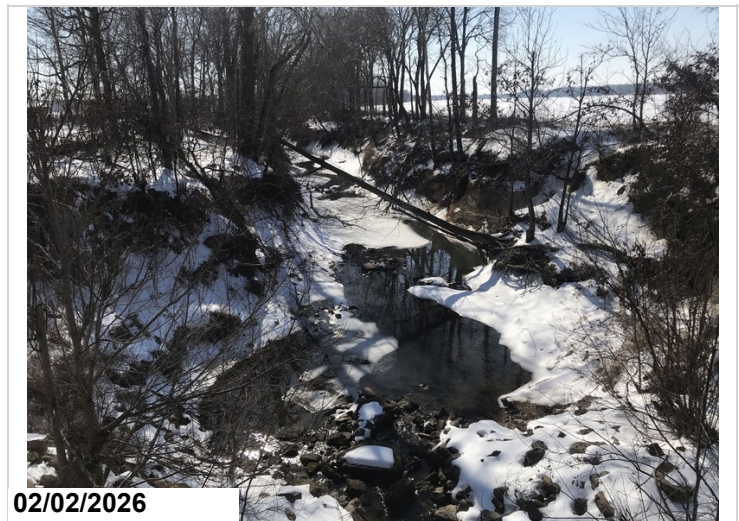
Channel downstream from bridge has cut banks/embankment erosion.

Right Side Downstream

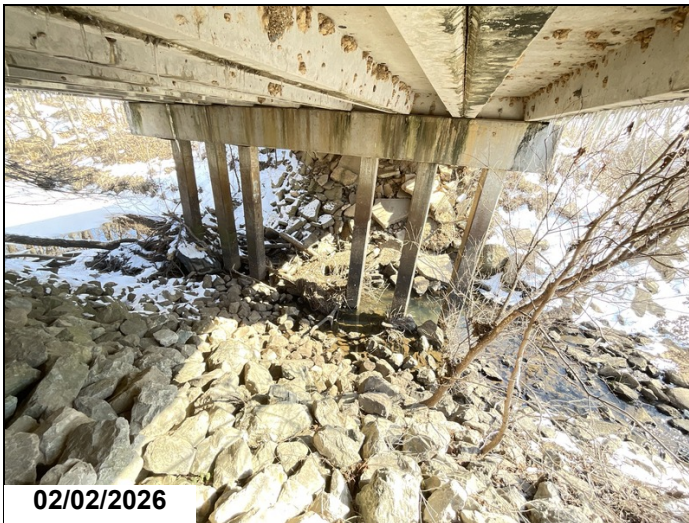
Minor drift is built up at bent 2.

Bent 2 drift

Type of Work: Channel Work/Drift Removal

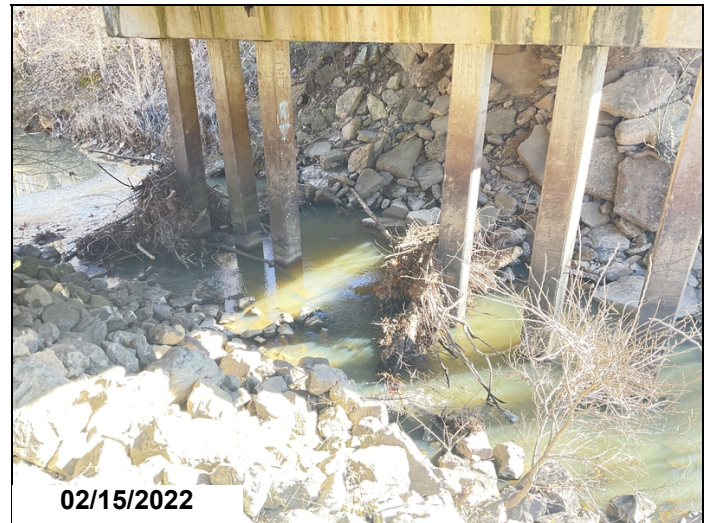
Drift

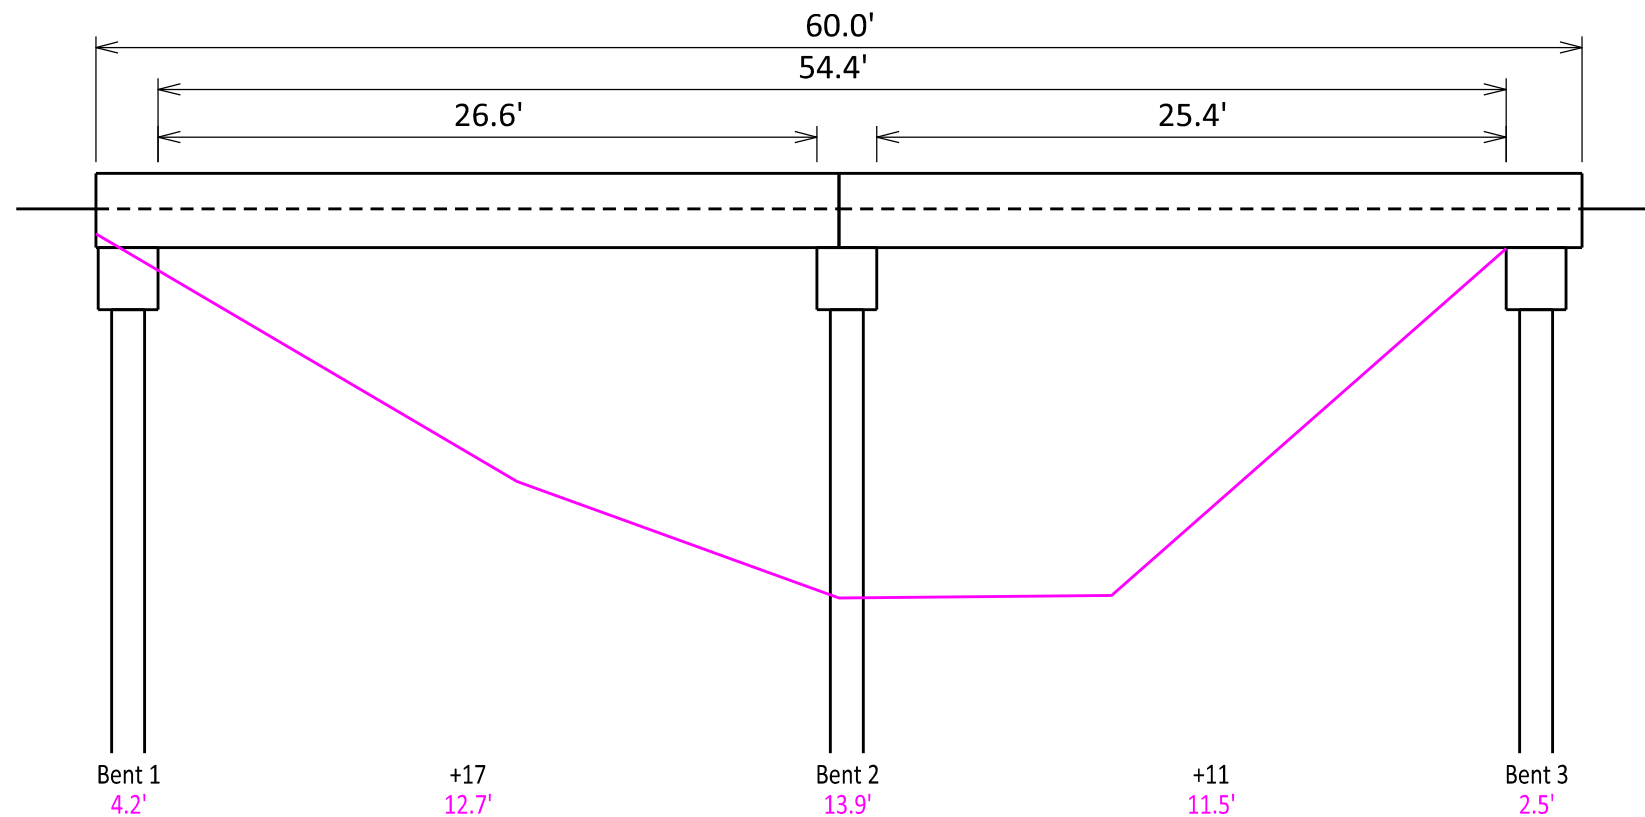
Channel profiled from top of deck on left side (upstream)
 Purple soundings taken on 2/02/2026

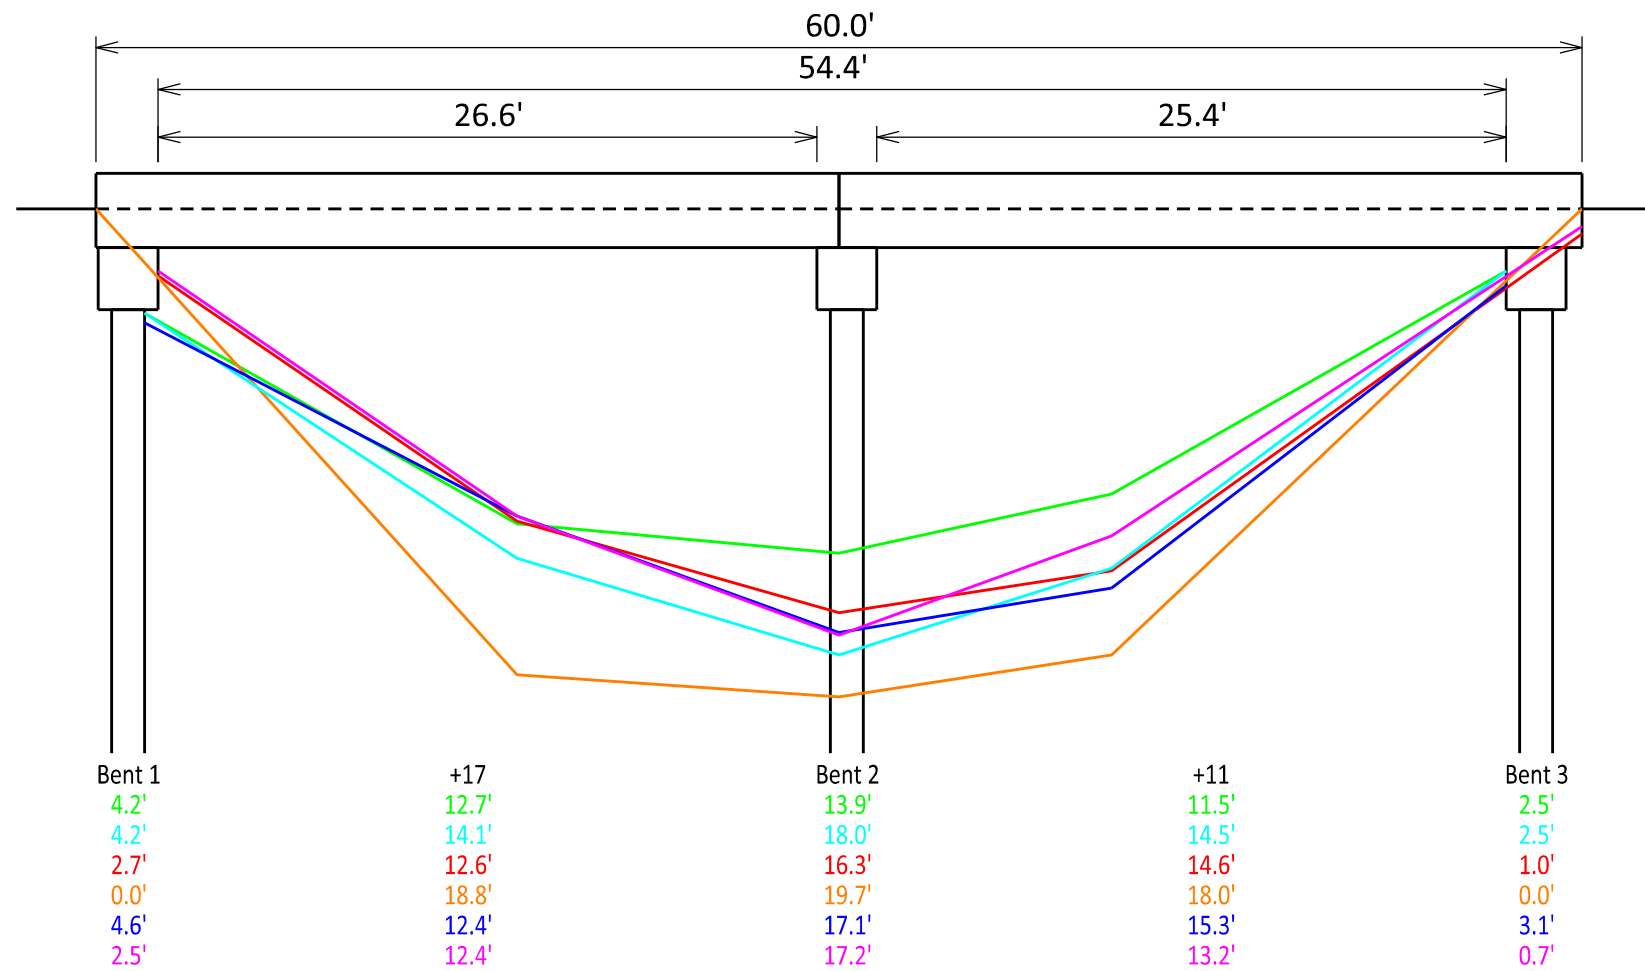
Channel profiled from top of deck on right side (downstream)
