## **Bridge 22976 Inspection Report**

Route:324 Section:00 Log:0.77

Team Lead: Richard Jones, Inspection Date: 03/05/2025

**Asset #22976**(Routine)  
**CR 324 - E over CREEK**  
**Location: 3 miles NE of Bono**

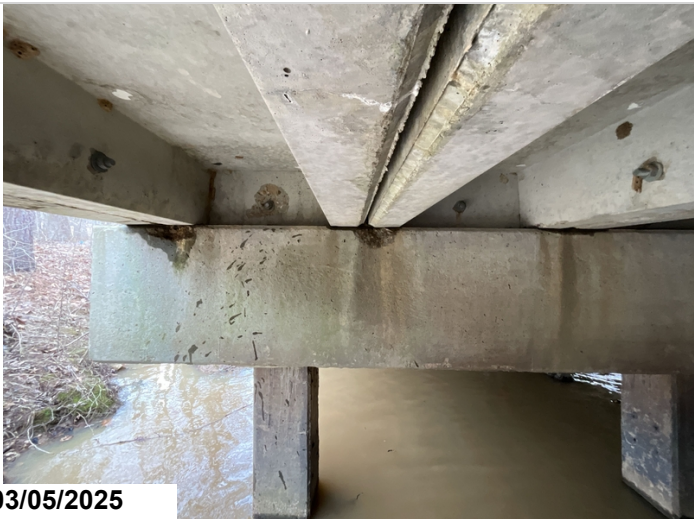
Bent 2 back side has a few minor spalls under units.

Bent 2 back side typical of spalls under units

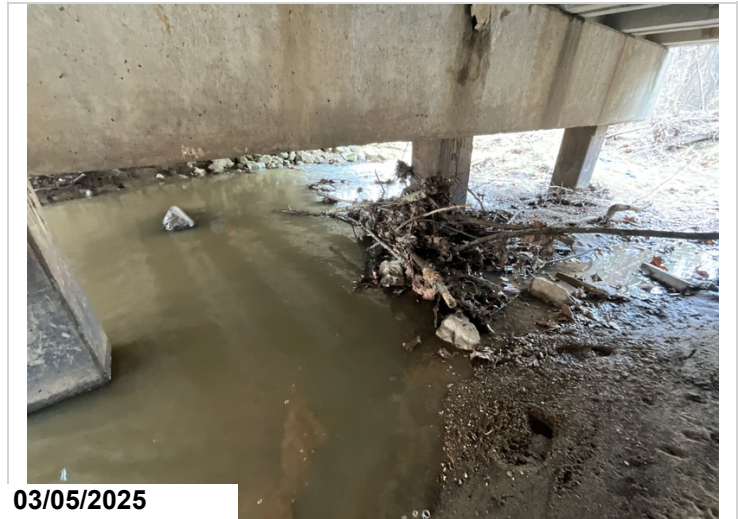
Bent 2 pile 3 has minor drift buildup.

Bent 2 pile 3 minor drift buildup

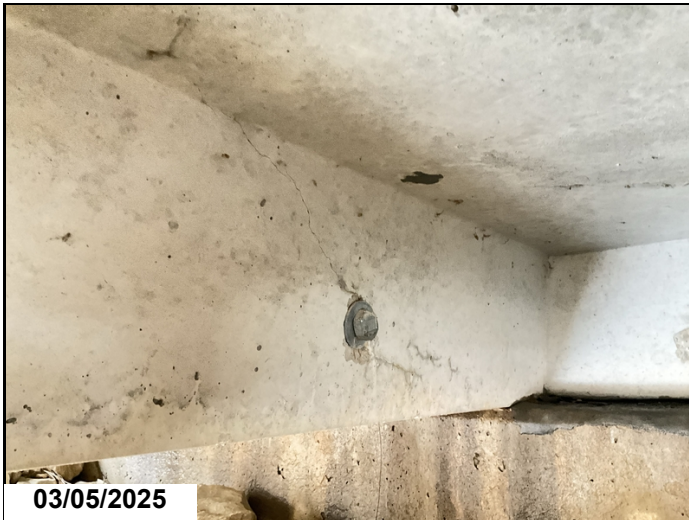
Span 2 bent 3 unit 2 Lt leg has a hairline to minor sized shear crack through transverse bolt connection.

Span 2 bent 3 unit 2 left leg has a hairline to minor sized shear crack through bolted connection.  
Span 2 Bent 3 Unit 4 left leg has a shear crack through bolted connection.

Span 2 bent 3 unit 2 left leg has a hairline to minor sized shear crack through bolted connection.

**Type of Work:** Superstructure Repair

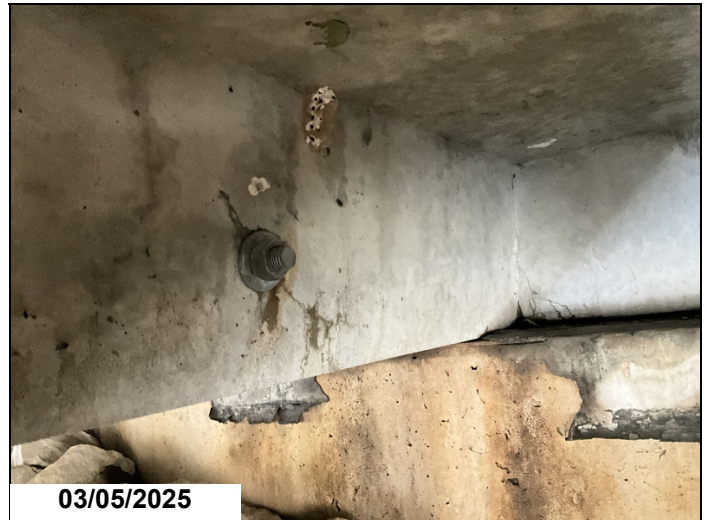
Span 2 bent 3 unit 4 Lt leg has a shear crack through transverse bolt connection.

Span 2 Bent 3 Unit 4 left leg has a shear crack through bolted connection.

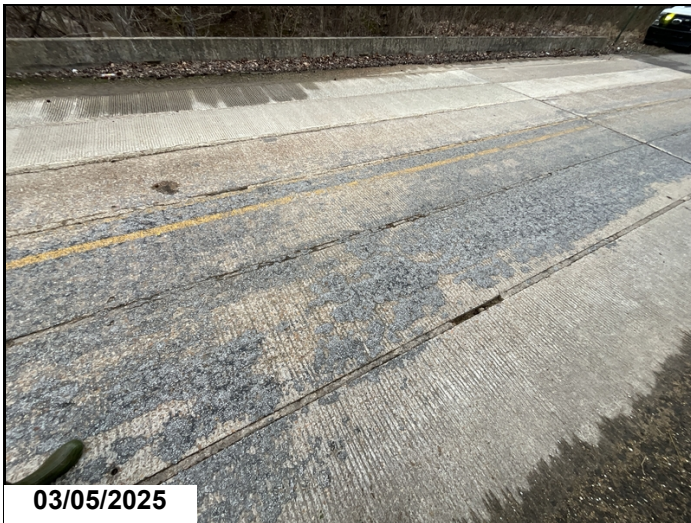
Shear key grout has cracks and a few scattered spalled areas between older units.

Shear key grout has cracks and a few scattered spalled areas between units.

Typical shear key grout spalls at older units.

**Type of Work:** Deck Repair

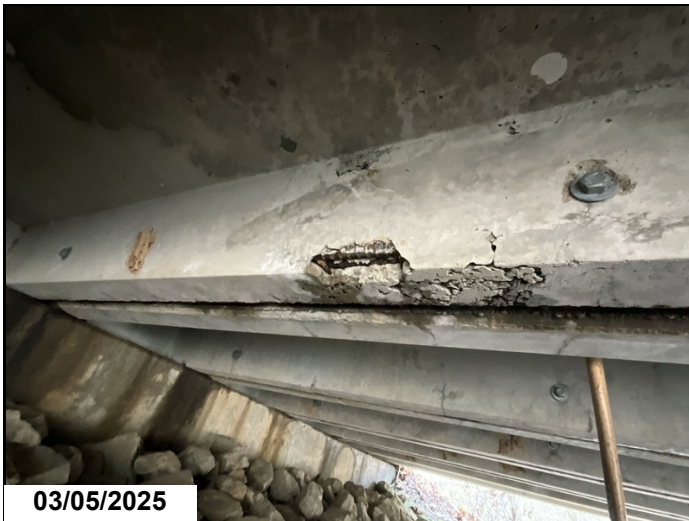
Span 1 bent 1 unit 6 Lt leg has a 2' honeycombed area exposing 1' of rebar.

Span 1 Bent 1 Unit 1 right leg has a small spall with exposed rebar.  
Span 1 Bent 1 Unit 6 left leg has a 2' honeycomb area exposing 1' of rebar.  
Span 2 unit 3 left leg has a minor honeycomb area exposing 6" of rebar.  
Span 2 Bent 2 Unit 7 left leg has a 1' area of honeycomb with exposed rebar.

Span 1 Bent 1 Unit 6 left leg has a 2' honeycomb area exposing 1' of rebar

**Type of Work:** Repair (General)

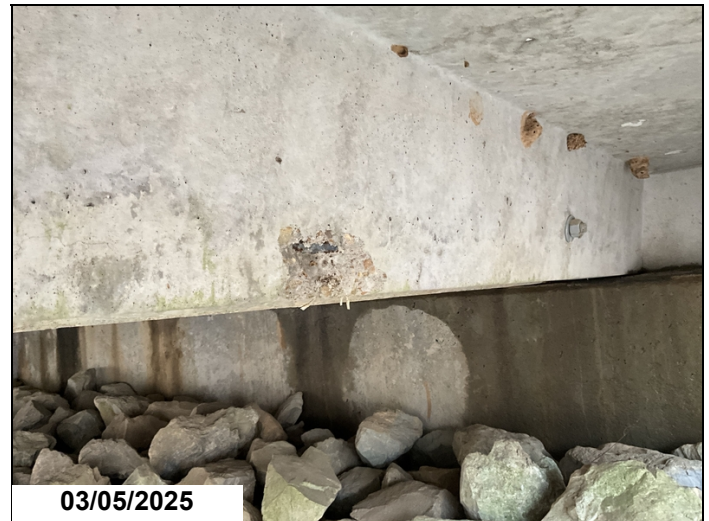
Span 1 Bent 1 Unit 1 right leg small spall with exposed rebar.
