Bridge 04657 Inspection Report

CR 928 - C over THOMPSON CREEK DITCH

Location: 1.5 MI WEST LESTER

Team Lead: Victoria Elliott Inspection Date: 07/01/2024

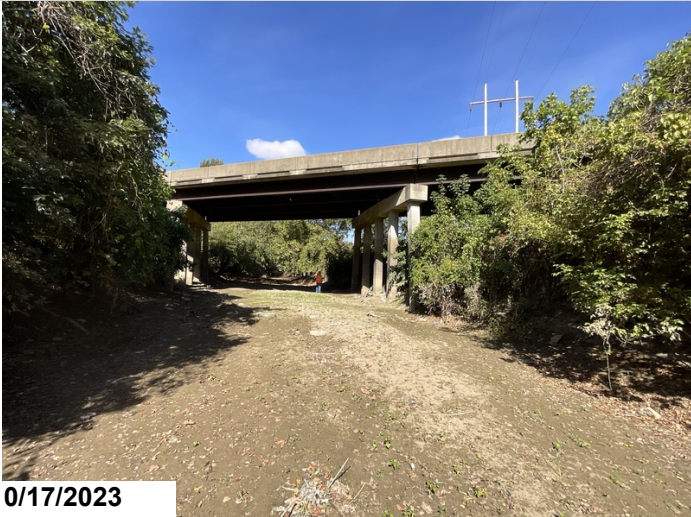
Elevation view

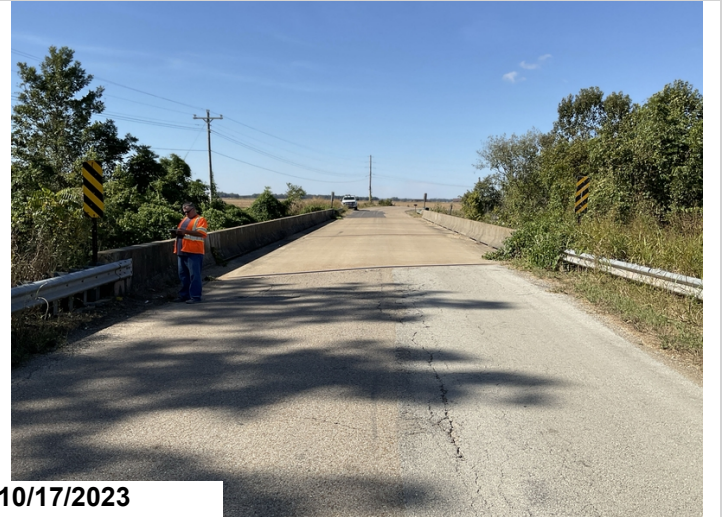
Roadway view
