Asset #12180(Routine)

Old Rudy Way over Creek - Crawford Co.

Team Lead: Jeff Jones, Inspection Date: 11/23/2021

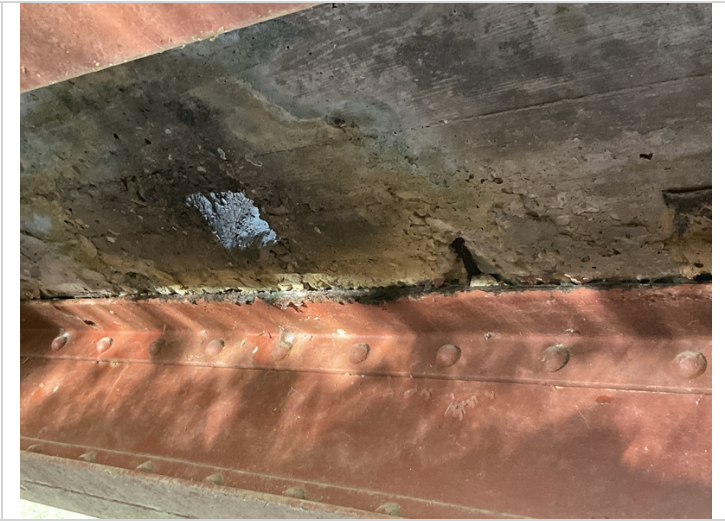
-Minor concrete deterioration adjacent to the deck drains with a couple of pieces of exposed reinforcing steel.
-Isolated areas of honeycomb from the construction process typical.

Exposed reinforcing steel in the deck soffit adjacent to the deck drain. Beam # 1.

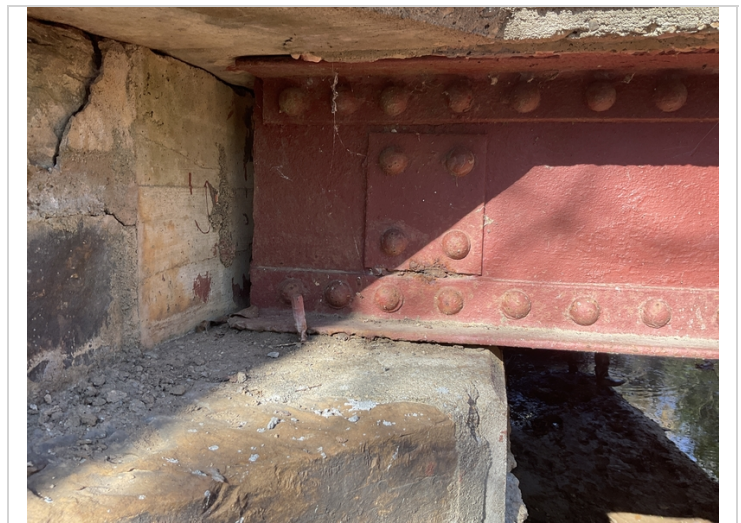
-The superstructure is constructed from riveted built up members.
-The top flanges have active corrosion adjacent to the deck drains with pack rust forming.
-Minor pitting along the bottom flanges of the beams that has been painted over in the past.
-Bent # 1 Beam # 10 and Bent # 2, Beams # 1 & 10 have up to 3/16" section loss and pack rust forming on the bottom flange between the cap and the beam.
-Several beam ends over Bent # 2 have up to 3/16" pack rust between the bottom flange and the bent cap.
-No visible cracks apparent during this inspection.

Bent # 1. Beam # 10 corrosion.

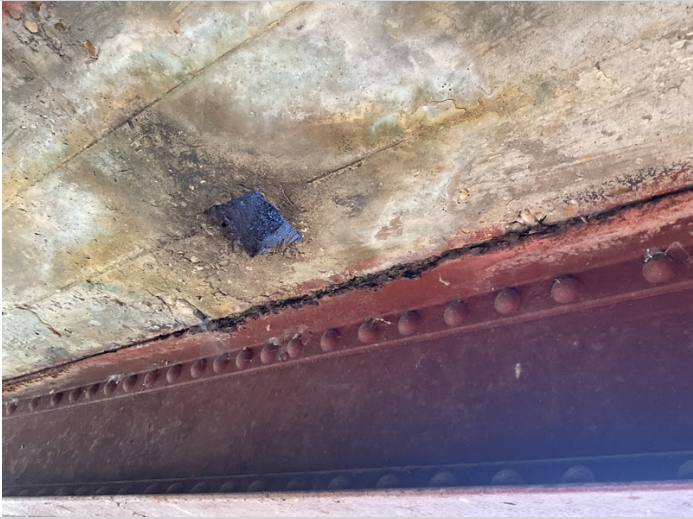
Beam # 10. Corrosion adjacent to the deck drains.

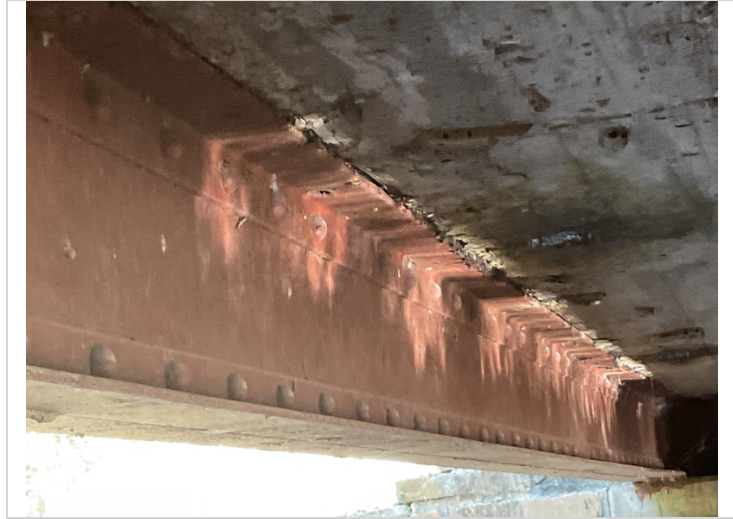
Beam # 1 - beam corrosion adjacent to the deck drain.

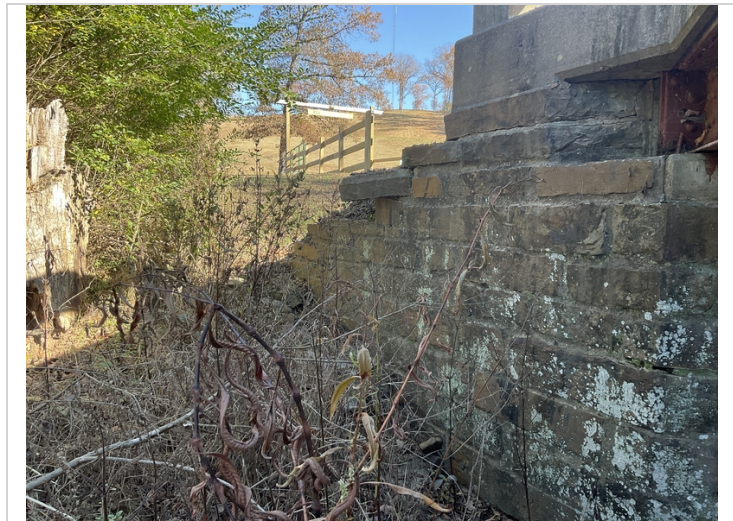
-The Northeast Rock masonry wing wall has stone displacement at the top of the wing.

Northeast wing wall. Stone displacement.

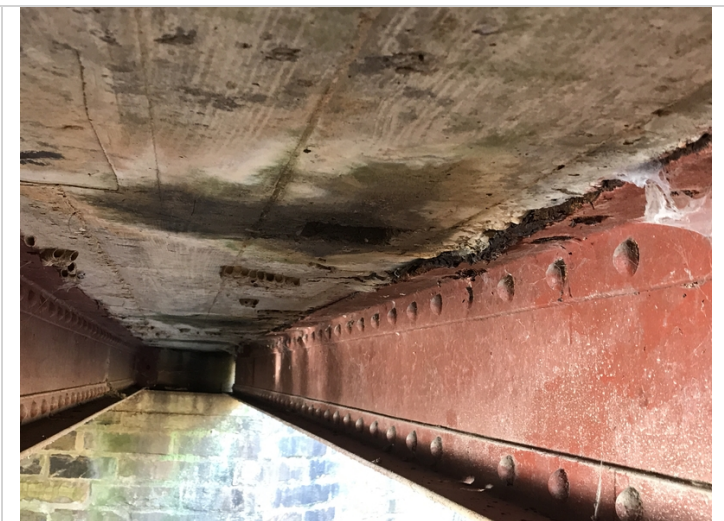
Beam1 active corrosion near the deck drains.

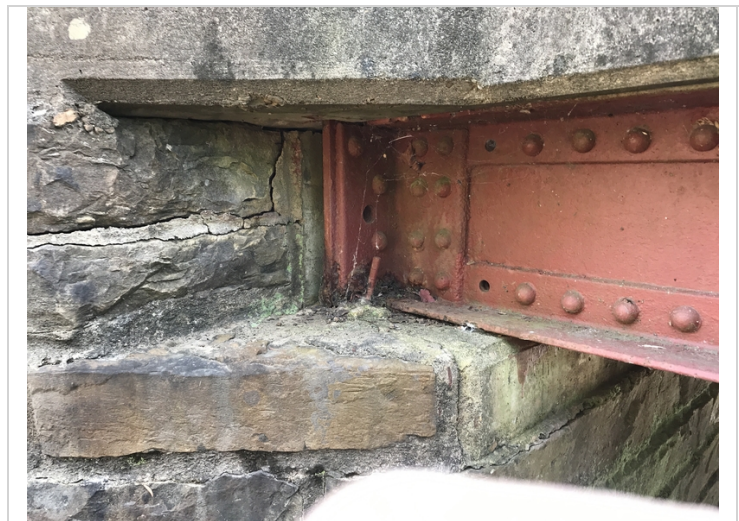
Bent 2 ,beam 1 active corrosion.

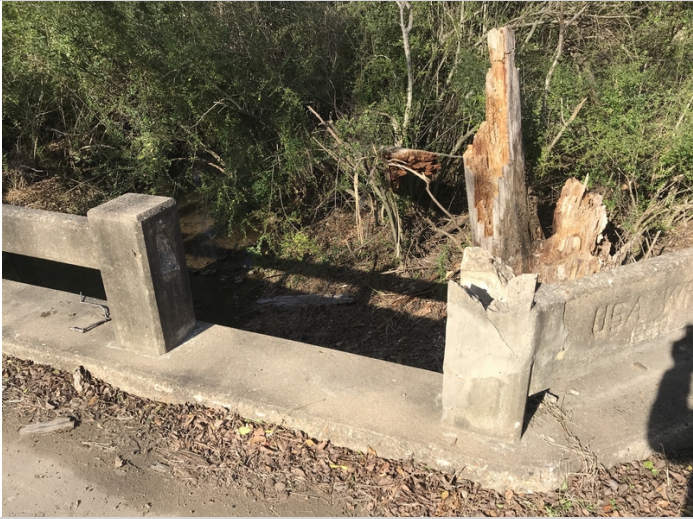
Northeast corner bridge rail damage.

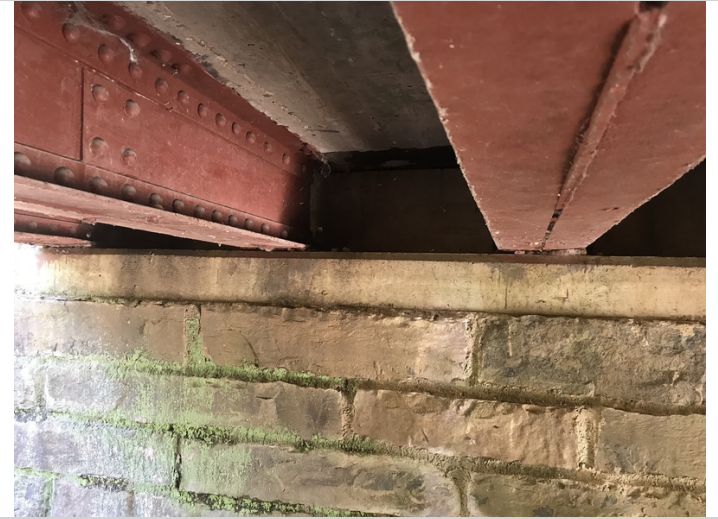
Bent 2 ,beams 2 and 3 pack rust between the cap and the bottom flange of the beam.

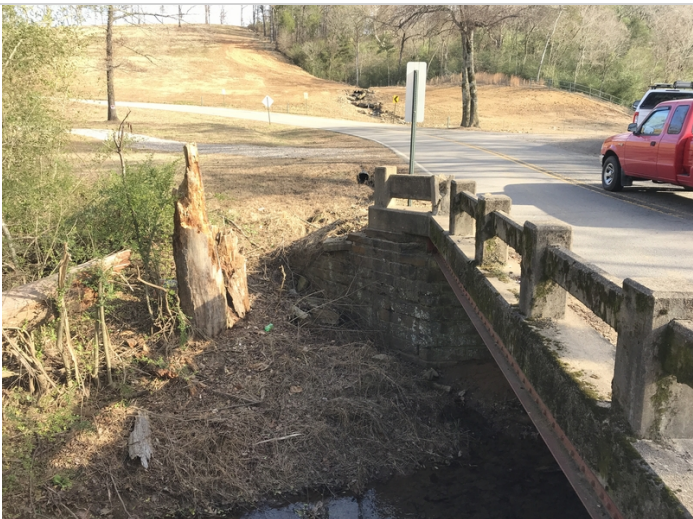
Stone displacement in wing wall at Bent 2 left.

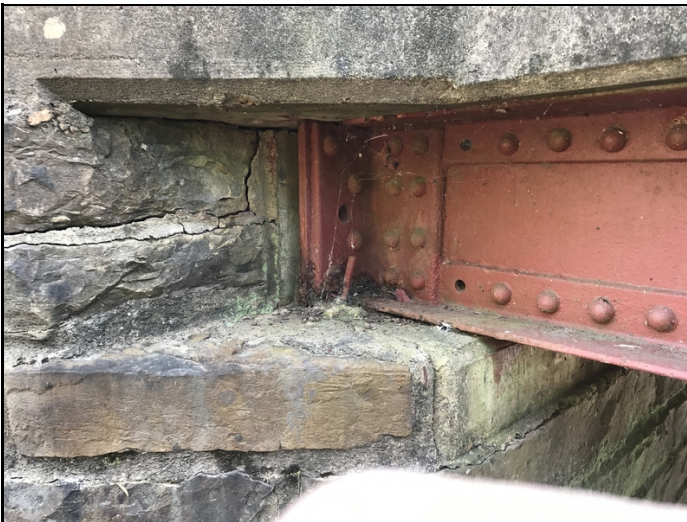
- The top flanges of the exterior beams have active corrosion and section loss with pack rust adjacent to the deck drains.
- End of exterior beams over Bents # 1 & 2 have up to 3/16" section loss with pack rust forming between the cap and the bottom flange.
- Several beams over Bent # 2 have pack rust forming between the bottom flanges and the abutment caps.

Bent # 2, Beam # 1 active corrosion.

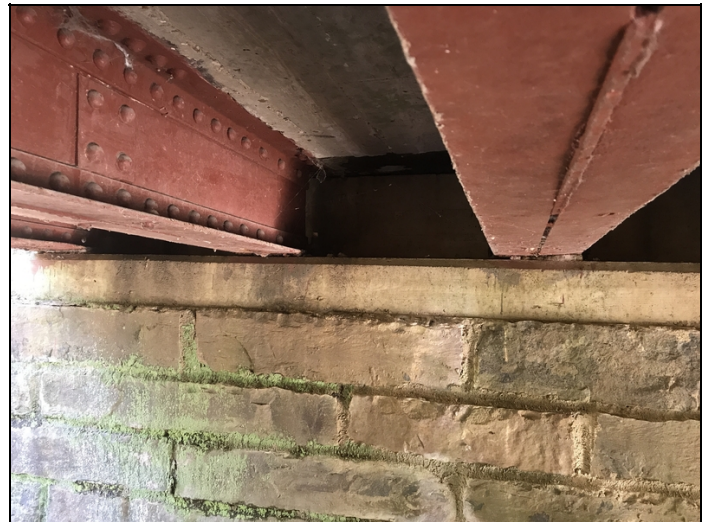
Bent # 2, Beams # 2 and 3 pack rust between the cap and the bottom flange of the beam.

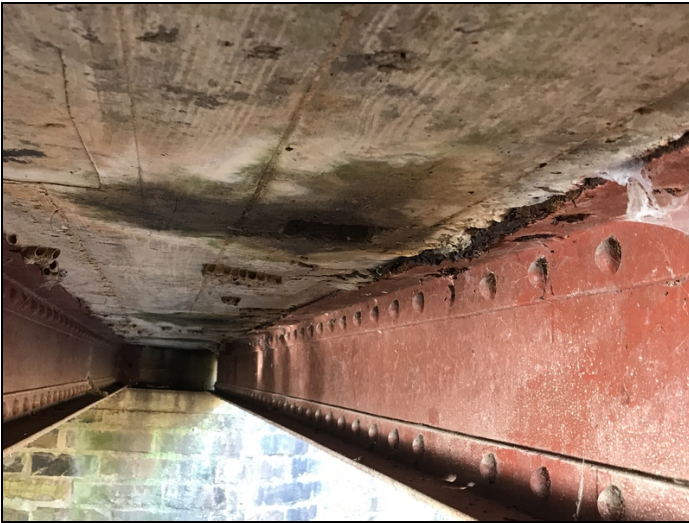
Beam # 1 active corrosion near the deck drains.

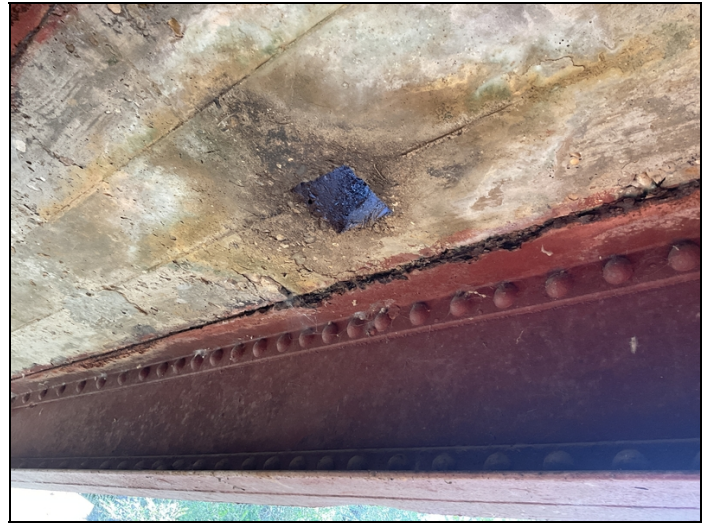
Beam # 10 corrosion adjacent to the deck drain.

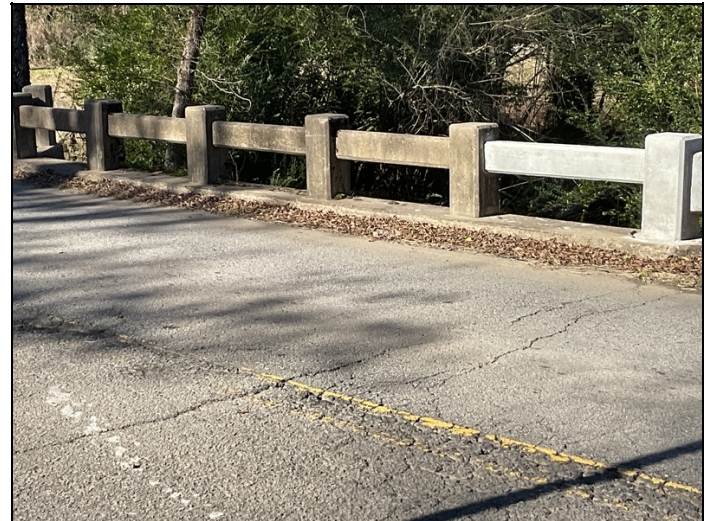
Asphalt driving surface with minor debris accumulation in the gutters.

Debris accumulation in the gutters.
