Asset #M3957(Routine)

Bucklake/Z-E/1.24 over Ditch

Location: 1.24 Mi E Of Jct Sh 149

Team Lead: Drew Melton Inspection Date: 04/04/2023

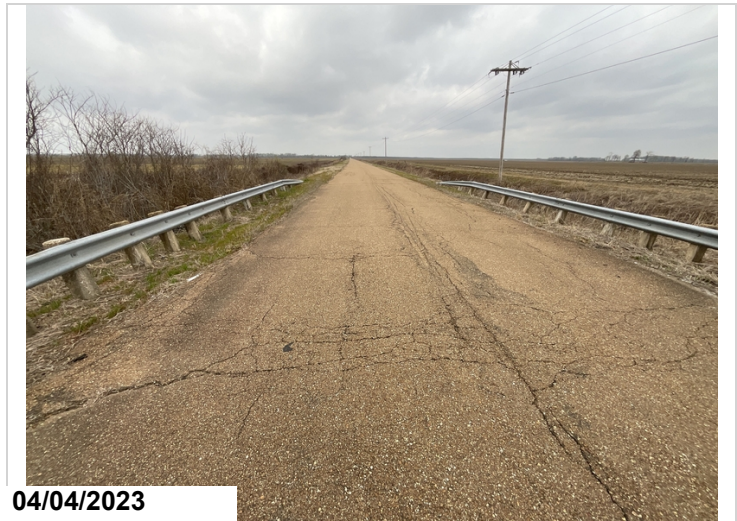
Abutment #1 approach rails

Abutment #1 approach shoulders eroded at bridge end.
Abutment #1 approach roadway, right side settled up to 2" for last 4' on right side.
Approach rails are leaning outward.

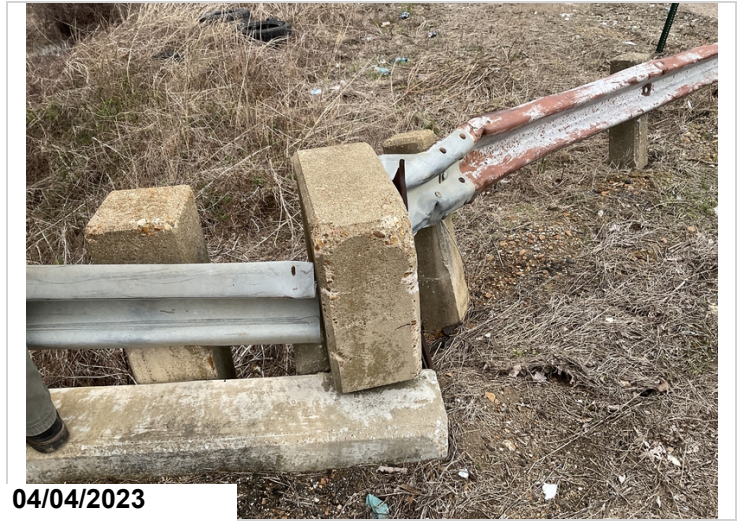
Abutment #2 left monument post is leaning back.

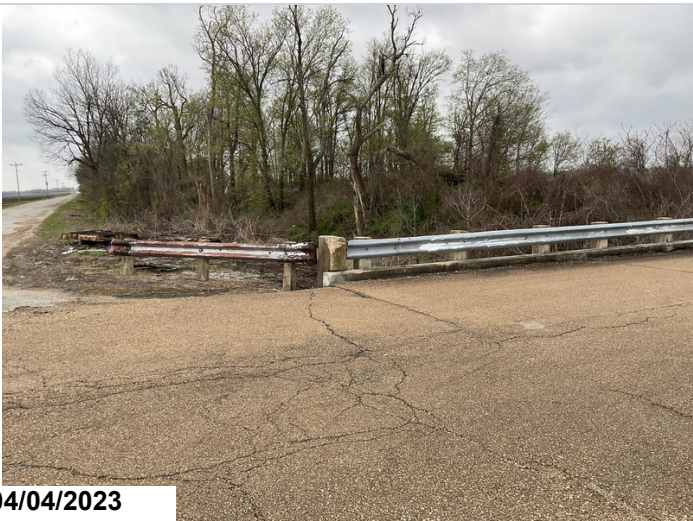
Abutment #2 right monument post corner is spalled off no rebar exposed.

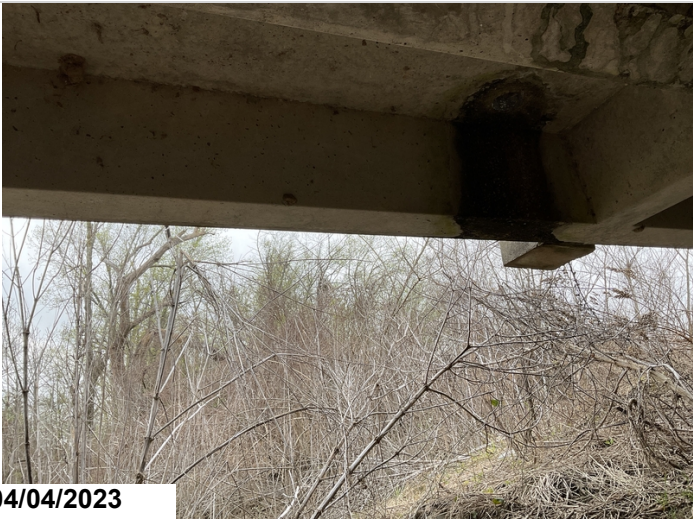
All units at drains have light to moderate abrasion for 1'.

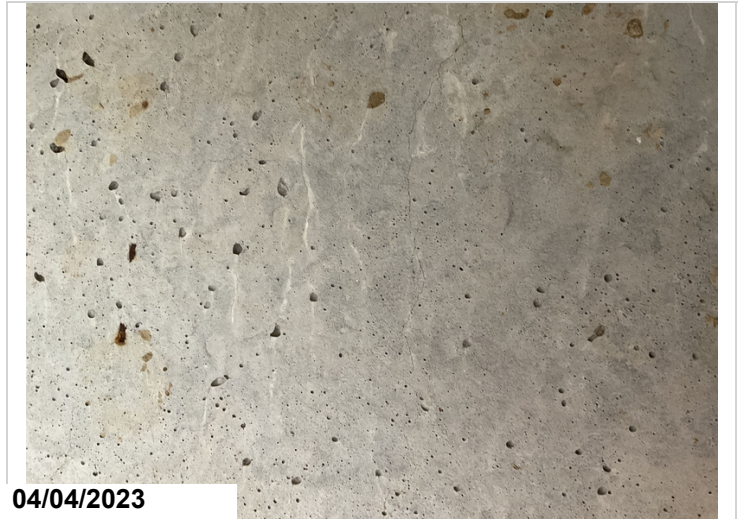
All girders have vertical hairline flexure cracks spaced six to eight inches apart.

Typical vertical flex crack in side of girder

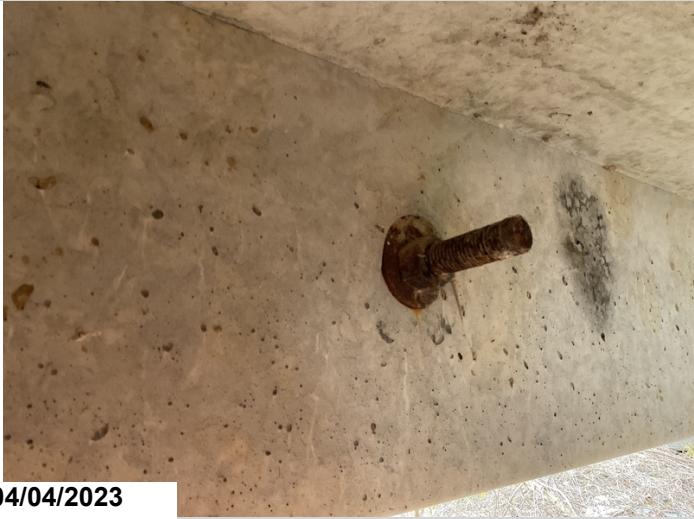
All connection bolts are corroded.

Typical corroded connection bolt

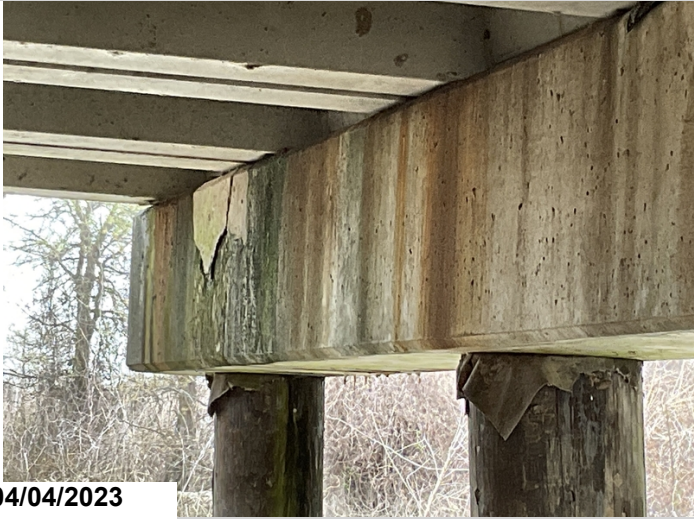
Bent #2 cap back face has a 2' delamination under unit #1 right leg.

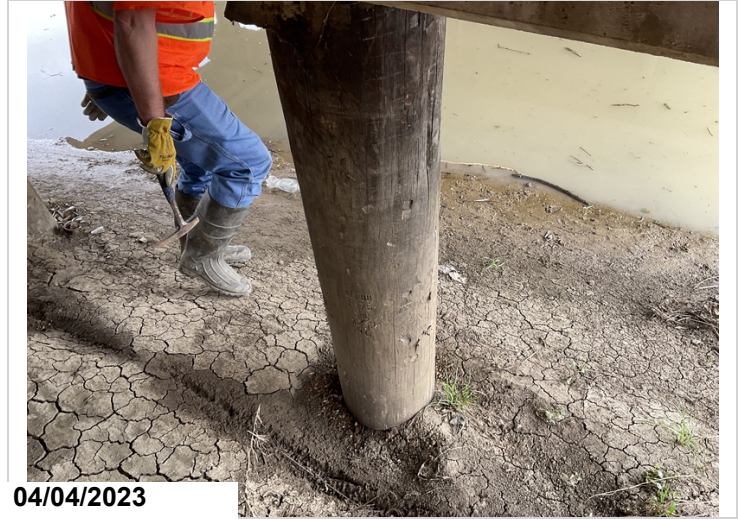
All piles are weathered and have minor vertical cracks.

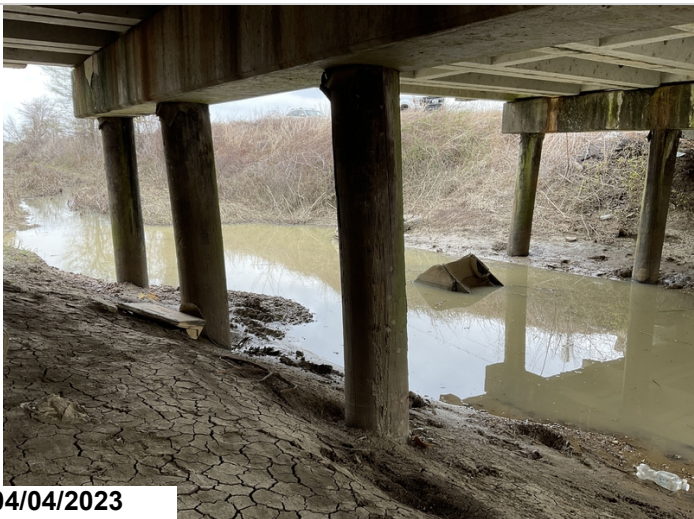
Bent #2 piles #1,3 are split by drift pin, and pile #3 is also sounds moderately hollow.

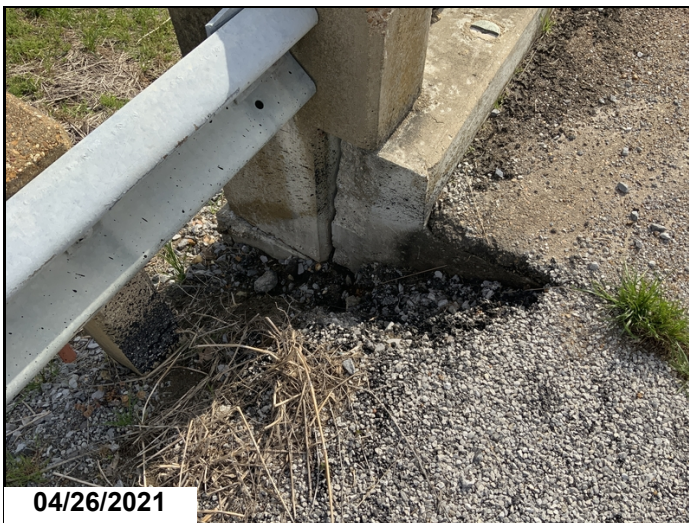
Abutment #1 left side approach shoulder is eroded three feet deep and into roadway.

Abutment #1 left approach shoulder eroded.

Type of Work: Approach Leveling/Maintenance

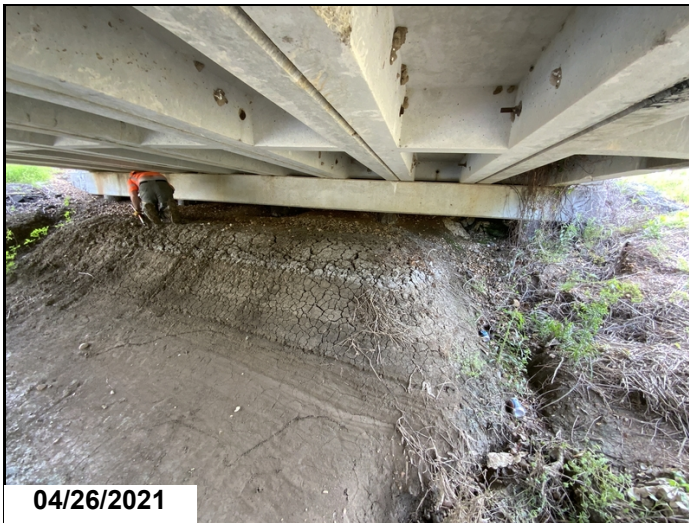
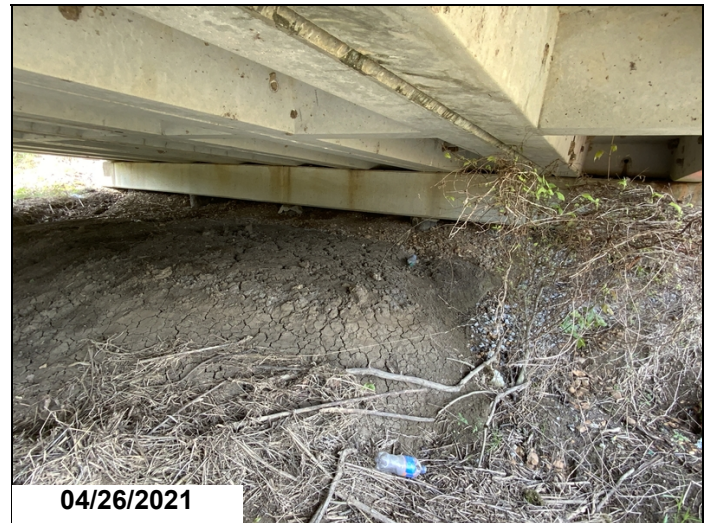
Abutment #1,2 caps are undermined full length up to 1' deep exposing all piles.

Abutment #1,2 caps are undermined full length up to one foot deep exposing all piles.

Type of Work: Repair (General)

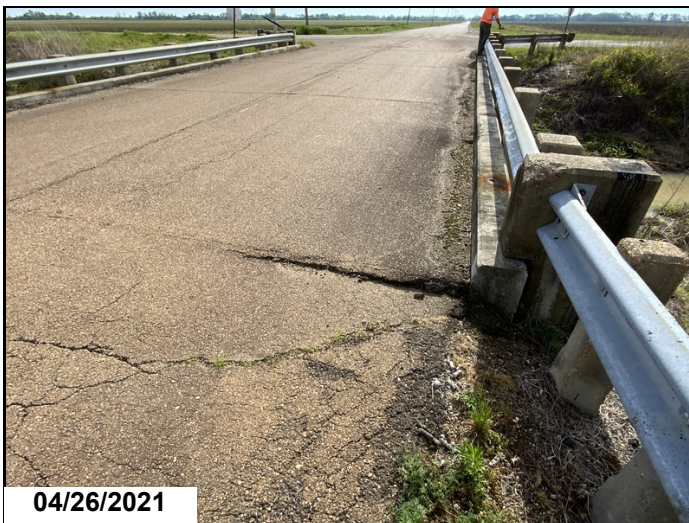
Abutment #1 right approach shoulder has settled up to two inches at bridge end for four feet wide.

Abutment #1 roadway settlement, right side.

Type of Work: Approach Leveling/Maintenance

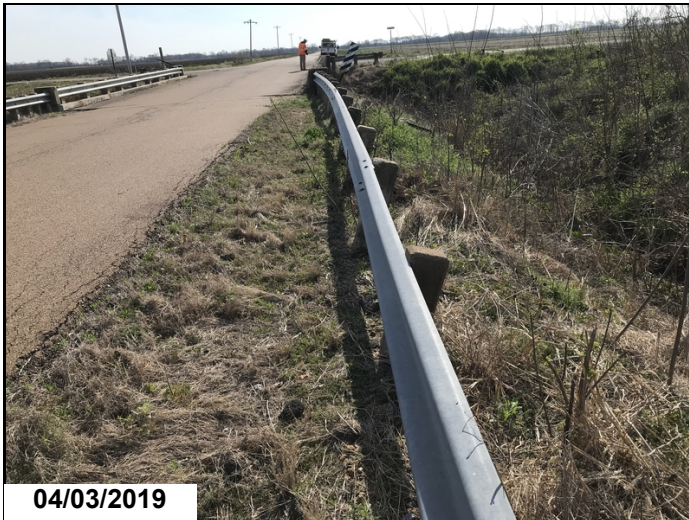
Approach rails are leaning outward.
Abutment #2 left approach rail has minor collision damage.

Approach rails are leaning outward.

Type of Work: Repair (General)

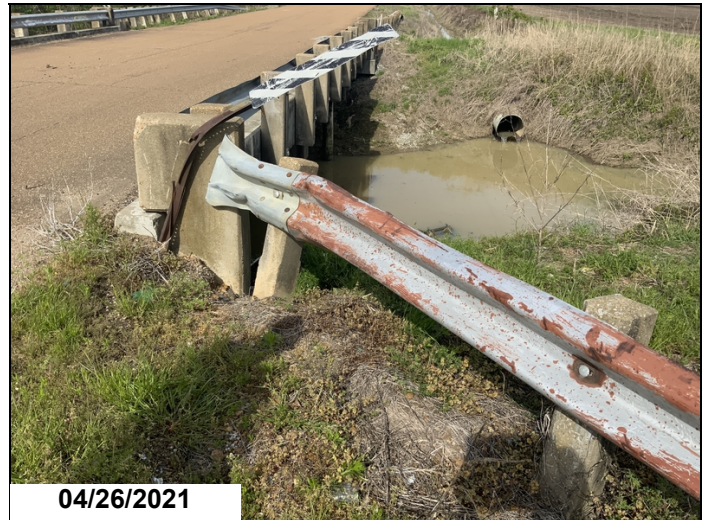
Abutment #2 left approach rail damage.
