Bridge Inspection Report

22237
Cr-724/Z-H/L-2.52
over
Creek

Structure Number: 22237

Facility Carried: Cr-724/Z-H/L-2.52

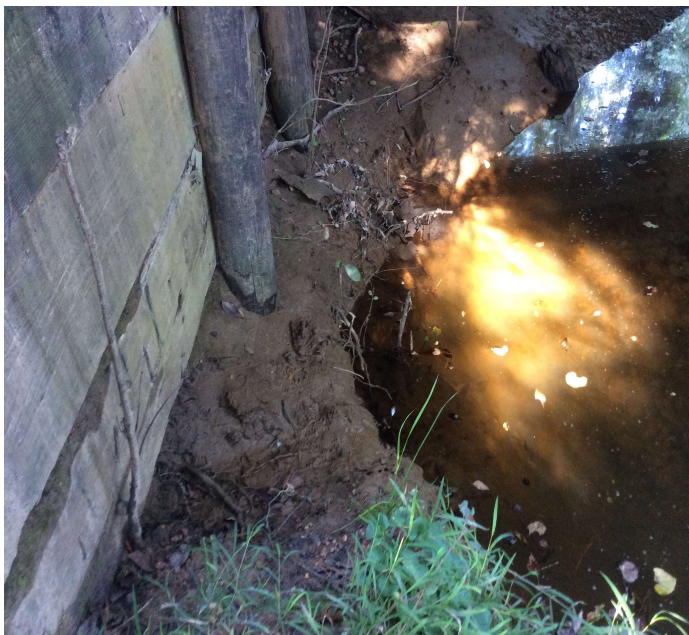
Channel near abutment #1 on right side local scour up to 3' deep within 3' of abutment #1 bulkhead on right. Abutment #1 left side has erosion up to concrete abutment

PHOTO 1 Description Abutment 1 right side erosion.

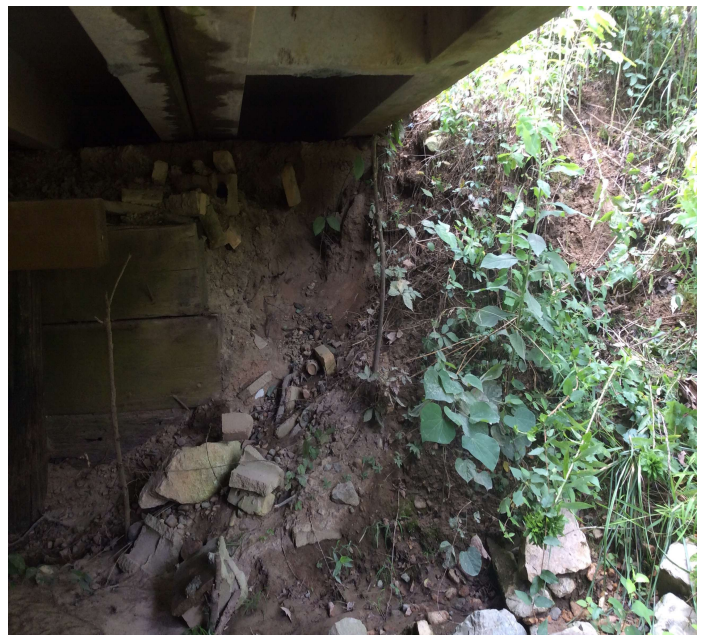
PHOTO 2 Description Abutment #1 left side erosion
