Bridge #04911(Routine, Underwater type 2)

Salttillo Road over LITTLE CYPRESS

Team Lead: Kevin Milligan Inspection Date: January 13, 2021

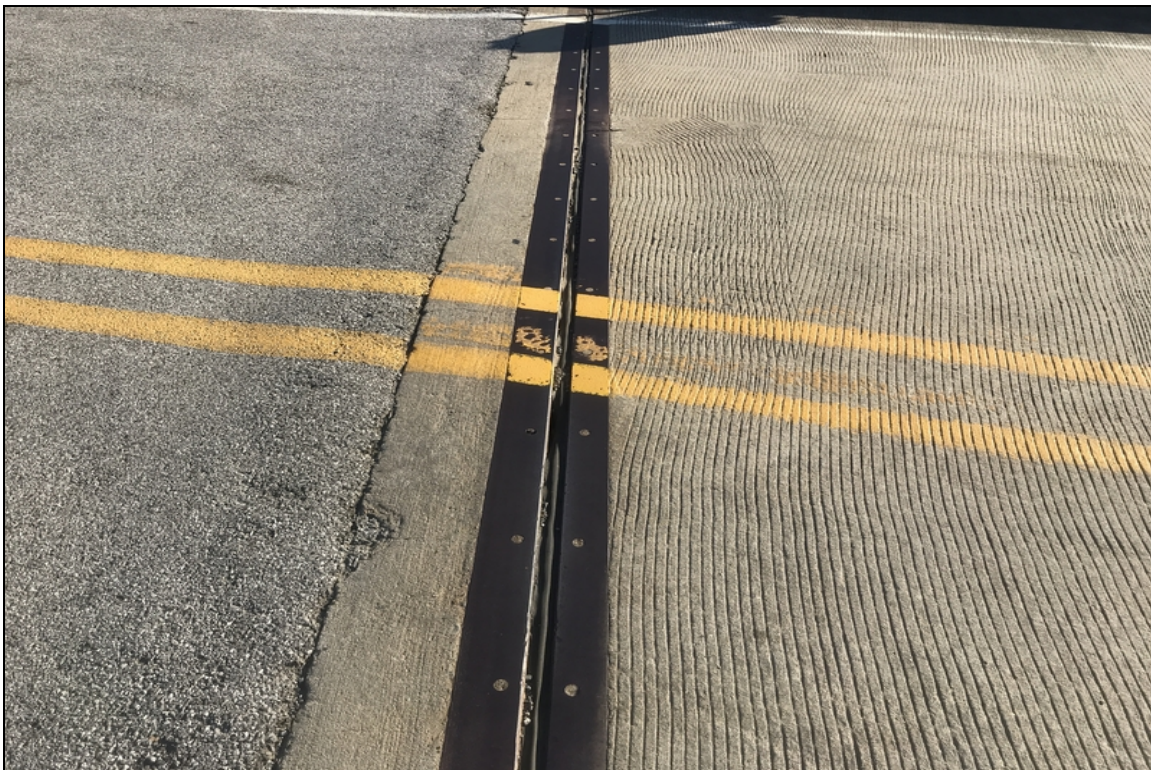
Bent 1 pourable joint has 6' of holes.

KRM & MLM 1/13/2021 Deck is in good shape, overhangs have a few cracks with efflorescence. Pourable joint at bent 1 has approximately 6" holes. Concrete bridge rail has vertical cracks scattered throughout structure.

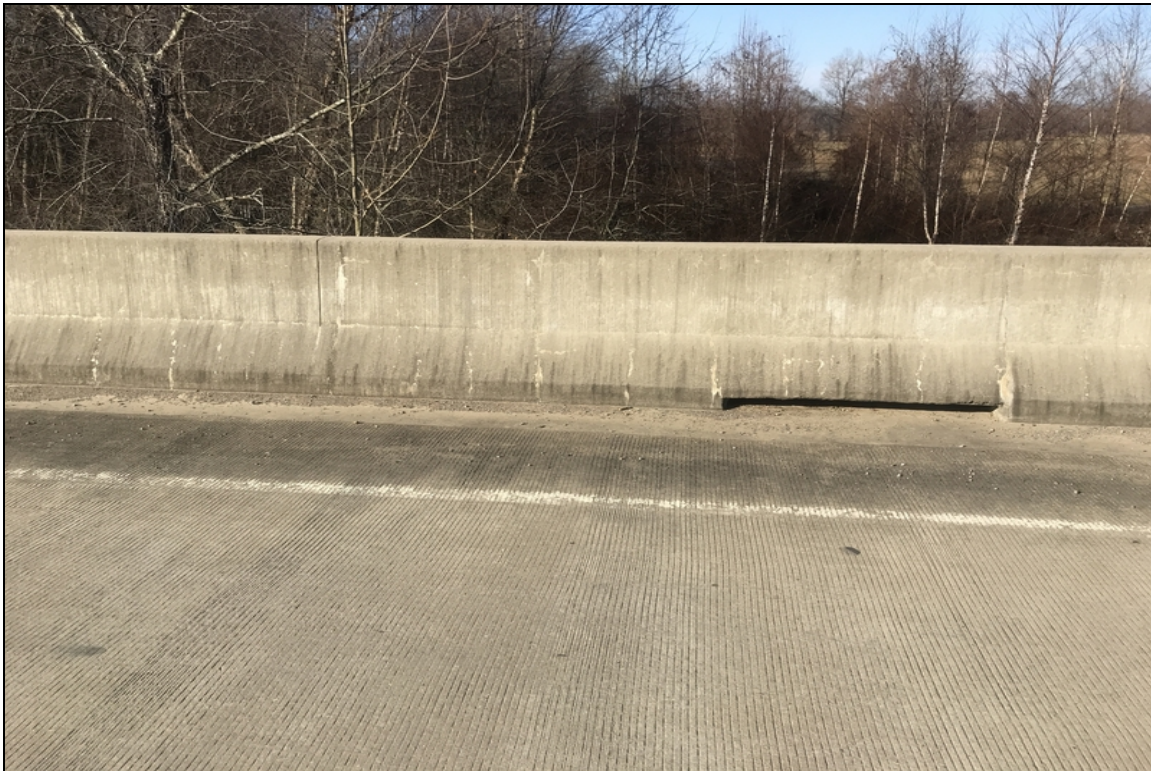
Concrete bridge rail has vertical cracks scattered throughout.

DECK - MINOR CRACKING W / EFFLOR IN EDGES OF DECK & OVERHANGS. RAIL - MINOR VERTICAL CRACKING.

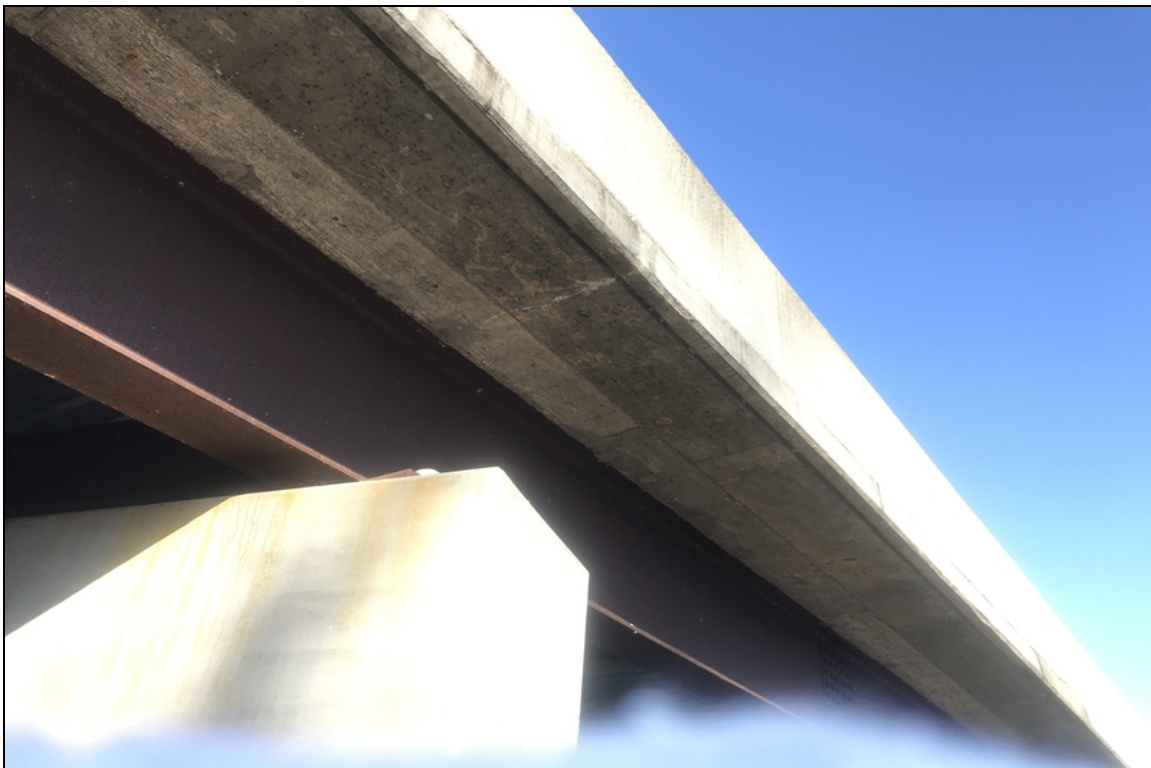
Overhangs have cracks with efflorescence.

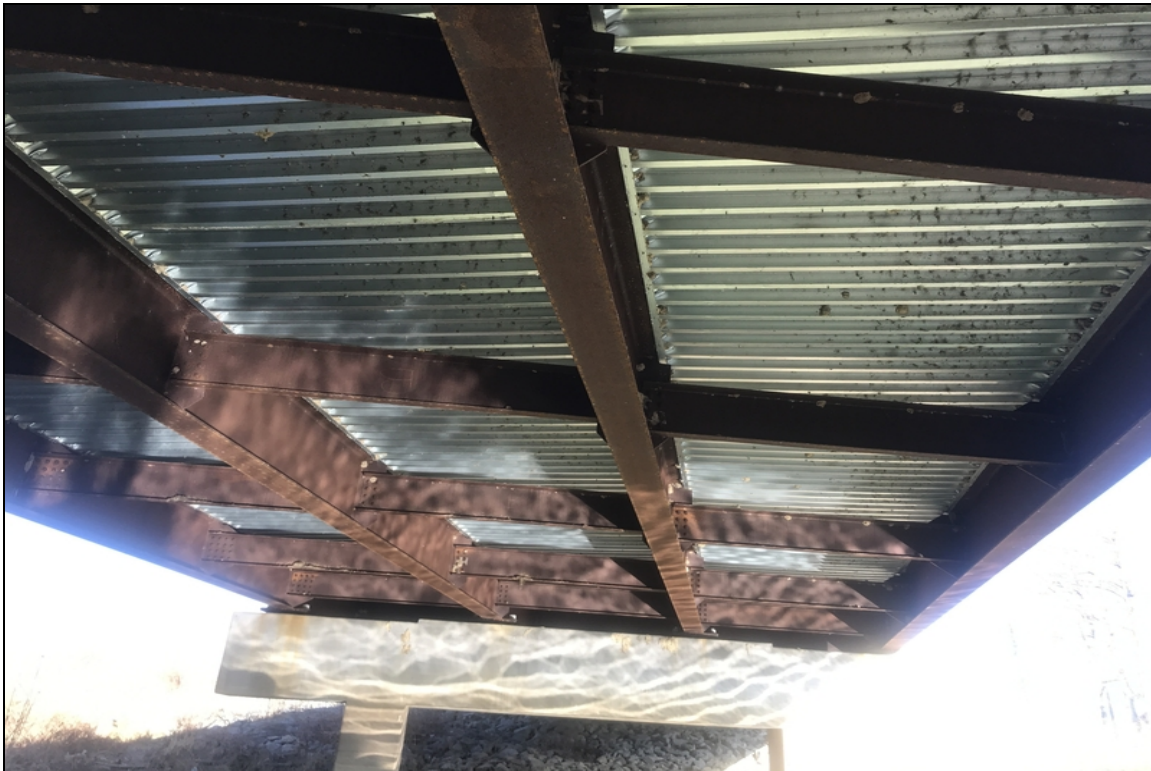
Typical condition of superstructure.

KRM & MLM 1/13/2021 No notable defects at this inspection.

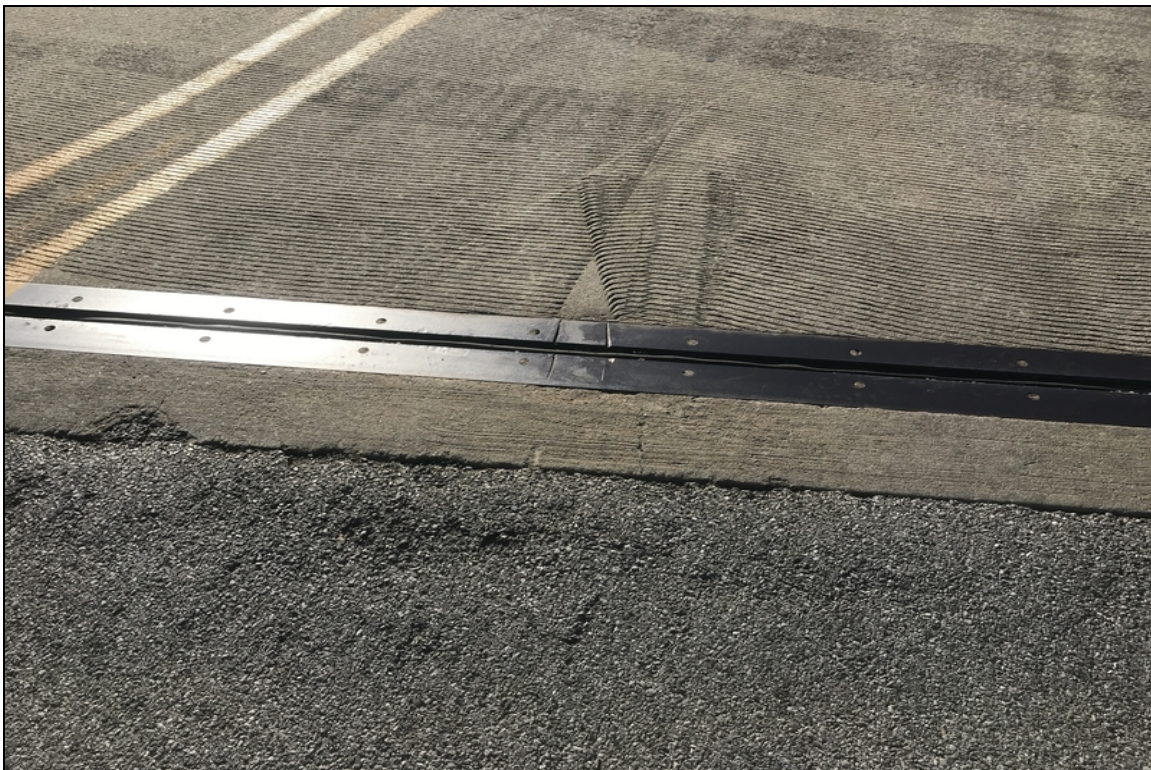
Top of back wall at bent 1 has cracks.

KRM & MLM 1/13/2021 Both abutments have vertical cracks with efflorescence, top of both back walls have cracks.

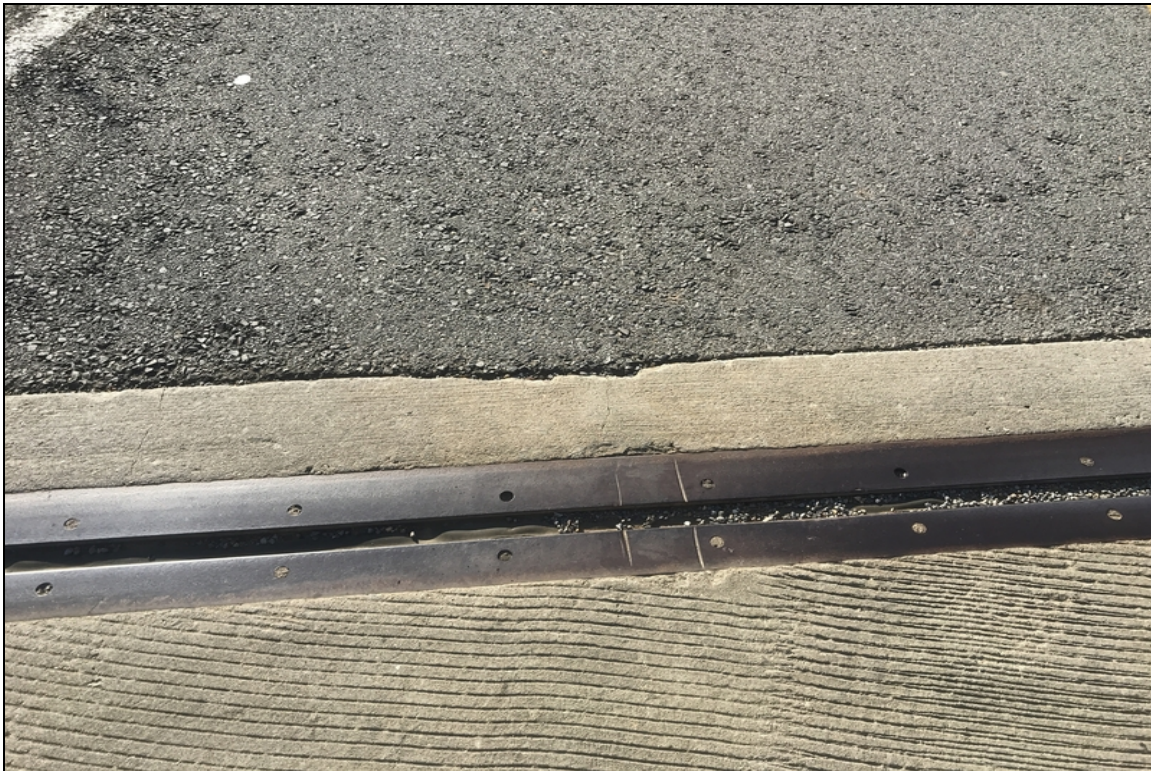
Bent 4 top of back wall has 6 cracks.

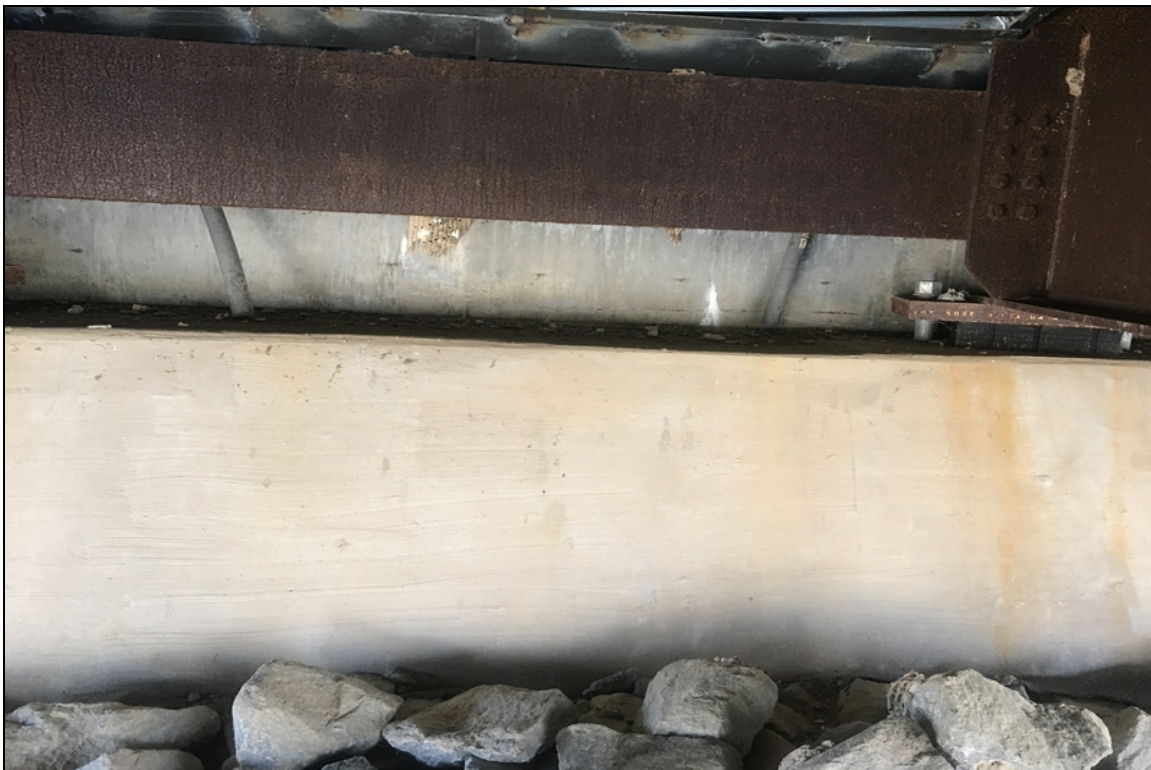
Bent 4 has cracks with efflorescence.

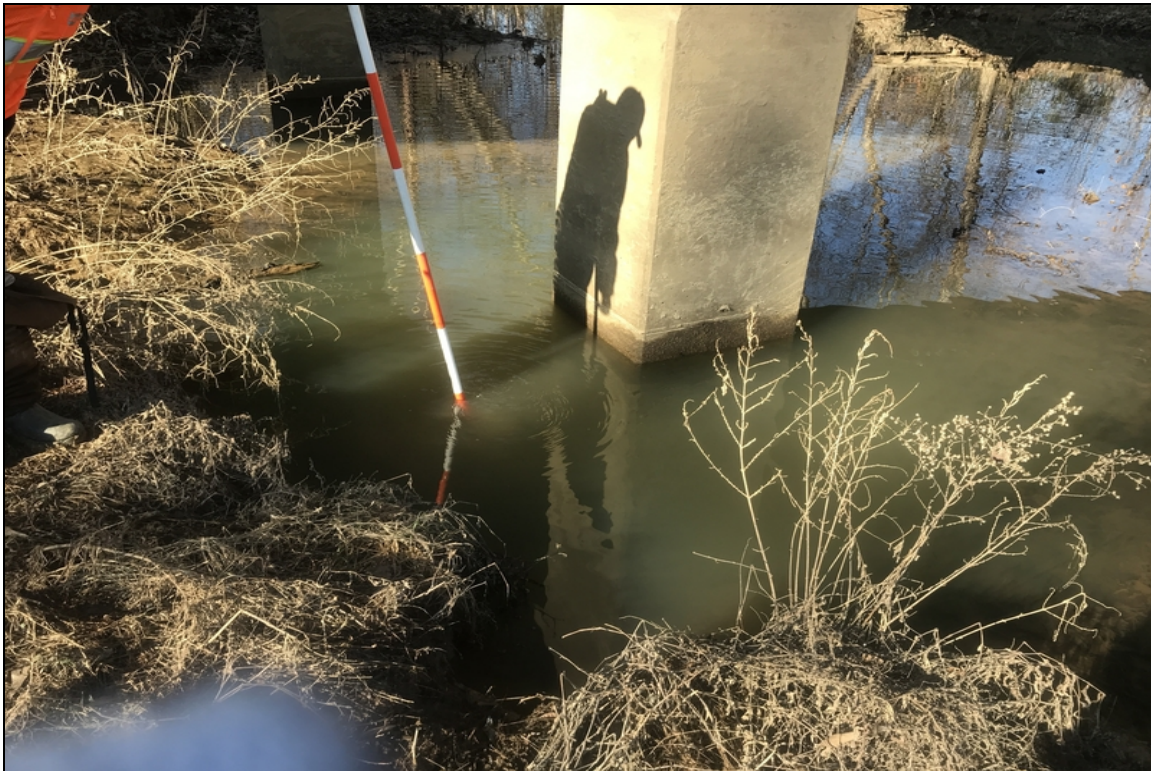
Bent 3 both columns have minor local scour.

Underwater Type II/Channel Profile was conducted this date, minor local scour was noted around both columns at bents 2 and 3. Measurements were taken with a weighted tape from the top of concrete rail.

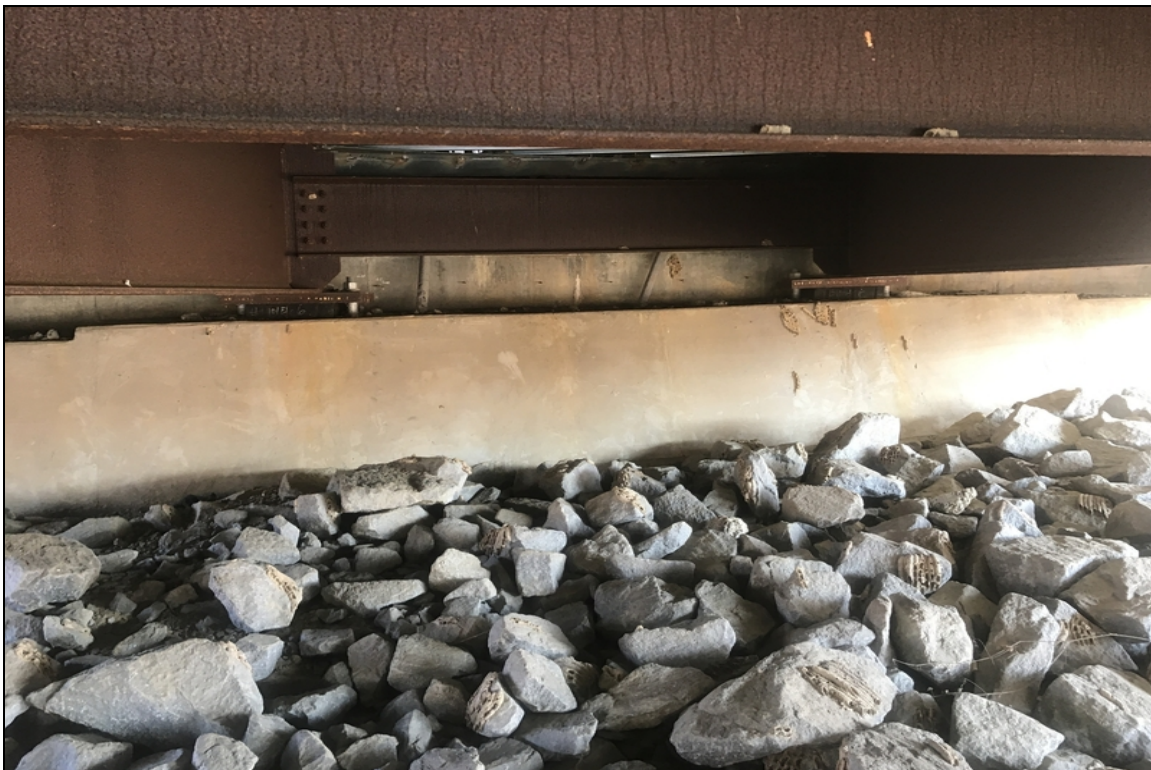
Bent 1 has cracks with efflorescence.

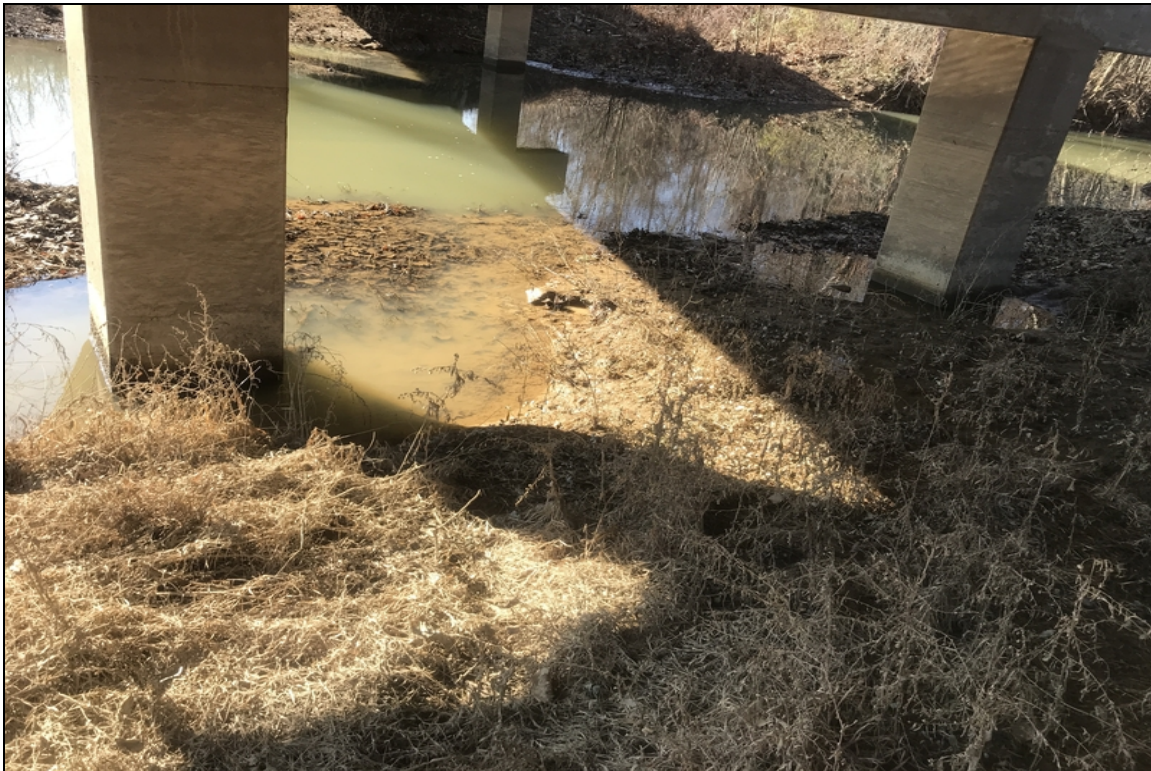
Bent 2 both columns have minor scour.

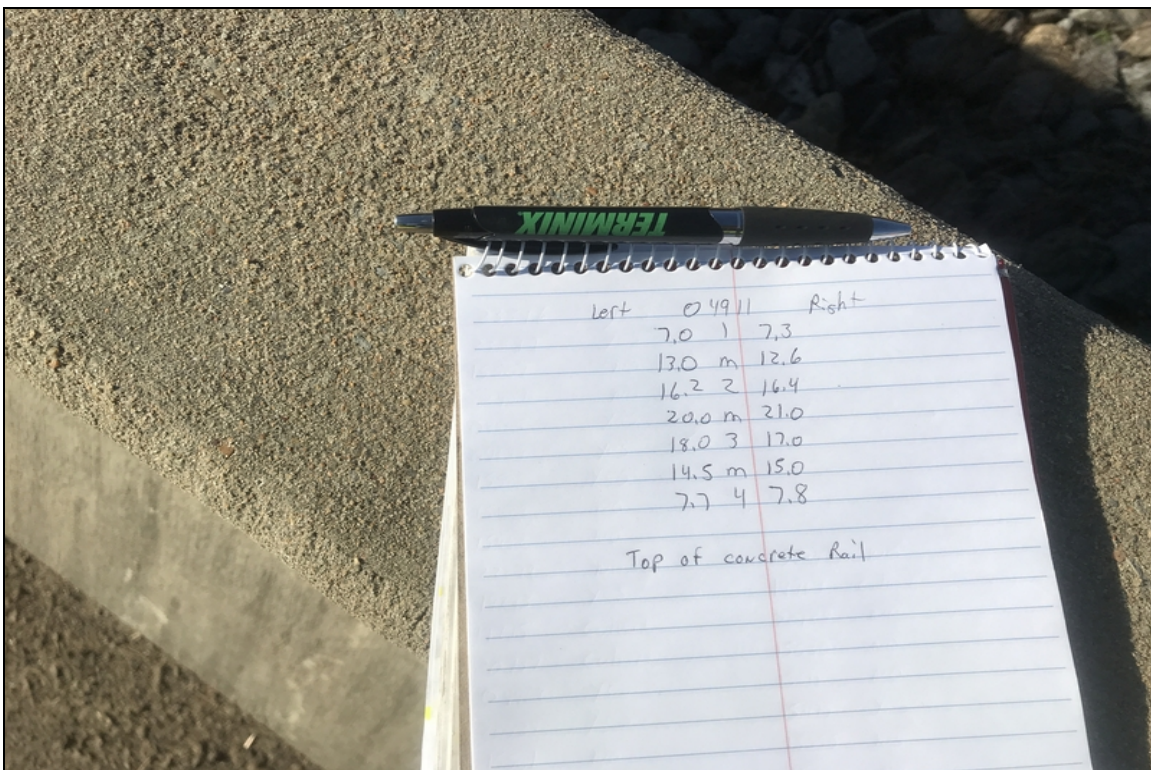
Channel profile measurements.
