Asset #13089(Routine, Underwater type 2)

Wire Road over Maxey Creek

Location: LONE ELM

Team Lead: Eric West Inspection Date: 06/06/2024

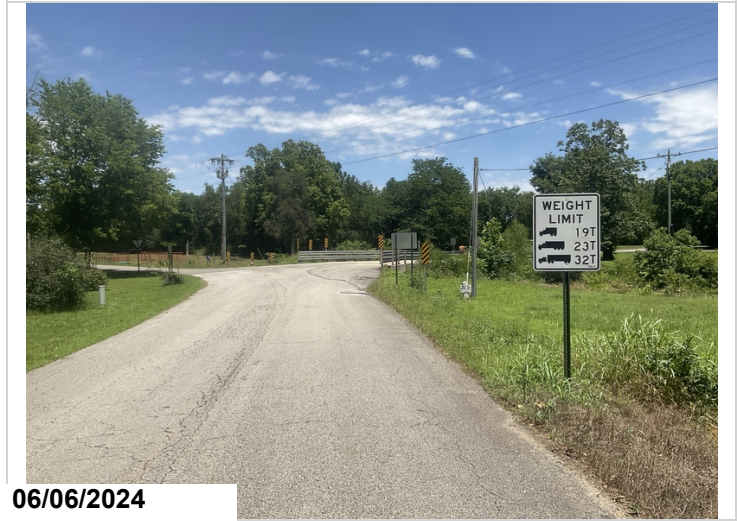
West approach load posting sign.

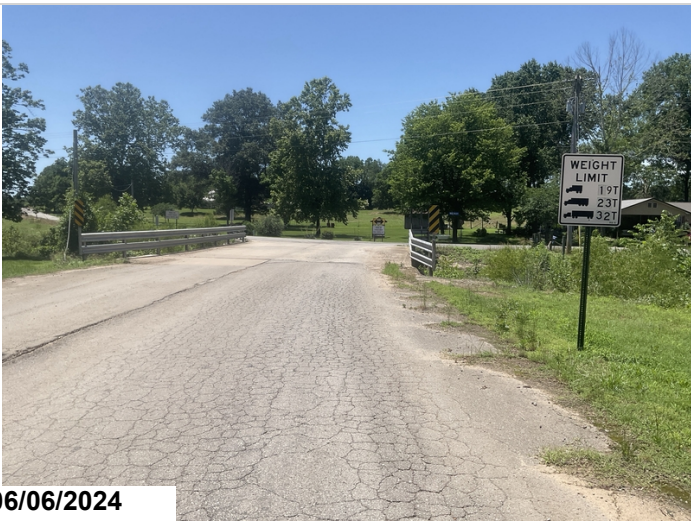
East approach load posting sign.

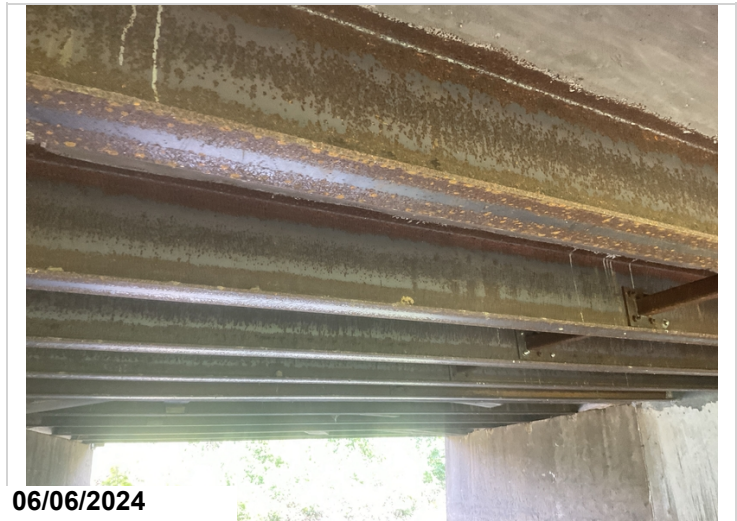
Old form work still in place over the majority of the original deck in span # 2.

Undersurface, Span # 2: typical.

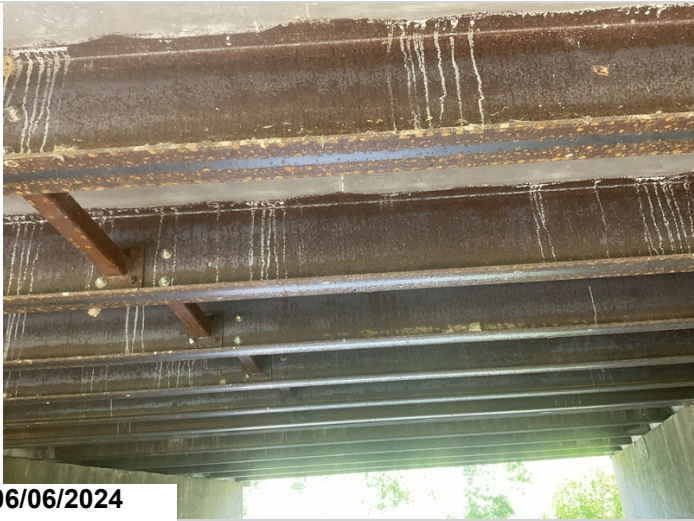
Span # 1: The original portion of span # 1 is partially covered with felt paper used during the construction process.

Undersurface, Span # 1: typical.

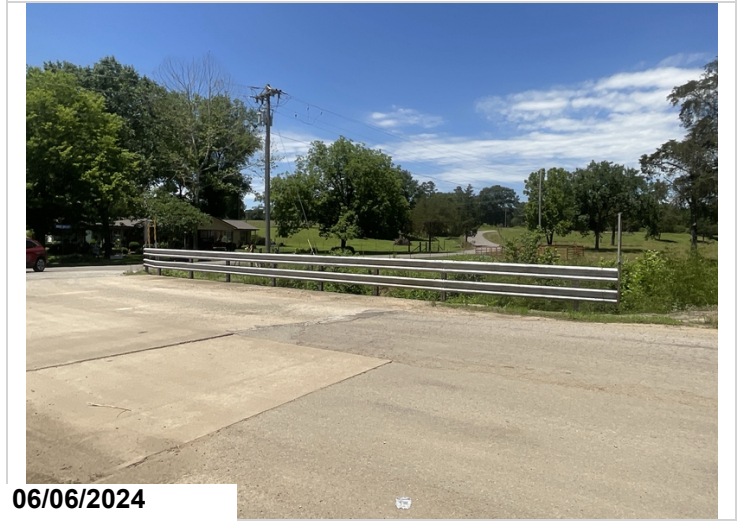
Bridge rail has been replaced in the past and has no apparent problems at this inspection.

Bridge rail: typical.

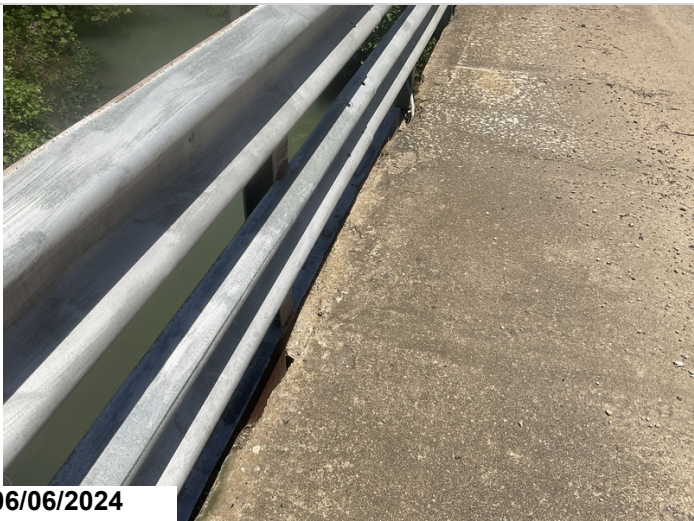
Span # 2, right: the edge of the deck in span # 2 has several spalls that are partially concealed by a steel channel where the bridge rail posts are attached to the deck. The spalled areas appear to be from past collision damage to the railing. The spalled areas in some locations expose steel cable used as reinforcing steel during the construction process. CS3

Span # 2, right: the edge of the deck in span # 2 has several spalls that are partially concealed by a steel channel where the bridge rail posts are attached to the deck.

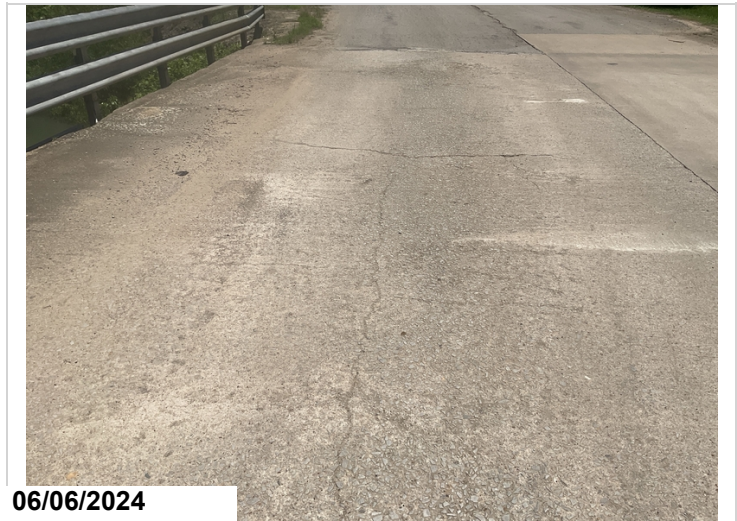
Full depth transverse and longitudinal cracks in the original portion of the deck (right side). CS2

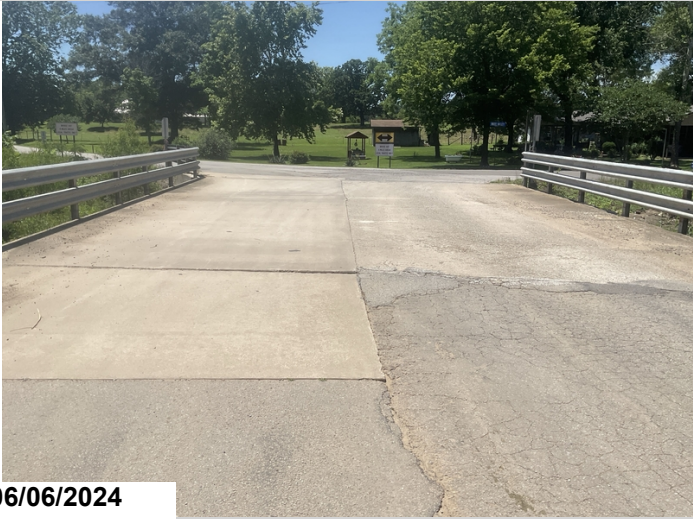
Driving surface: typical.

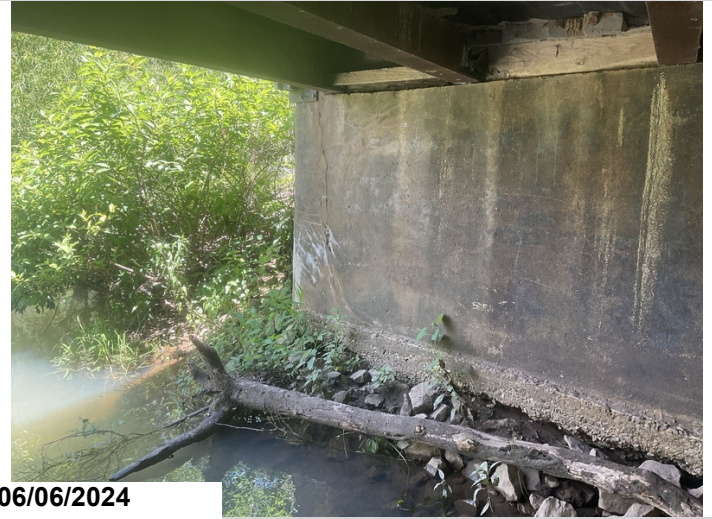
Abutment # 1 Rt stem wall has a wide full height vertical crack under the outside edge of the right exterior beam outside the bearing area. The crack is 1/4" wide measured 4" below the bridge seat. There is a 3/16" offset at the crack location.

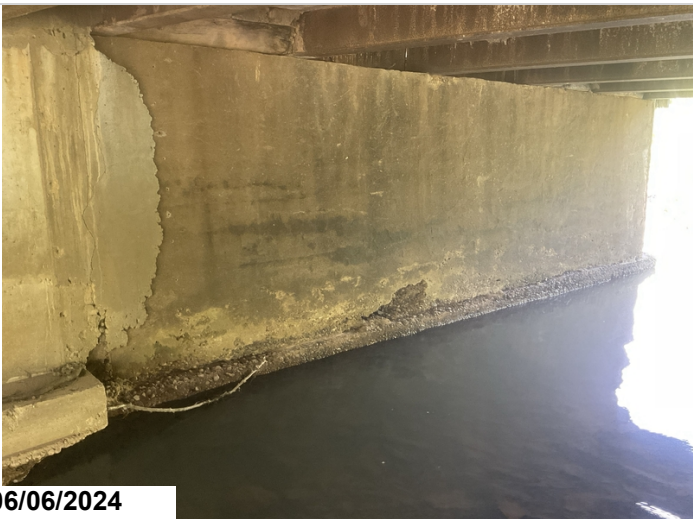
Bent # 2 backface has a 24" area concrete deterioration with approximately 4" of concrete section loss located approximately 8' Rt of centerline.

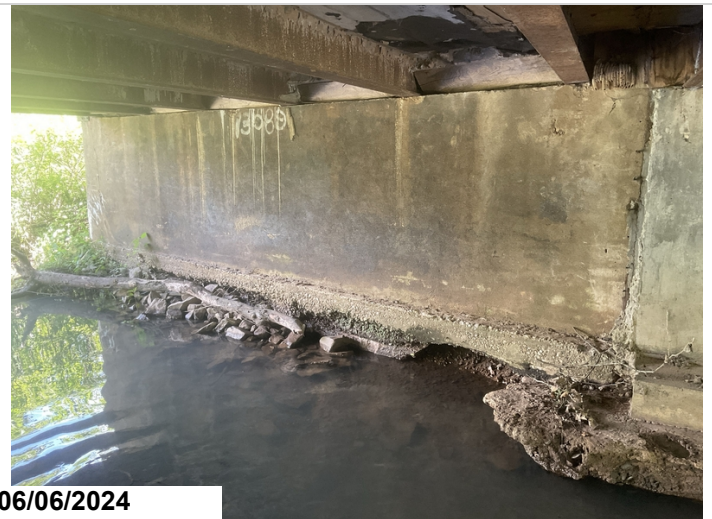
Abutment # 1 Rt footing has voids/concrete deterioration along the original portion of structure (right side). Worst case is adjacent to the North wing wall with one void that penetrates up to 3' under stem wall in one isolated location.

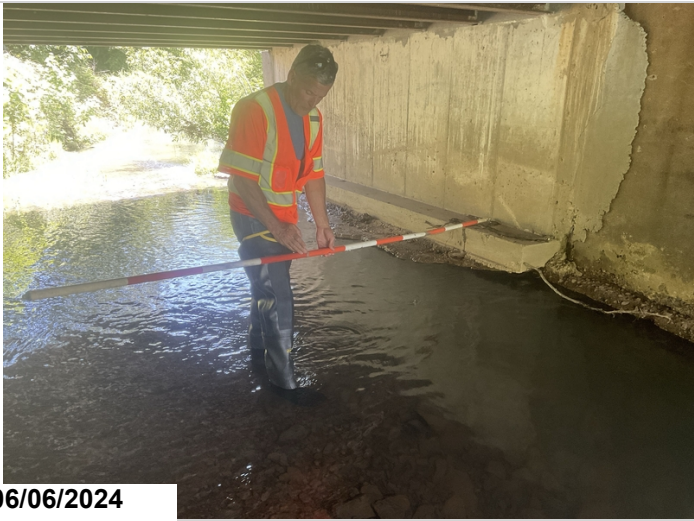
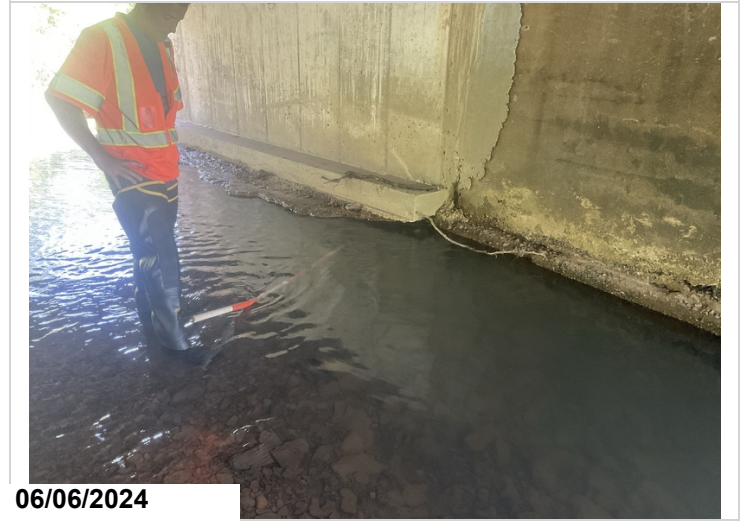
Bent # 2 has an area of full depth undermining to the new portion of pier wall left of centerline that extends approximately 6' in length at this inspection. The original portion of bent # 2 footing has voids along the footing that penetrate up to 2" under the pier wall in some locations. The inlet end of bent # 2 has voids that penetrate up to 12" under the pier wall.

Bent # 2, back: the footing has an area of full depth undermining to the new portion of pier wall left of centerline that extends approximately 6' in length at this inspection.

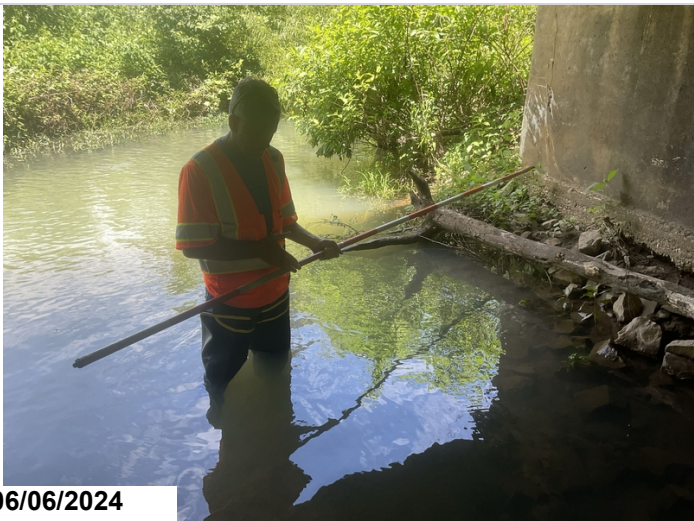
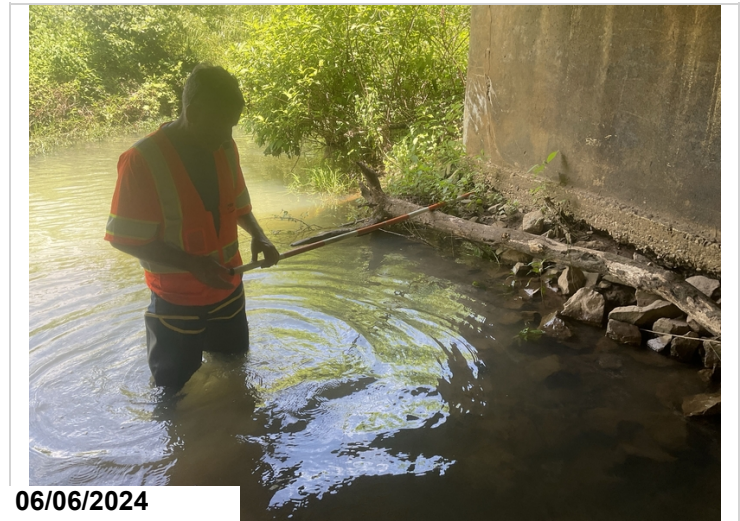
Abutment # 1 Lt footing is exposed with voids along and under the edge of the irregular footing. The Rt footing is exposed with concrete deterioration and voids under the footing. The Rt footing has concrete deterioration with a 6" void adjacent to the centerline construction joint. The right wing wall has a 3' deep void at the wing wall juncture.

Abutment # 1, right: The Rt footing has concrete deterioration with a 3' deep void adjacent to the right wing wall.

Abutment # 1, right: The Rt footing has concrete deterioration with a 3' void adjacent to the right wing wall.

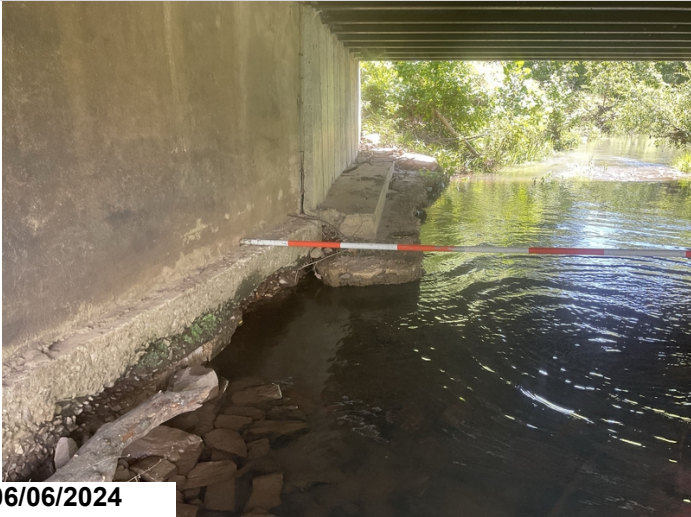
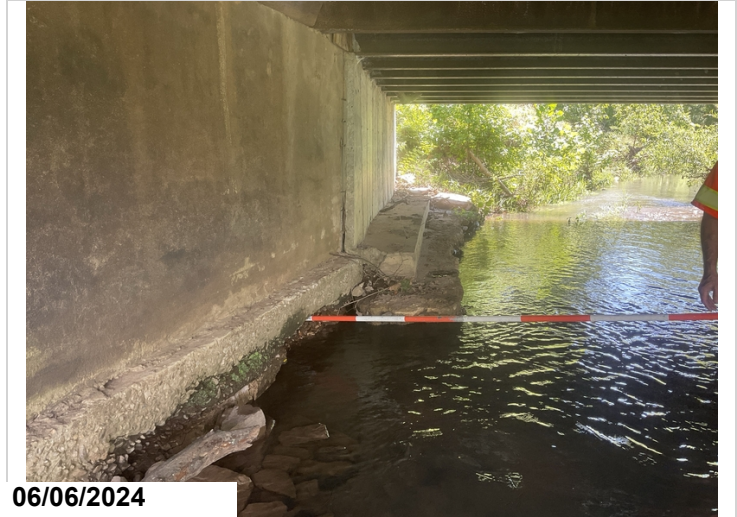
Abutment # 1, right: The Rt footing has concrete deterioration with a 6" void adjacent to the centerline construction joint.

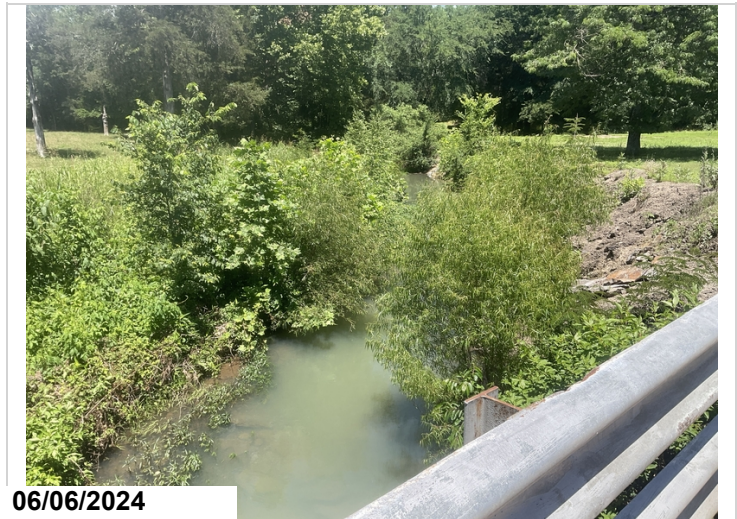
Upstream

The channel is generally in satisfactory condition, the banks have areas of erosion with trees and streambed material accumulation partially restricting the channel flow.

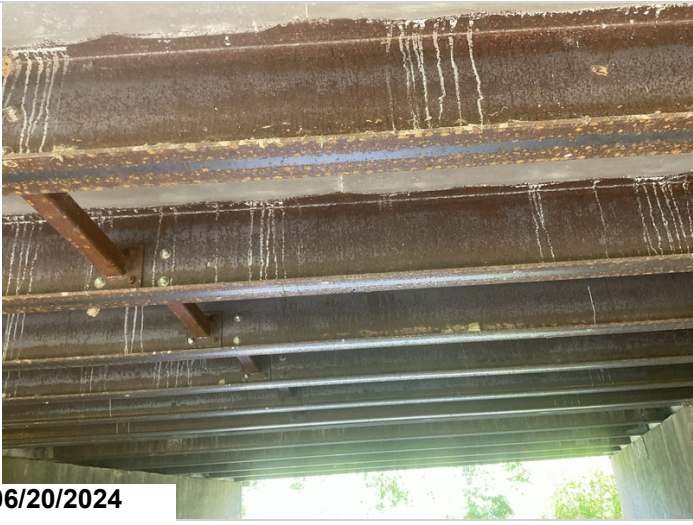
Undersurface, Span # 1: typical.

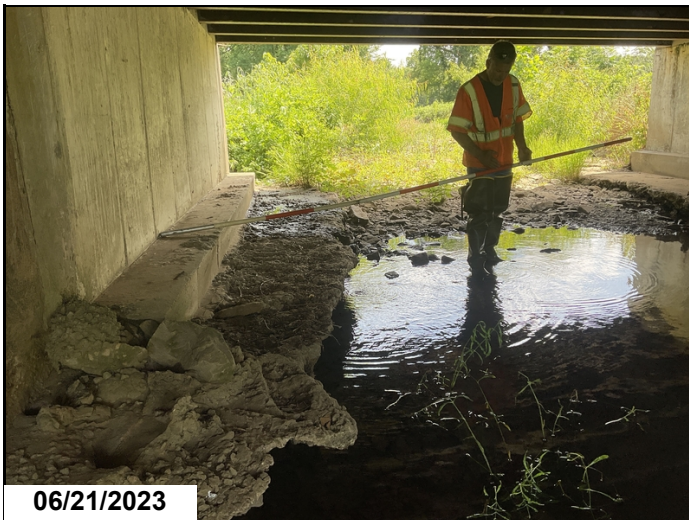
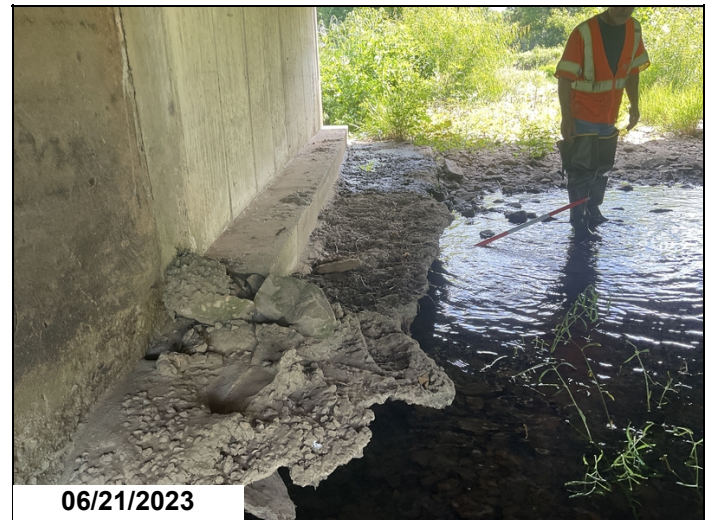
-Bent # 2 has an area of full depth undermining to the new portion of pier wall left of centerline that extends 6' - 8' in length measured along the length of pier wall. The inlet end of bent # 2 pier wall has voids that penetrate up to 12" under the pier wall.

Bent # 2 aheadface undermine scale.

Bent # 2 aheadface undermine.

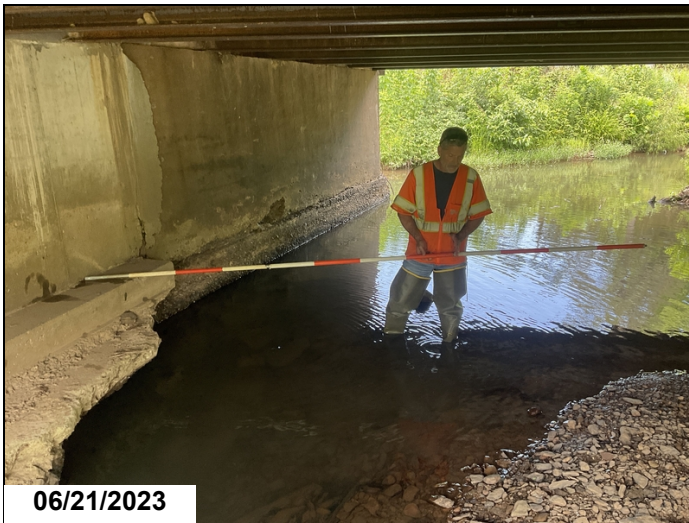
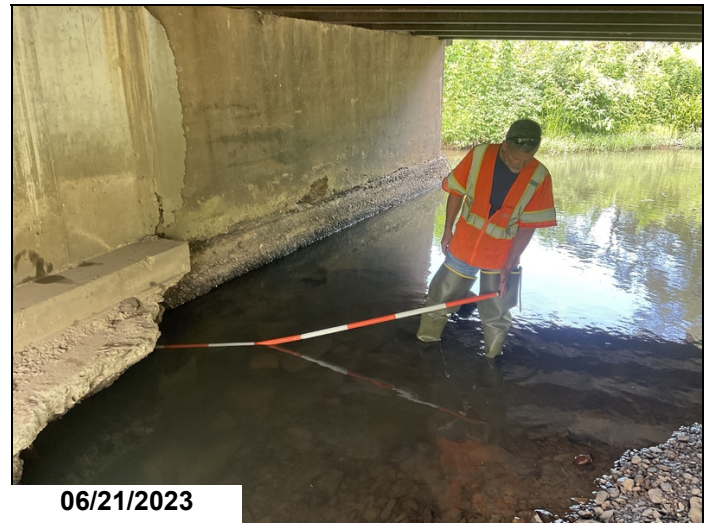
Bent # 2 backface undermine scale.

Bent # 2 backface undermine.

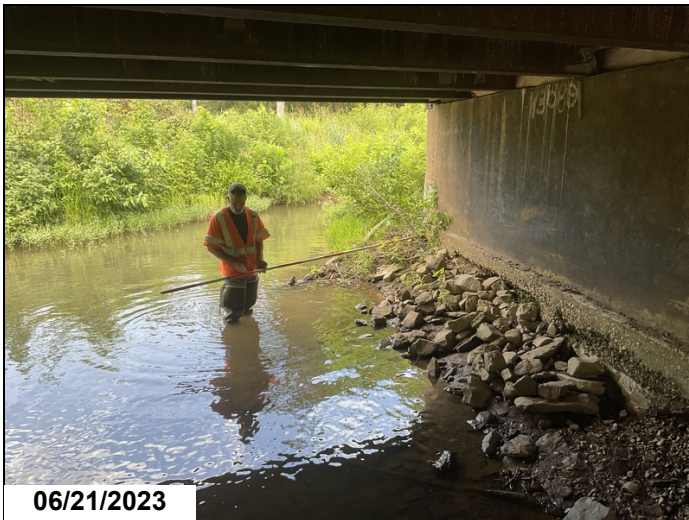
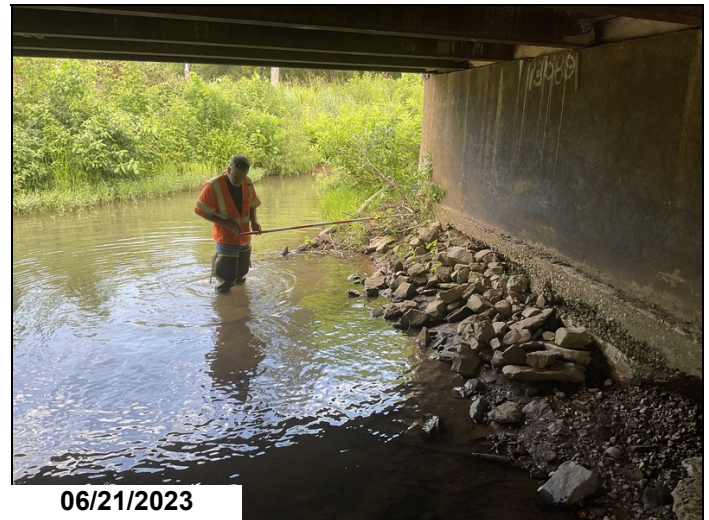
-Abutment # 1 (East Abutment) has voids that penetrate up to 3' past the face of abutment # 1 stem wall on the right end adjacent to the wing wall juncture.

Abutment # 1 Rt undermine scale.

Abutment # 1 Rt wing wall undermining.

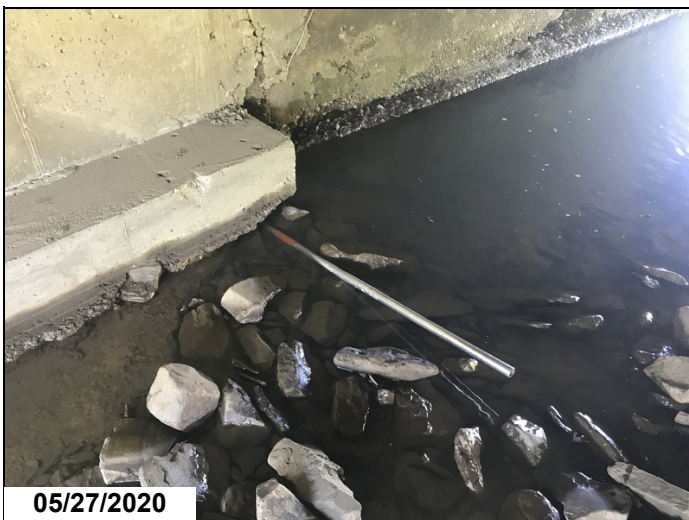
Bent 2 footing, span 1-Void under footing.

The substructure appears to be founded on creek gravel and soil with voids that penetrate under the footings.

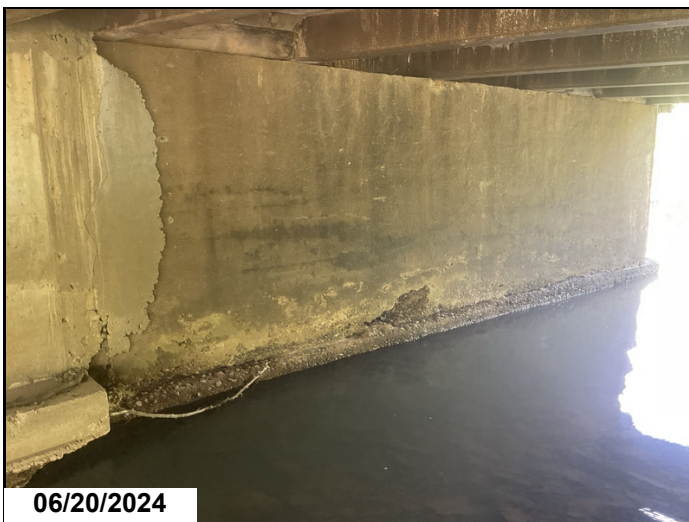
Bent # 2 backface has a 24" area concrete deterioration with approximately 4" of concrete section loss located approximately 8' Rt of centerline.

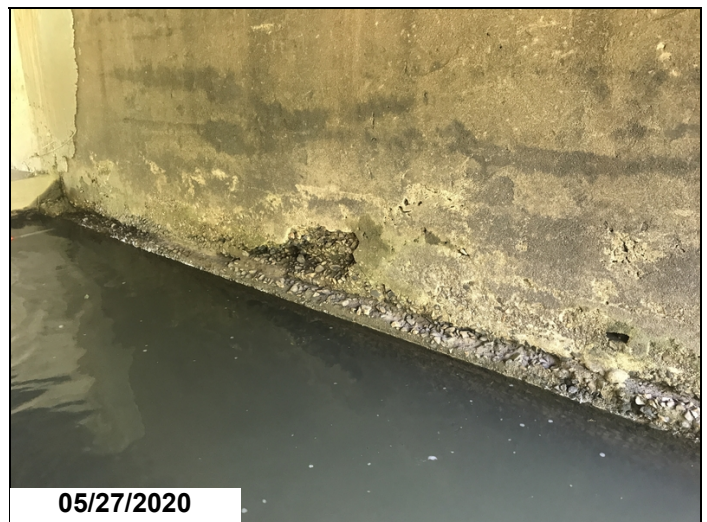
Rip Rap placed adjacent to the footings in the past as a scour countermeasure has been displaced.

The bases of the bent walls and the footings in the original portion of structure (Right side) have soft deteriorated concrete with concrete section loss. The substructure appears to be founded on creek gravel and soil with voids that penetrate under the footings.

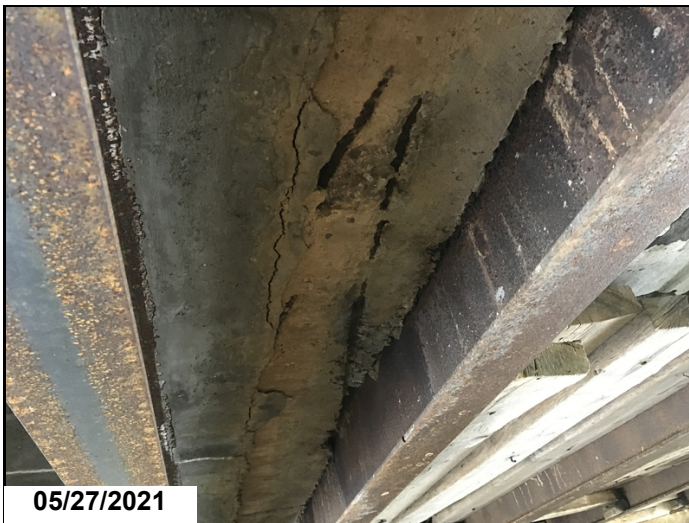
The undersurface of the original portion of deck has spalling between beams # 8 and # 9 with exposed cable used as reinforcing steel during the construction process. CS3

Span # 2, bay # 8-Exposed cable in deck undersurface.

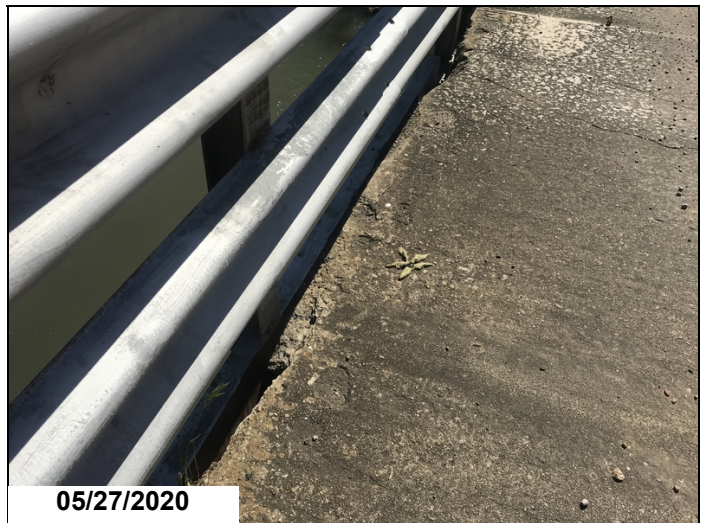
The original portion of the deck (Right side) has areas of spalling along the right edge in span # 2. The most extreme area is adjacent to bent # 2 which has a spall approximately 16" long X 5" wide with exposed wire rope that was apparently cast into the deck for reinforcement at the time of construction. There is an area of spalling in the undersurface between beams # 8 and # 9 with exposed cable used as reinforcing steel during the construction process.

Right side of deck-Spalling.

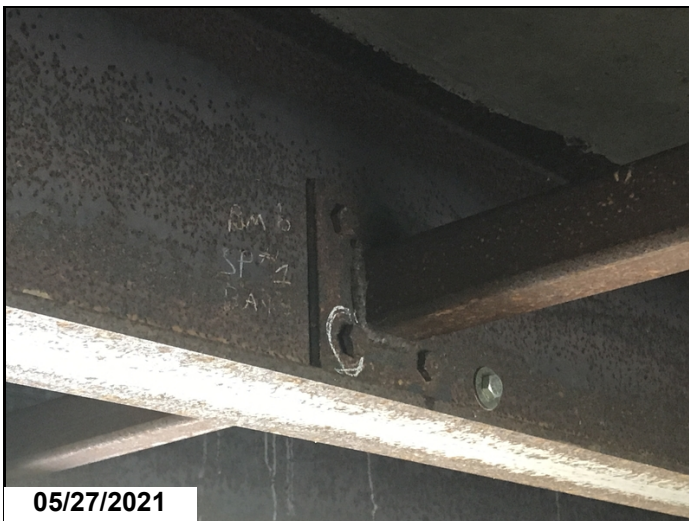
Diaphragm in span # 1 between beams # 6 and # 7 has a loose bolted connection where it attaches to beam # 6.

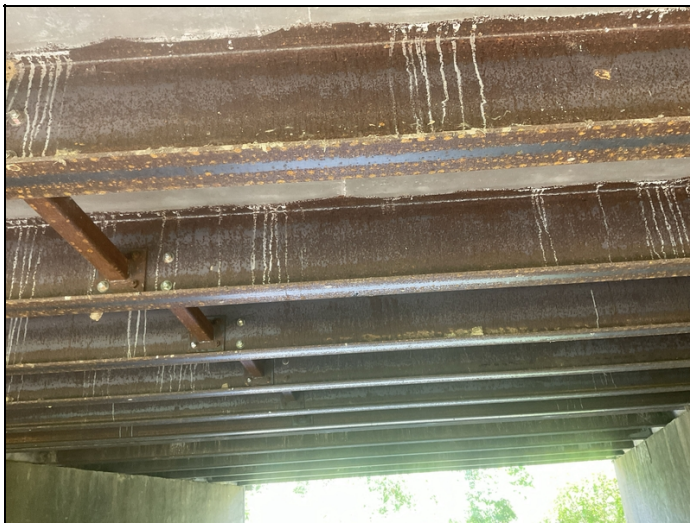
Beams have no paint system. The original beams have areas of corrosion with flaking rust in the bearing areas in a few locations. The new beams under the widened portion of the structure have mill scale and light rust forming.

Undersurface, Span # 1: typical.

A-60 - Full Girder Painting Needed (Yes)
