District: 4 Co.: 24 / Franklin Rte.: 67 Sect/Zone D Log Mile: 6.439 Str. No.: 13089

BRIDGE INSPECTION REPORT
FORM III

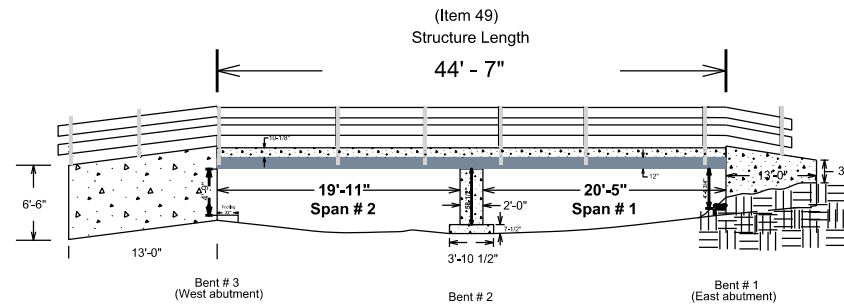
Elevation view of
Widened Portion of
Structure

Substructure skew inconsistent
