Asset #13184(Routine)

CR 111-H Moore Rd over ROCK CREEK

Location: 1.47MI NW HWY 70

Team Lead: Chris Doggett Inspection Date: 09/06/2023

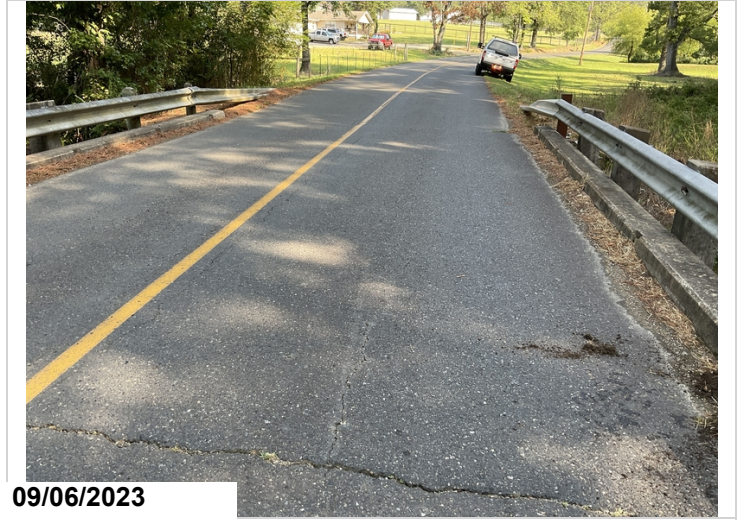
Longitudinal cracks in the asphalt wearing surface.

Deck view

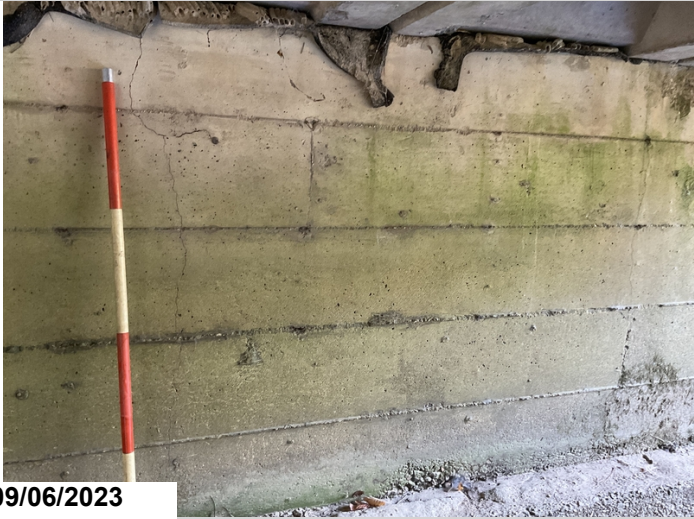
Bt. 2 has 2 vertical cracks & 1 spall below unit 6.

Bent 2: couple of vertical cracks in the abutment near mid span

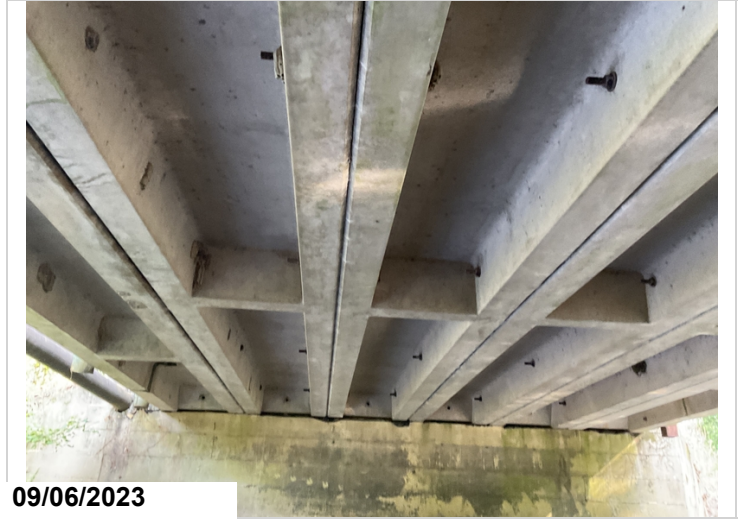
No signs of distress to the soffit.

Soffit view
