Asset #04603(Routine)

CR 2-AMITY RD over CLEAR CREEK

Location: .53 MI W GARLAND CO LINE

Team Lead: Shane Byrd, Inspection Date: 03/02/2021

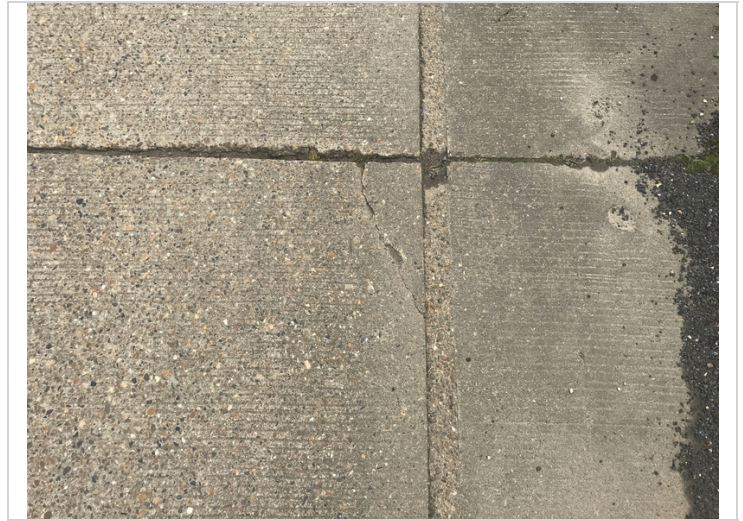
Unit 6 in both spans 1 & 2 have a crack on the ahead, right corner.

Comment: Unit 6 in both spans 1 & 2 have a crack on the ahead, right corner.

Span 1 unit 6 has crack in the ahead right corner common span 2.

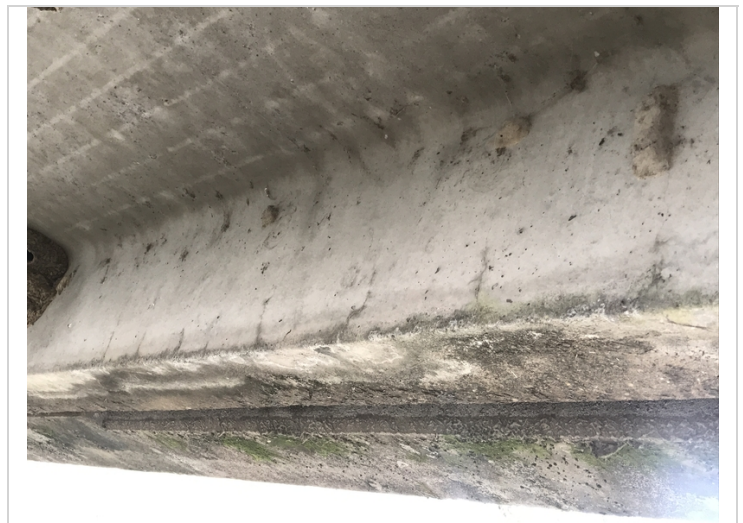
All units have small flexure cracks on bottoms of legs.

Comment: All units have small flexure cracks on bottoms of legs.

Span 2 unit 1 left leg has flexure cracks.
