Asset #20790(Routine, NSTM)
CR 60-B/COUNTRY CL over THOMAS CREEK

Location: 2.6 MI CR 60 & SH 9 JCT

Team Lead: Chris Doggett Inspection Date: 11/16/2023

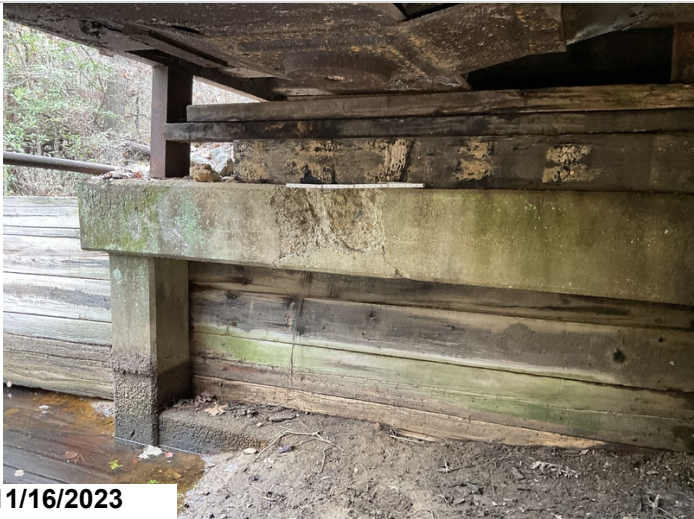
Timber cap at bent 1 is rotting on the north side, bent 6 concrete abutment has two spalls. Channel profile and sounding sheet attached to Sketch tab.

Bent 6: spall in cap under the left car. 2023

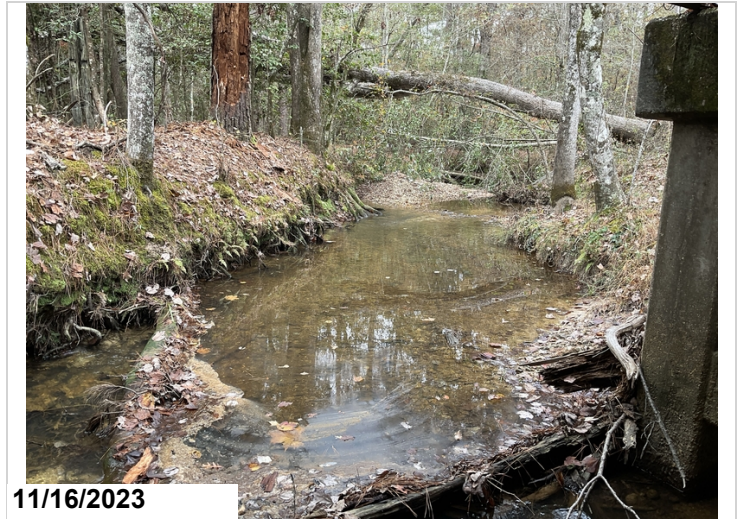
Channel looking upstream

Bank protection is being eroded.

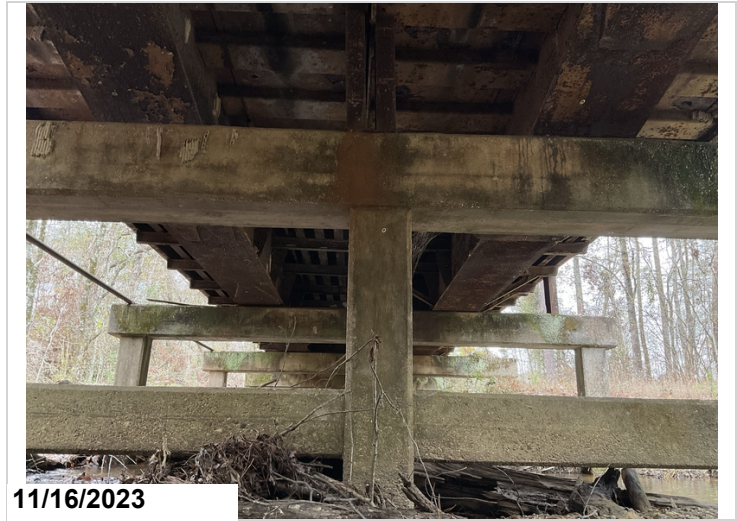
NSTM

All elements have minor corrosion with minor pitting.

A-60 - Full Girder Painting Needed (Yes)

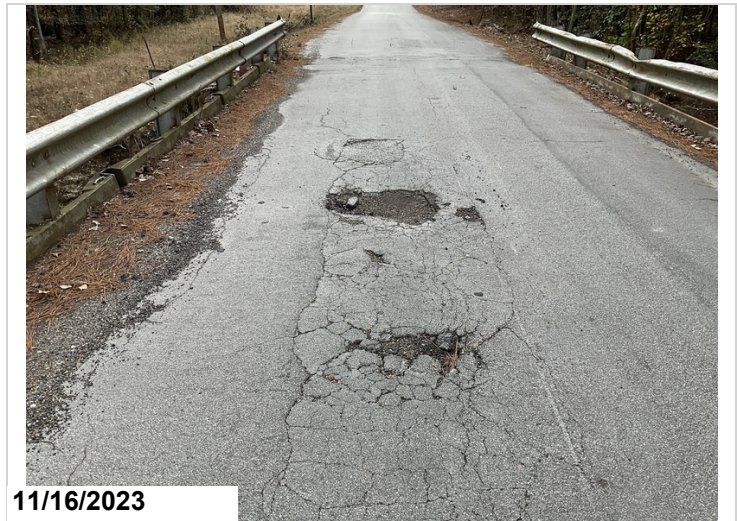
Pot holes in the asphalt wearing surface on the east side

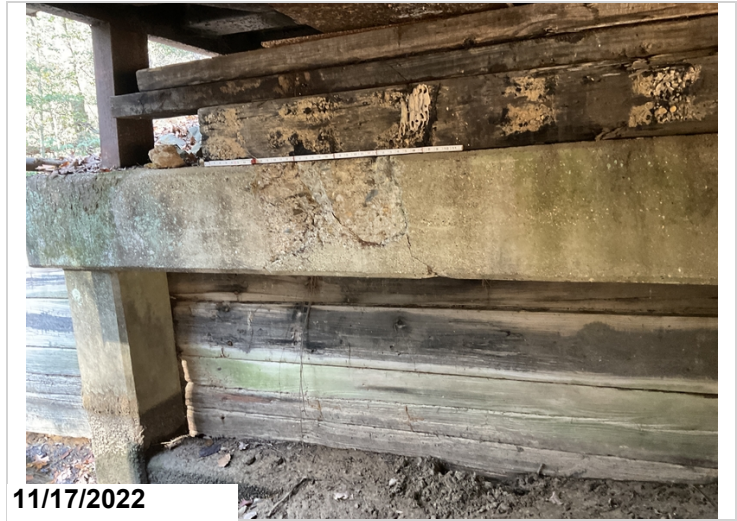
Bent 6: Spall to face of cap between columns 1&2.

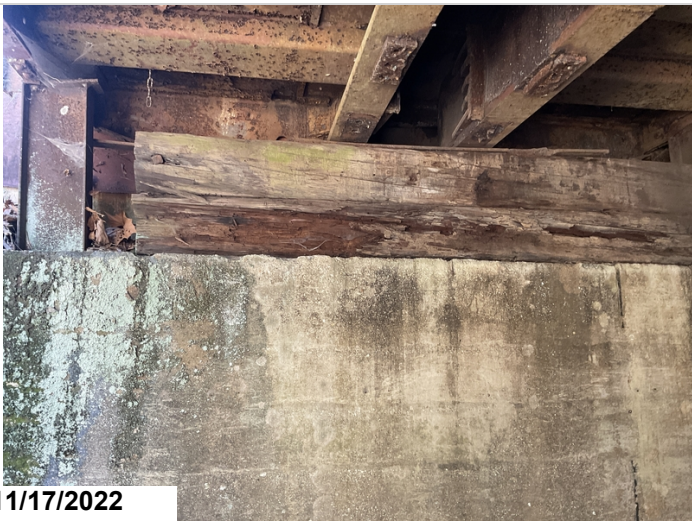
Bent 1: Timber cribbing beginning to have some rot on the end

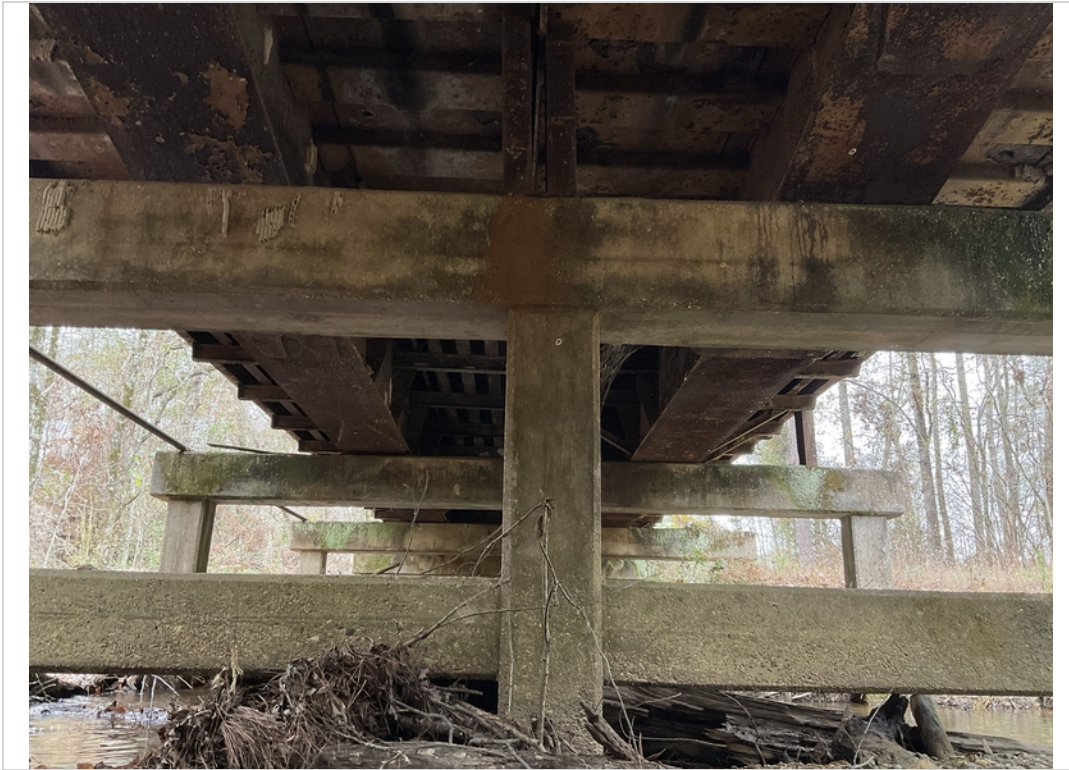
NSTM

All elements have minor corrosion with minor pitting.
