Asset #20976(Routine, NSTM)

CR324/Country Club over CLEAR CREEK

Location: 4.5 MI W GRANT CO. LINE

Team Lead: Keith Harris Inspection Date: 11/13/2024

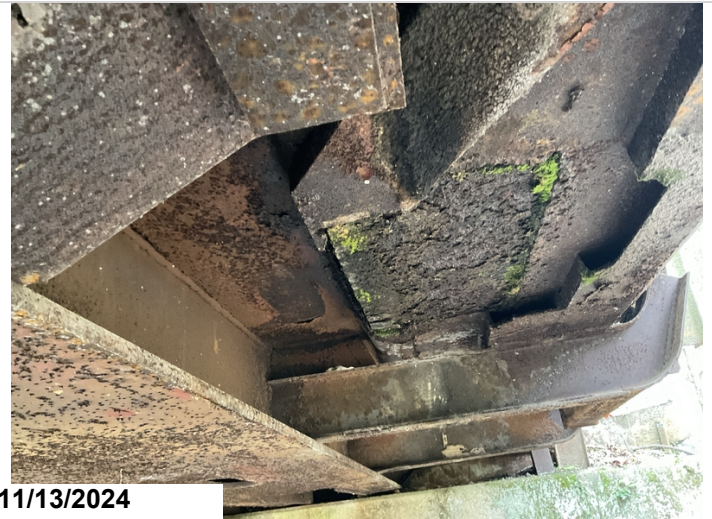
Steel deck has active corrosion and with section loss.

Left car 10' away from bent 1, active corrosion with section loss.

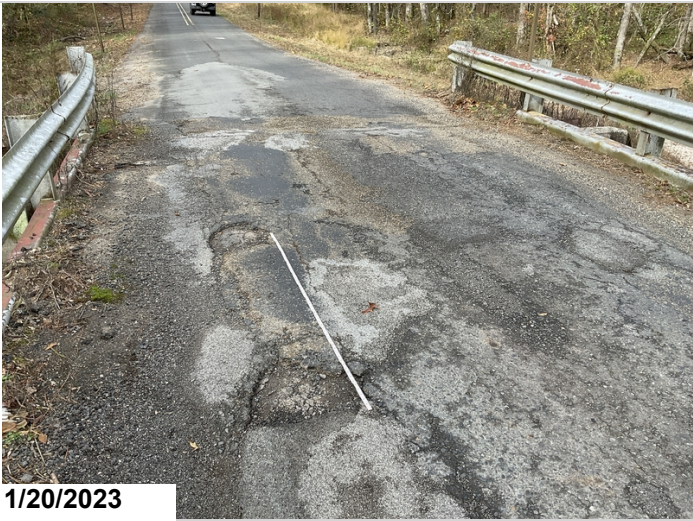
11/20/2023

Wearing surface has small potholes, patches and large cracks.

Multiple pot holes in the asphalt overlay

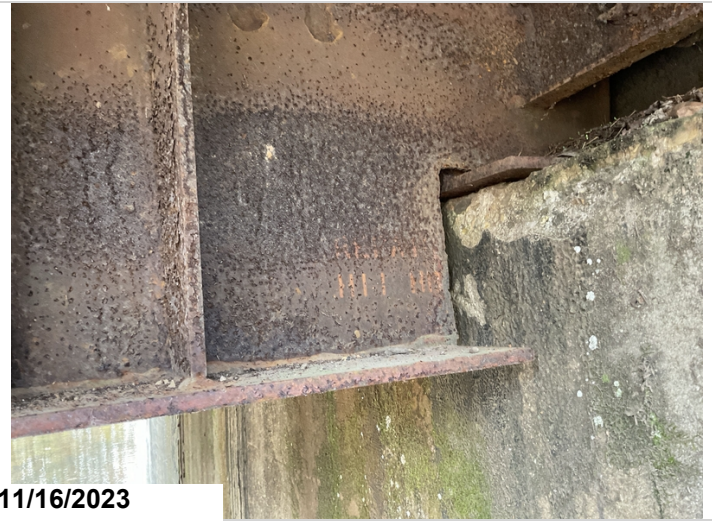
11/16/2023

Both cars have minor pitting to center sills. Bent 1, left car: both left and right car center sills are notched to fit the abutment.

Special attention was given to these coped areas.

Bent 1, left car: both left and right car center sills are notched to fit the abutment. Special attention was these coped areas.

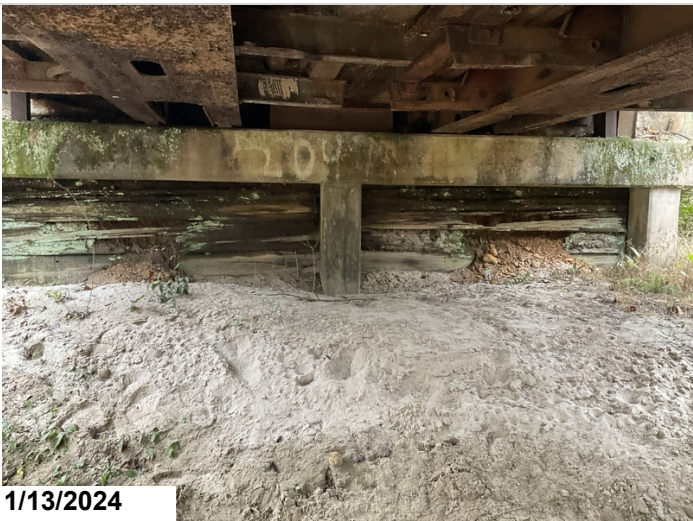
11/13/2024

Bent 1 timber cribbing has severe decay allowing embankment to spill through.

Bent 1, timber cribbing: severe decay allowing embankment to spill through. 2024

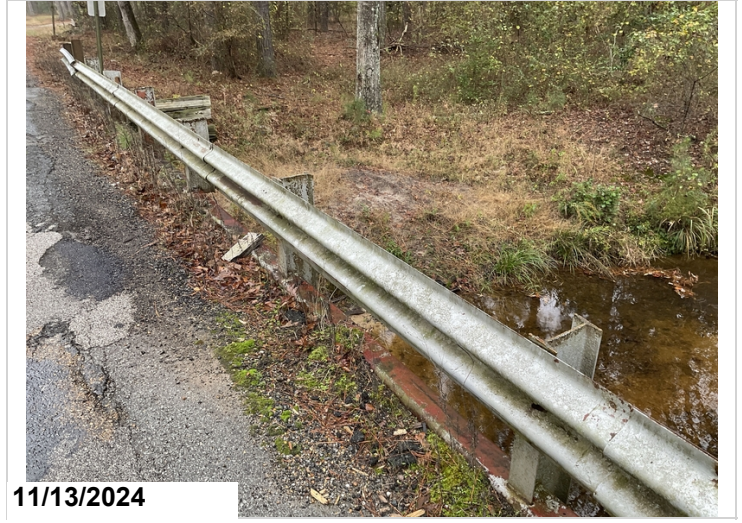
Debris in both gutters

A-55 - Deck Washing Needed (Yes)

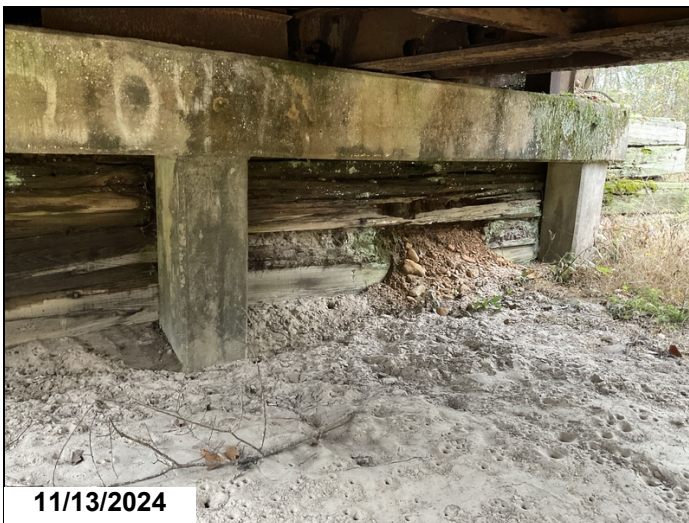
Bent 1, the timber cribbing has severe decay. Embankment is beginning to spill through the decayed cribbing.

Bent 1: timber cribbing has rotted to where backfill is
spilling through
2024

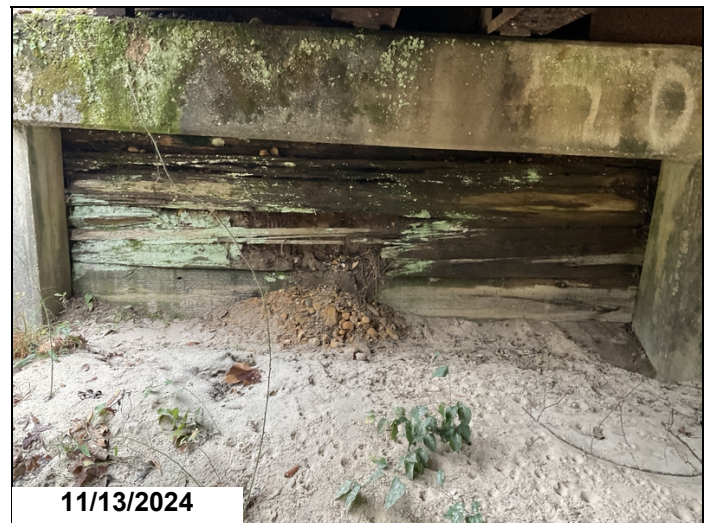
Bent 1: timber cribbing has rotted to where backfill is
spilling through
2024

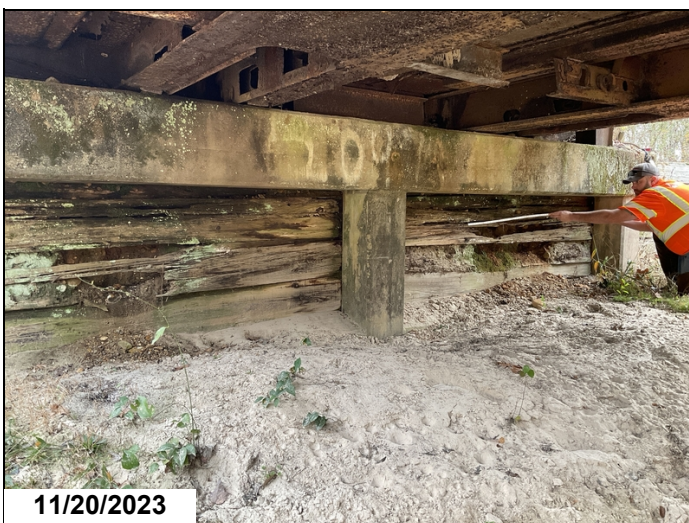
Bent 2, timber cribbing: severe decay allowing
embankment to spill through. 2023

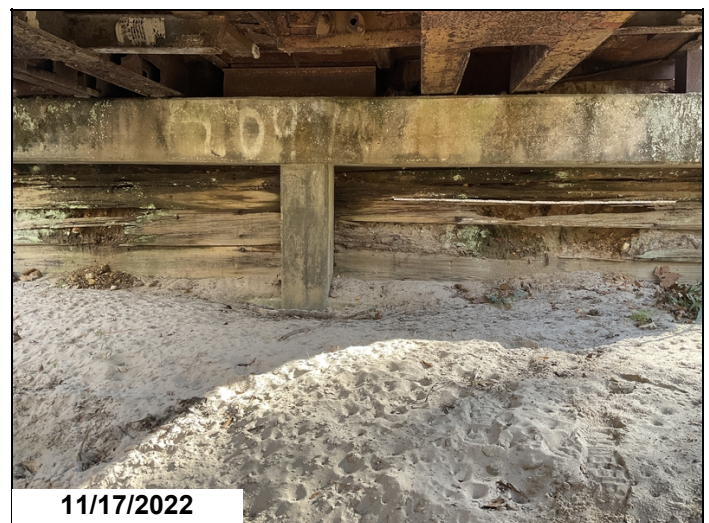
Bent 1: timber cribbing has rotted to where backfill is
spilling through
2022

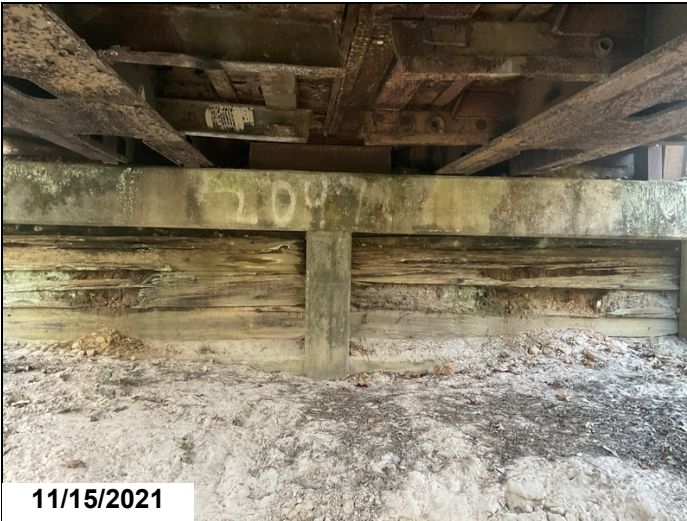
Bent 1, the timber cribbing has severe decay. Embankment is beginning to spill through the decayed cribbing.

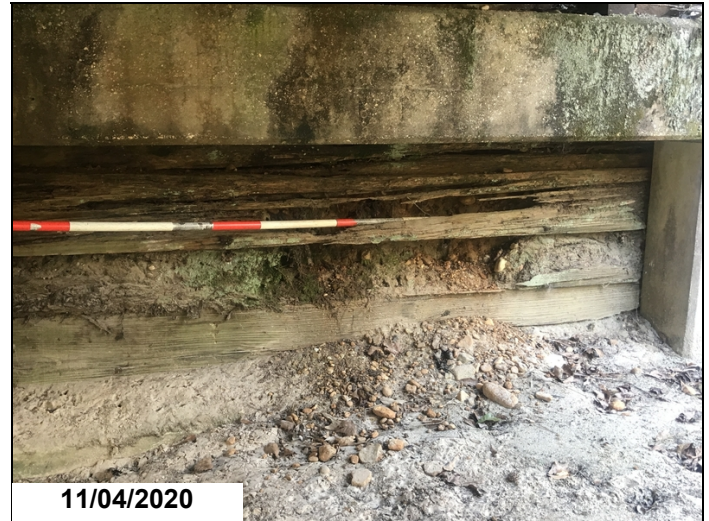
Bent 1 timber cribbing has severe decay allowing embankment to spill through.

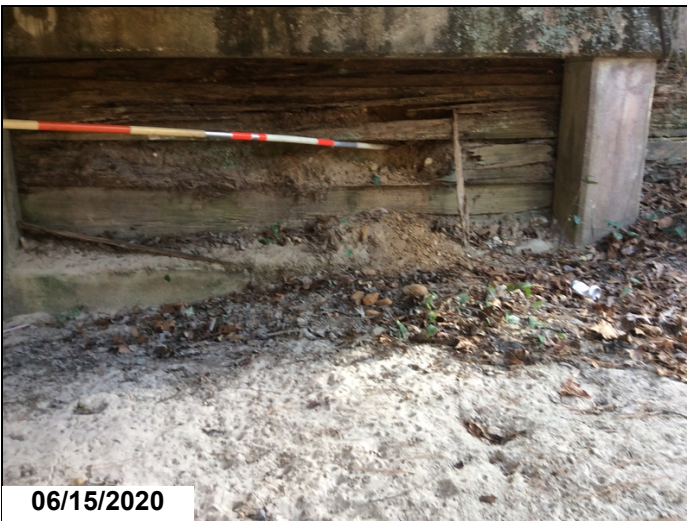
Bent 1 timber cribbing has severe decay.

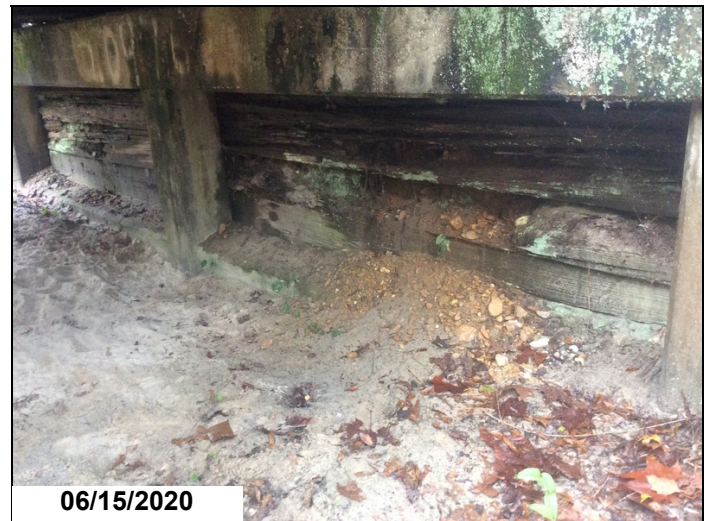
Bent 1 timber cribbing, severe decay allowing embankment to spill through.

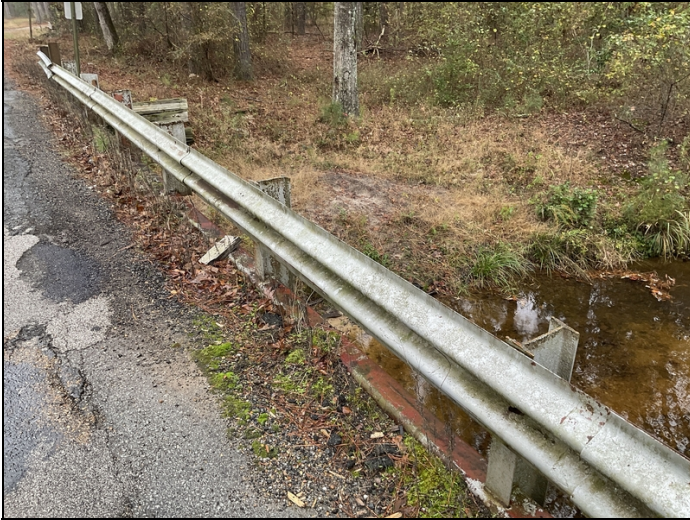
Debris in both gutters

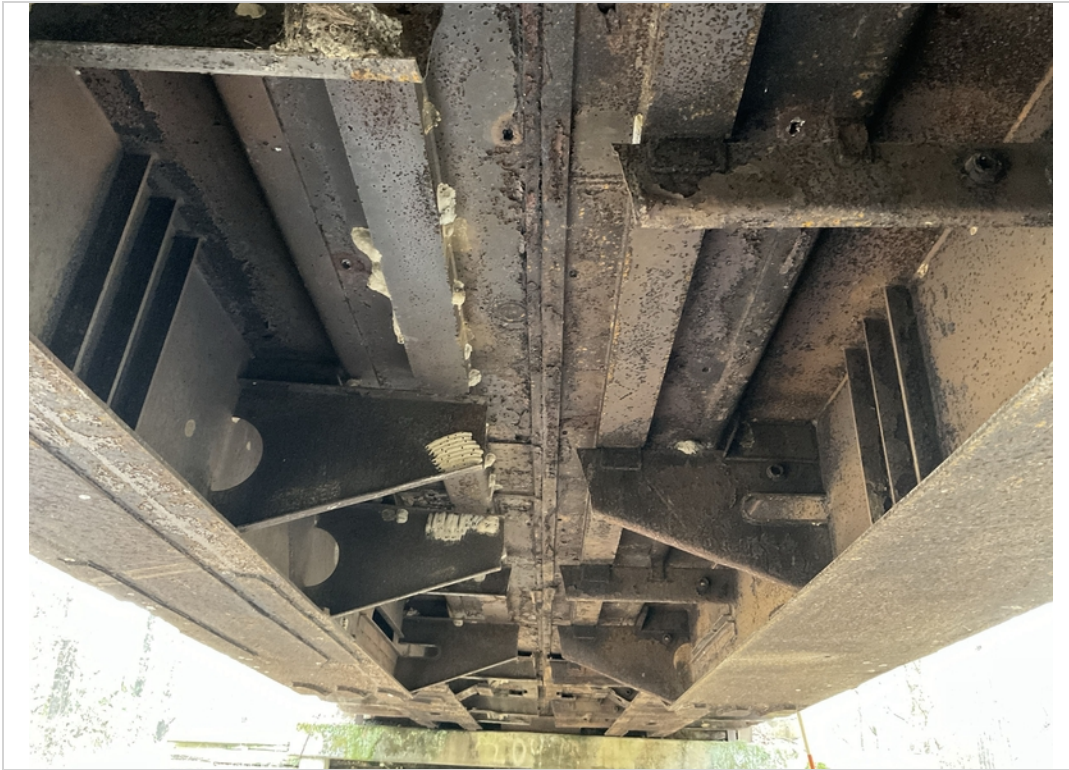
NSTM

Both cars have minor pitting to center sills.

Bent 1, left car: both left and right car center sills are notched to fit the abutment.

Special attention was given to these coped areas.
