**Asset #24300**(Routine, Underwater type 2)

**Country Club Rd. over creek**

**Location: M CR 60 & SH 9 JCT**

**Team Lead:** Chris Doggett **Inspection Date:** 08/29/2023

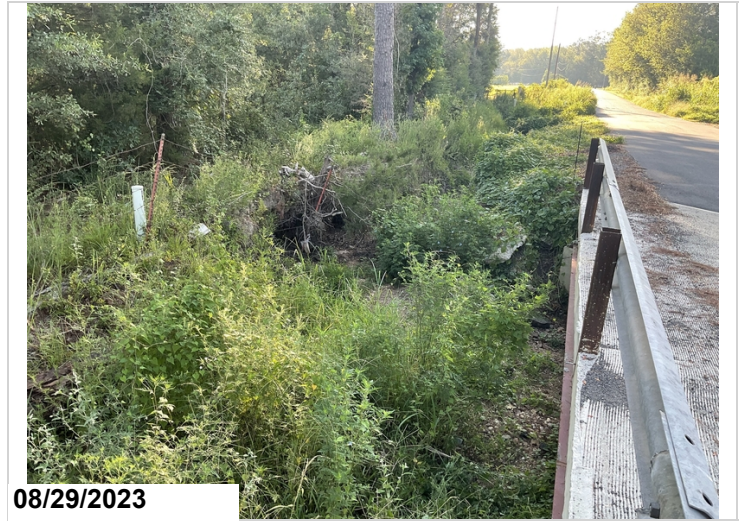
Channel looking down stream

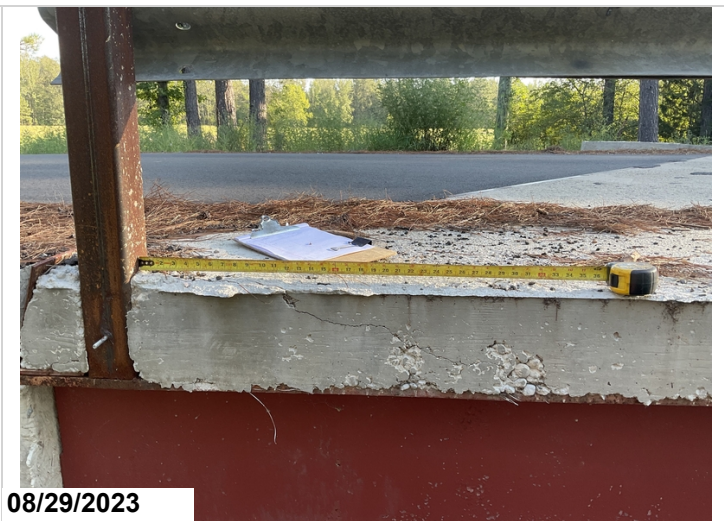
The bridge deck is in good condition. There is a delamination on the south west corner.

Deck at bent 2: delam to the deck.

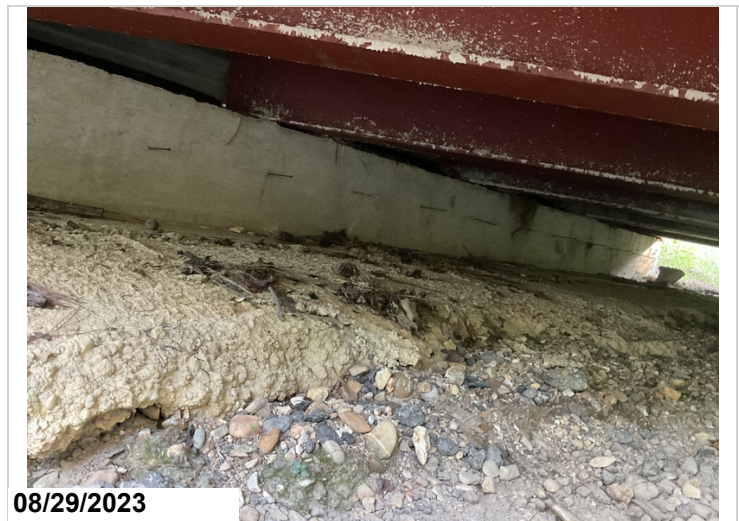
Both abutments are in good condition.

Bent 1 abutment.

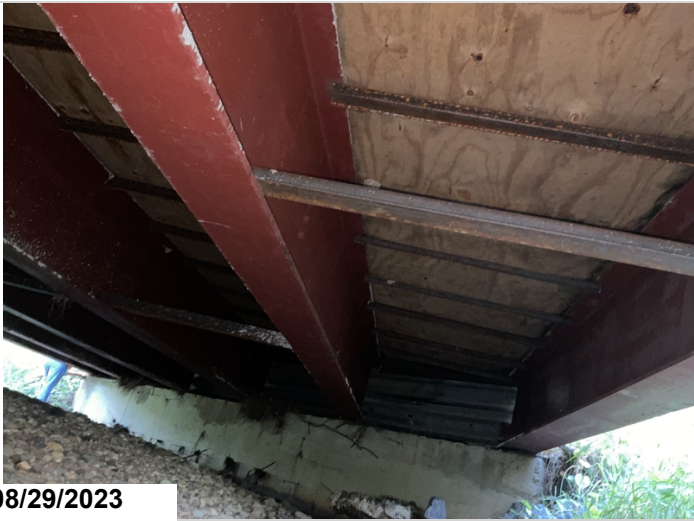
Beams on the structure are used painted steel beams

Soffit view

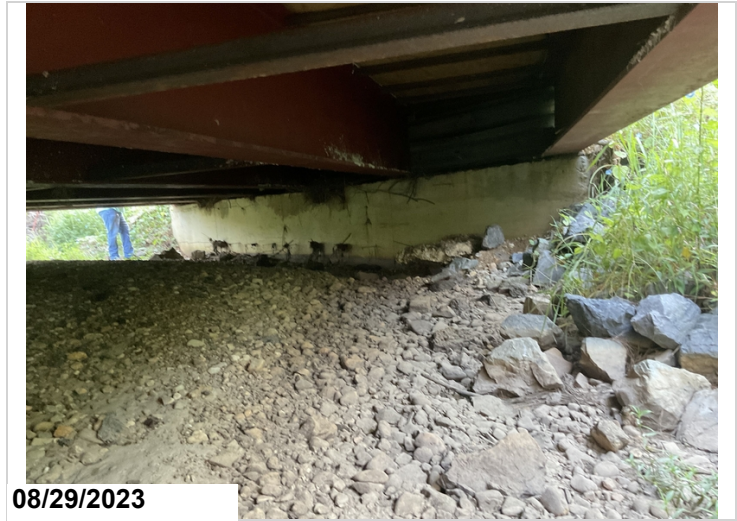
Bent 2 abutment

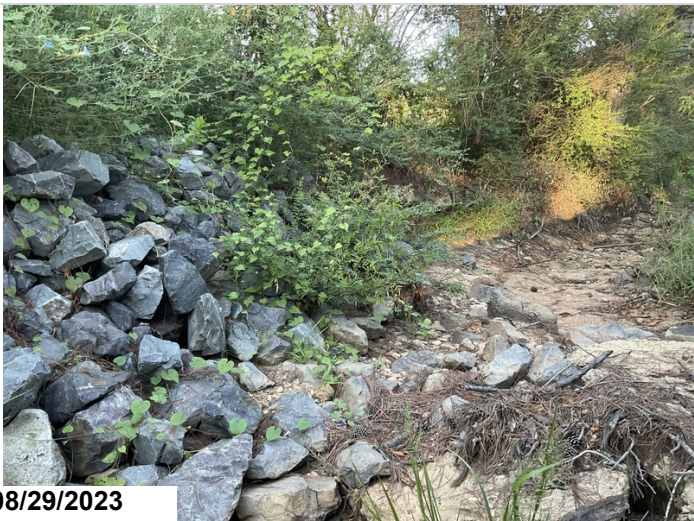
Channel looking upstream

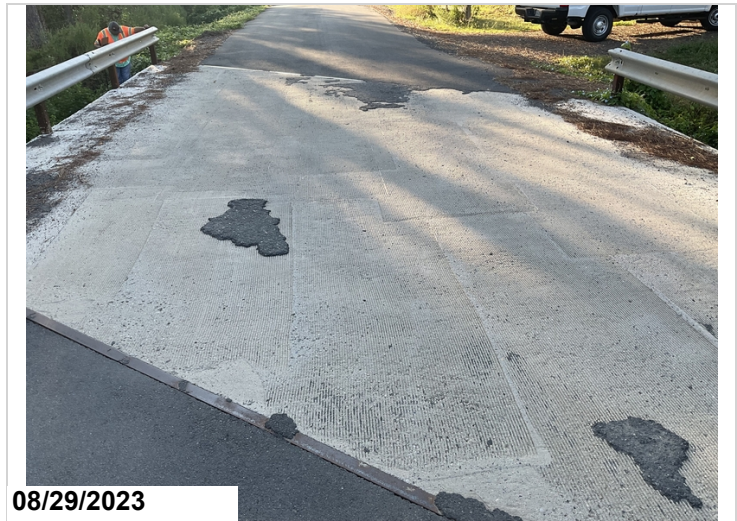
Deck view.

**A-55 - Deck Washing Needed (Yes)**

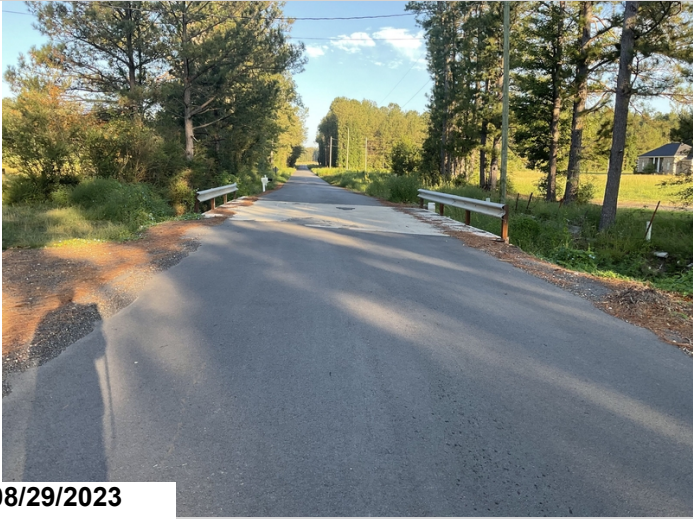
Inventory looking west
