Bridge 23494 Inspection Report

Sycamore Road over Caney Creek

Location: 3 MI N.W. of Caney

Team Lead: Keith Harris Inspection Date: 01/14/2026

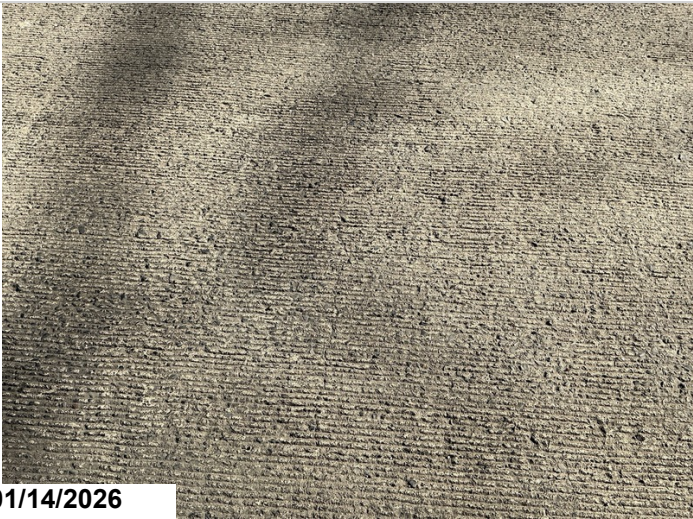
Stay in place forms have minor corrosion. Two transverse cracks in the concrete deck.

Transverse crack in the deck.

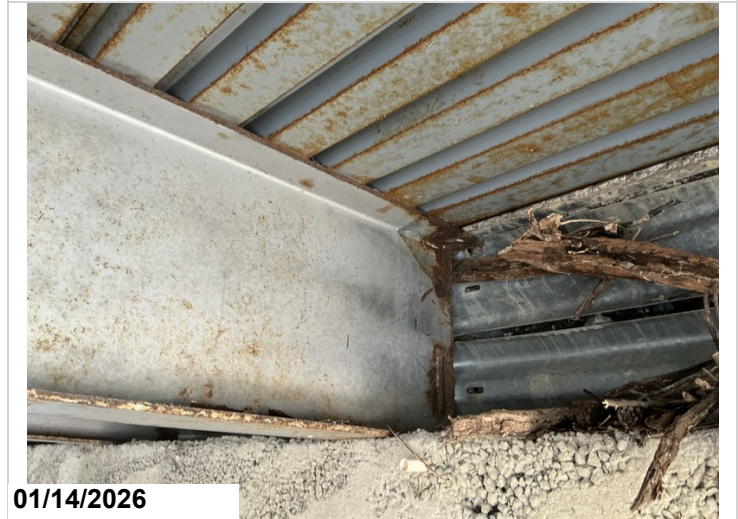
Bent 2, girder 4: girder ends with small amount of active rust.
This is common to all girders ends at both bents.

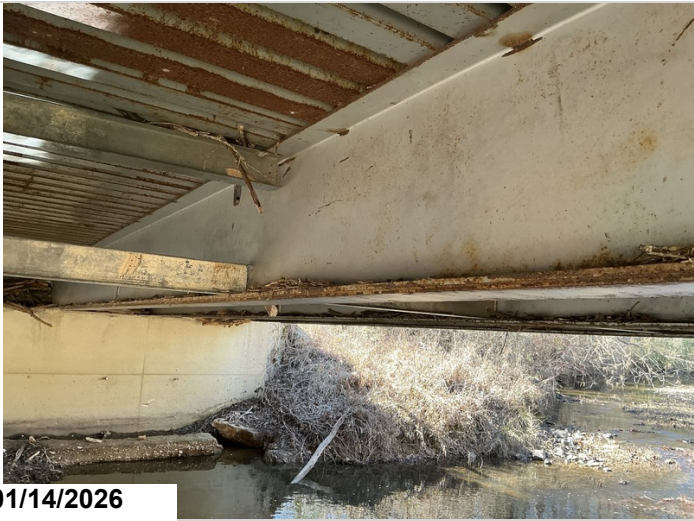
There are scattered areas of surface rust on all girders and holes were cut in the top of the web of all girders at mid span. Girders have cover plates.

All girders have areas of freckling rust.

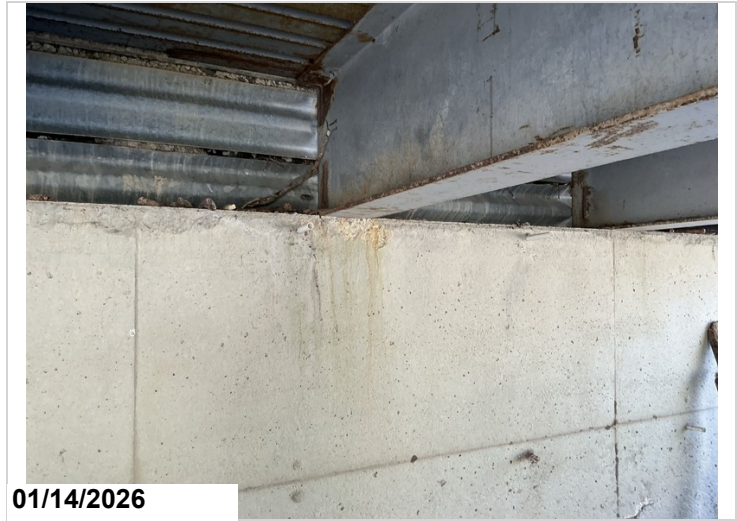
Bent 1 spall under girder 3.

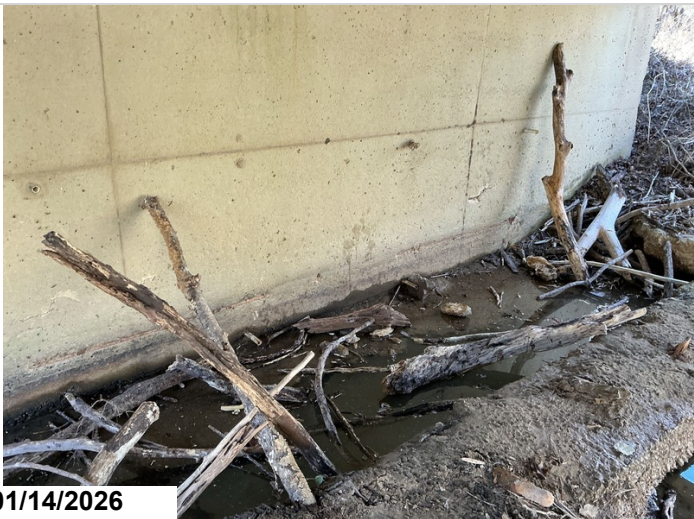
Bent 1 has exposed rebar on bottom face of abutment.

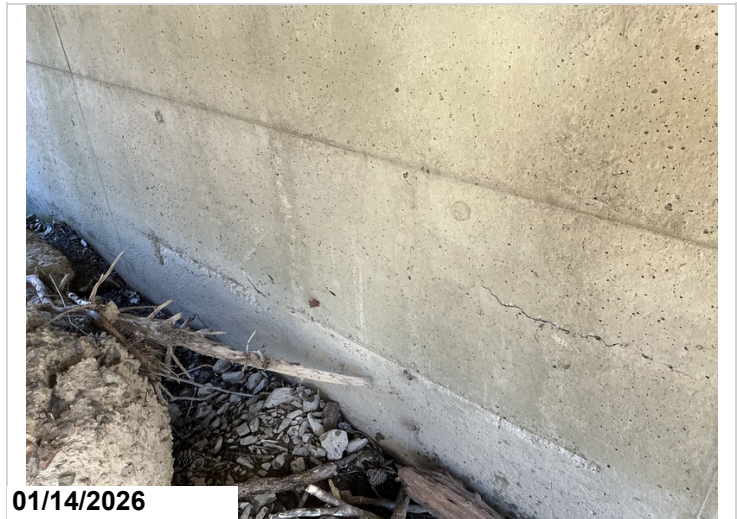
Bent 2 has large honeycomb areas and 4' of exposed rebar.

Bent 2: the entire length of the abutment has exposed rebar and honey combing.

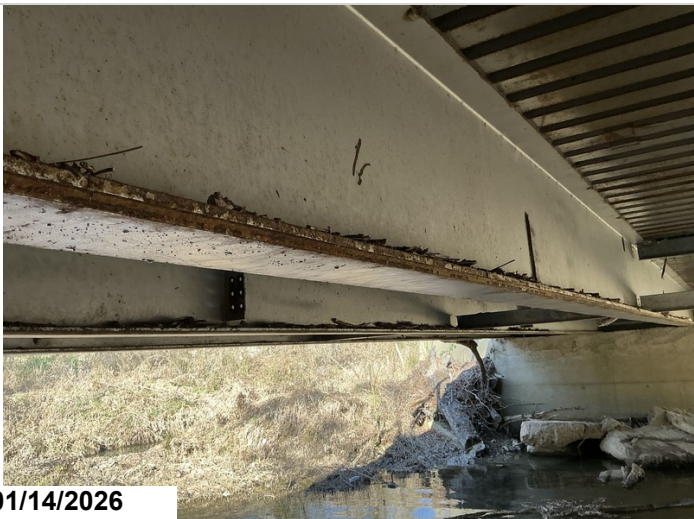
All girders have scattered areas of corrosion.

A-60 - Full Girder Painting Needed (Y)

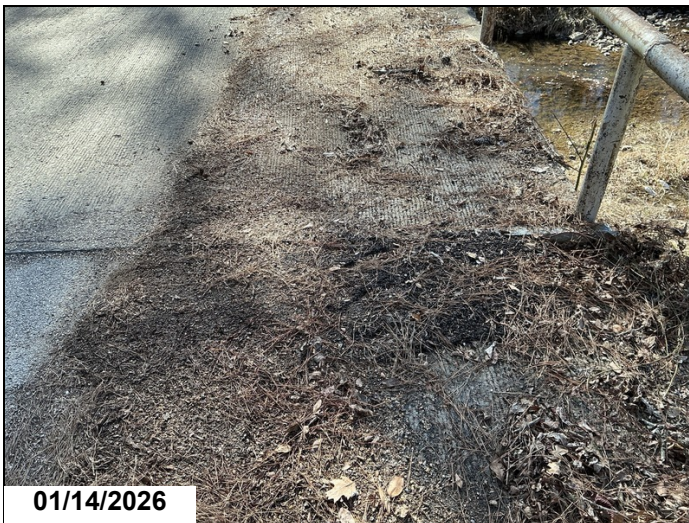
Approach slabs on both ends of bridge have settled 1"

County has placed asphalt where approach settled.

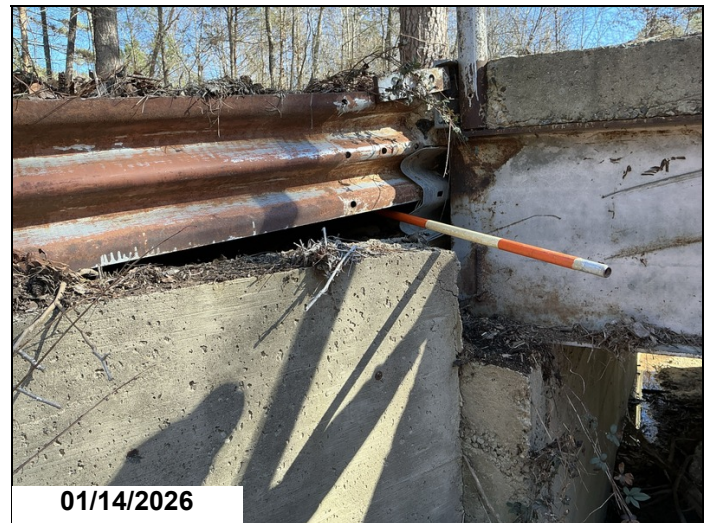
Northwest corner of bridge, approach slab is undermined 8' under roadway. Void is approximately 8" deep

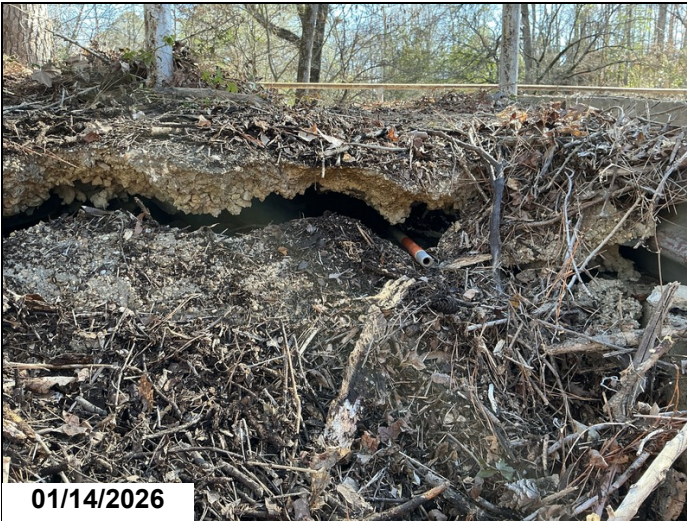
Bent 1 approach slab has settled 1".
Approach slabs is undermined up to 3' by 8" deep.

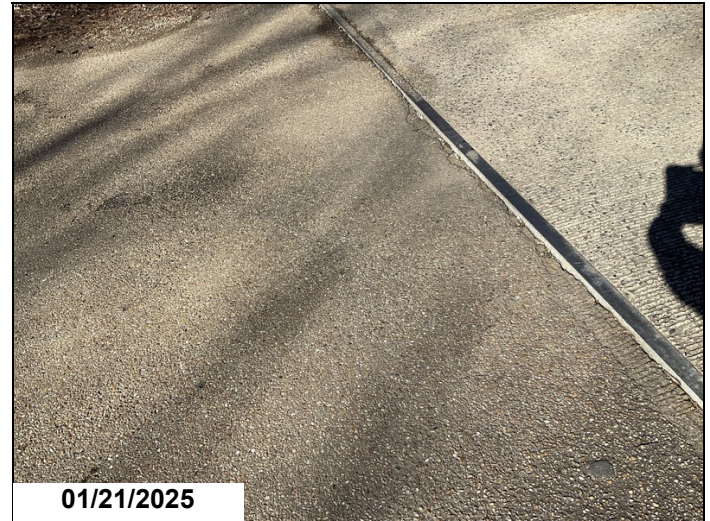
Bent 1 approach slab has settled 1".
Approach slabs is undermined up to 3' by 8" deep.

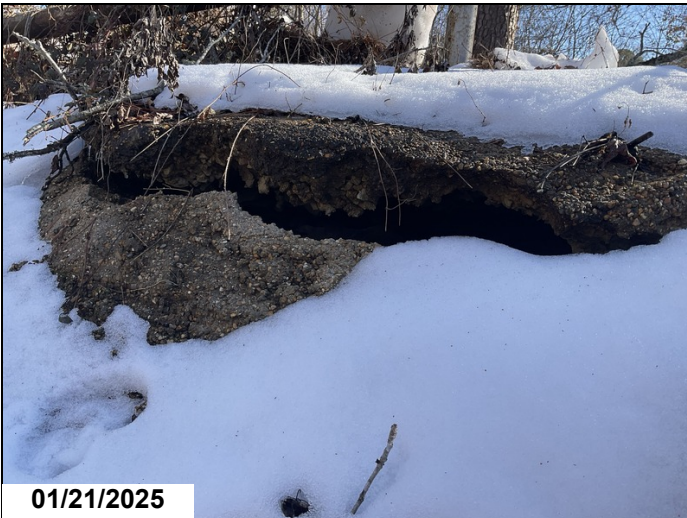
Northwest corner of bridge, approach slab is undermined
8' under roadway. Void is approximately 8" deep

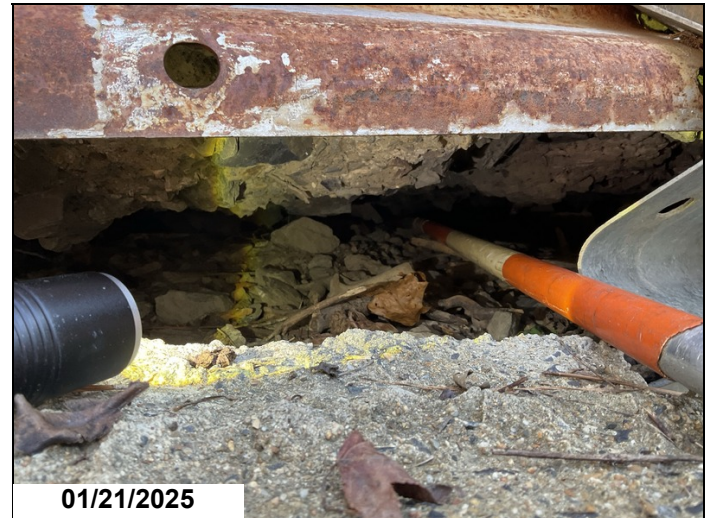
Northwest corner of bridge, approach slab is undermined
8' under roadway. Void is approximately 8" deep

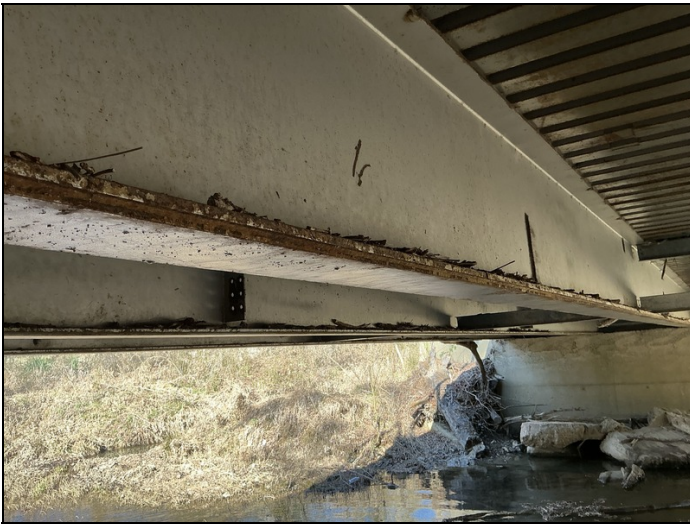
All girders have scattered areas of corrosion.

A-60 - Full Girder Painting Needed (Yes)
