**Asset #13878**(Routine, Underwater type 2)

**CR2/BRIGHT STAR RD over MINE CREEK**

**Location: 1.38 W SH 355**

**Team Lead: Jared Kegley Inspection Date: 12/11/2023**

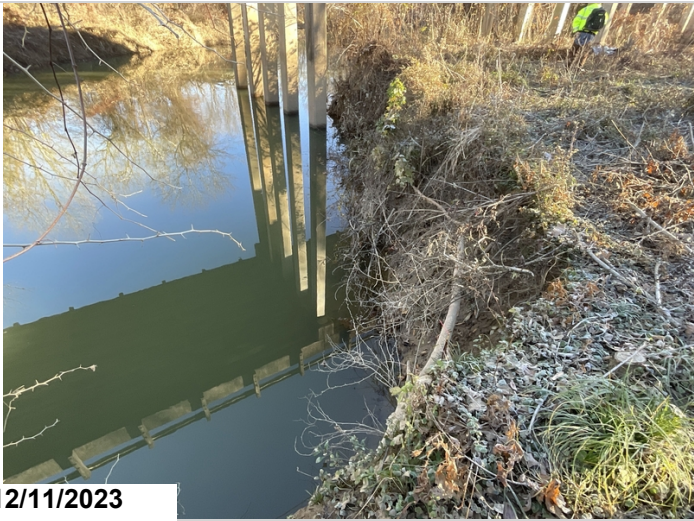
Scour is rated a 6 this inspection due to isolated moderate scour around bent 6.

Scour to bank around bent 6

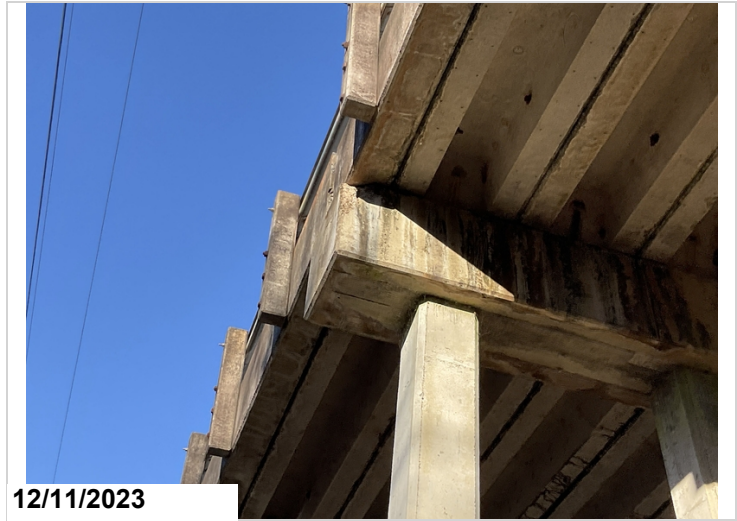
Spall on left side of bent 5 cap

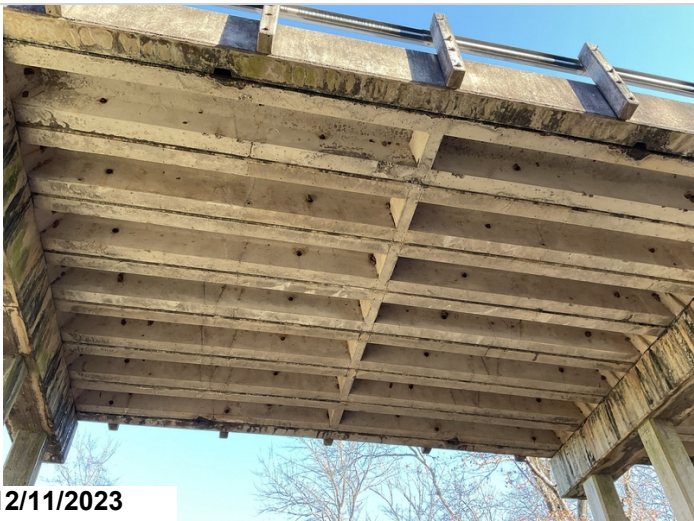
Minor spalling on various precast units. Span 3

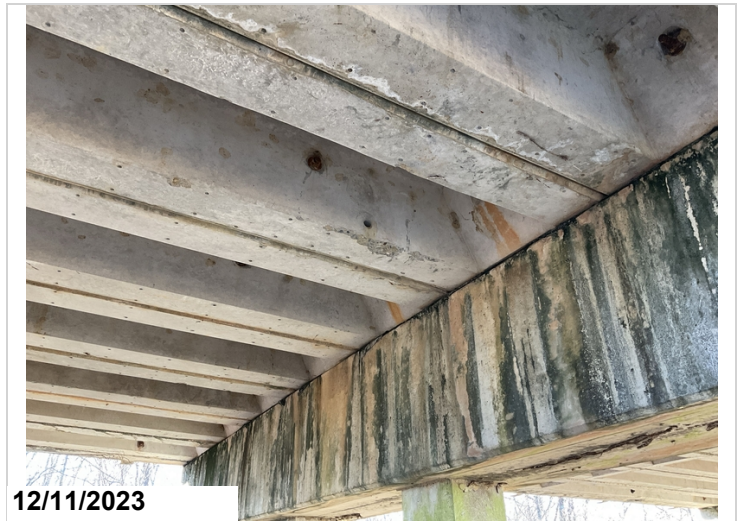
Minor spalling on various precast units

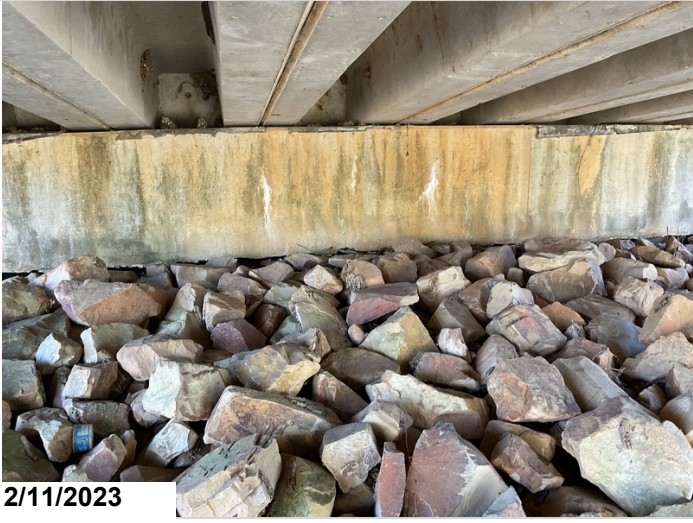
Cracking with Efflorescence in abutment 1

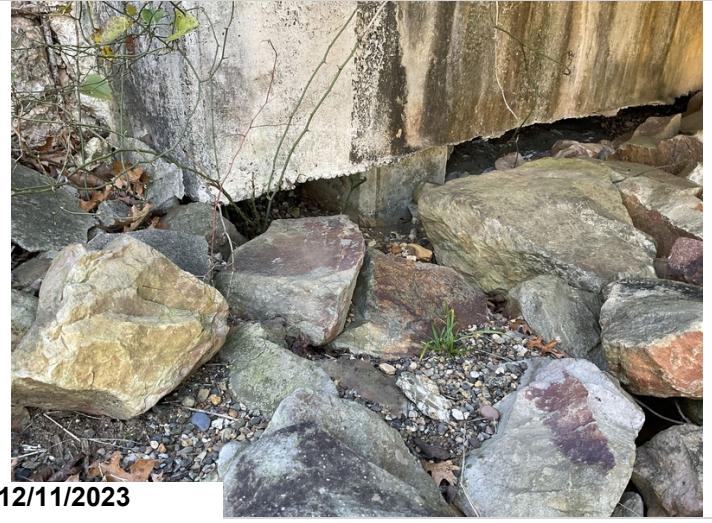
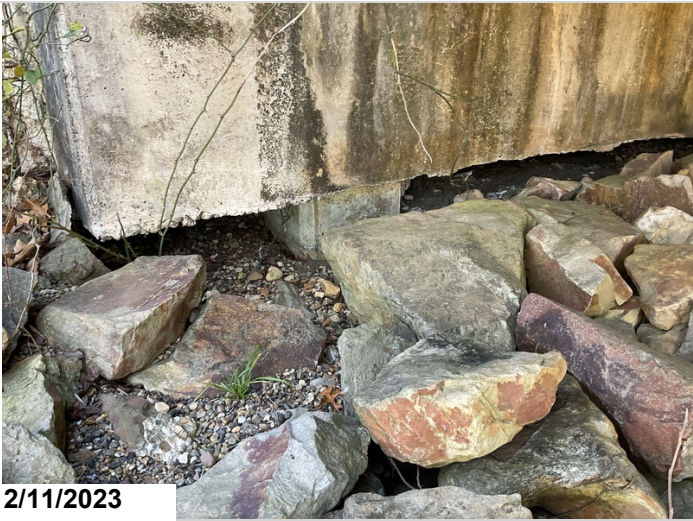
Pile exposed right side of abutment 1

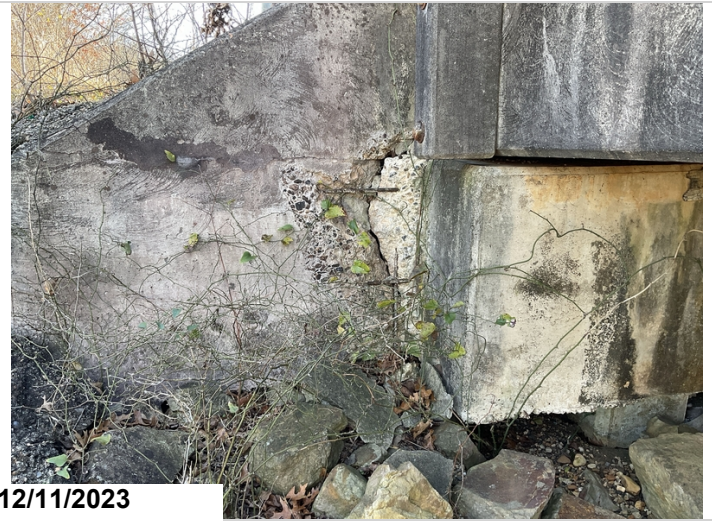
Spalling with rebar exposed to right side of bent 1 abutment wing

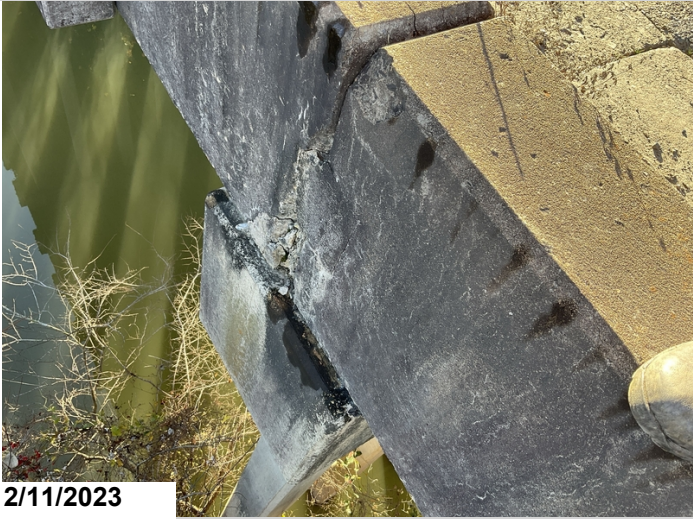
Spalling on right and left sides of bent 6

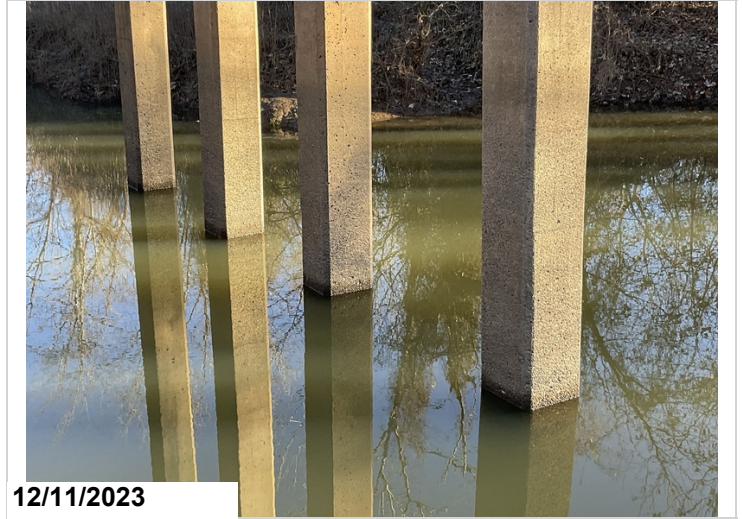
Abrasion to columns

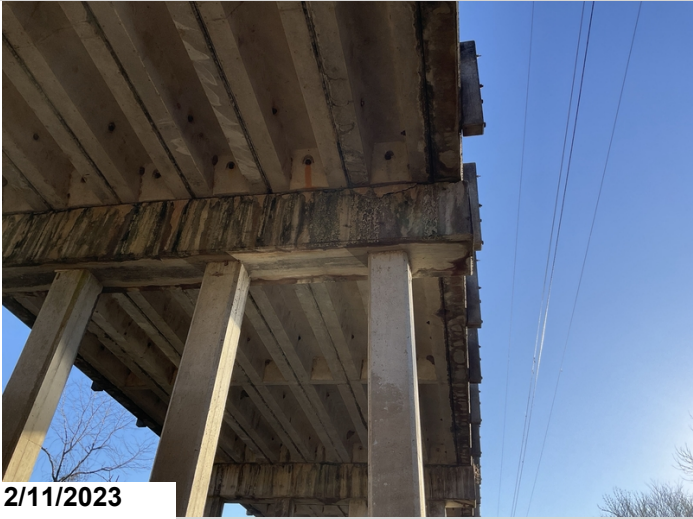
Delam on left side of bent 9, span 10 side.

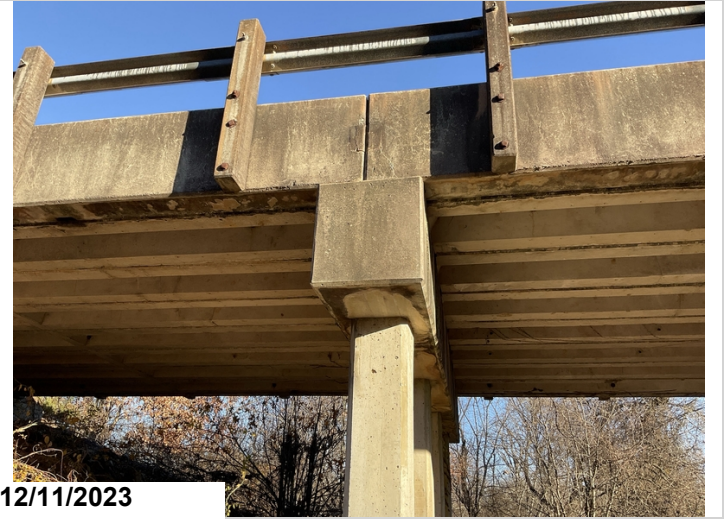
Delam and cracking with efflorescence above bent 11. Both sides have cracking with efflorescence

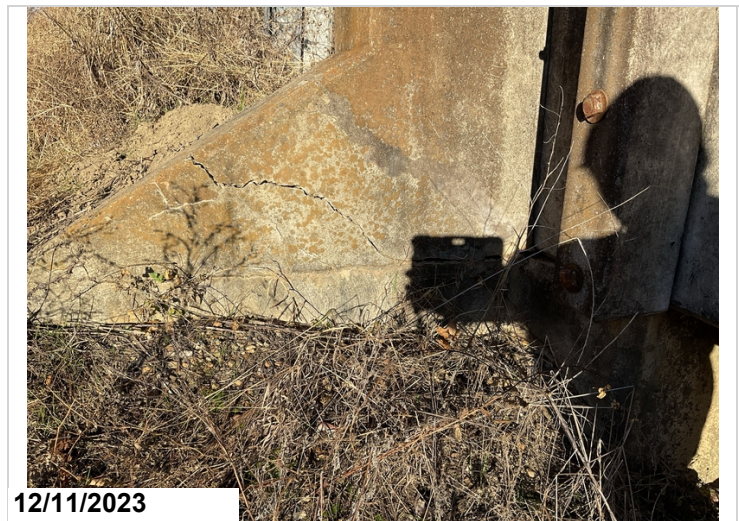
End of bridge left side cracking on abutment wing

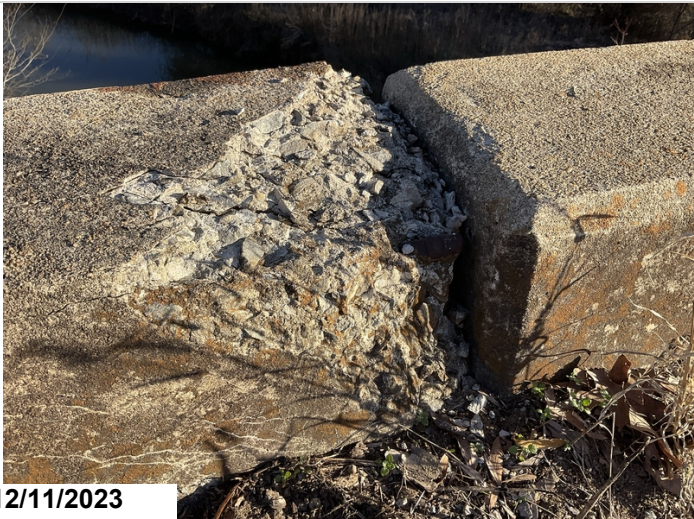
Spall with rebar exposed on right side of concrete bridge railing in span 7

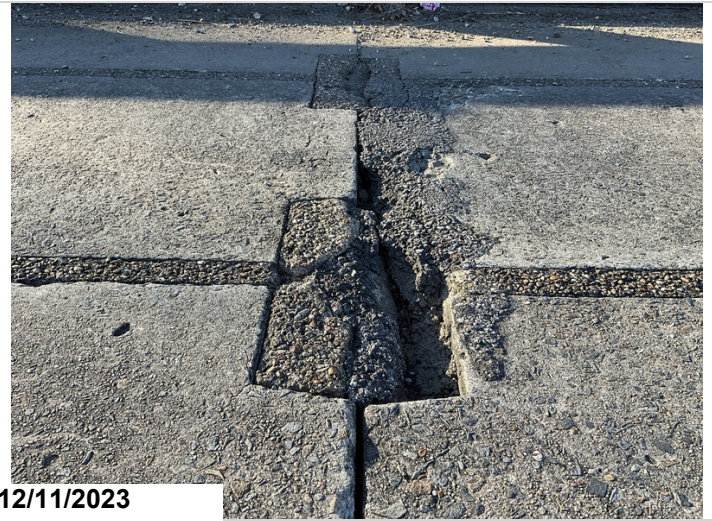
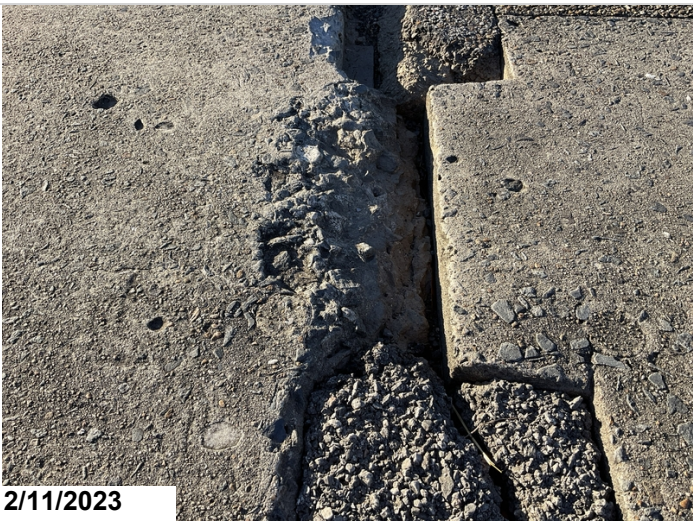
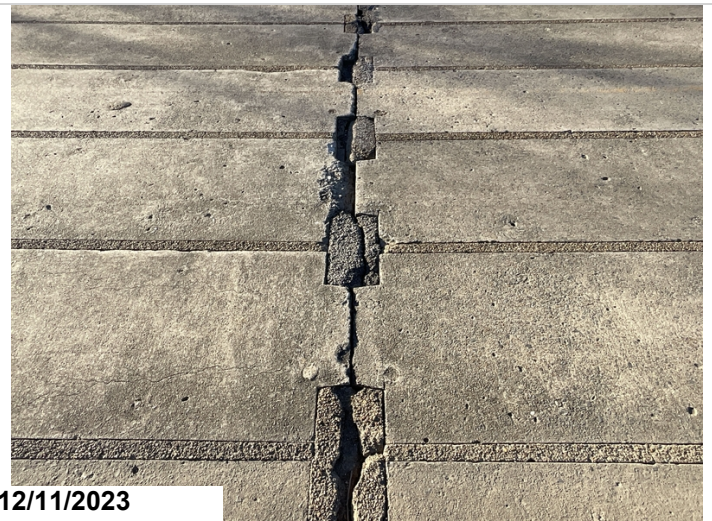
Spalls on edges of precast units

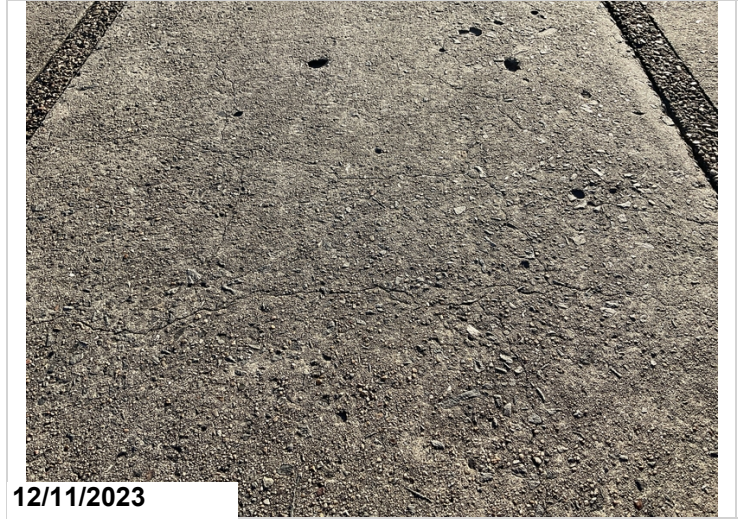
Sealable deck cracking in all spans in various locations of top flange.

Sealable deck cracking in all spans

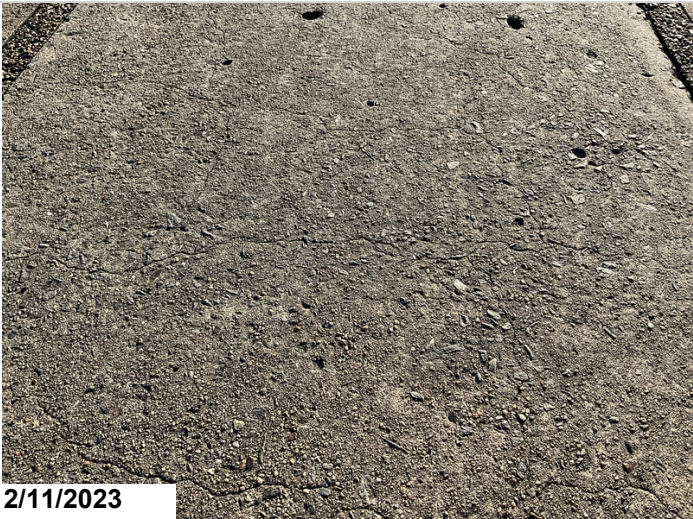
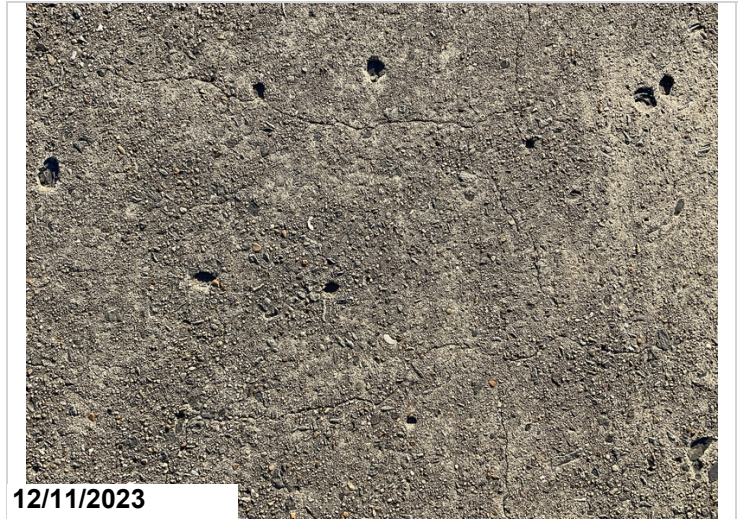
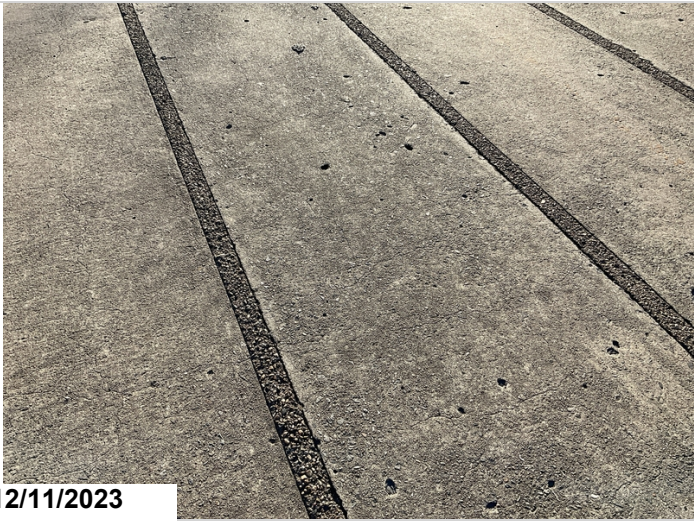
Cracking in units

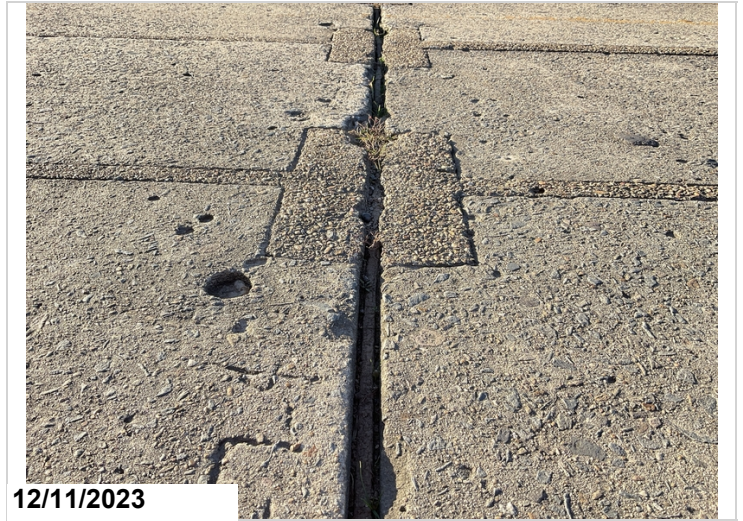
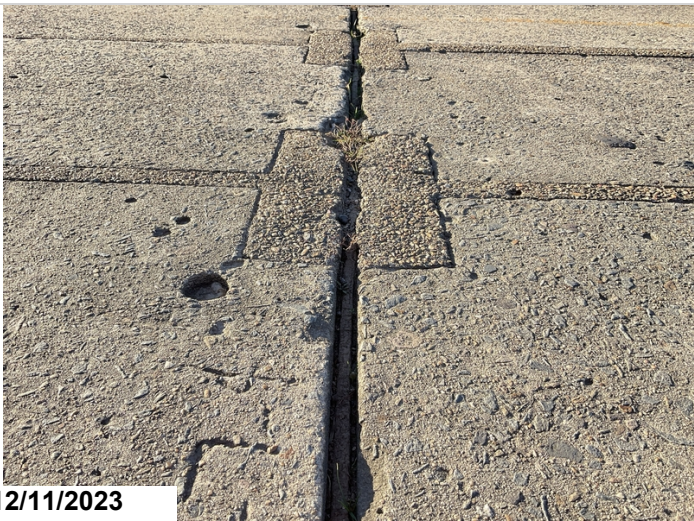
Joints are leaking at various bents.

Loss of joint material

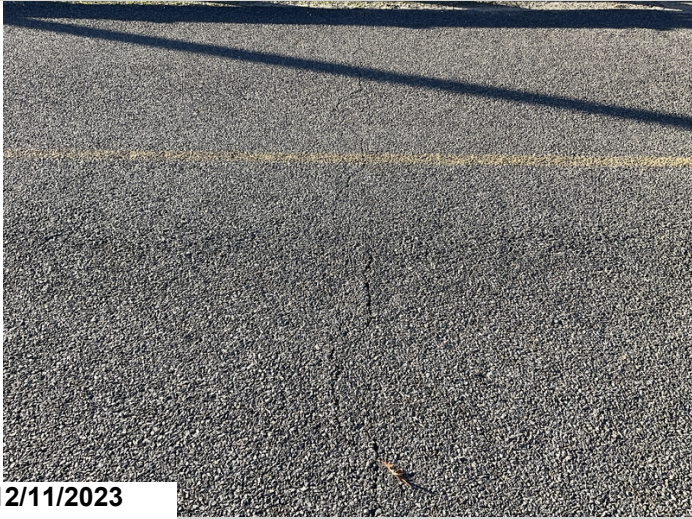
Cracking in asphalt wearing surface in span 1

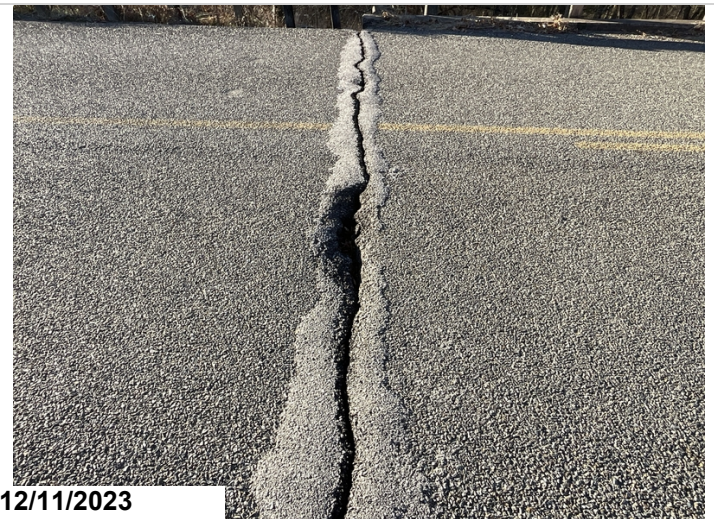
Large cracking in asphalt at beginning of bridge

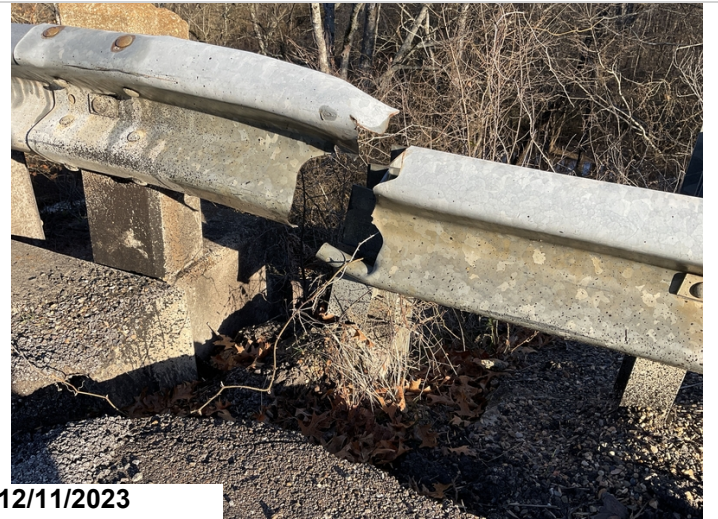
Beginning of bridge right side damage

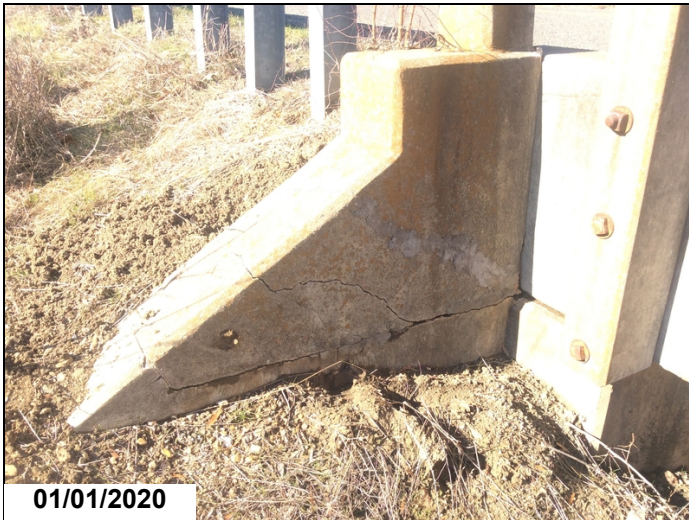
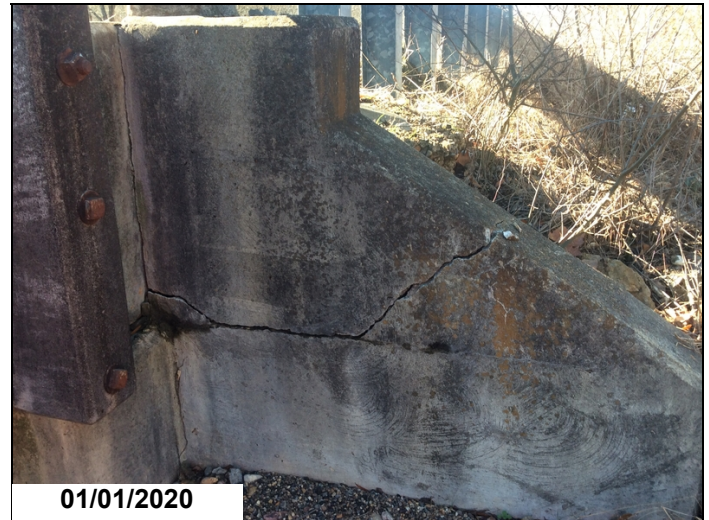
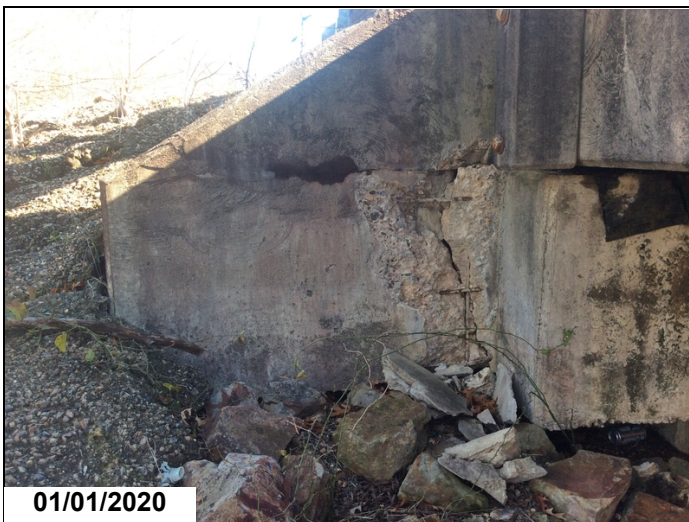
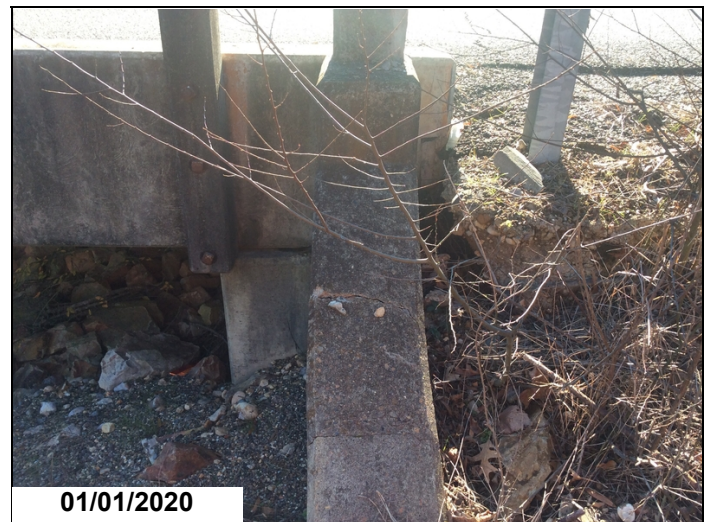
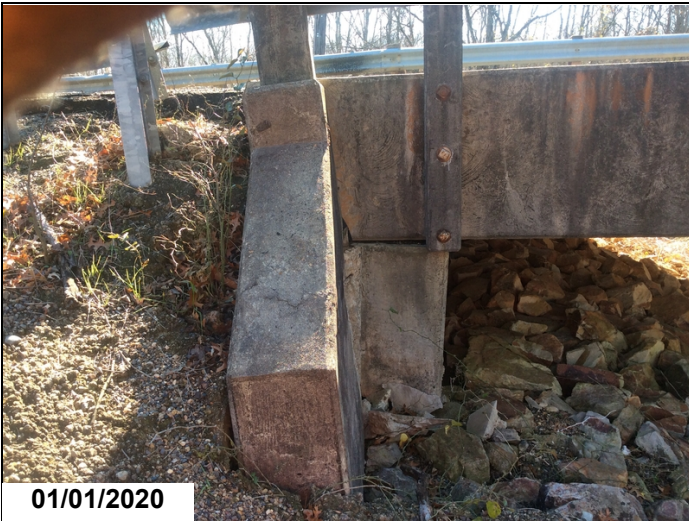
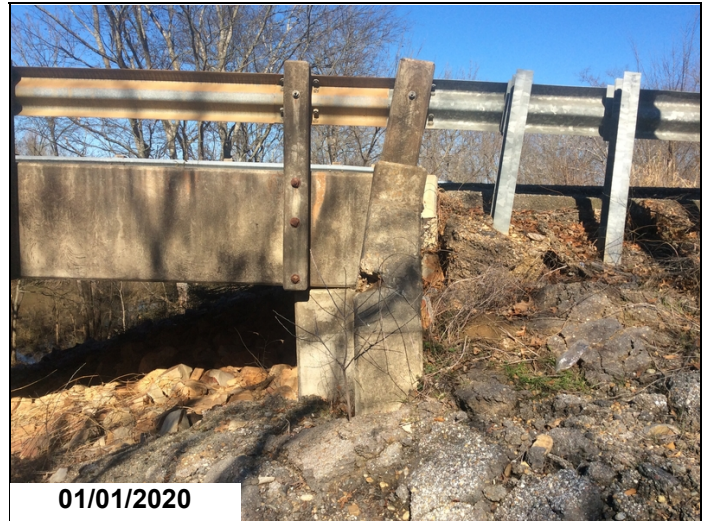
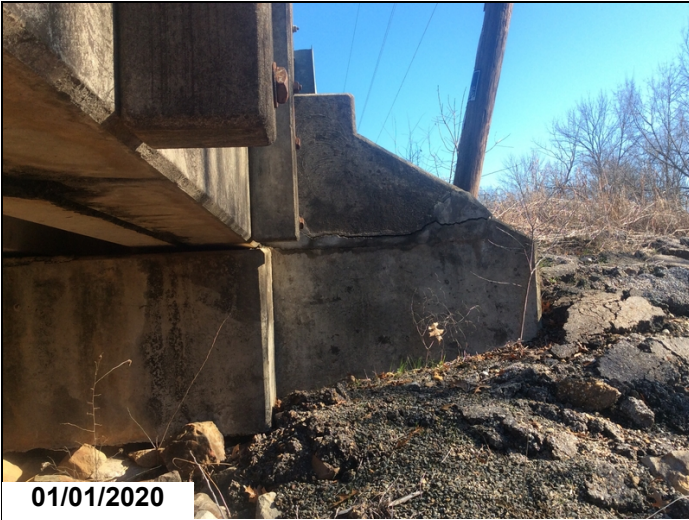
Beginning of bridge Right side has exposed rebar and Left side wing walls has cracking and are leaning do to embankment pushing against them End of bridge wing walls has cracking present also and slight leaning to them also

Abutment wing wall left side cracks

Right side end of bridge abutment wing wall cracks

Abutment wing wall cracked and exposed rebar right side beginning of bridge

Right side abutment wing wall end of bridge

Right side beginning of bridge wing wall leaning and cap leaning opposite direction

Left side beginning of bridge wing leaning also cap leaning in opposite direction

Abutment wing wall crack left side of beginning of bridge

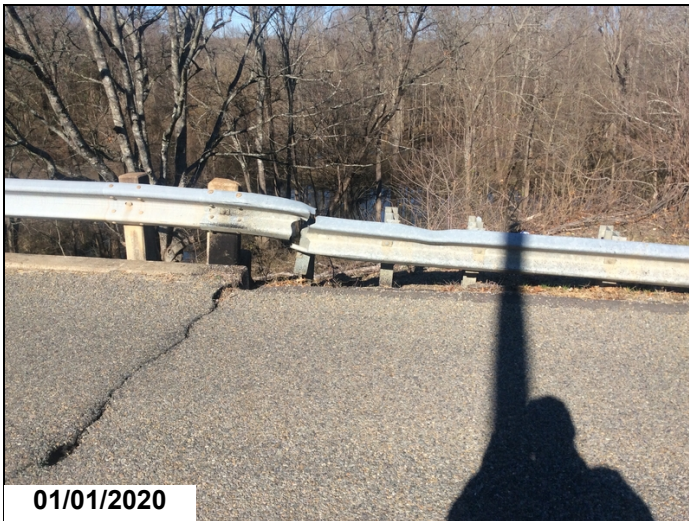
Guard rail beginning of bridge right side is sheared next to the first guard rail post

Guard rail busted right side beginning of bridge

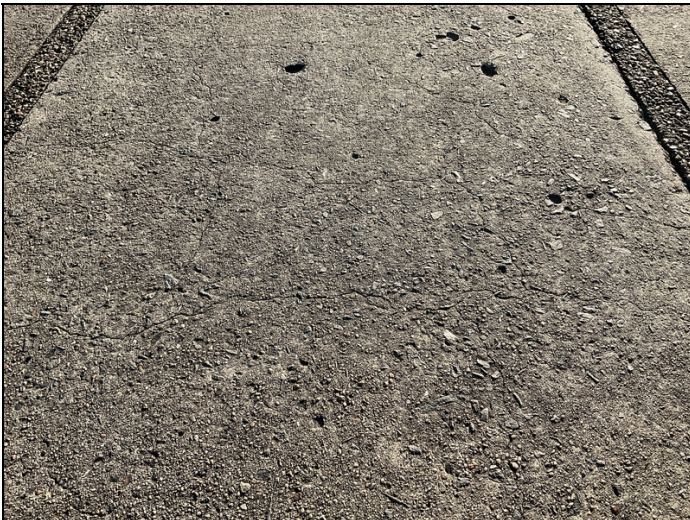
Sealable deck cracking in all spans in various locations of top flange.

Sealable deck cracking in all spans

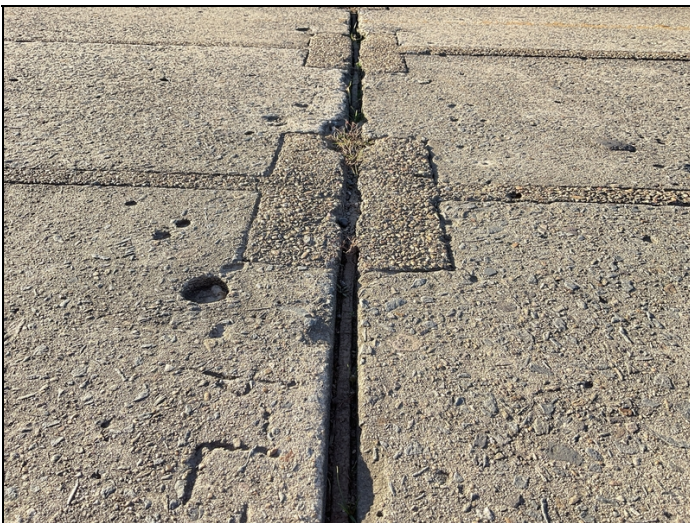
**A-59 - Joint Repair Needed (Yes)**  
Joints are leaking at various bents.

Loss of joint material
