**Asset #13879**(Routine, Underwater type 2)

**CR2/BRIGHT STAR Rd over INGRAHAM CREEK**

**Location: 2 MI W SH 355**

**Team Lead: Jared Kegley Inspection Date: 12/11/2023**

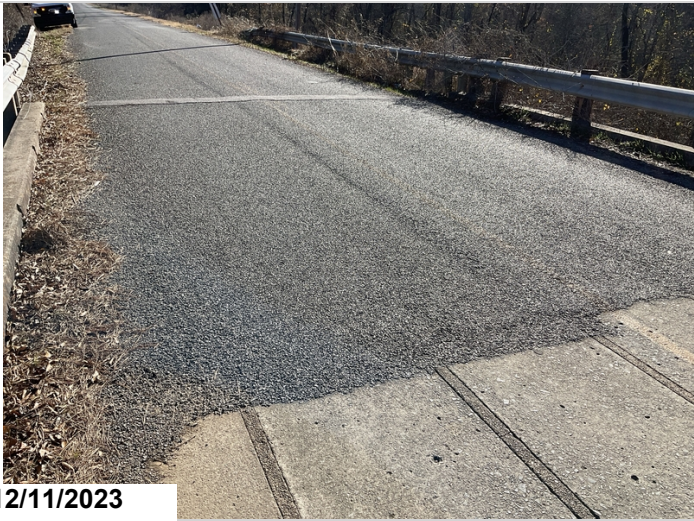
Asphalt covers ring beginning and end bents

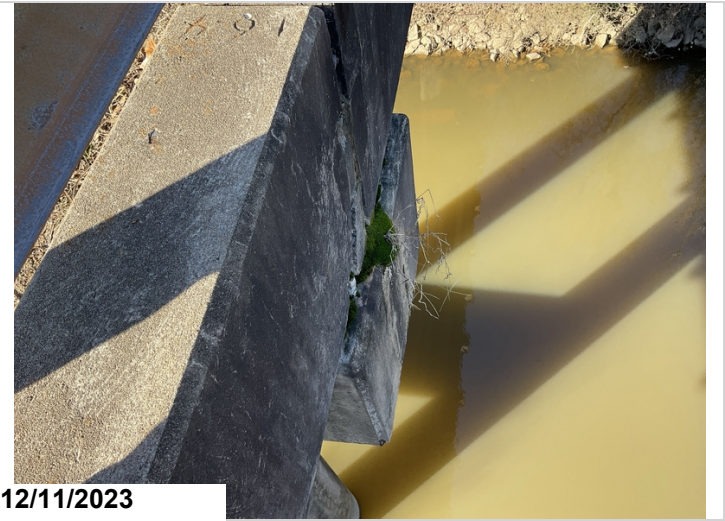
Superstructure is rated a 6 this inspection due to minor spalls in various locations of channel beams. Bent 4 RT side spall on corner of unit above cap. All units are bolted together, all bolts have corrosion.

Bent 4 RT side spall on corner of unit above cap

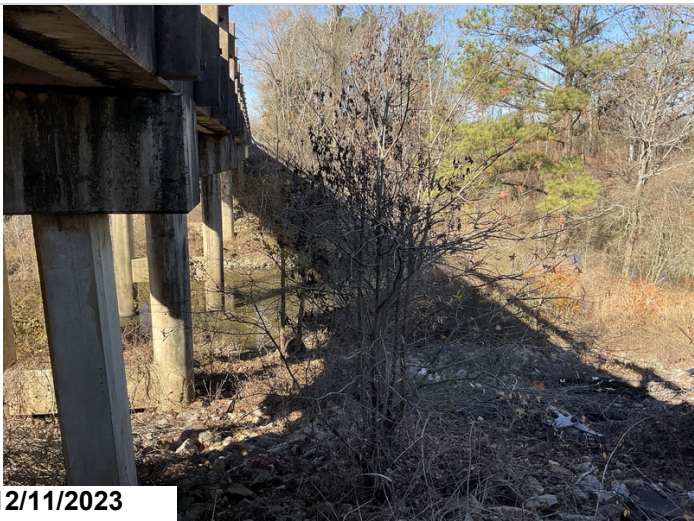
Trees and vegetation growing on both sides of bridge.

Trees growing on RT side of bridge

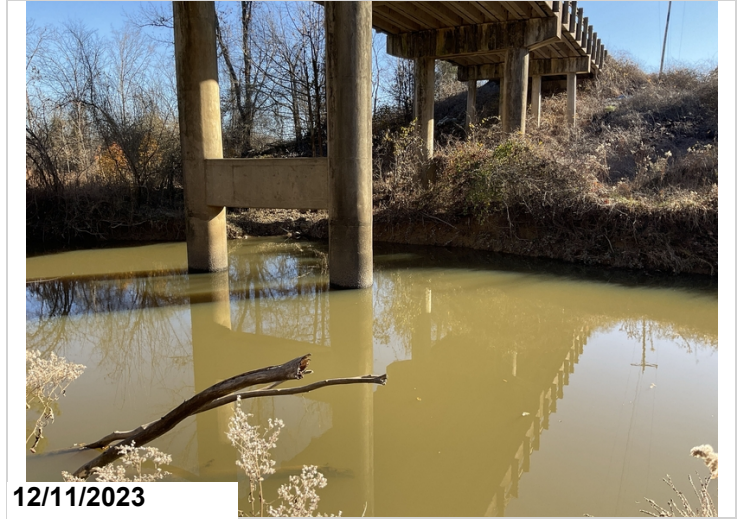
Dropped scour to a 6 this inspection due to isolated moderate scour around bents 4 and 5.

Some scour around bents 4 and 5

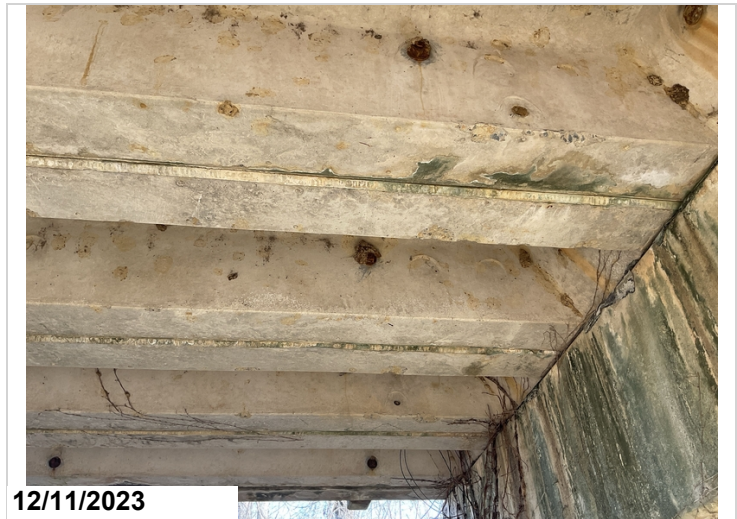
All precast units are bolted together, bolts have corrosion

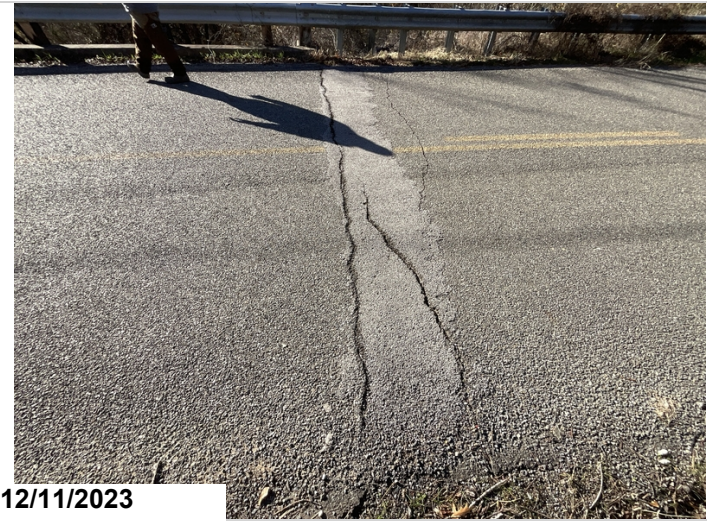
End of bridge joint covered with asphalt

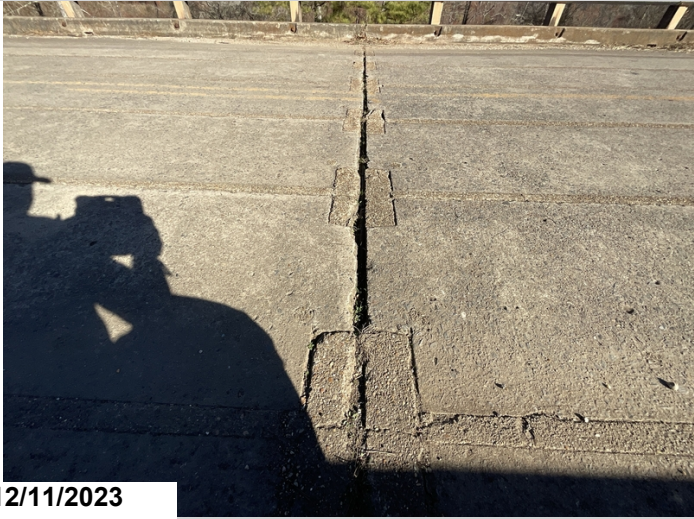
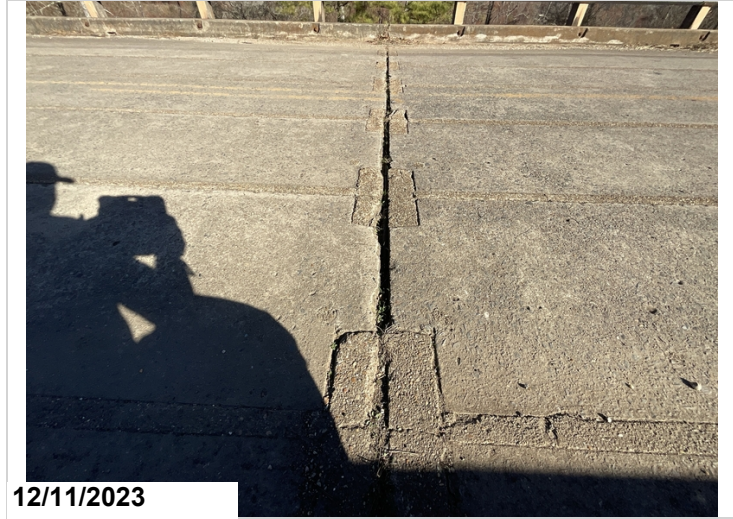
Bent 4 joint

Joints leaking at various bents on bridge.

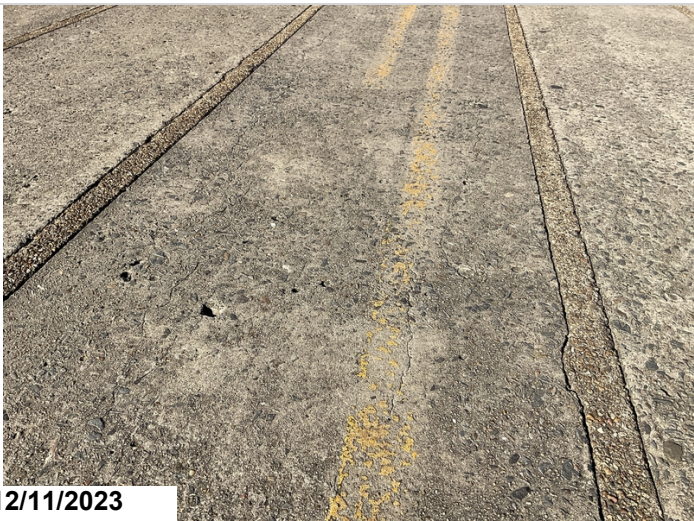
Sealable deck cracks in various locations of top flange.

Sealable deck cracks in various locations of top flange

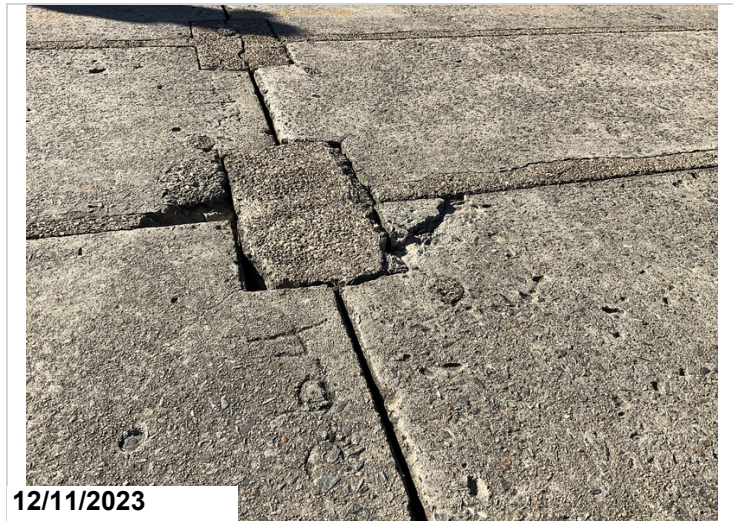
Bent 3 unit 6 end spall

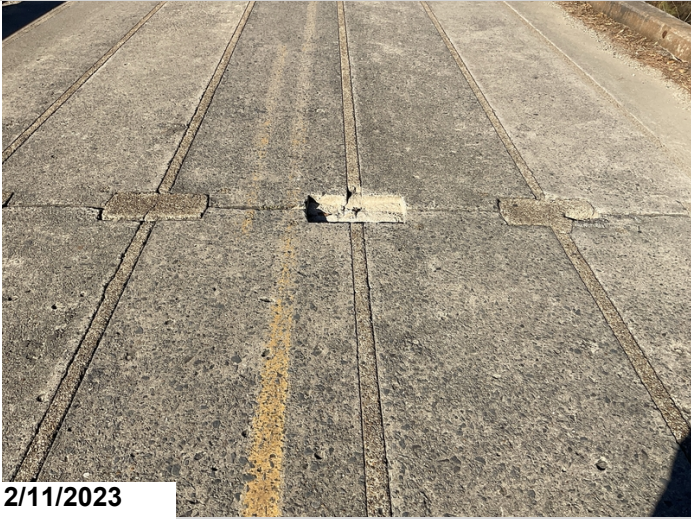
Bent 2 joint spall on centerline

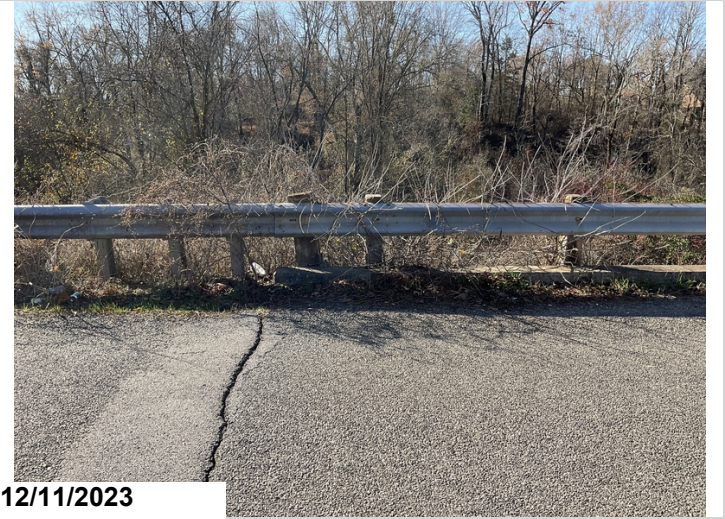
Vegetation LT side

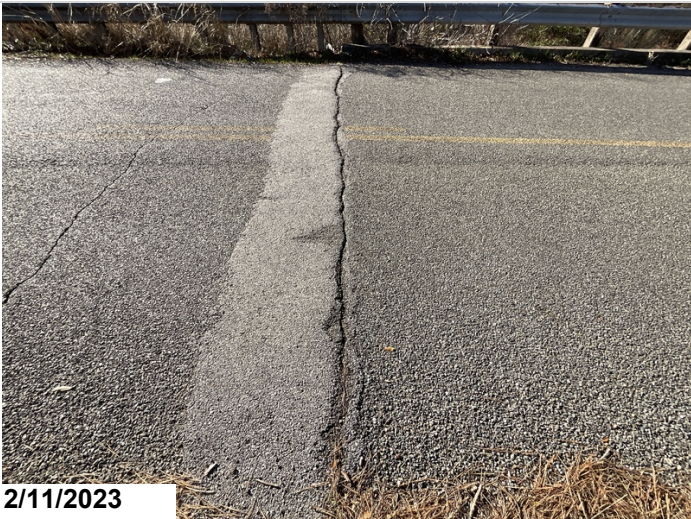
Joint at beginning of bridge covered with asphalt

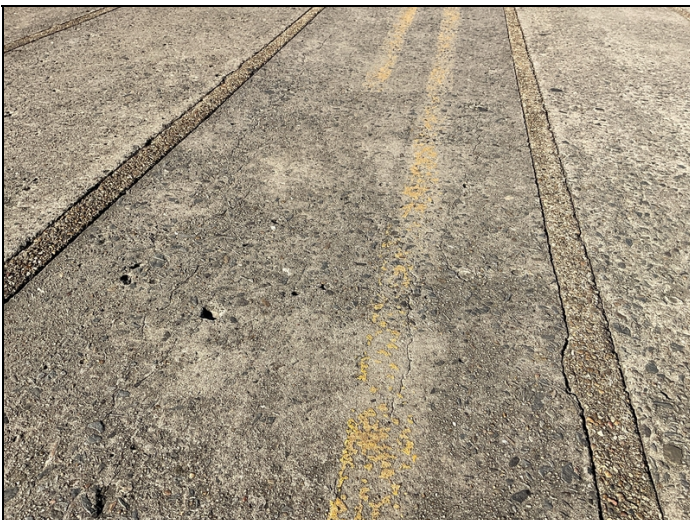
Sealable deck cracks in various locations of top flange.

Sealable deck cracks in various locations of top flange

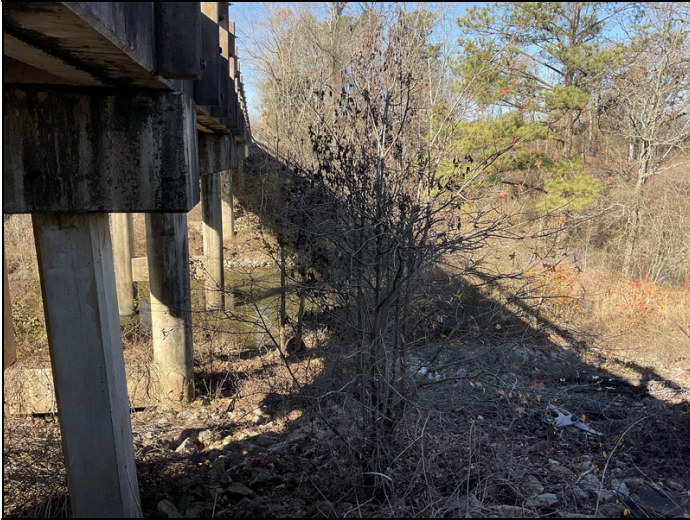
Trees and vegetation growing on both sides of bridge.

Trees growing on RT side of bridge

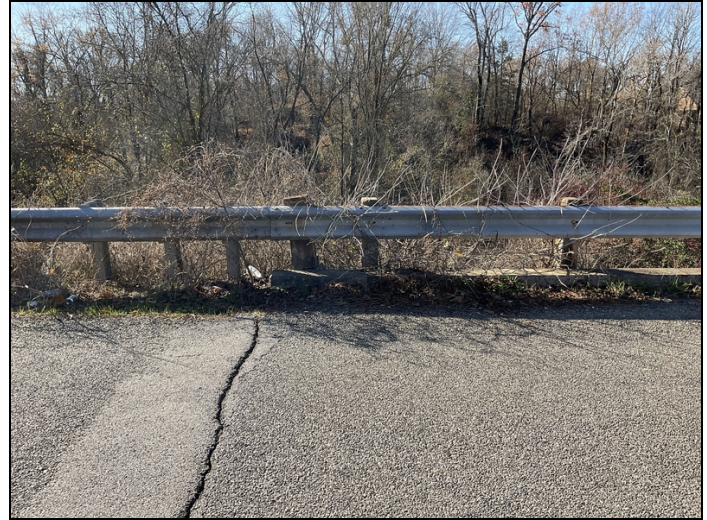
Vegetation LT side
