**Bridge #20917(Routine)**  
**CR70/Independ. Co. over BAKER BRANCH**  
**Location: 1.9 MI W SH 122**

**Team Lead: Nathan Edwards Inspection Date: February 03, 2021**

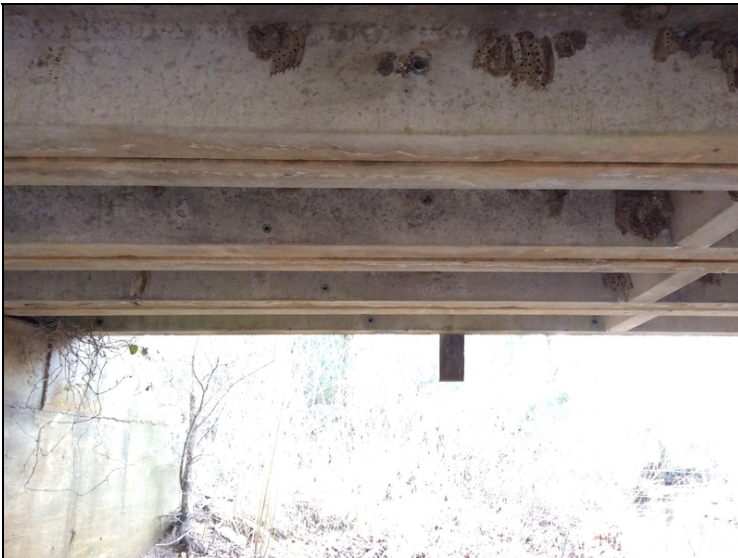
Span 1  
Units 1 thru 6 are not bolted together.

Units are not transversely bolted together.

A few minor spalls to girders.  
Units are not transversely bolted together.

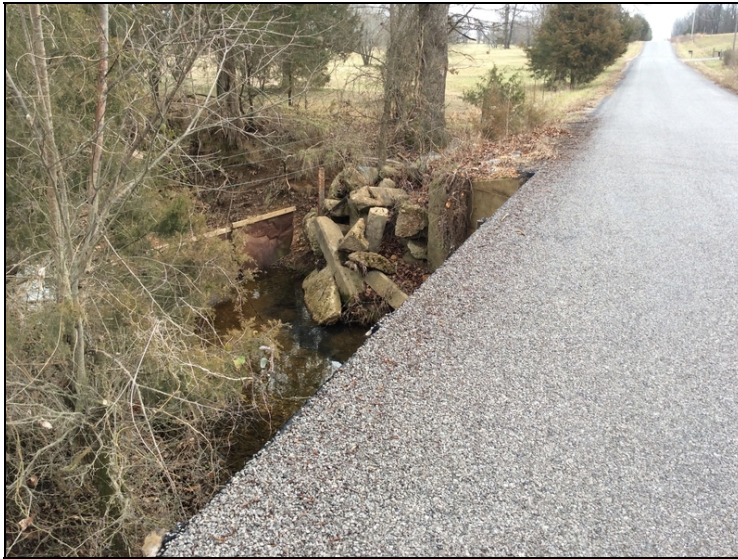
Span 1  
Bridge rail is missing on Left & Right sides.

Bridge rail is missing on Left side.

A few spalls to ends of units @ Abutments 1 & 2.  
Timber railing has been removed and/or broken off of bridge.

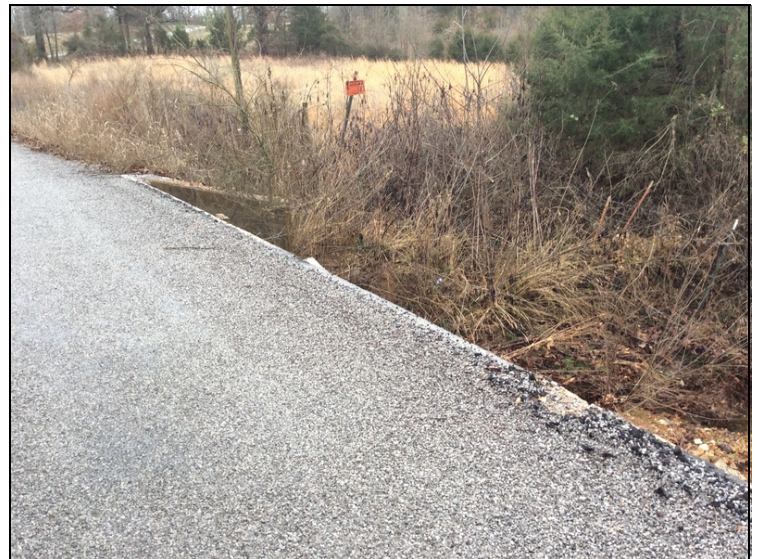
Bridge rail is missing on Right side.

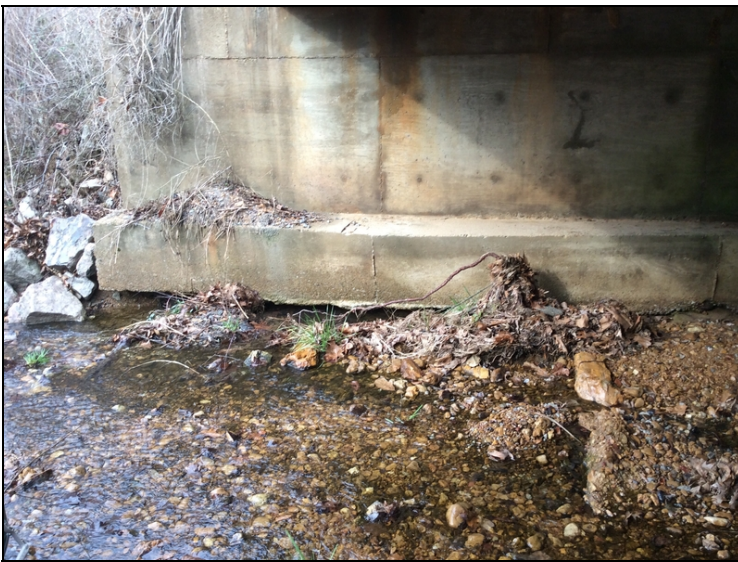
Abutment 1  
Scoured 1' below bottom of footing & 2' back under.

Scoured 1' below bottom of footing & 2' back under  
@ Abutment 1.

Scoured 1' below bottom of footing & 2' back under to Right end of Abutment 1.  
Scoured 1.5' below top of footing Left end of Abutment 2.

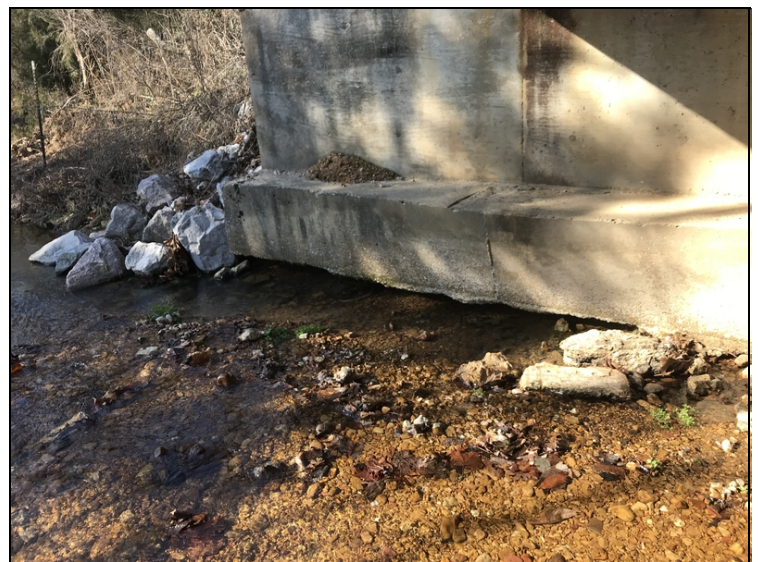
Abutment 1  
Scoured 1' below bottom of footing & 2' back  
under.

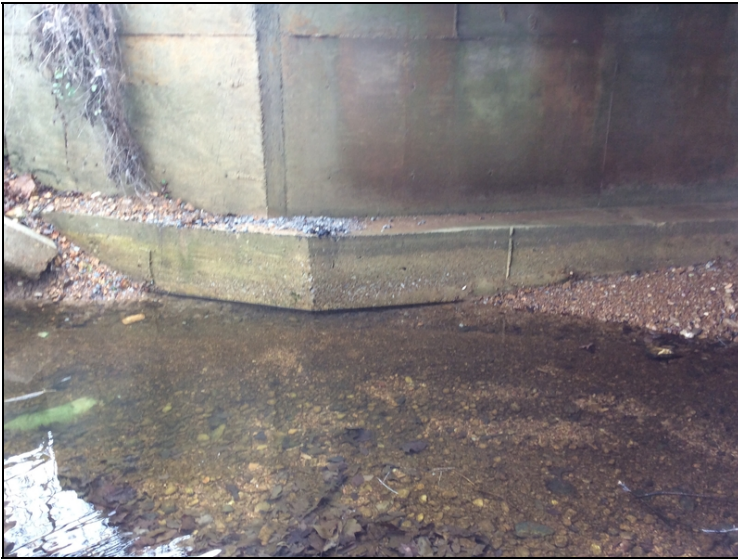
Abutment 2  
Scoured 1.5' below top of footing for full length & 6" below bottom of footing & 6" back under at Left end.

Scour @ Abutment 2.
